Wolgan Road, NSW

Review of Wolgan Gap Slope Hazards 2022

PS129742-SYD-GEO-REP-001-REV 0

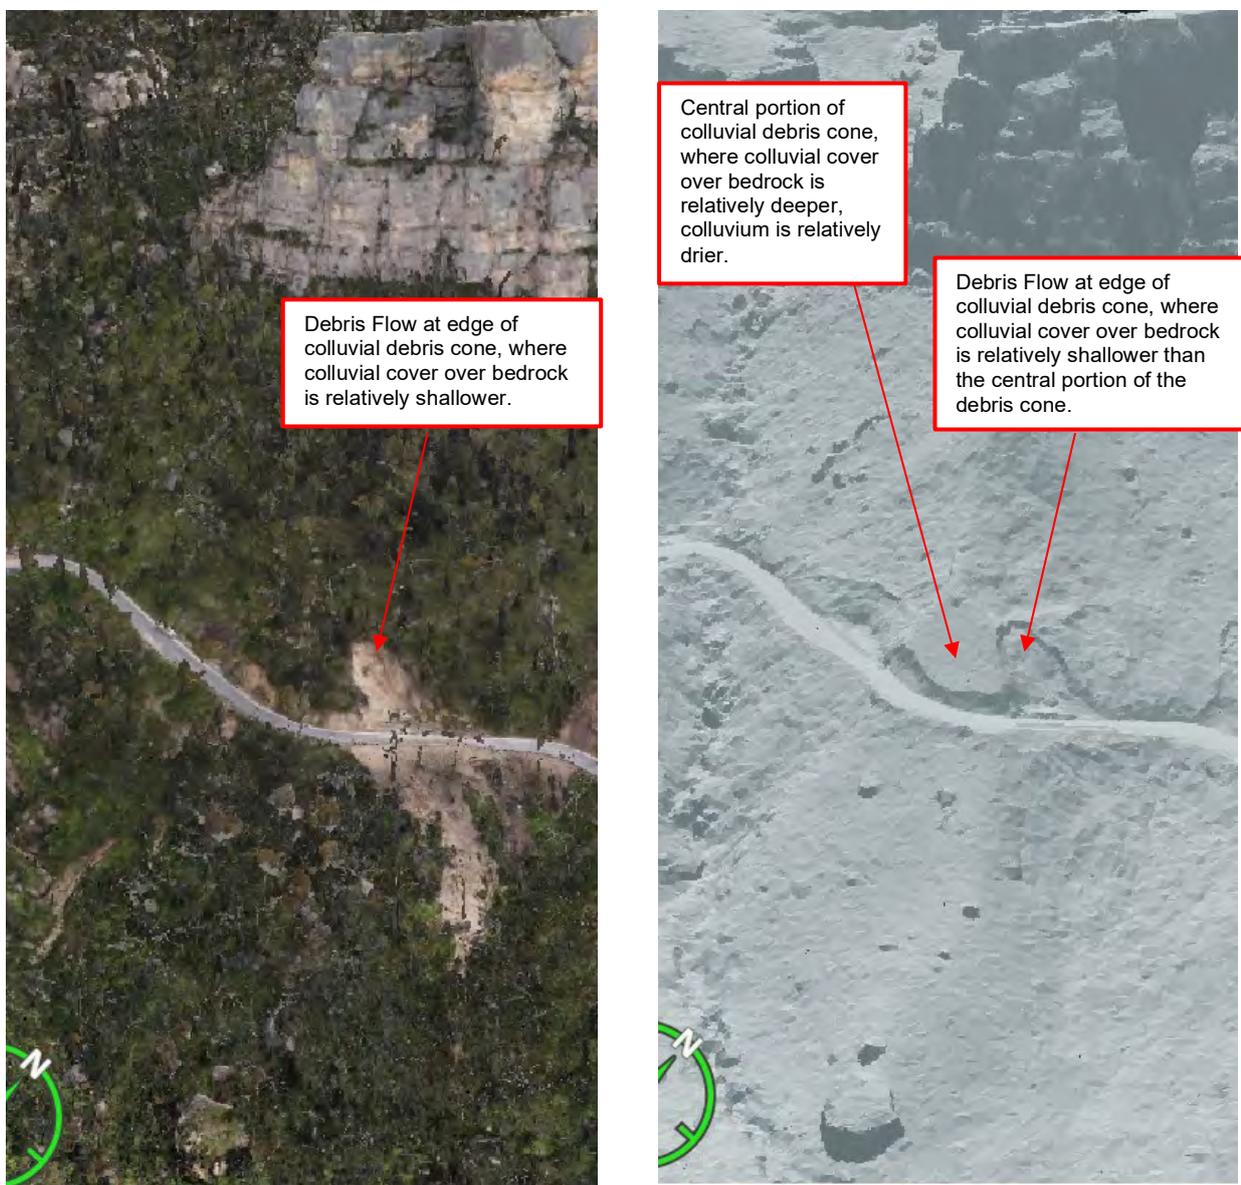
Figure 2 : Example of Debris Flow at edge of colluvial debris cone (Site 3C), shown on 15 November 2022 UAV photo aerial (left image) and LiDAR derived hillshade (right image).

weathered rock with concentrated saturated zones and seeps near the weathered rock interface were made at other landslides which occurred during 2022 including adjacent to Site 3C, as shown in Figure 2 further below.

A frequent observation of landslides within the colluvial slopes at Wolgan Gap in 2022 has been the propensity for relatively wetter, higher velocity and more shallow debris flow type landslides to develop at the edges of colluvial debris cones or landslide lobes more frequently and typically prior to the development of relatively drier, lower velocity and deeper debris slides of the central portion of the cones/lobes. That characteristic is inferred to be a 3 dimensional effect resulting from the relative lack of confinement at the edges compared to within the central portion of the cone/lobe where the colluvium is deeper. The result is that the edges reach a fully saturated state with a mobilised failure surface (typically close to rock contact, in accordance with Slide Type A of Figure 1) sooner than the central portion which has a deeper cover of relatively drier colluvium. An example of a debris flow at the edge of a cone of colluvial debris, at Site 3C is shown in Figure 2 below.

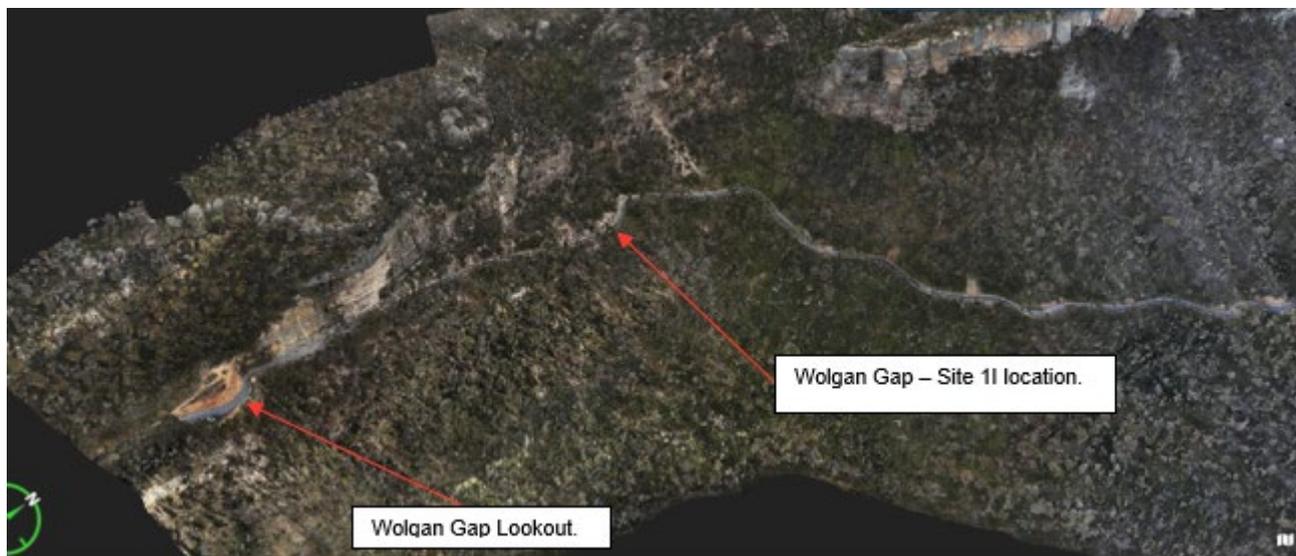
Figure 3 : Wolgan Gap, Site 11 location

On Sunday 6th November 2022 Council reported to WSP Golder that a new landslide had been observed on Saturday 5th November 2022 at the approximate location shown in Figure 3 below. Temporary remediation works were on-going elsewhere on the site in the week prior but no works had occurred at the site of the new landslide, referred to hereafter as Site 11.

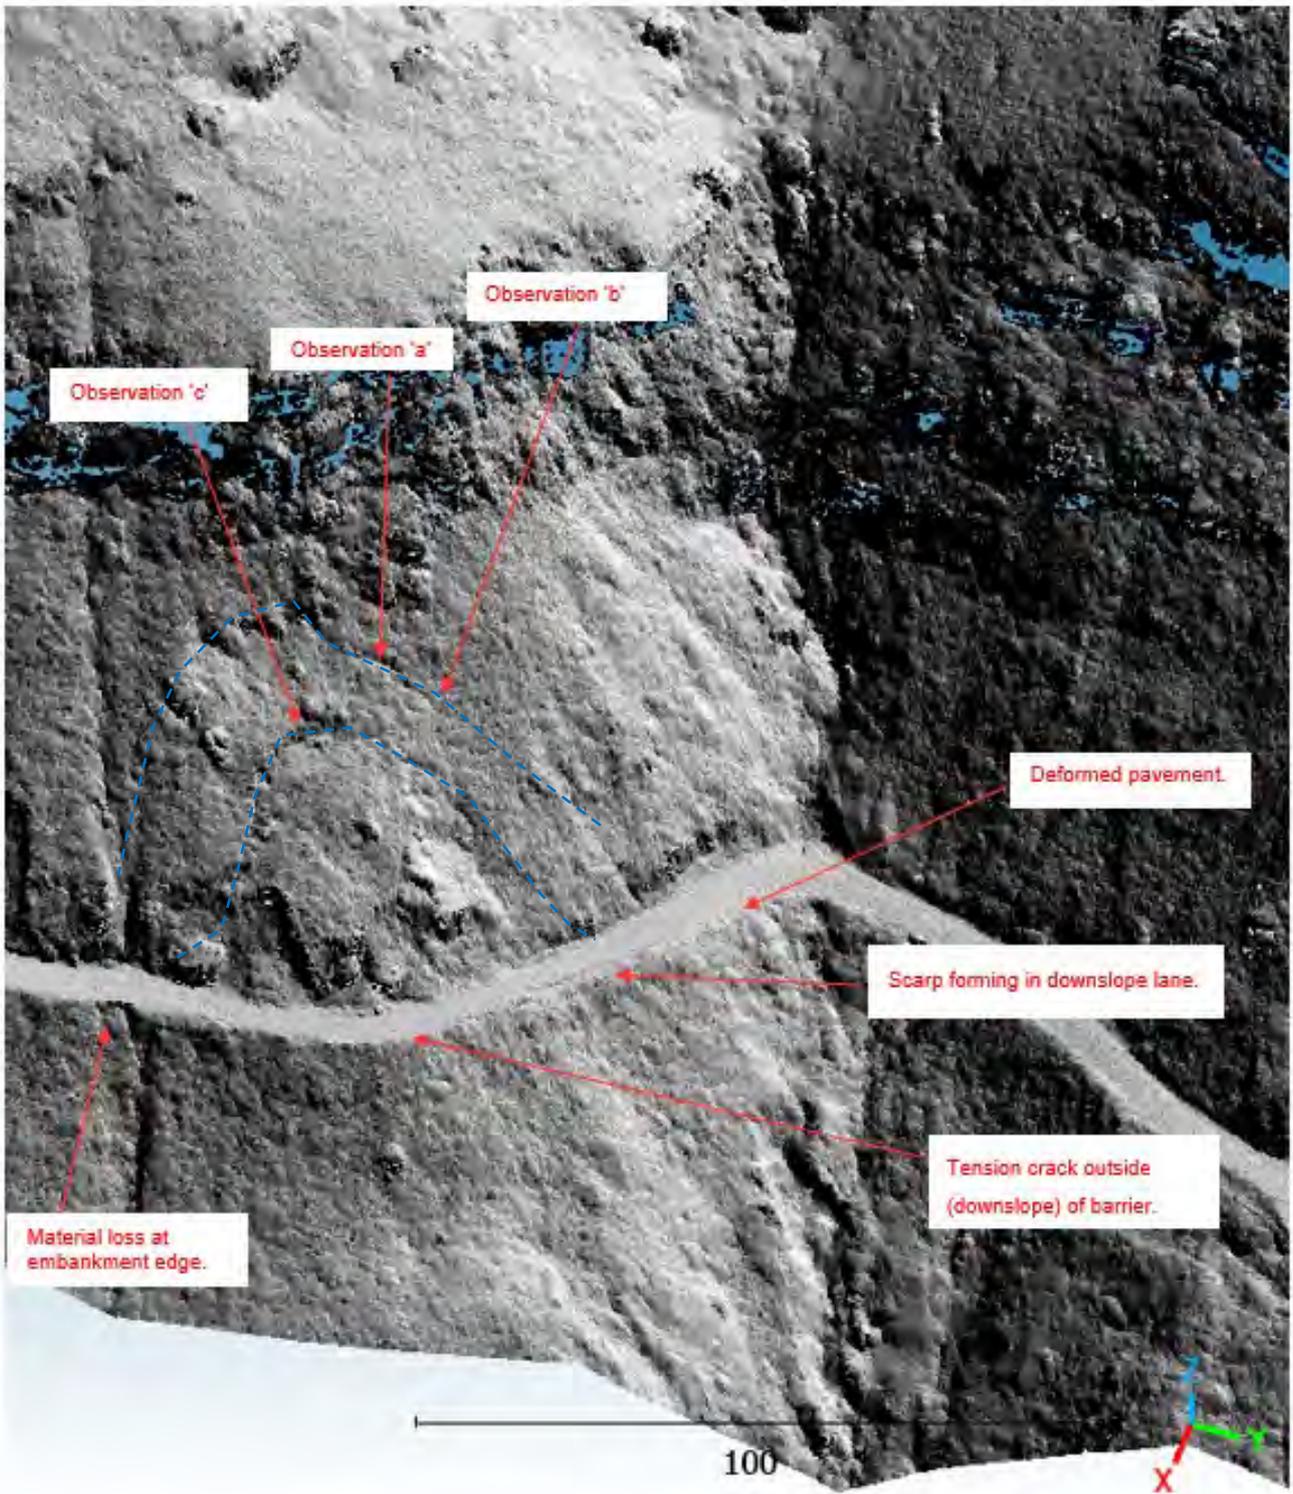
Figure 4 : Surface features inferred to correspond with slope instability observed at Site 1I, November 2022, annotated on 15.11.22 LiDAR derived hillshade.

The mobile colluvial mass observed at Site 1I includes sandstone boulders of minimum dimension greater than 5 m. Slide debris which had reached the road by 7th November 2022 included up to approximately 2 m diameter sandstone boulders. Approximately 250 m³ of slip material was removed from the road. In accordance with Item 1 above the risk posed by leaning trees was assessed by a team of professional arborists contracted by Council. Following completion of that risk assessment on 11th November 2022, a safety line was established by a professional rock climber to enable access to steep terrain above the landslide by our Principal Geotechnical Engineer with chaperone by a team of arborists. Our Principal Geotechnical Engineer observed three clearly visible features upslope of the crest of Site 1I consistent with the mobilisation of a landslide, as follows:

- a) An approximately crescent shaped crack, 0.3 m wide and 0.5 m deep.
- b) An approximately 0.1 m wide and 0.3 m deep tension crack.
- c) An approximately 1.5 m high scarp (depth unable to be safely determined at the time of observation).

The landslide was assessed to be small (i.e. 5,000 m³ to 50,000 m³) in accordance with Fell's 1994 classification. However, we inferred that the landslide could form part of a medium landslide (i.e. in the range 50,000 m³ to 250,000 m³) on the basis of observed areas of adjacent instability (e.g. colluvial material below road level which displayed an approximately 30 m long tension crack at road level).

The locations of site observations a, b and c above are annotated on Figure 4 and 5 below, which are a hill shade image and photo aerial image derived from the 15th November 2022 UAV survey respectively. The location of adjacent surface features inferred to be indicative of slope instability are shown on Figure 4 and Figure 5. Those adjacent instabilities have the potential to contribute to a landslide in the medium scale category via a regressive mechanism whereby movement of downslope material removes support to upslope material and/or a successive mechanism (i.e. a Type B slide as shown in Figure 1 above). The location of the primary and minor scarp inferred from site observations and reference to the UAV survey are shown by the blue dashed lines of Figure 4 and 5.

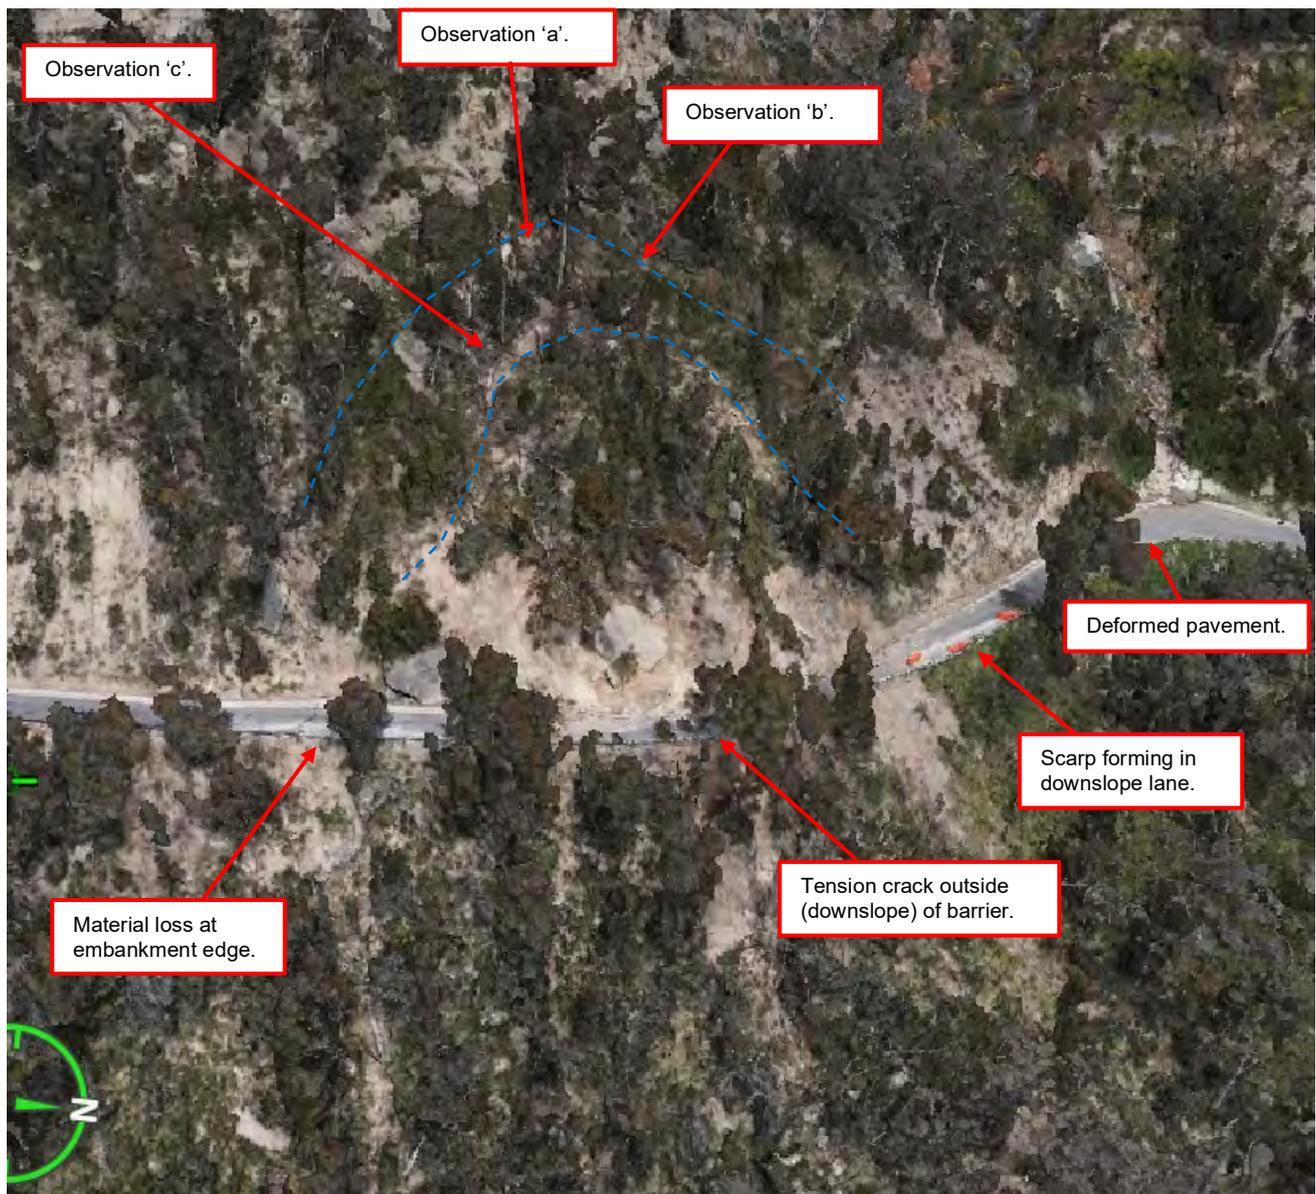
Figure 5 : Surface features corresponding with slope instability observed at Site 11, November 2022, annotated on 15.11.22 aerial photogrammetric survey.

The active landslide at Site 11 is categorised as a slow moving (i.e. with a speed of between approximately 5 mm per day and 500 mm per day) translational debris slide in accordance with Appendix B of the Practice Note Guidelines for Landslide Risk Management 2007 (AGS 2007) based on the overall rate of movement observed between 6th November 2022 and 15th November 2022. However, individual portions of the landslide mass up to approximately 50 m³ in volume released to road level during that period at an extremely rapid velocity (i.e. more than 20 km per hour). It is possible that the overall landslide mass could mobilise at an extremely rapid velocity.

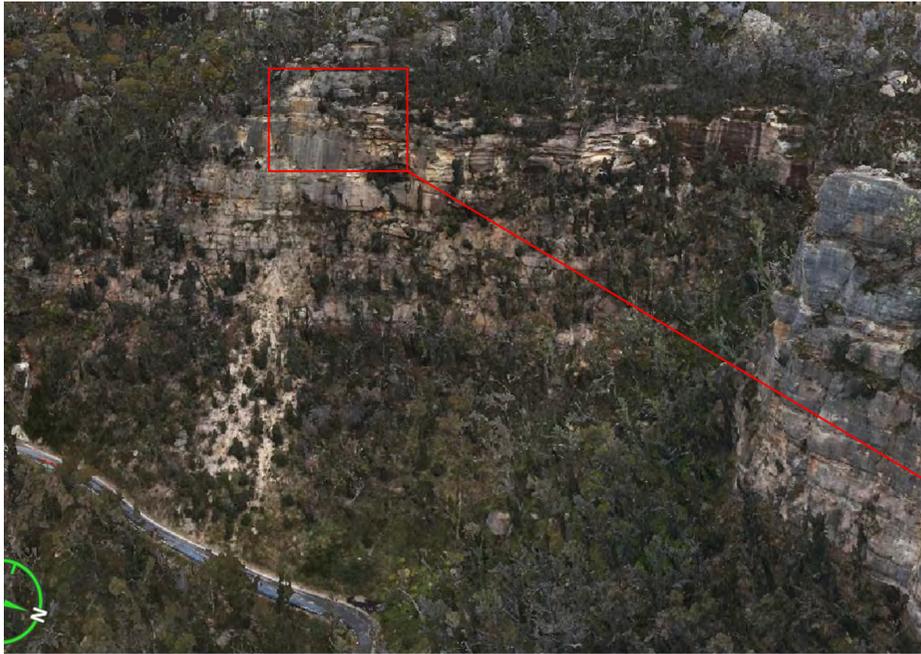
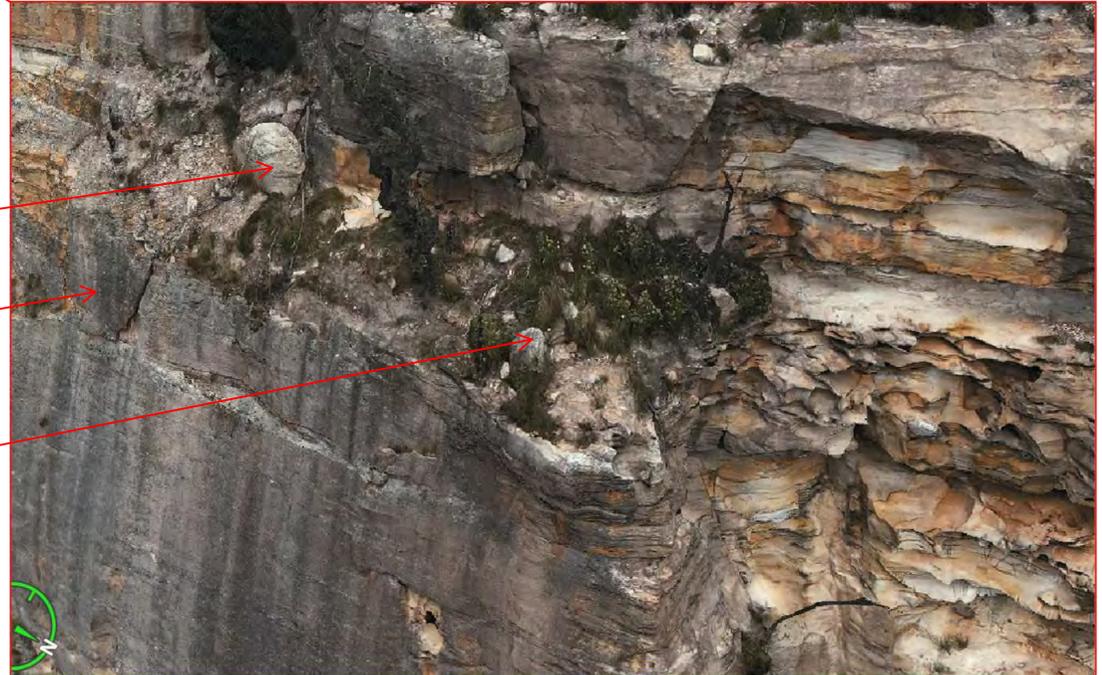
TITLE
Review of Wolgan Gap Slope Hazards 2022
Figure B1 - Example H1.1.1 and H1.1.2 Rockfall Hazards Domain 1 - Upper Source Zone

Example H1.1.2 Rockfall (re-mobilisation) Hazard (Approx. diameter 2 m)

Example H1.1.2 Rockfall (Kinematic) Hazard (Approx. diameter 2 m)

Example H1.1.1 Rockfall (re-mobilisation) Hazard (Approx. diameter 0.5 m)

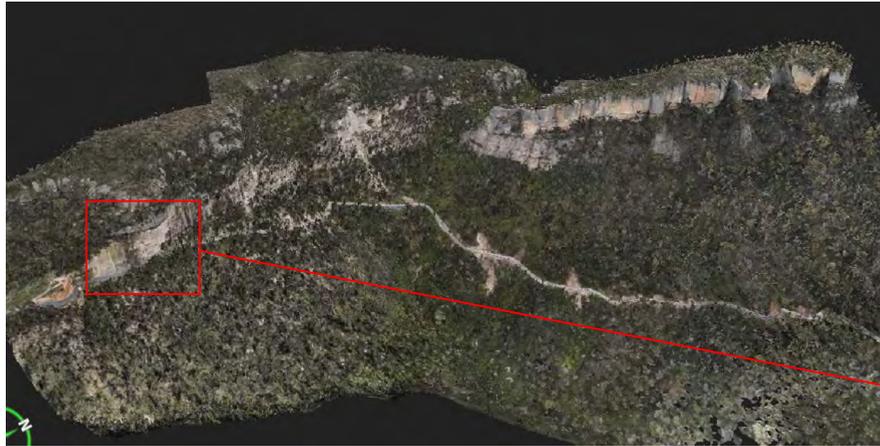
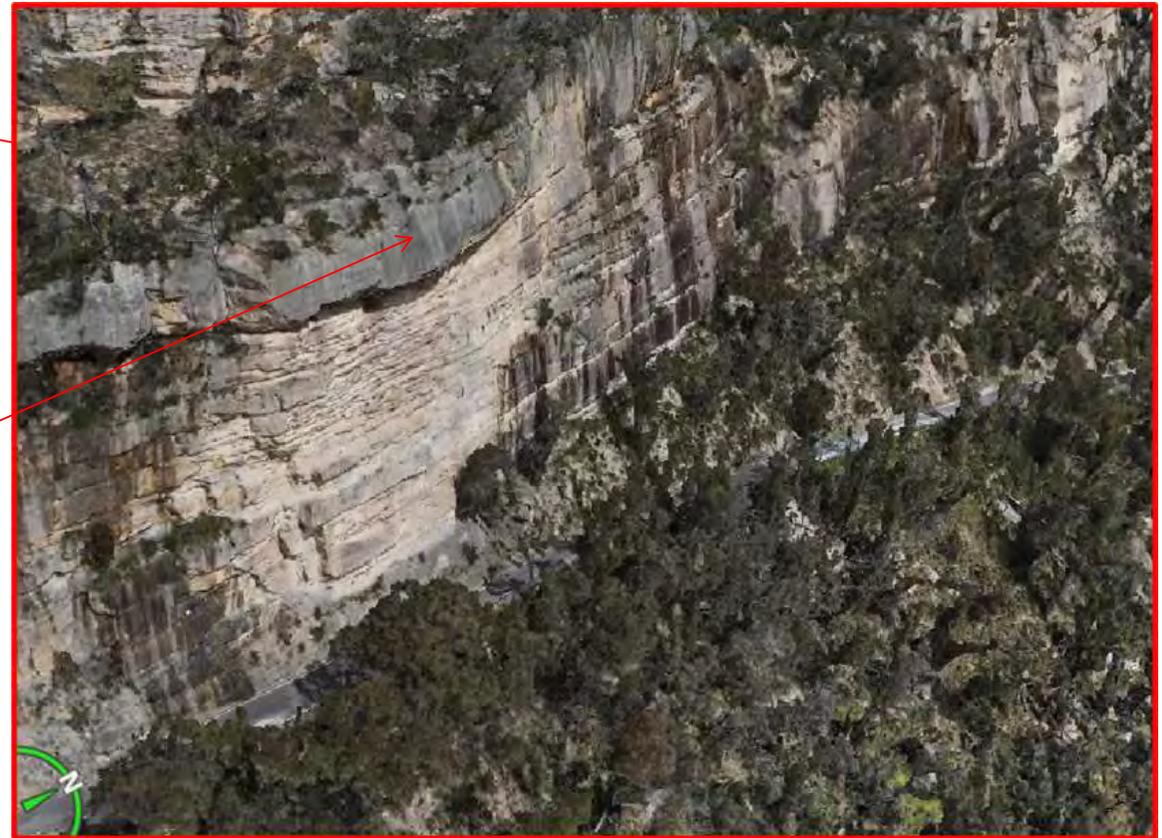
TITLE
Review of Wolgan Gap Slope Hazards 2022
Figure B5 - Example H1.2 Rock Topple Hazards Domain 1

Example H1.2 Rock Topple Hazard (Approx. 65 m long)

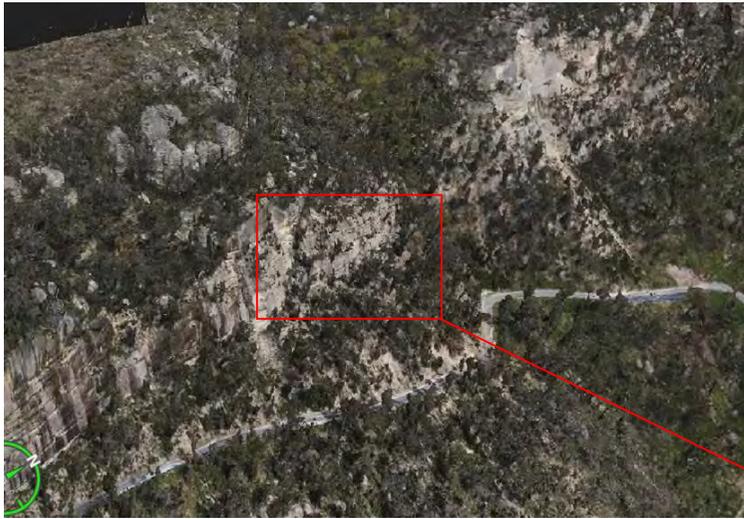
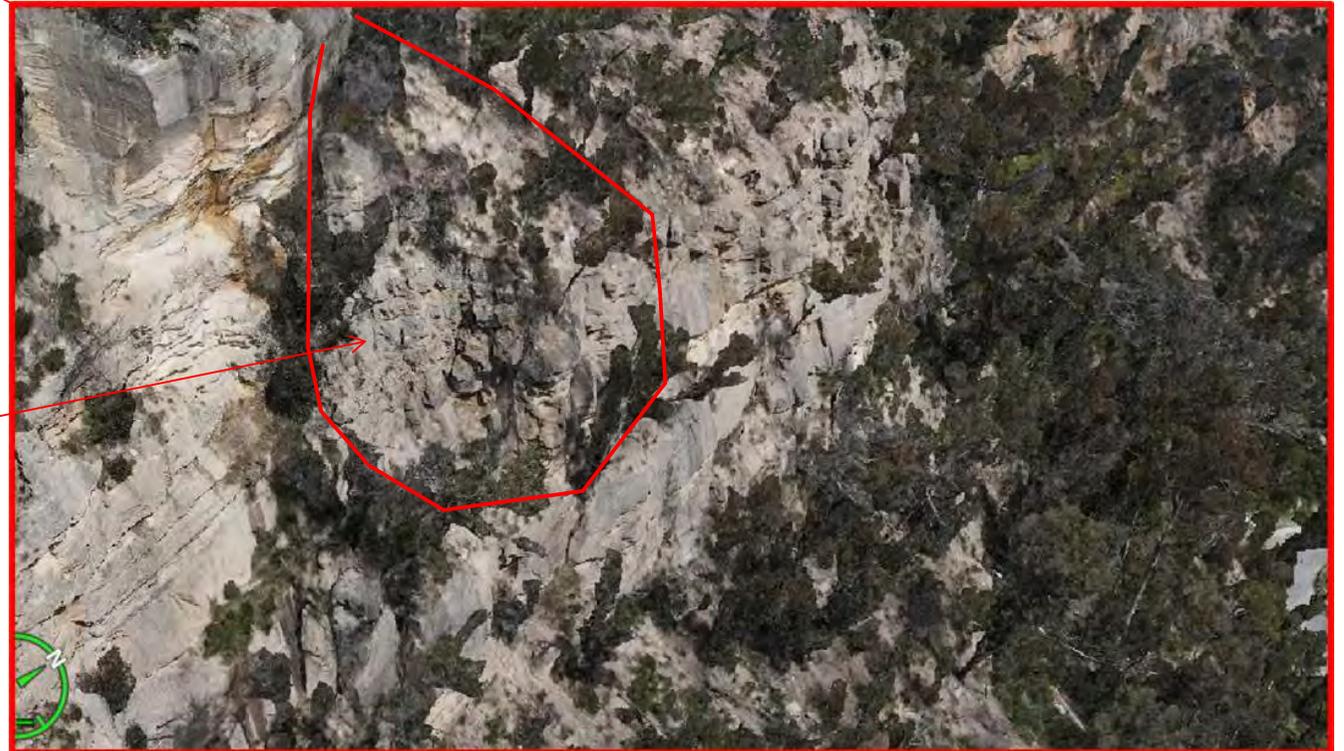
TITLE
Review of Wolgan Gap Slope Hazards 2022
Figure B7 - Example H1.3 Rock Slide Hazards Domain 1

Example H1.3 Rock Slide Hazard (Estimated >5,000 m³)

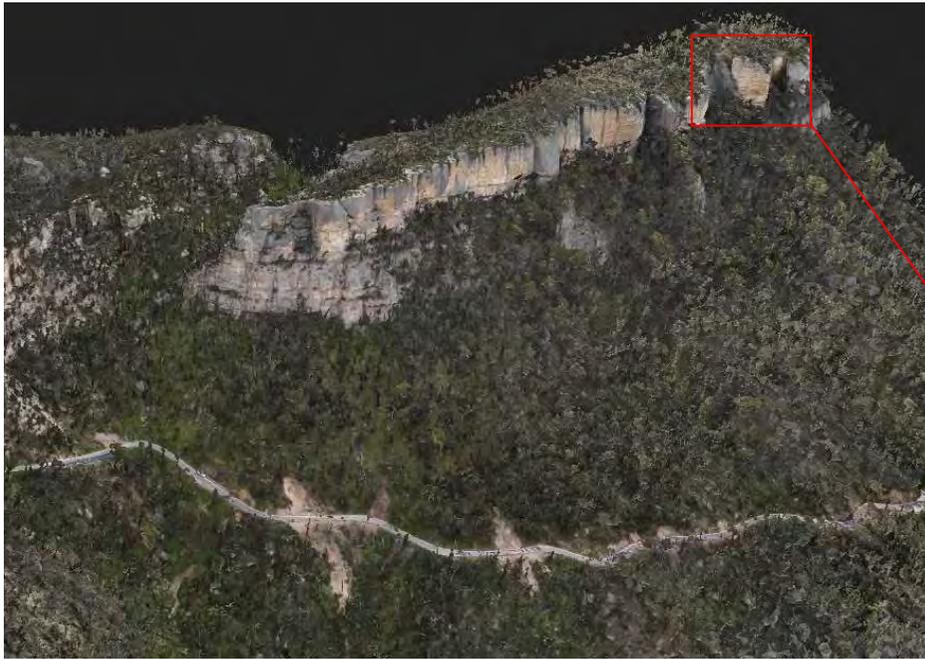
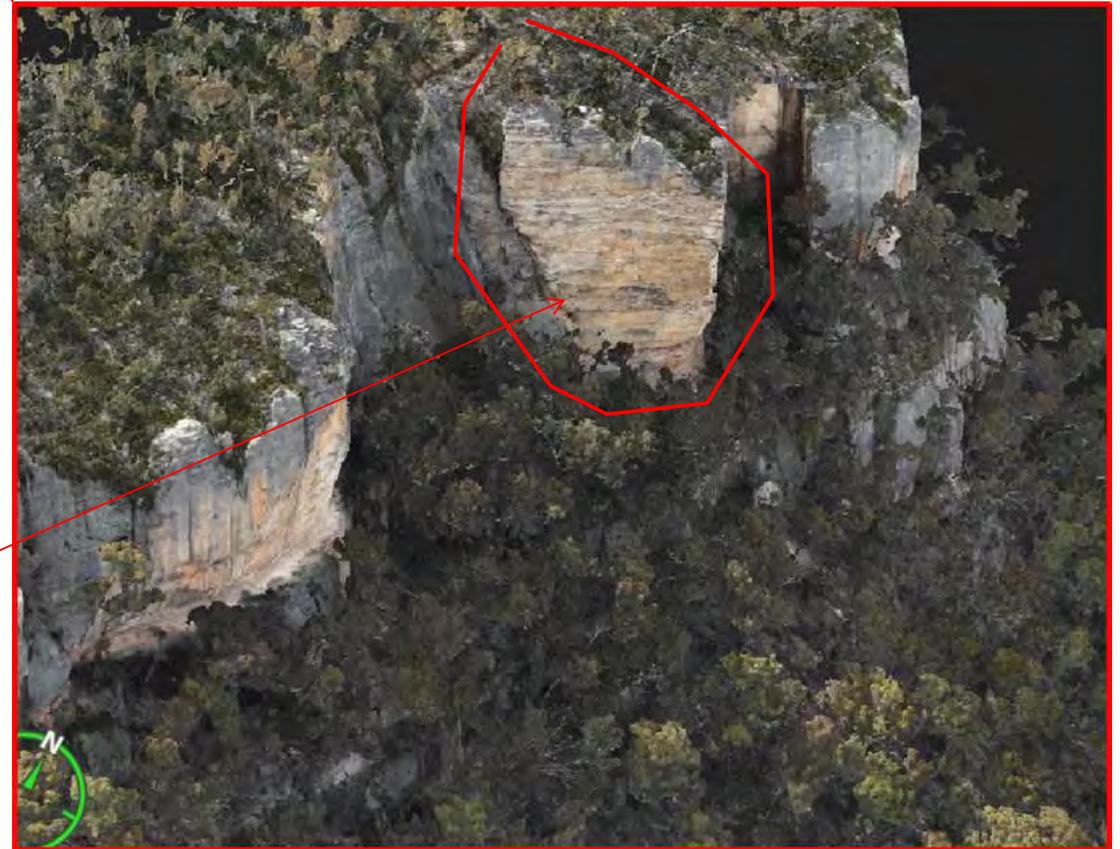
TITLE
Review of Wolgan Gap Slope Hazards 2022
Figure B8 - Example H1.3 Rock Slide Hazards Domain 2

Example H1.3 Rock Slide Hazard (Estimated >5,000 m³)

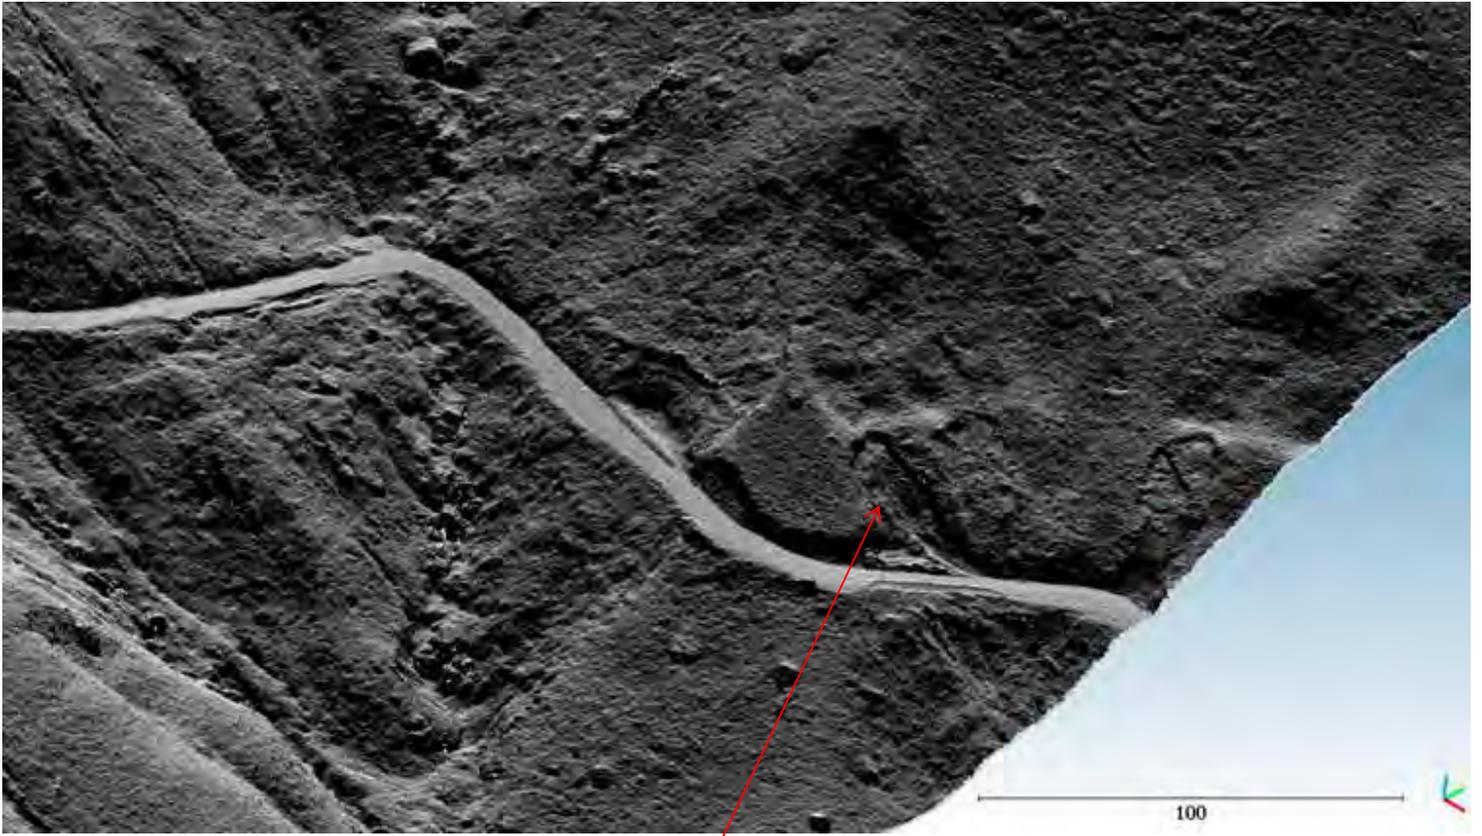
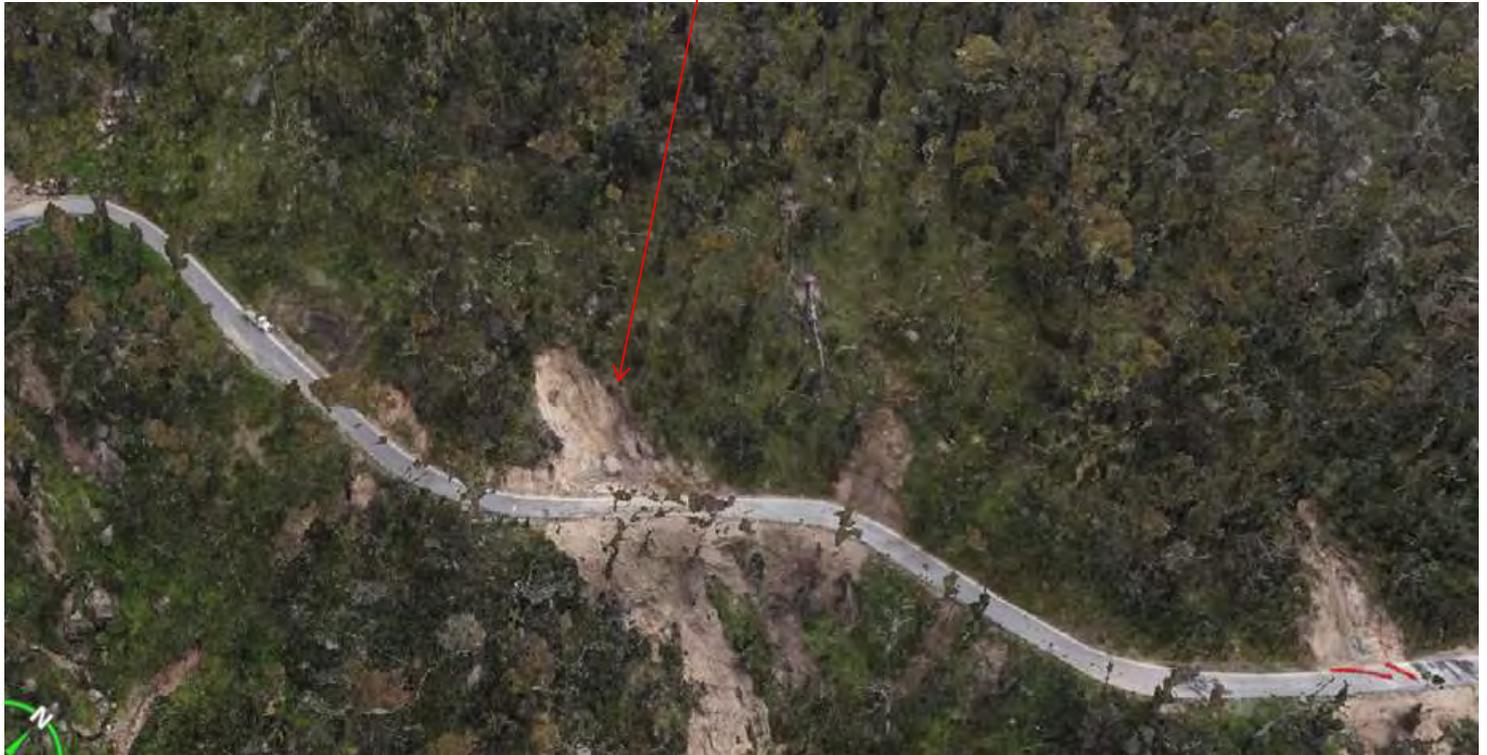
TITLE
Review of Wolgan Gap Slope Hazards 2022
Figure B9 - Example H2.1 Upslope Debris Flow

Example H2.1 Upslope Debris Flow Hazard, left flank
(Approx. 40 m wide, 40 m long, 2 m deep)

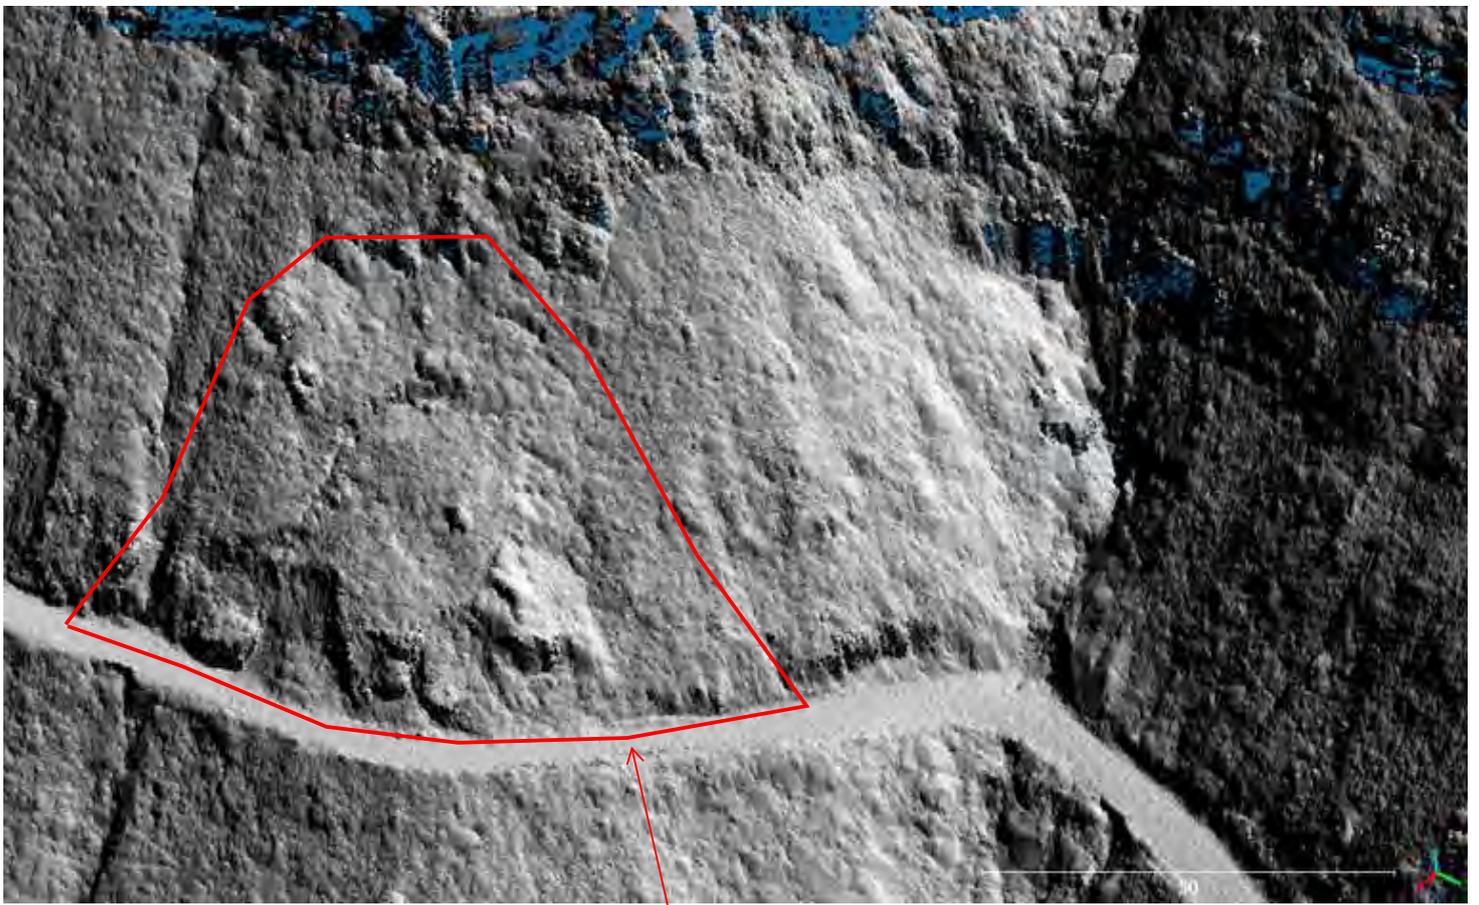
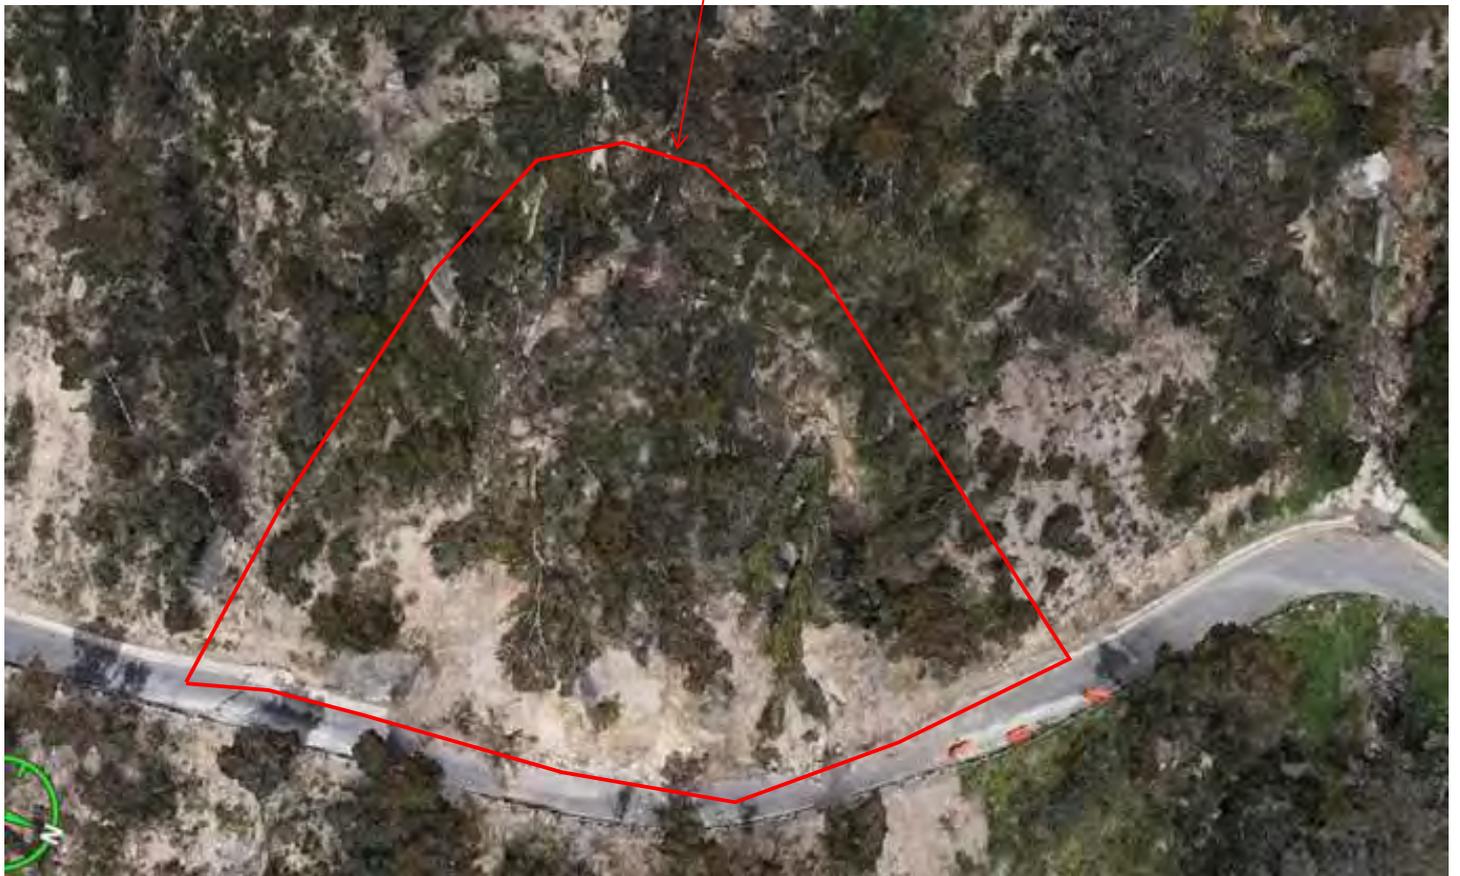
TITLE
Review of Wolgan Gap Slope Hazards 2022
Figure B10 - Example H2.2 Upslope Debris Slide

Example H2.1 Upslope Debris Slide Hazard, enlarging (Approx. 60 m wide, 60 m long)

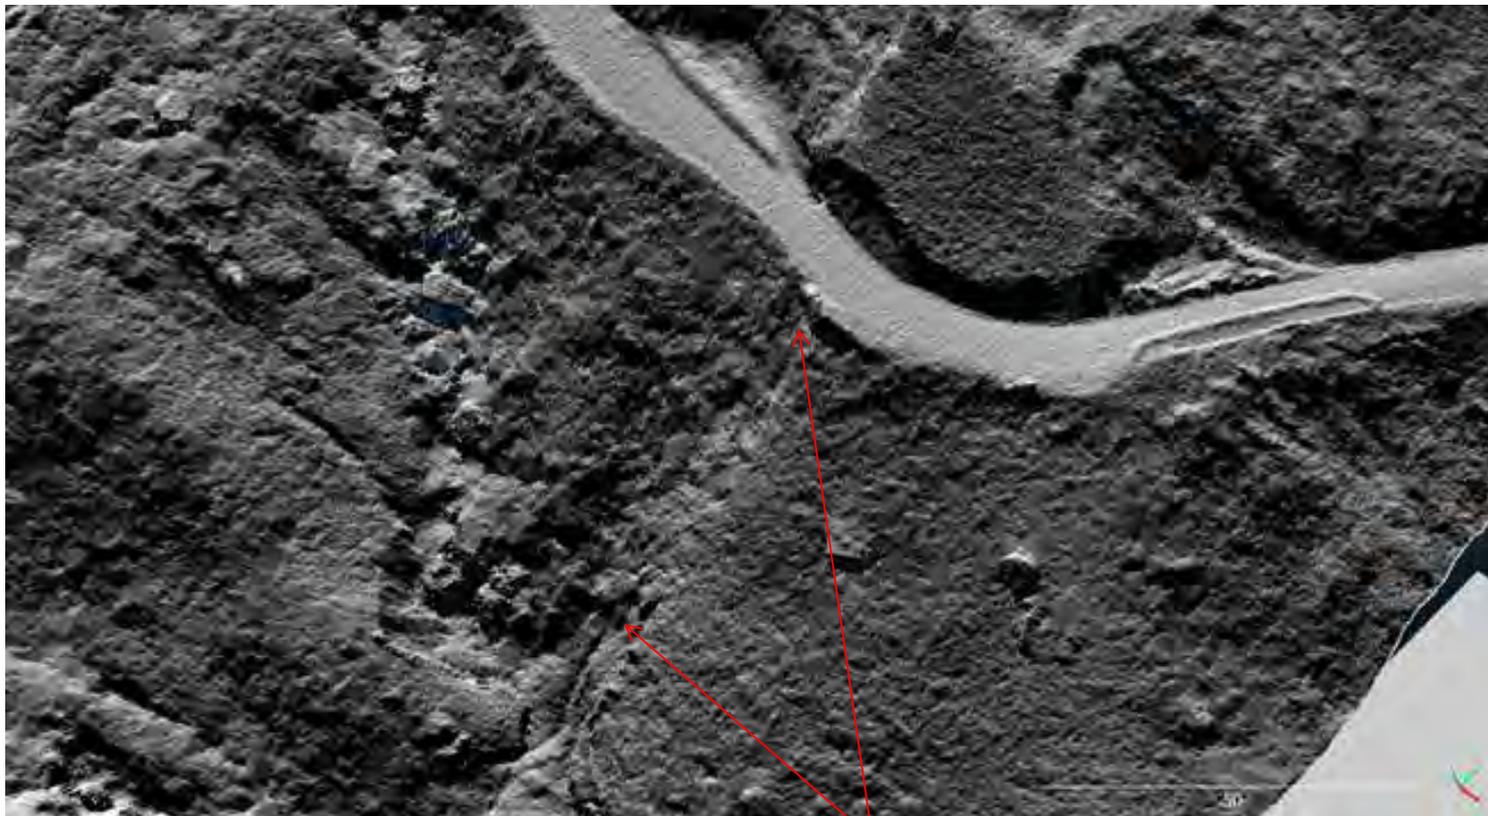
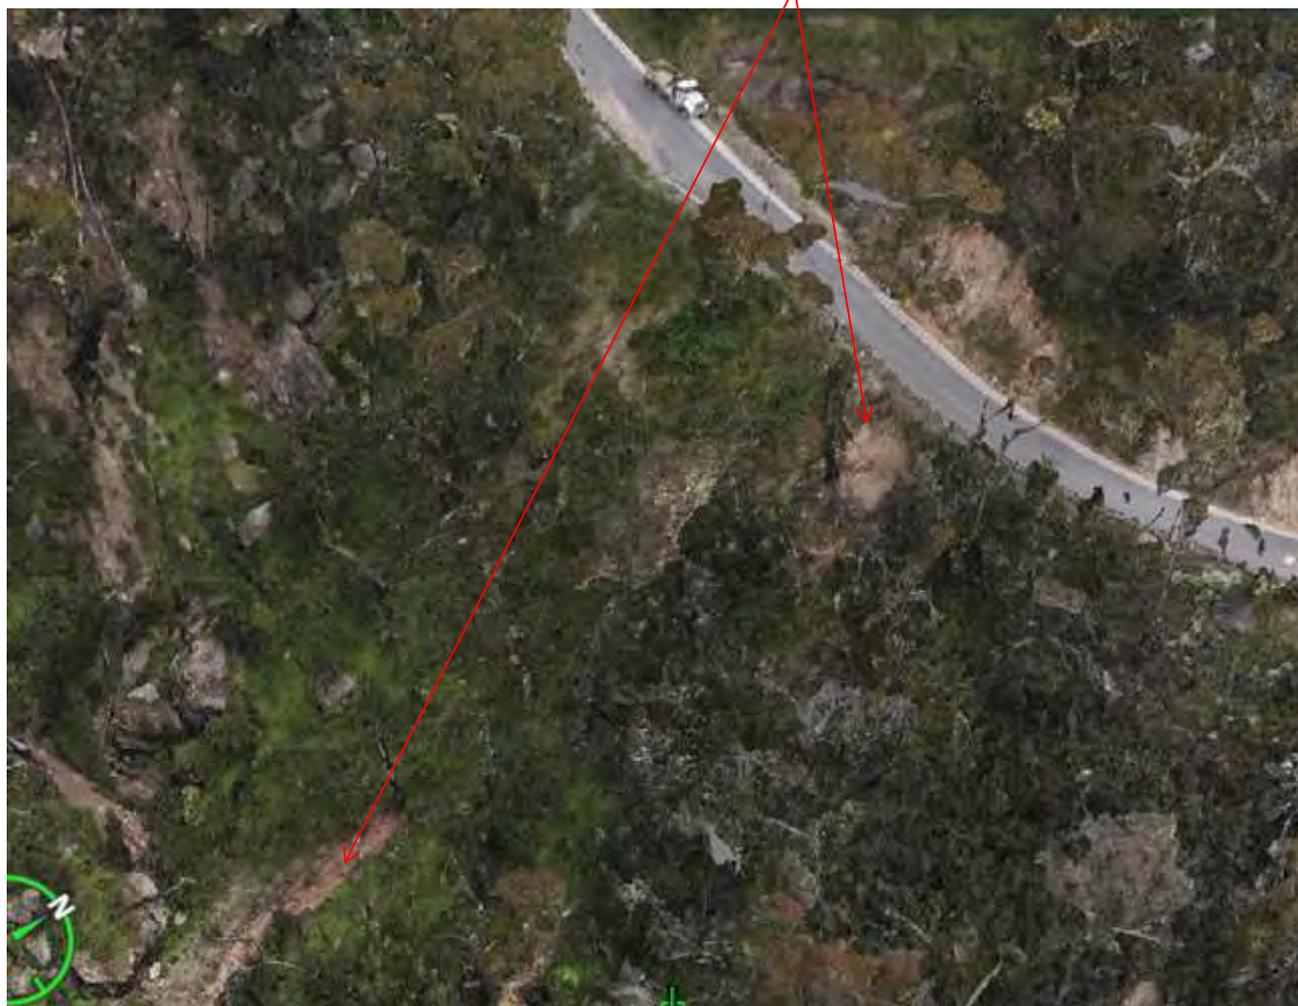
TITLE
Review of Wolgan Gap Slope Hazards 2022
Figure B11 - Example H3.1 Downslope Debris Flow

Example H3.1 Downslope Debris Flow Hazard, right flank
(Approx. 5 m wide, 10-20 m long, 2 m deep)

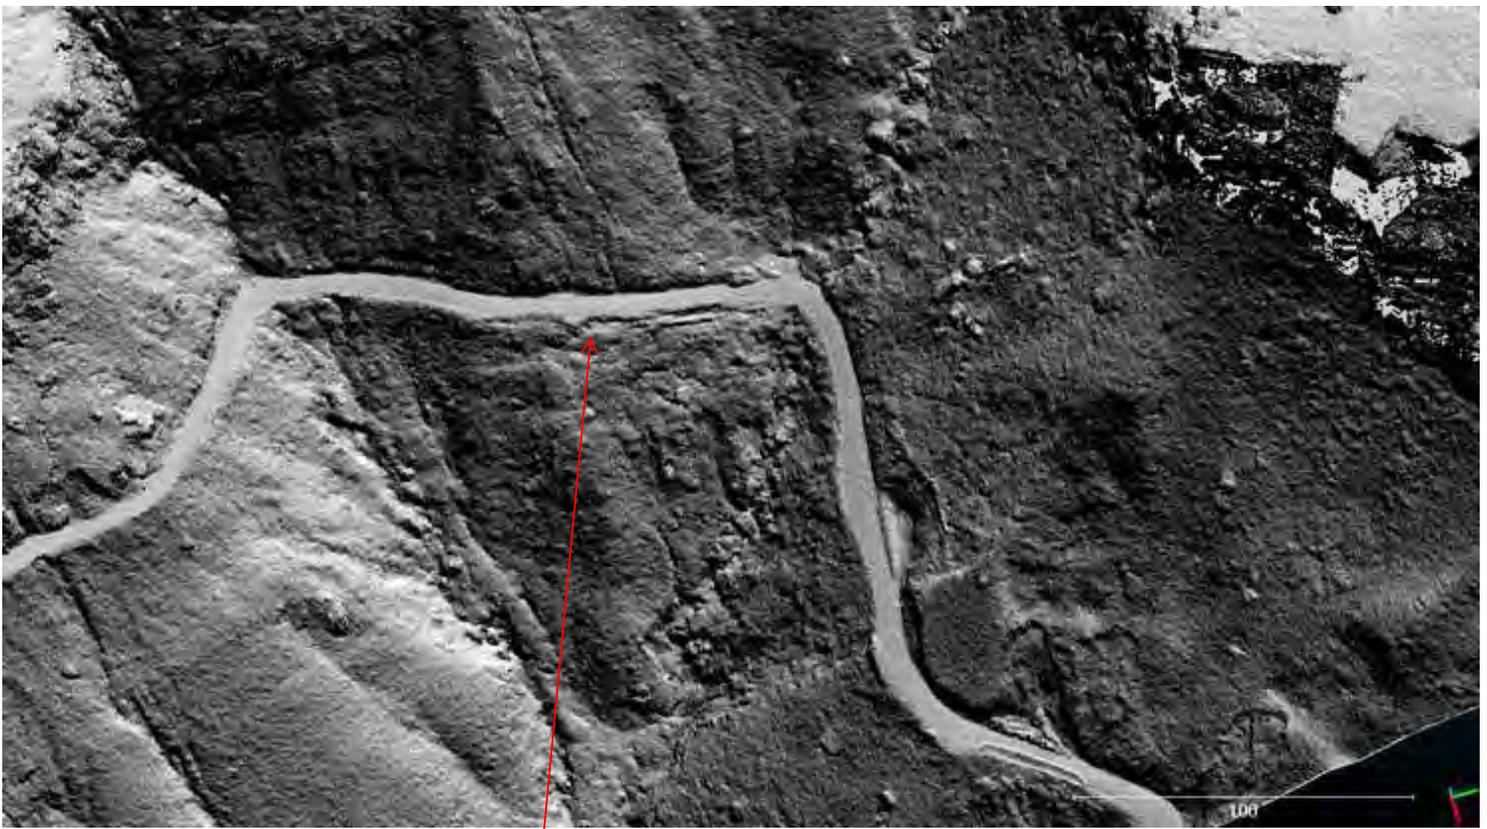
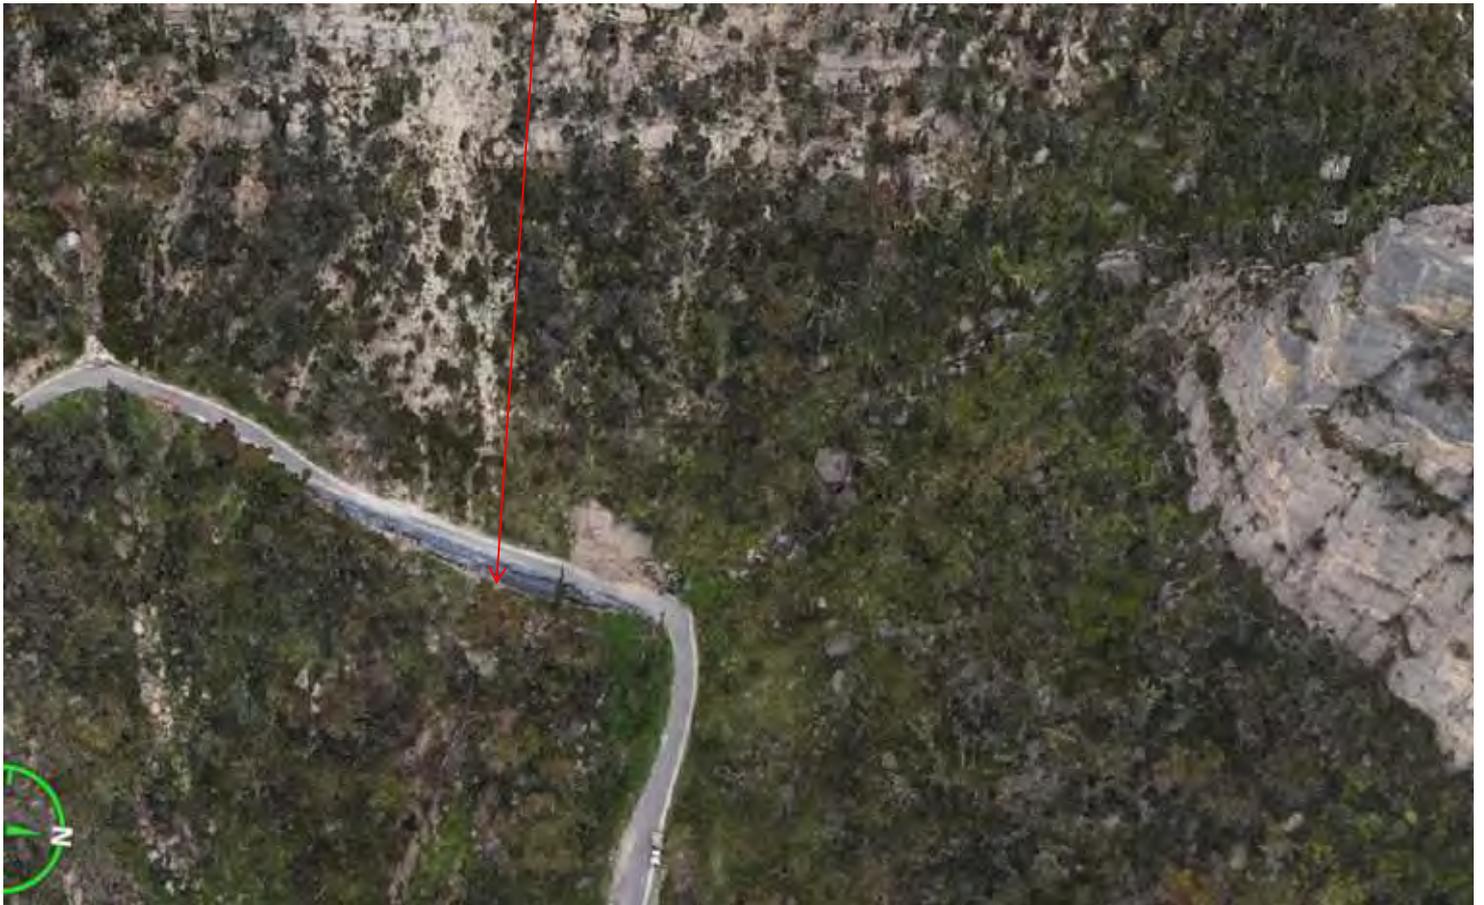
TITLE
Review of Wolgan Gap Slope Hazards 2022
Figure B12 - Example H3.2 Downslope Debris Slide

Example H3.2 Downslope Debris Slide Hazard, (Approx. 100 m wide)
