Wolgan Road, NSW

Review of Wolgan Gap Slope Hazards 2022

PS129742-SYD-GEO-REP-001-REV 0

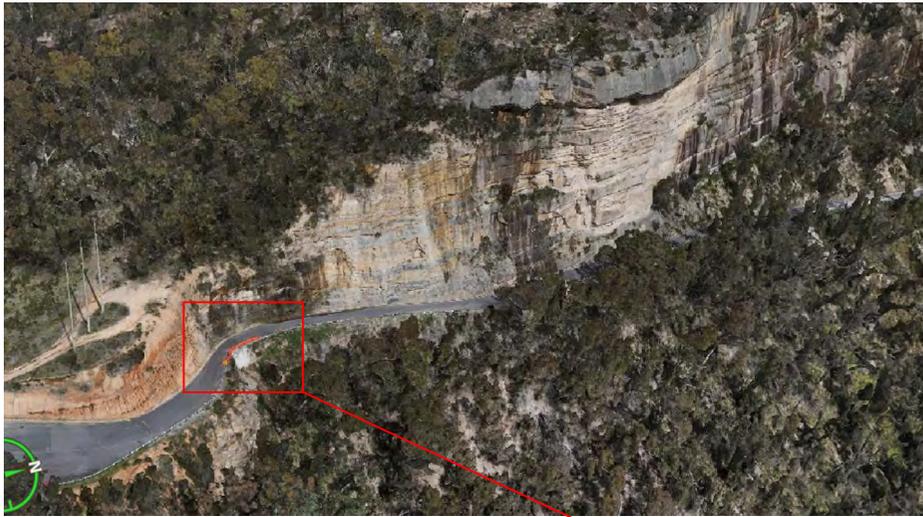
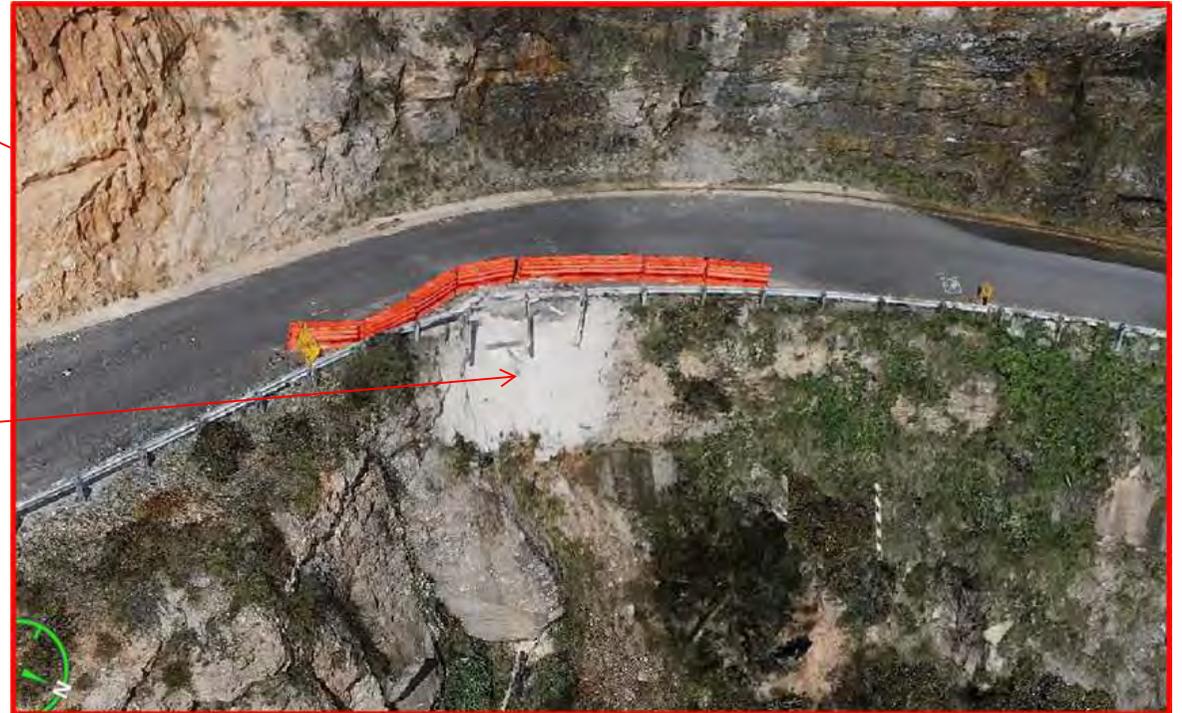
TITLE
Review of Wolgan Gap Slope Hazards 2022
Figure B13 - Example H1.4 Retention Element Failure

Example H4.1 Retention Element Failure Hazard. (Sandstone block wall approximately 5 m high and 20 m long). Temporary fibrecrete and mesh treatment in place.

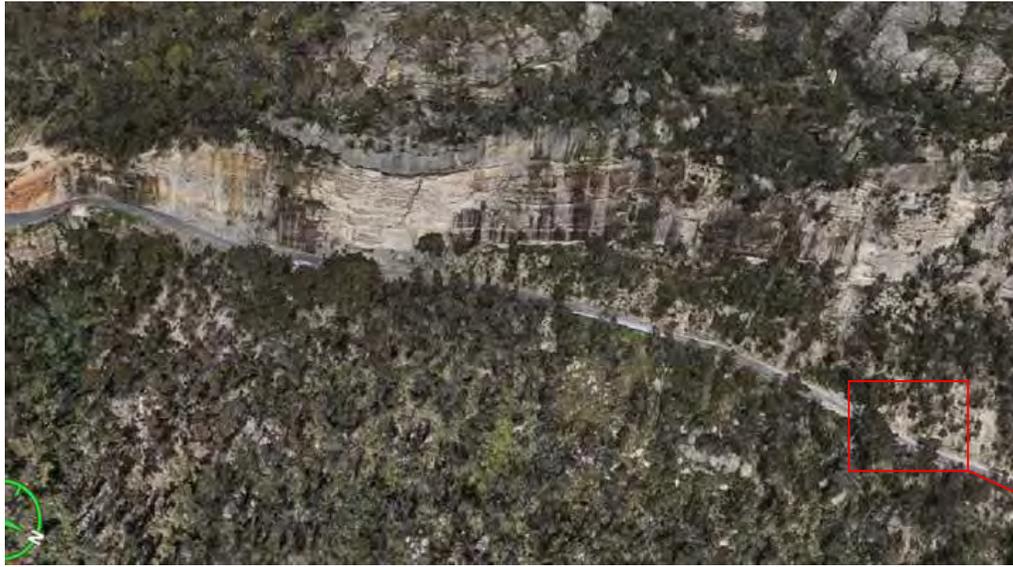
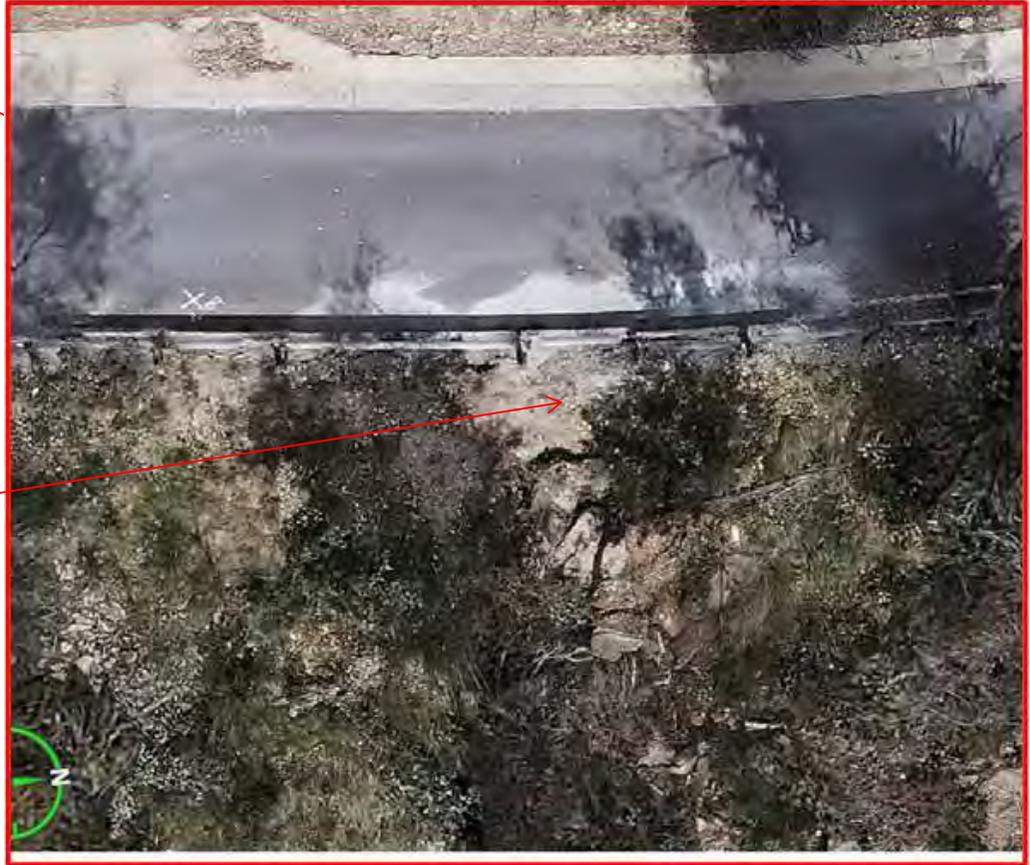
Example H4.2 Drainage Element Failure Hazard
Culvert has lost integrity and headwall has 'blown out'
