Our ref: PS217104-WSP-SYD-GEO-LTR- Rev0

Wolgan Road Project - Gap Slope Risk Assessment

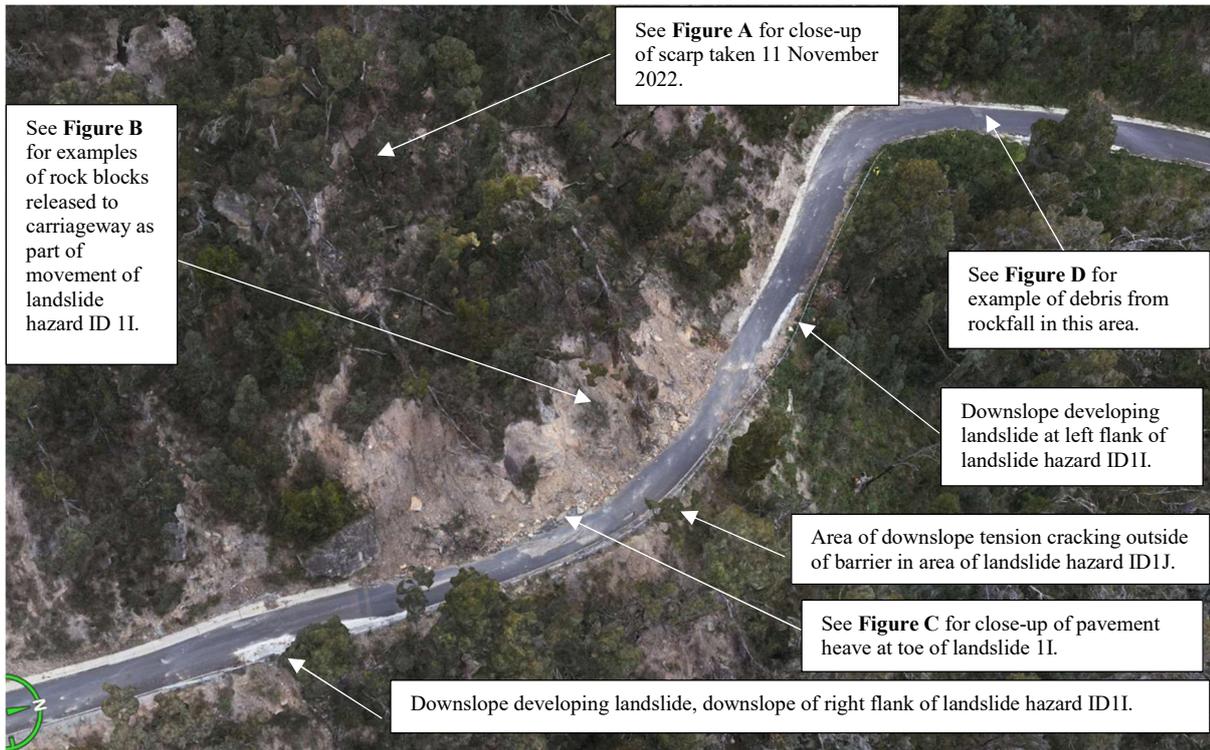
An example of an upslope landslide in November 2022 is shown in the aerial photograph (from March 2024) in Figure 2 below. The landslide is more than 70 m in length, with a back scarp approximately 50 m upslope of Wolgan Road. In Figure 2 we have provided references to other photographs which are appended to this document in Attachment A, that show conditions before and after the development of the landslide, along with photographs of some individual rock blocks which were released from the landslide debris.

Figure 2 Landslide hazard 1I further development of scarp evident since November 2022 – aerial image March 2024

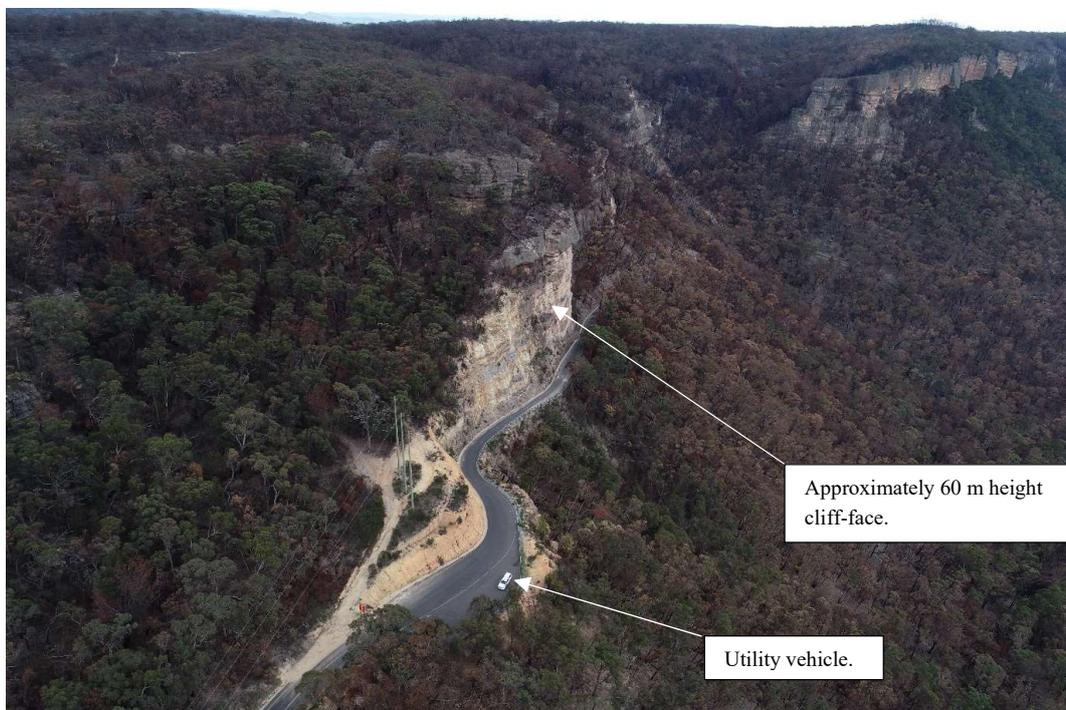
Figure 3 View looking north at Wolgan Gap showing high cliff line and potential significant fall height and impact velocity – aerial imagery February 2020

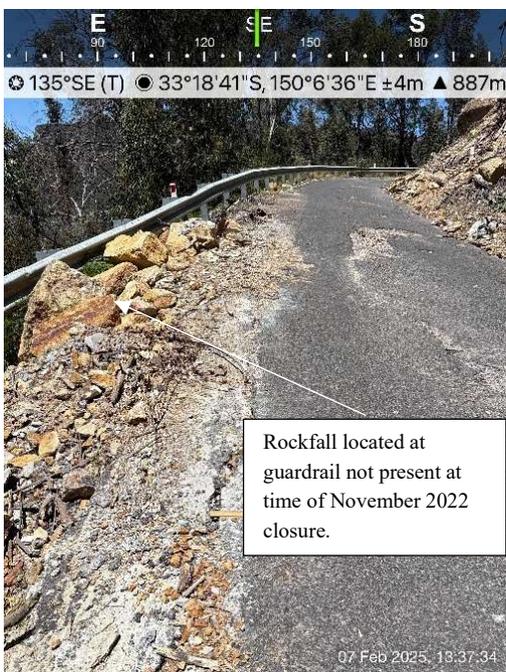
Rockfall located at guardrail not present at time of November 2022 closure.

Figure 4 Rockfall against guard rail below landslide hazard ID11 – February 2025

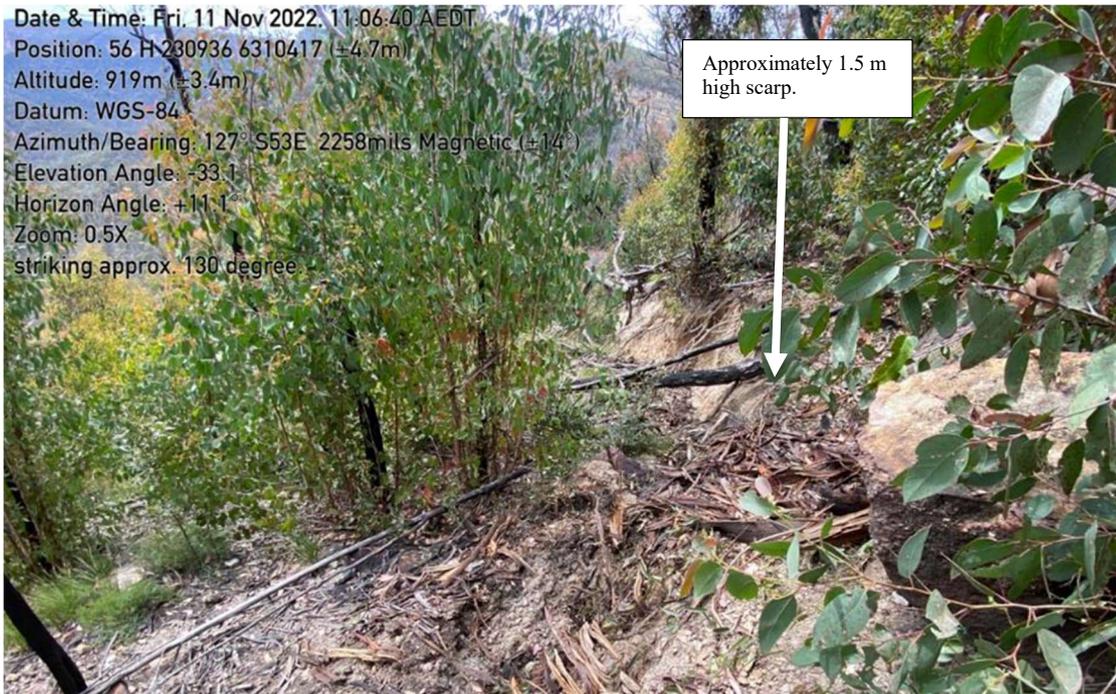
Figure A Close-up of an accessible portion of landslide hazard 11, with backscarp – 11th November 2022

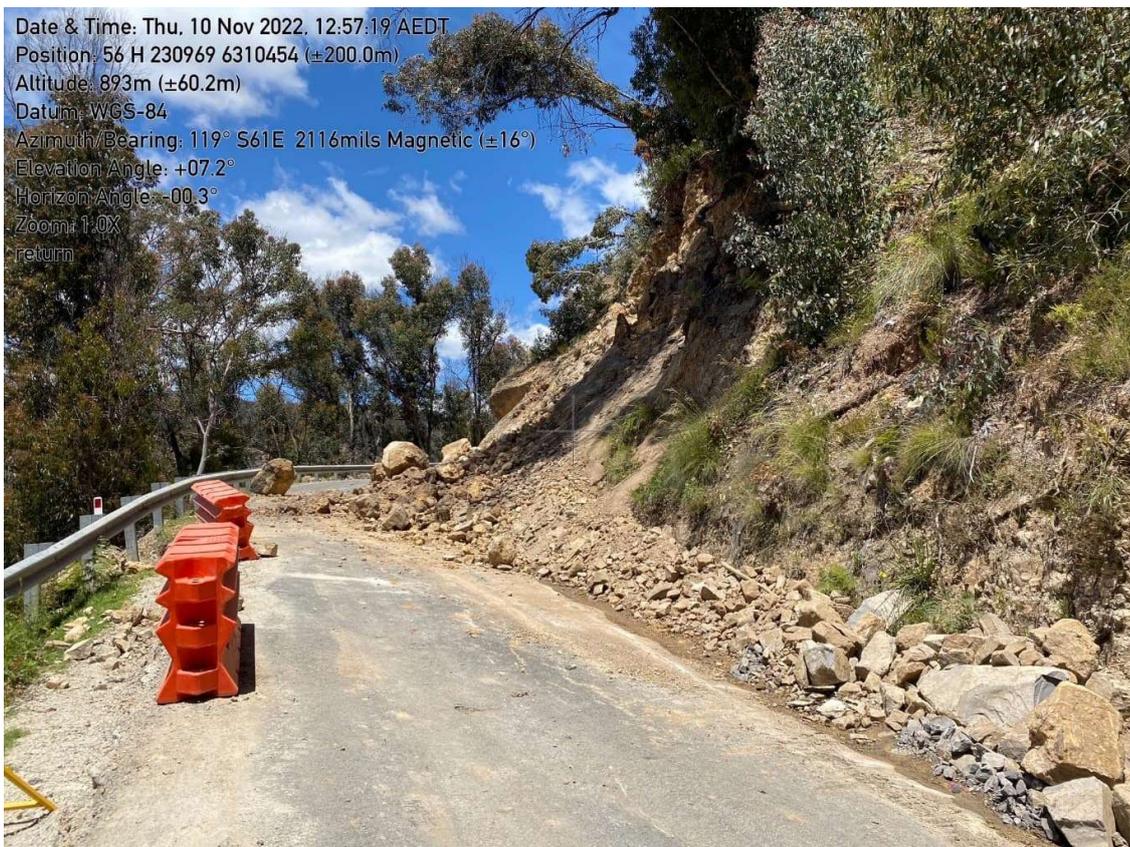
Figure B Landslide hazard 11 – debris lodged on carriageway includes blocks greater than 1 m minimum dimension – 10 November 2022

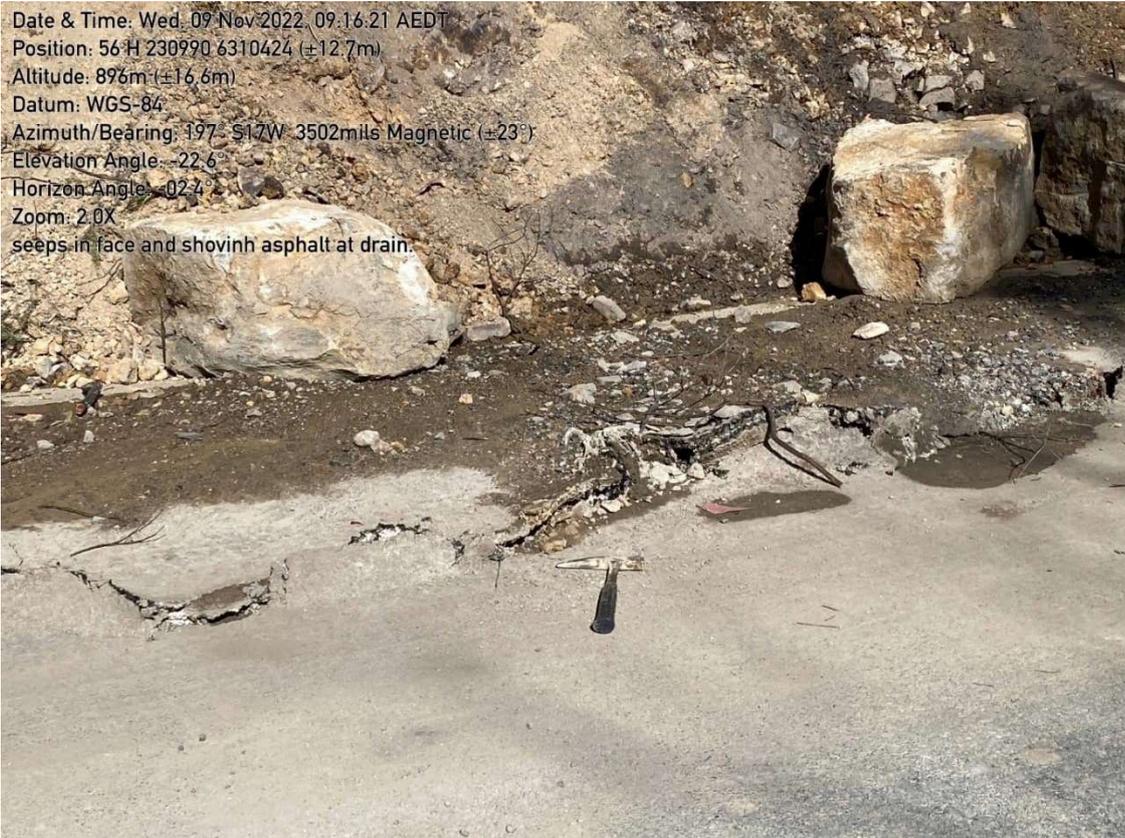
Figure C Landslide hazard 11 – ‘shoving’/heave of asphalt at toe of cut batter – 09 November 2022

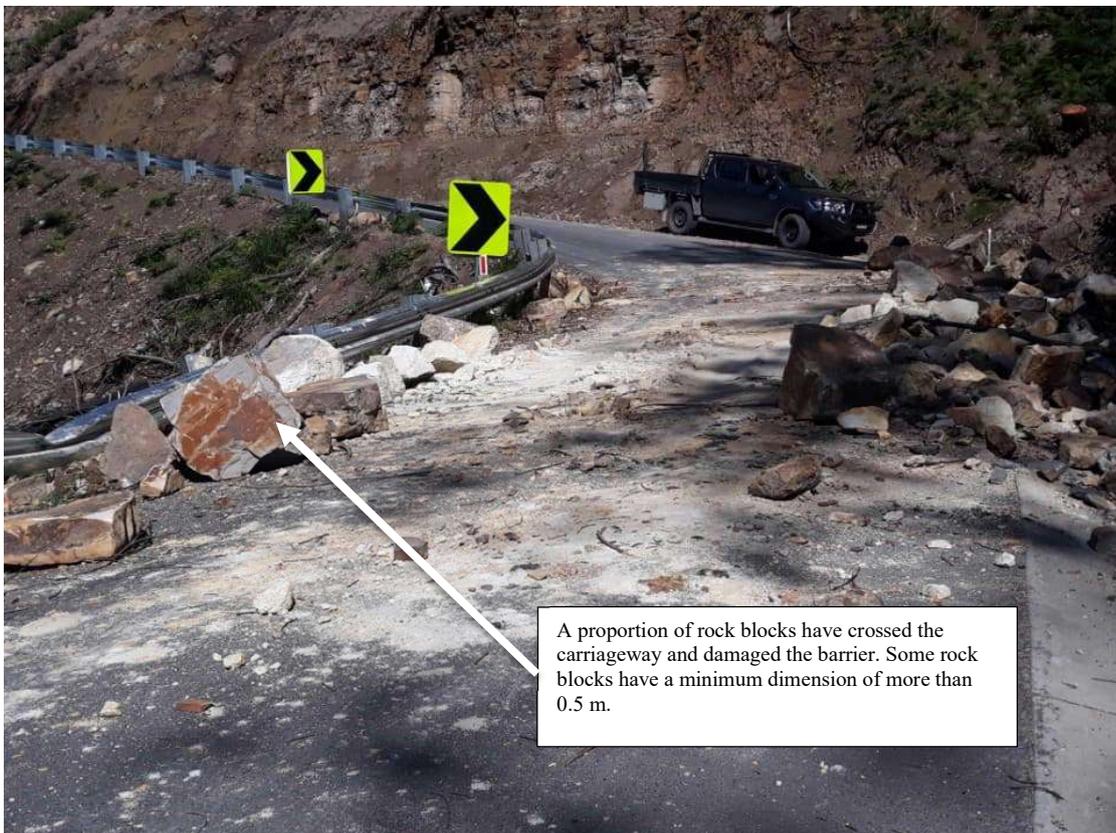
Figure D Rockfall between hazard ID1 and hazard ID2B, following partial clean-up – August 2020

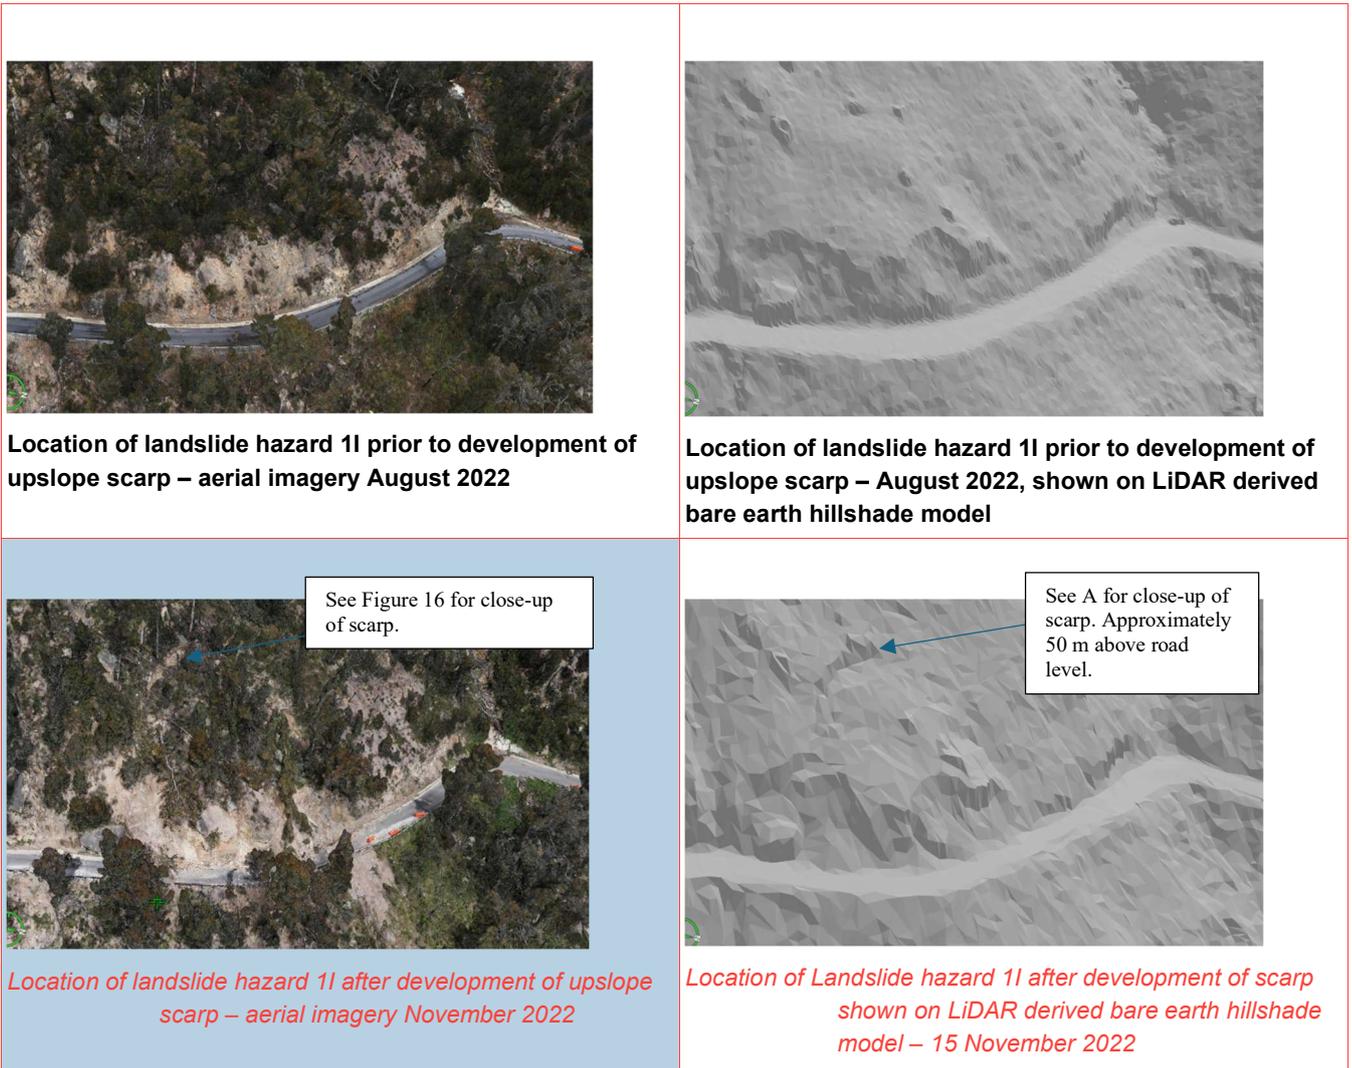
Figure E Aerial photographs and LiDAR images of Landslide hazard 11, showing backscarp development.

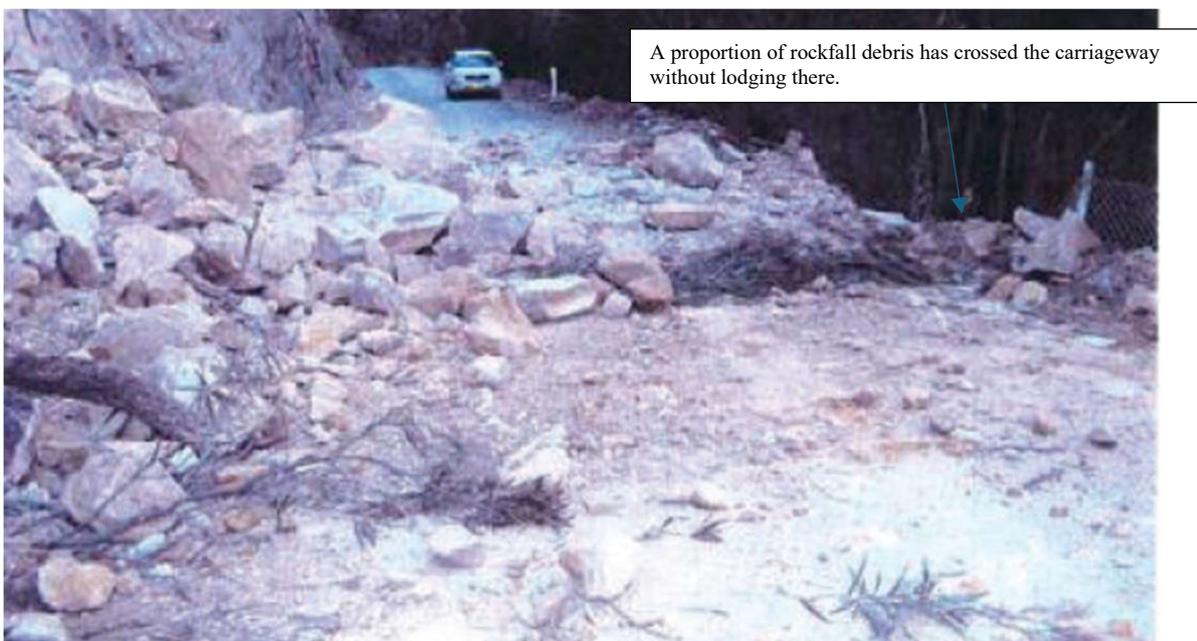
Figure F View looking north at Wolgan Gap showing some of the rockfall debris remaining at road level following an event in September 2008

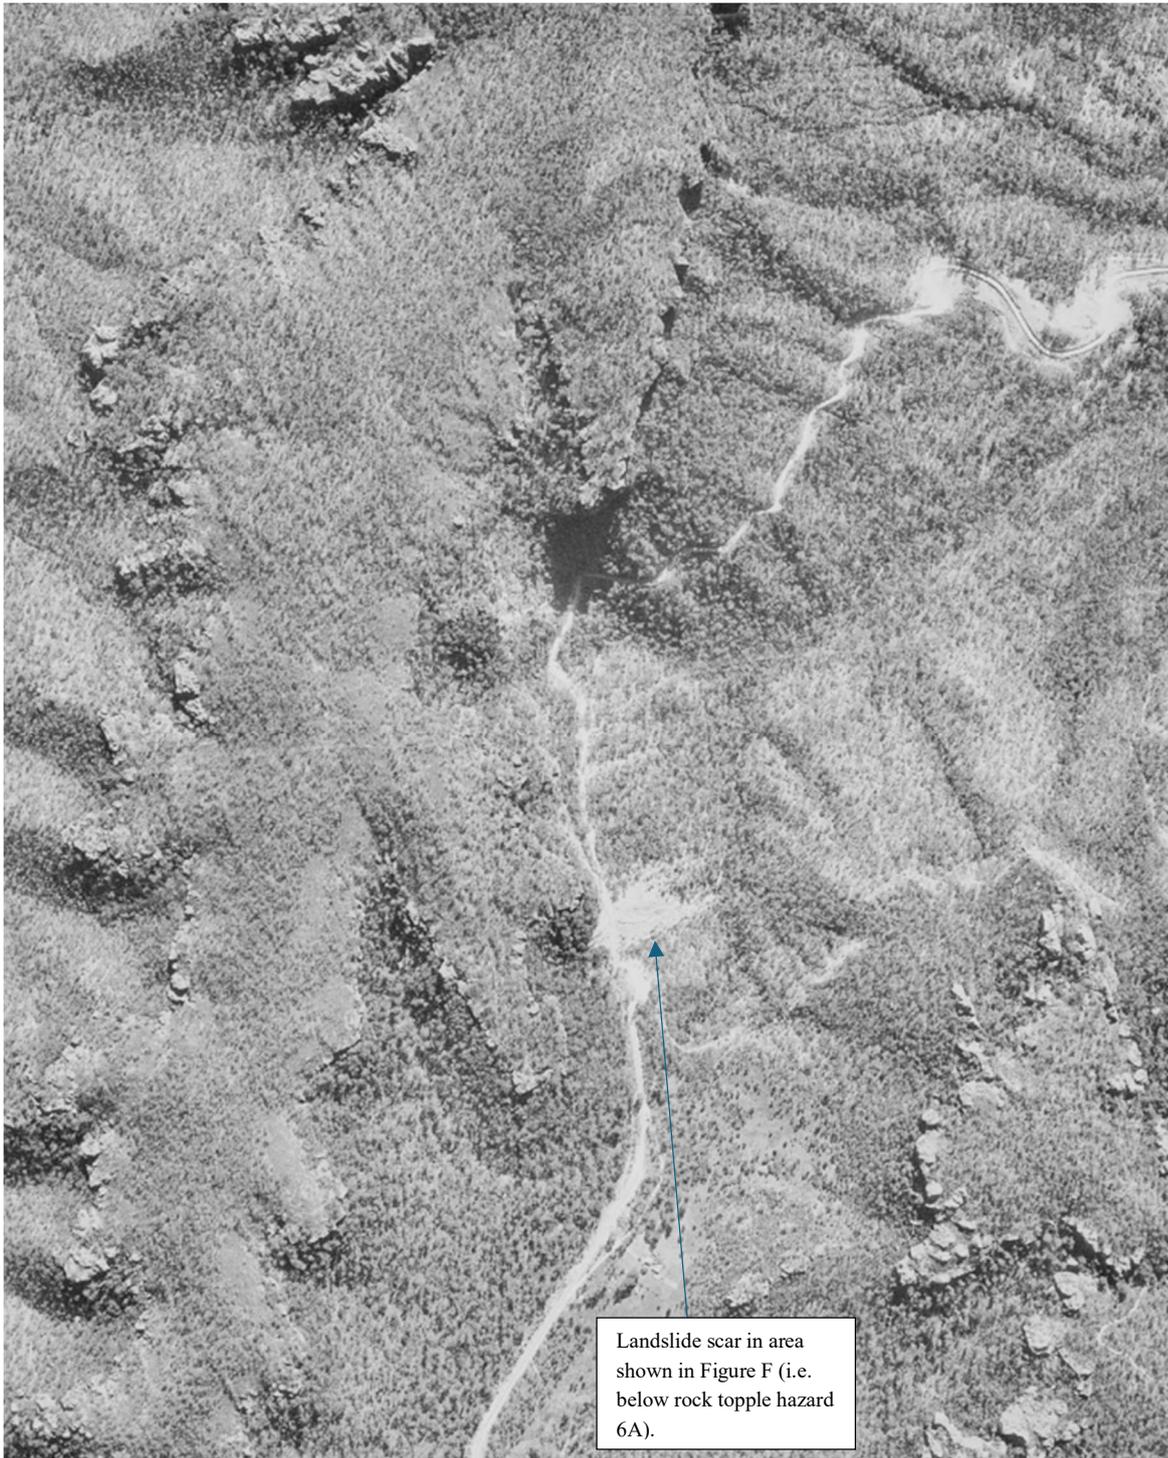
Landslide scar in area shown in Figure F (i.e. below rock topple hazard 6A).

Figure G 1969 aerial photograph of Wolgan Gap showing landslide scar in area shown in Figure F.

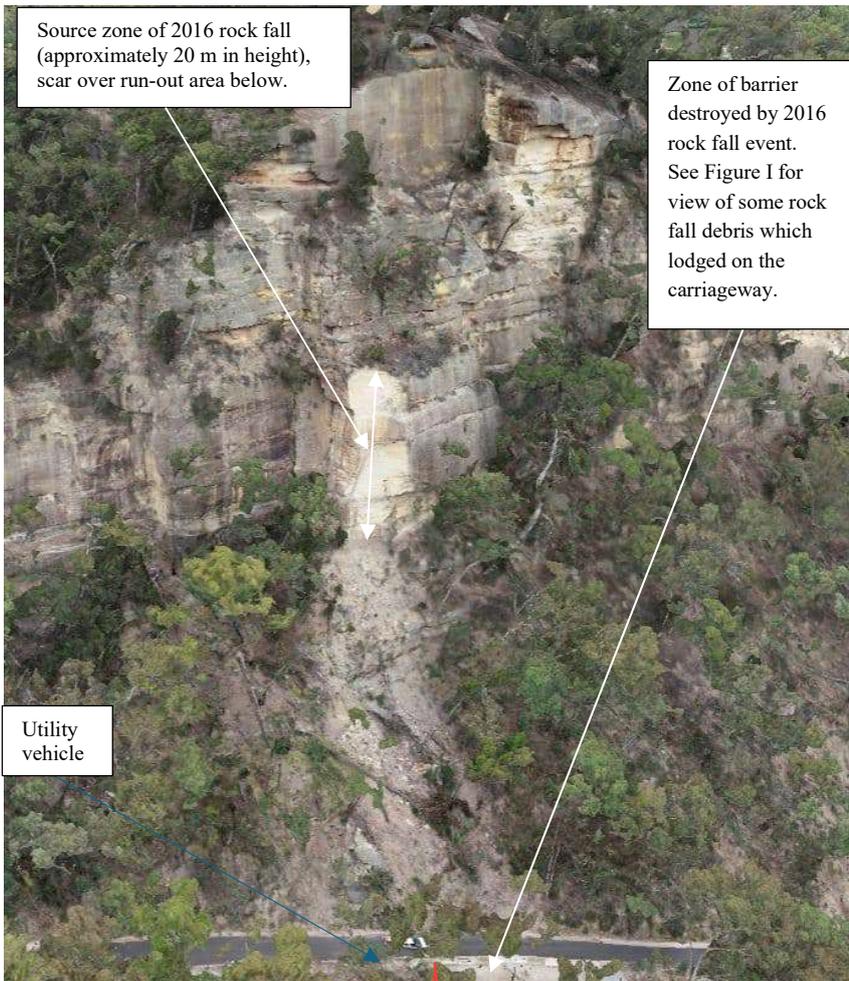
Figure H Aerial view of source zone and run-out scar to road level and barrier damage from 2016 rock topple and rock slide event shown on February 2019 aerial imagery

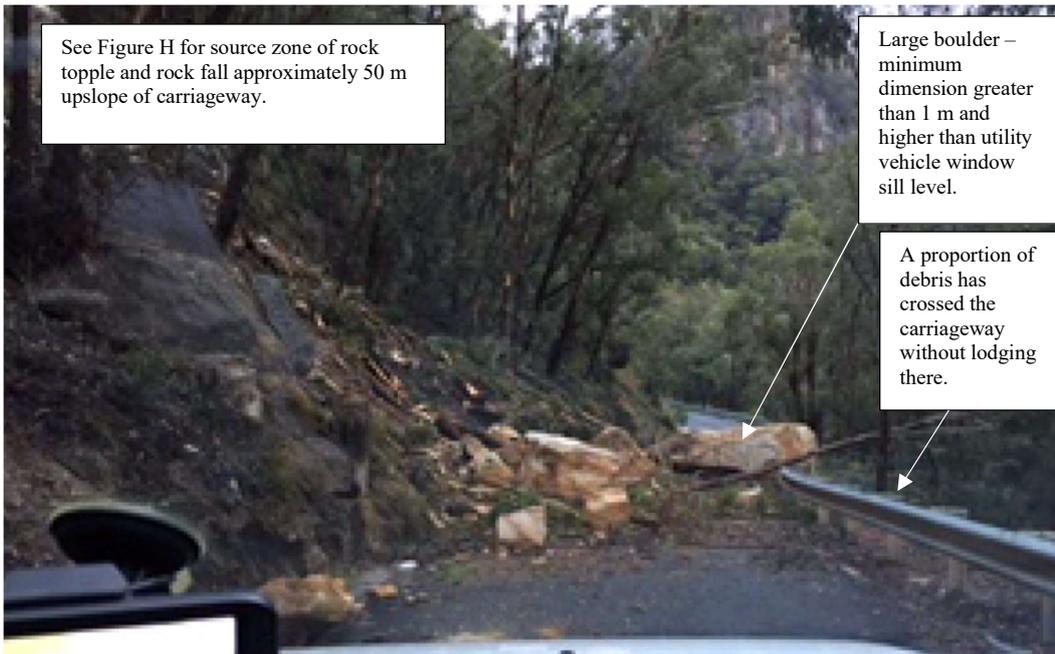
Figure I View from inside vehicle showing portion of landslide debris which lodged on the carriageway at the time of the 2016 rock topple and rockfall event.

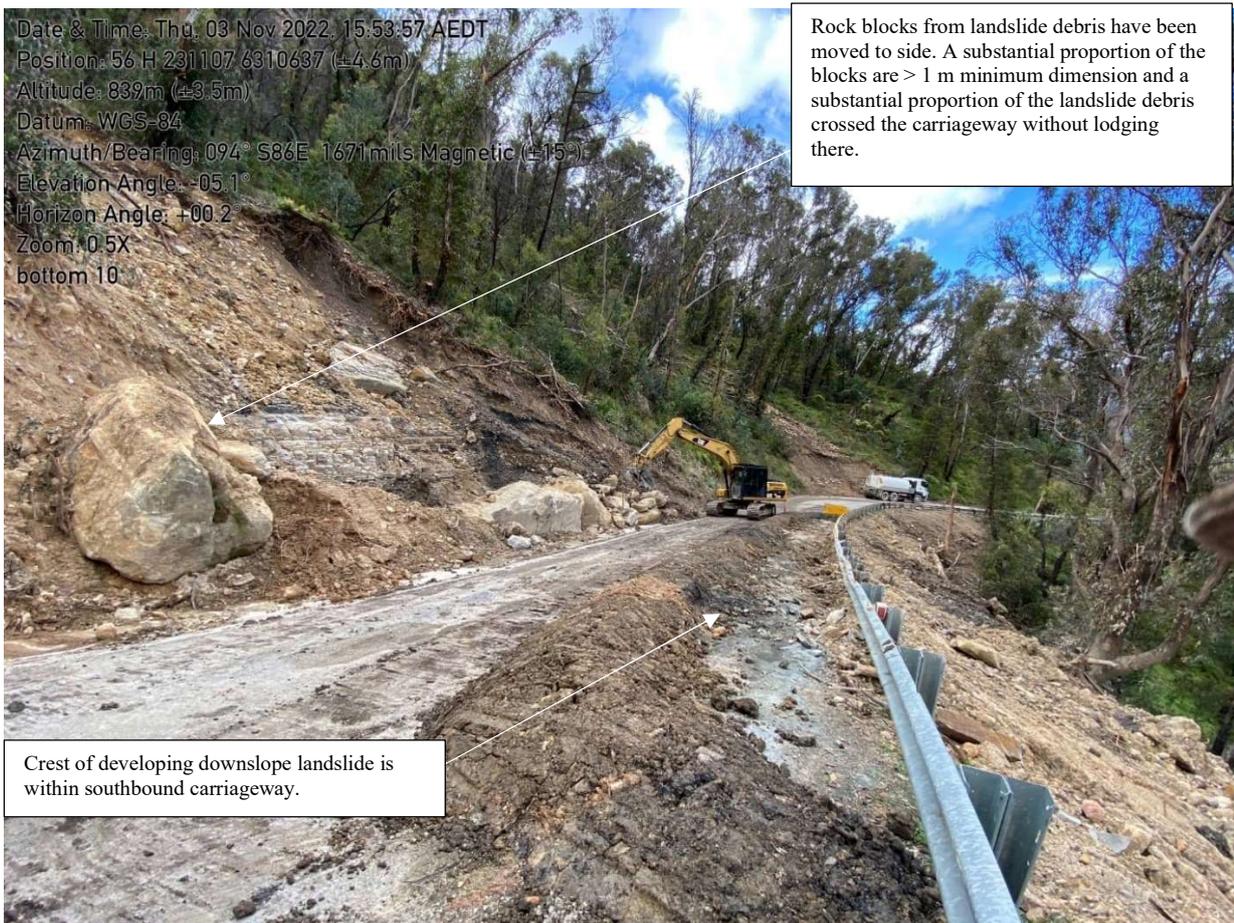
Figure J: Landslide hazard 3C during clean-up showing size of rock blocks within debris a proportion of which crossed the carriageway without lodging there and the zone of developing downslope landslide with crest within southbound lane – November 2022

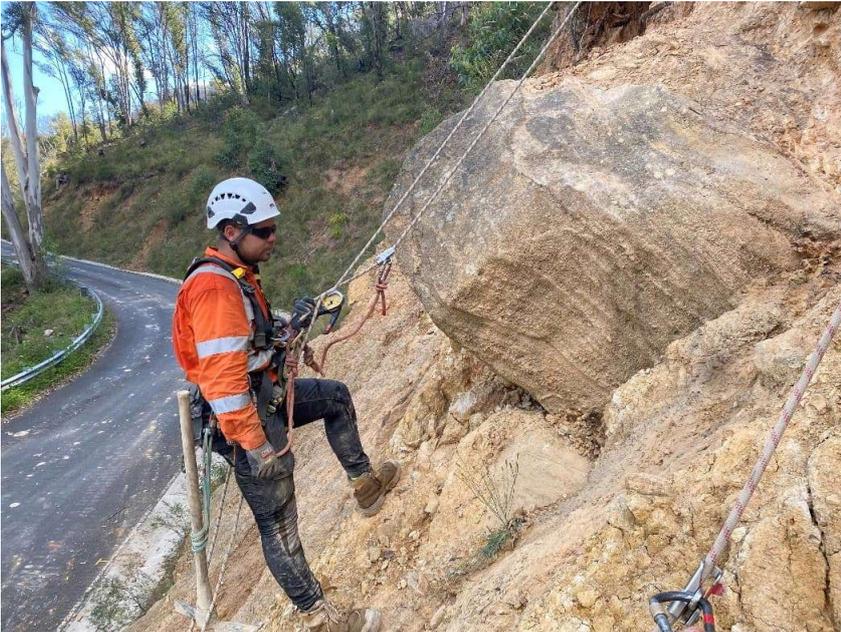
Figure K: Rock block with minimum dimension > 1 m embedded within colluvium of landslide hazard 4D – December 2021
