Wolgan Road, NSW

Review of Wolgan Gap Slope Hazards 2022

Lithgow City Council

PS129742-SYD-GEO-REP-001-REV 0

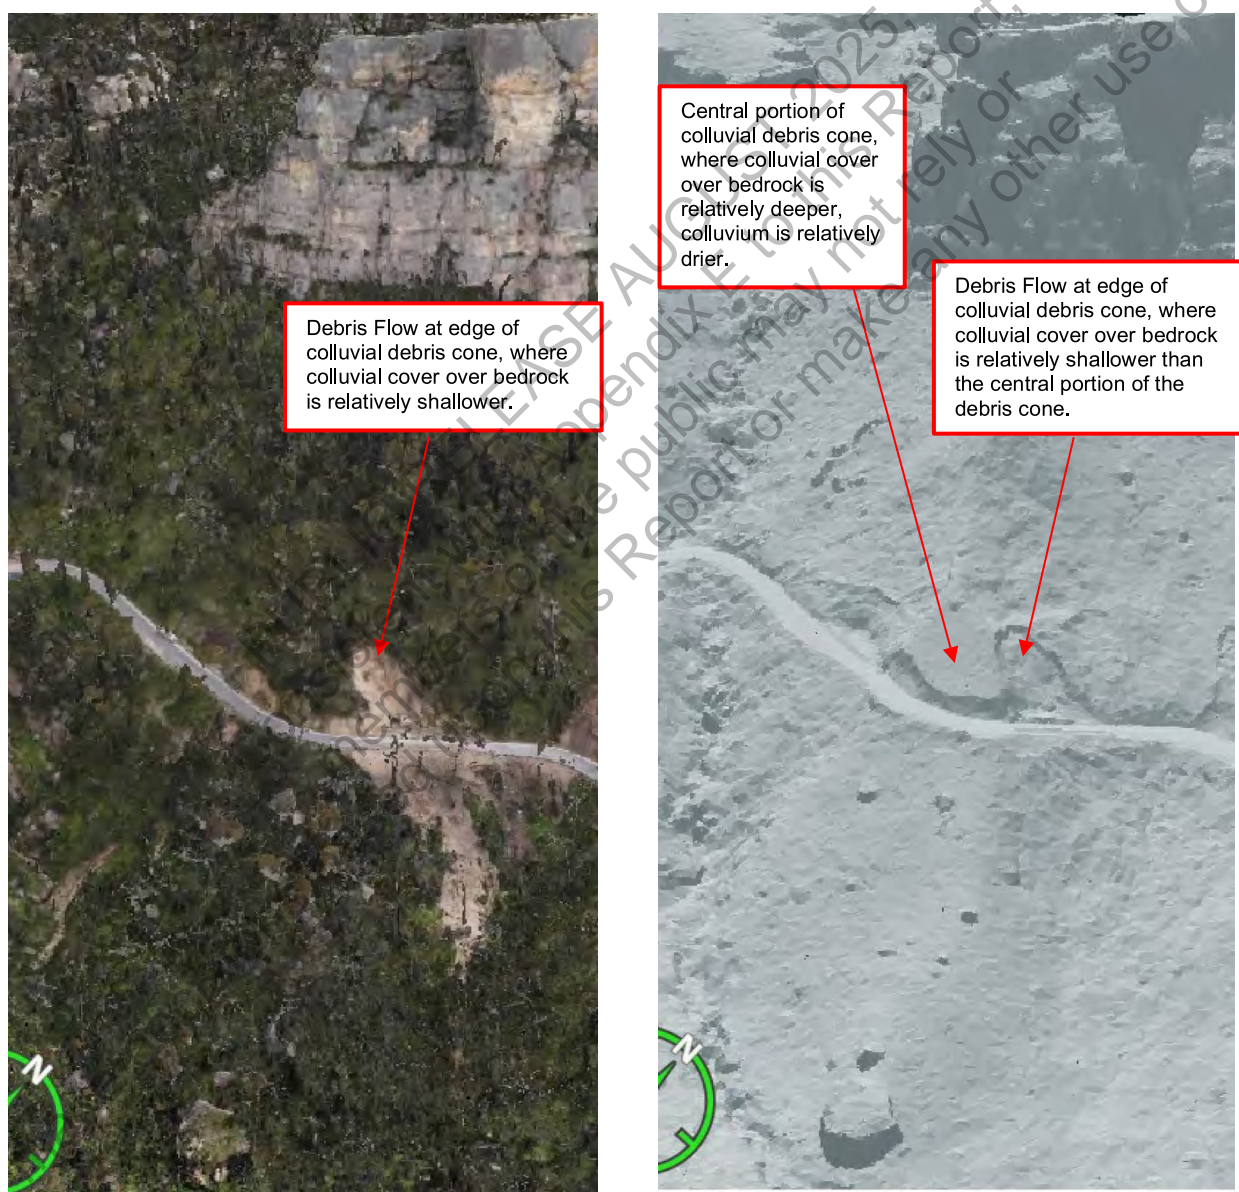
Figure 2 : Example of Debris Flow at edge of colluvial debris cone (Site 3C), shown on 15 November 2022 UAV photo aerial (left image) and LiDAR derived hillshade (right image).

weathered rock with concentrated saturated zones and seeps near the weathered rock interface were made at other landslides which occurred during 2022 including adjacent to Site 3C, as shown in Figure 2 further below.

A frequent observation of landslides within the colluvial slopes at Wolgan Gap in 2022 has been the propensity for relatively wetter, higher velocity and more shallow debris flow type landslides to develop at the edges of colluvial debris cones or landslide lobes more frequently and typically prior to the development of relatively drier, lower velocity and deeper debris slides of the central portion of the cones/lobes. That characteristic is inferred to be a 3 dimensional effect resulting from the relative lack of confinement at the edges compared to within the central portion of the cone/lobe where the colluvium is deeper. The result is that the edges reach a fully saturated state with a mobilised failure surface (typically close to rock contact, in accordance with Slide Type A of Figure 1) sooner than the central portion which has a deeper cover of relatively drier colluvium. An example of a debris flow at the edge of a cone of colluvial debris, at Site 3C is shown in Figure 2 below.

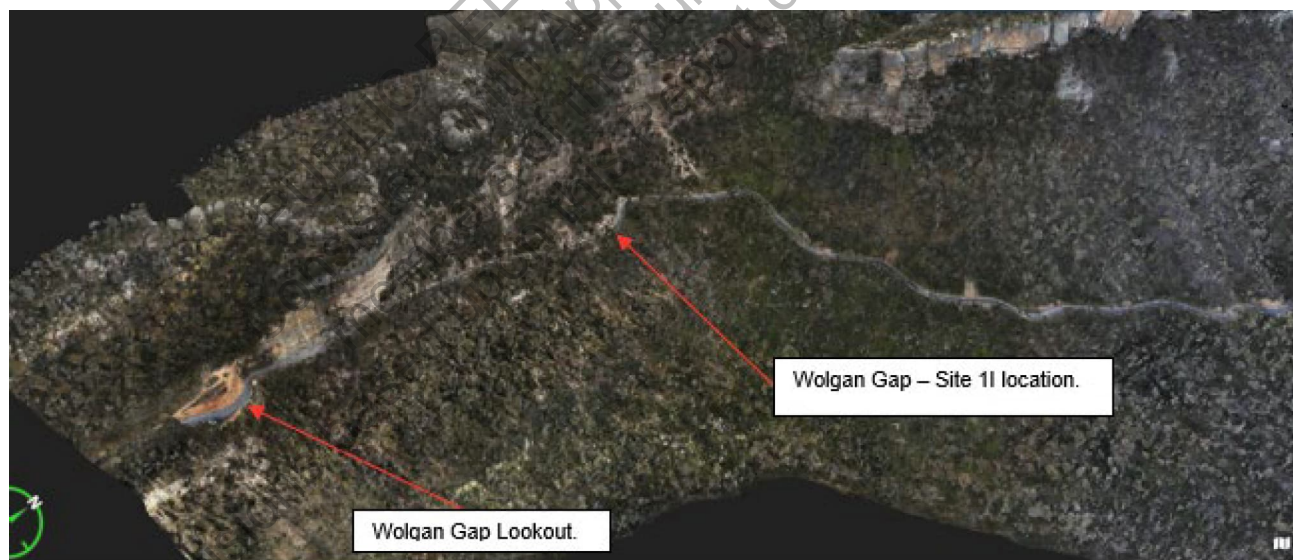
Figure 3 : Wolgan Gap, Site 11 location

On Sunday 6th November 2022 Council reported to WSP Golder that a new landslide had been observed on Saturday 5th November 2022 at the approximate location shown in Figure 3 below. Temporary remediation works were on-going elsewhere on the site in the week prior but no works had occurred at the site of the new landslide, referred to hereafter as Site 11.

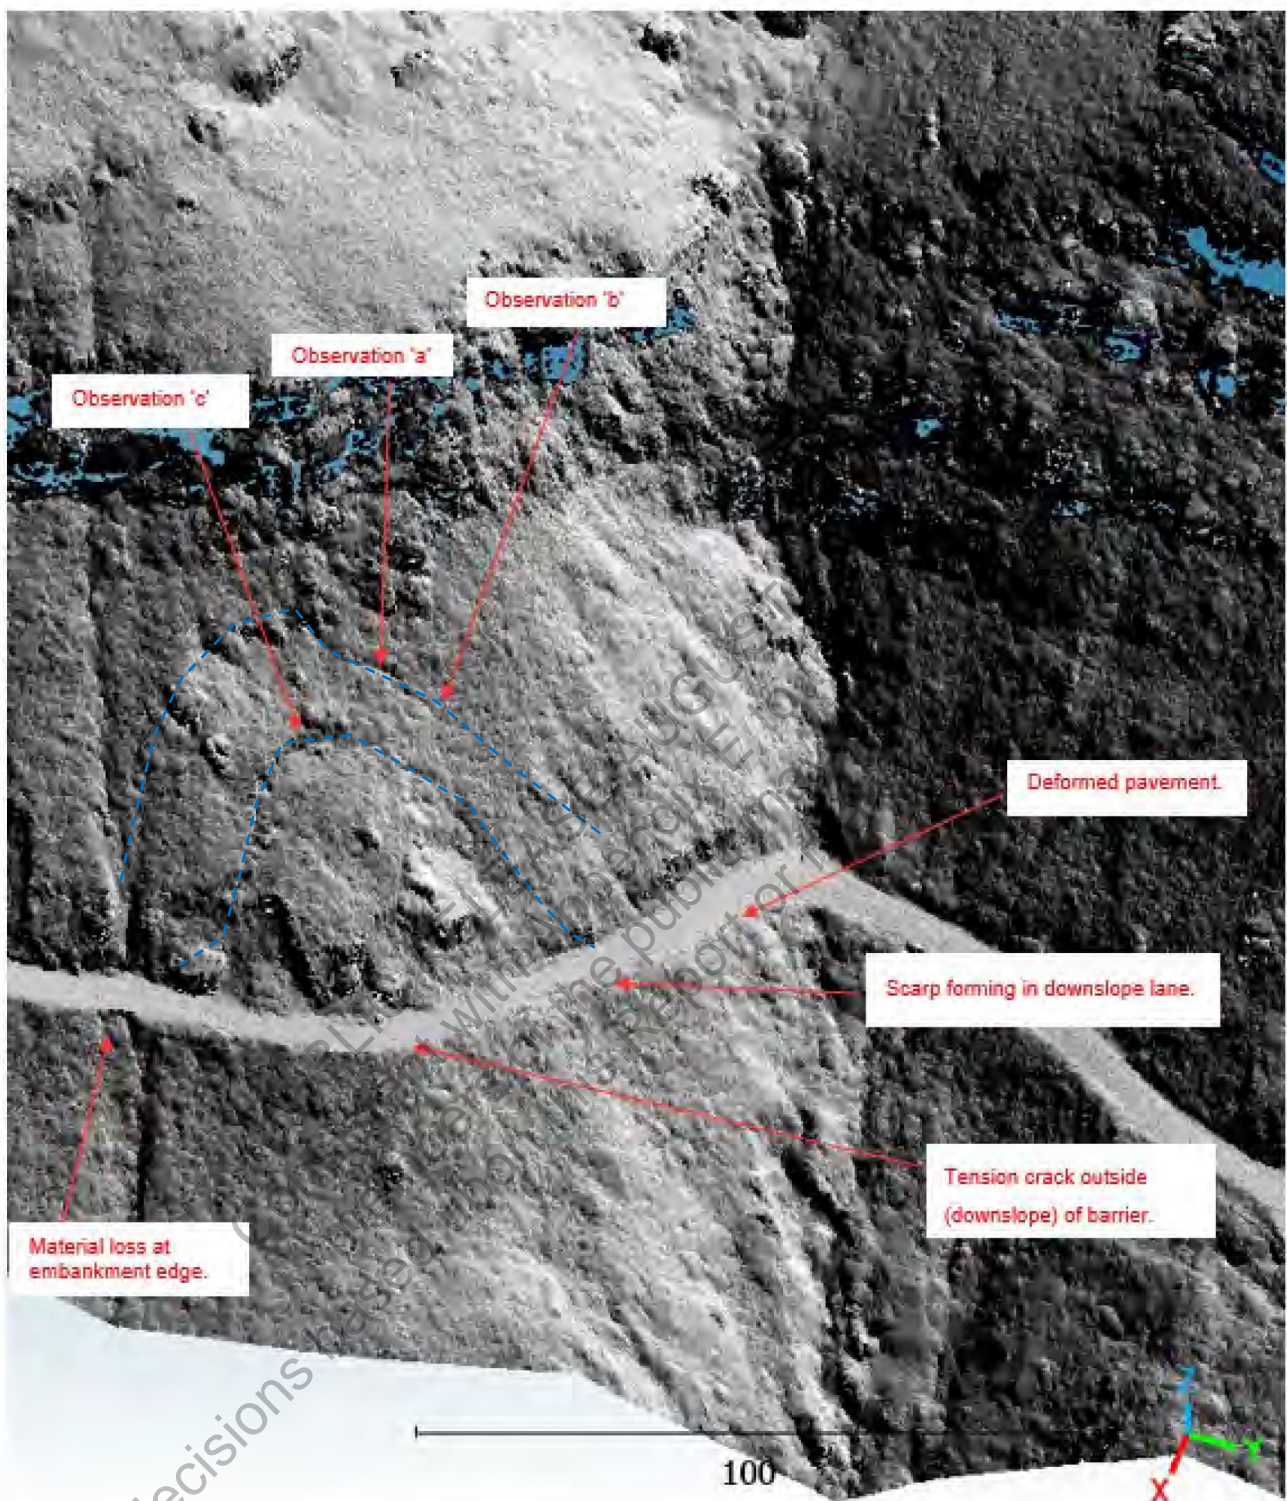
Figure 4 : Surface features inferred to correspond with slope instability observed at Site 1I, November 2022, annotated on 15.11.22 LiDAR derived hillshade.

The mobile colluvial mass observed at Site 1I includes sandstone boulders of minimum dimension greater than 5 m. Slide debris which had reached the road by 7th November 2022 included up to approximately 2 m diameter sandstone boulders. Approximately 250 m³ of slip material was removed from the road. In accordance with Item 1 above the risk posed by leaning trees was assessed by a team of professional arborists contracted by Council. Following completion of that risk assessment on 11th November 2022, a safety line was established by a professional rock climber to enable access to steep terrain above the landslide by our Principal Geotechnical Engineer with chaperone by a team of arborists. Our Principal Geotechnical Engineer observed three clearly visible features upslope of the crest of Site 1I consistent with the mobilisation of a landslide, as follows:

- a) An approximately crescent shaped crack, 0.3 m wide and 0.5 m deep.
- b) An approximately 0.1 m wide and 0.3 m deep tension crack.
- c) An approximately 1.5 m high scarp (depth unable to be safely determined at the time of observation).

The landslide was assessed to be small (i.e. 5,000 m³ to 50,000 m³) in accordance with Fell's 1994 classification. However, we inferred that the landslide could form part of a medium landslide (i.e. in the range 50,000 m³ to 250,000 m³) on the basis of observed areas of adjacent instability (e.g. colluvial material below road level which displayed an approximately 30 m long tension crack at road level).

The locations of site observations a, b and c above are annotated on Figure 4 and 5 below, which are a hill shade image and photo aerial image derived from the 15th November 2022 UAV survey respectively. The location of adjacent surface features inferred to be indicative of slope instability are shown on Figure 4 and Figure 5. Those adjacent instabilities have the potential to contribute to a landslide in the medium scale category via a regressive mechanism whereby movement of downslope material removes support to upslope material and/or a successive mechanism (i.e. a Type B slide as shown in Figure 1 above). The location of the primary and minor scarp inferred from site observations and reference to the UAV survey are shown by the blue dashed lines of Figure 4 and 5.

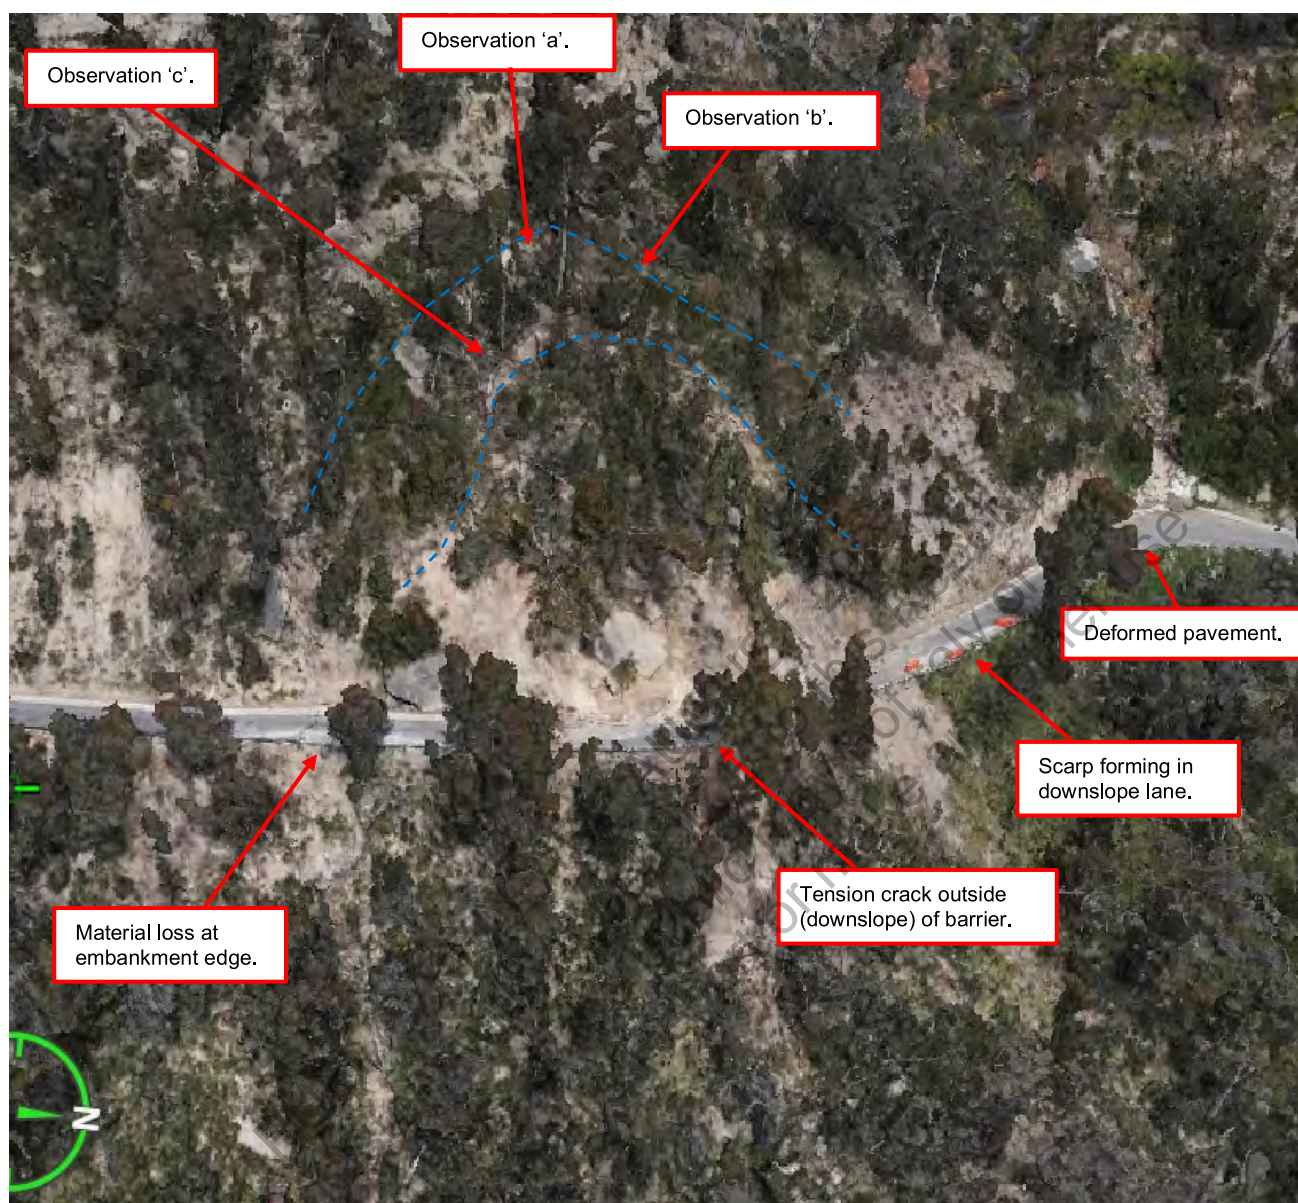
Figure 5 : Surface features corresponding with slope instability observed at Site 11, November 2022, annotated on 15.11.22 aerial photogrammetric survey.

The active landslide at Site 11 is categorised as a slow moving (i.e. with a speed of between approximately 5 mm per day and 500 mm per day) translational debris slide in accordance with Appendix B of the Practice Note Guidelines for Landslide Risk Management 2007 (AGS 2007) based on the overall rate of movement observed between 6th November 2022 and 15th November 2022. However, individual portions of the landslide mass up to approximately 50 m³ in volume released to road level during that period at an extremely rapid velocity (i.e. more than 20 km per hour). It is possible that the overall landslide mass could mobilise at an extremely rapid velocity.

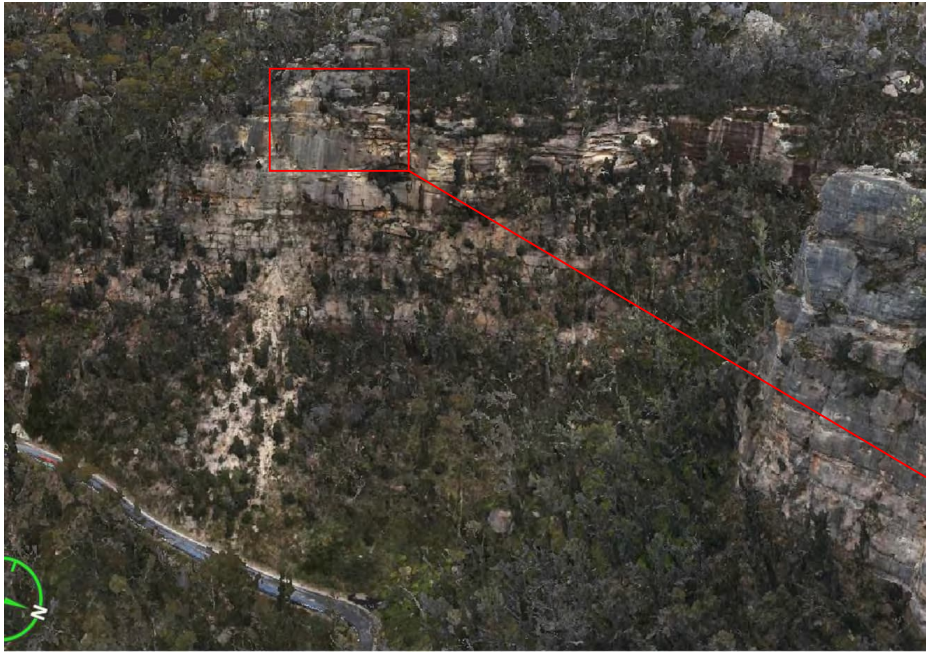
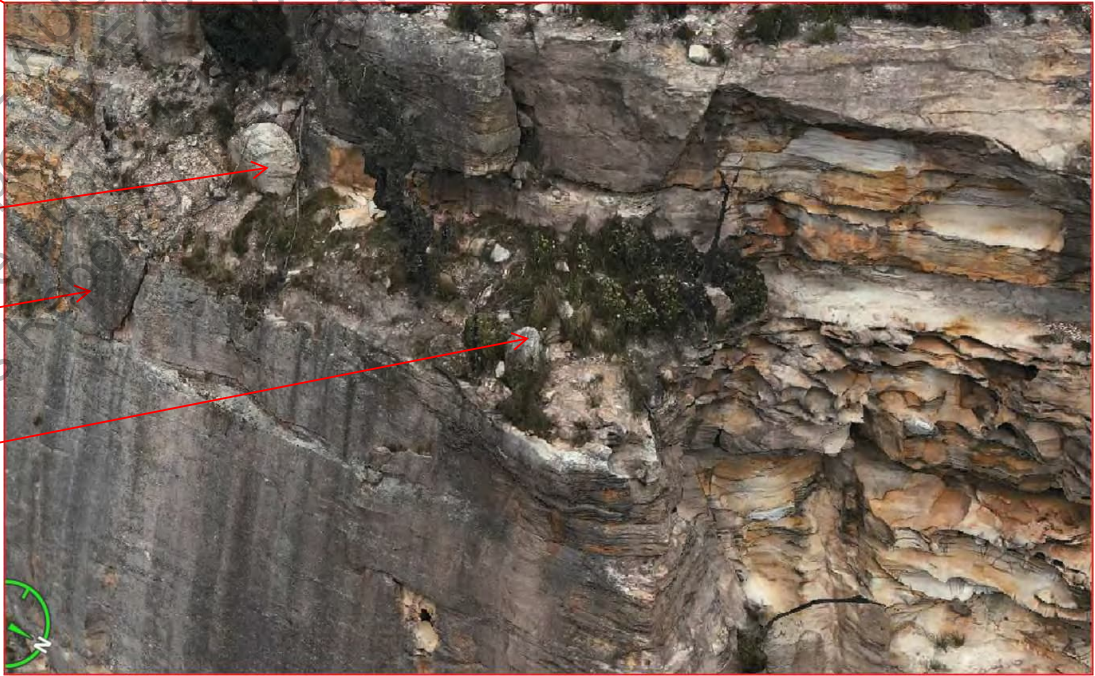
TITLE Review of Wolgan Gap Slope Hazards 2022 Figure B1 - Example H1.1.1 and H1.1.2 Rockfall Hazards Domain 1 - Upper Source Zone			
PROJECT NO	DOC	REV.	FIGURE
PS129742	001	0	B1

Example H1.1.2 Rockfall (re-mobilisation) Hazard (Approx. diameter 2 m)

Example H1.1.2 Rockfall (Kinematic) Hazard (Approx. diameter 2 m)

Example H1.1.1 Rockfall (re-mobilisation) Hazard (Approx. diameter 0.5 m)

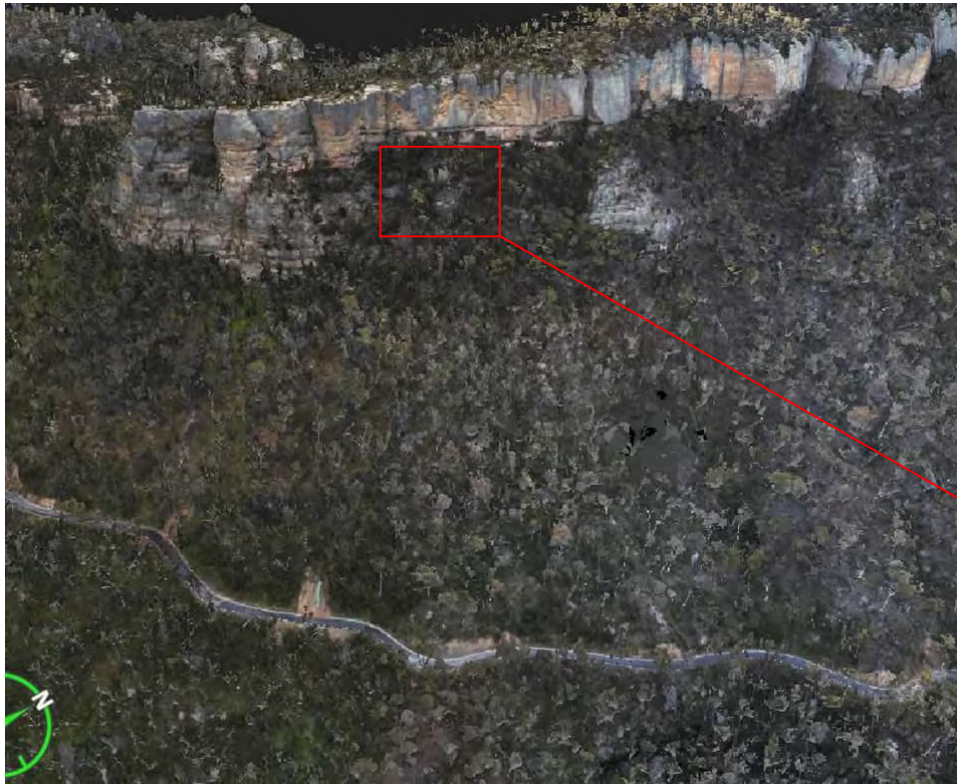
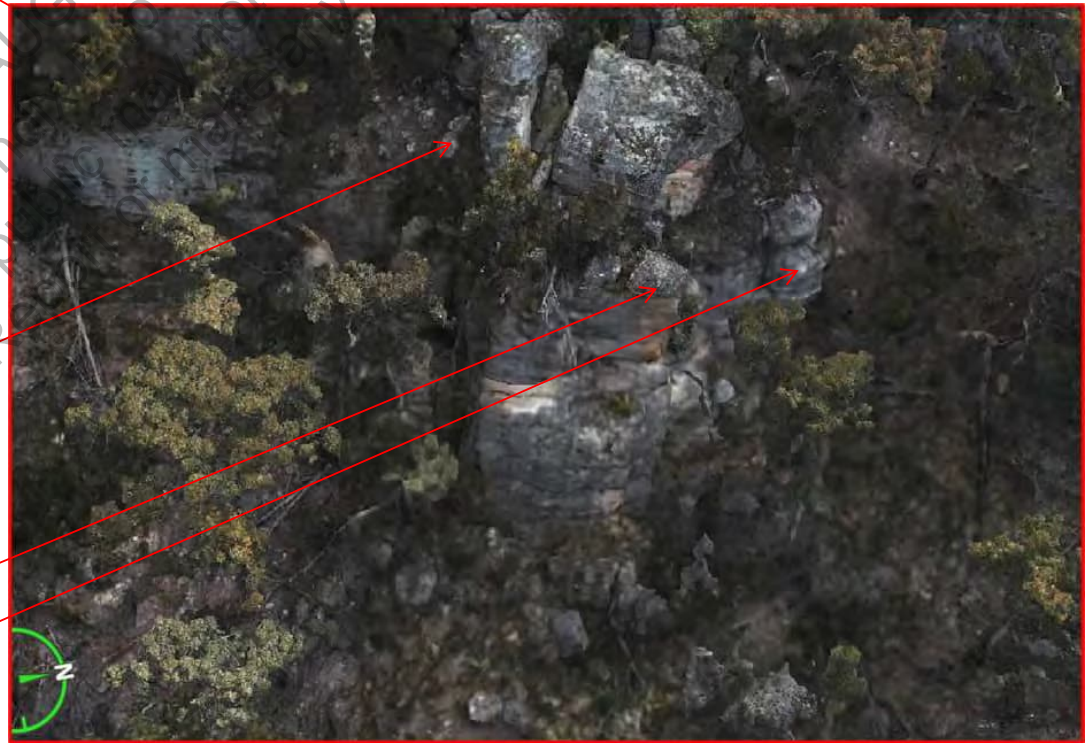
Example H1.1.1 Rockfall (re-mobilisation) Hazard (Approx. diameter 0.5 m)

Example H1.1.2 Rockfall (re-mobilisation) Hazard (Approx. diameter 3 m)

Example H1.1.2 Rockfall (kinematic) Hazard (Approx. diameter 3 m)

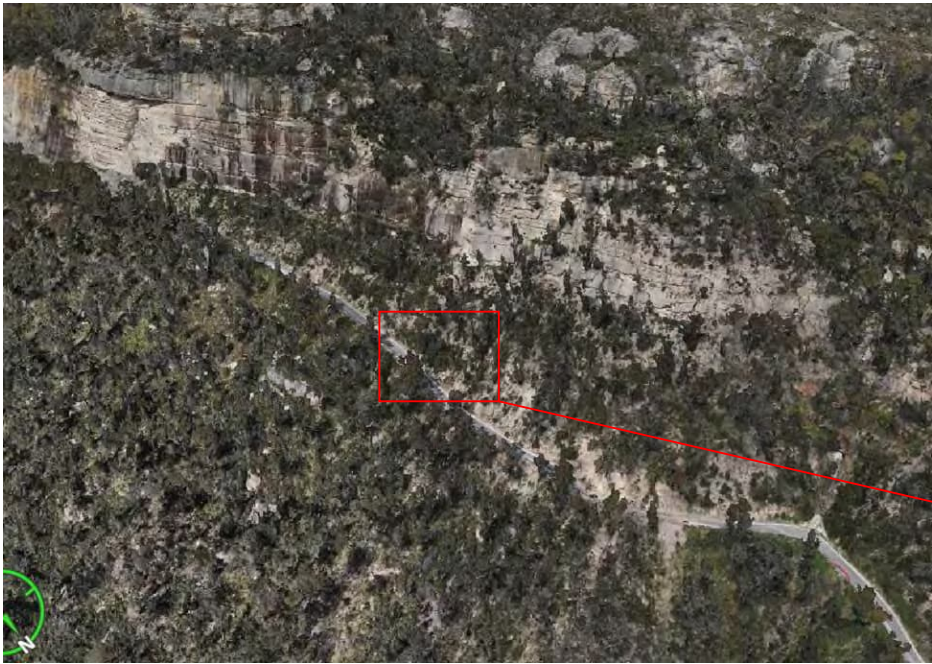
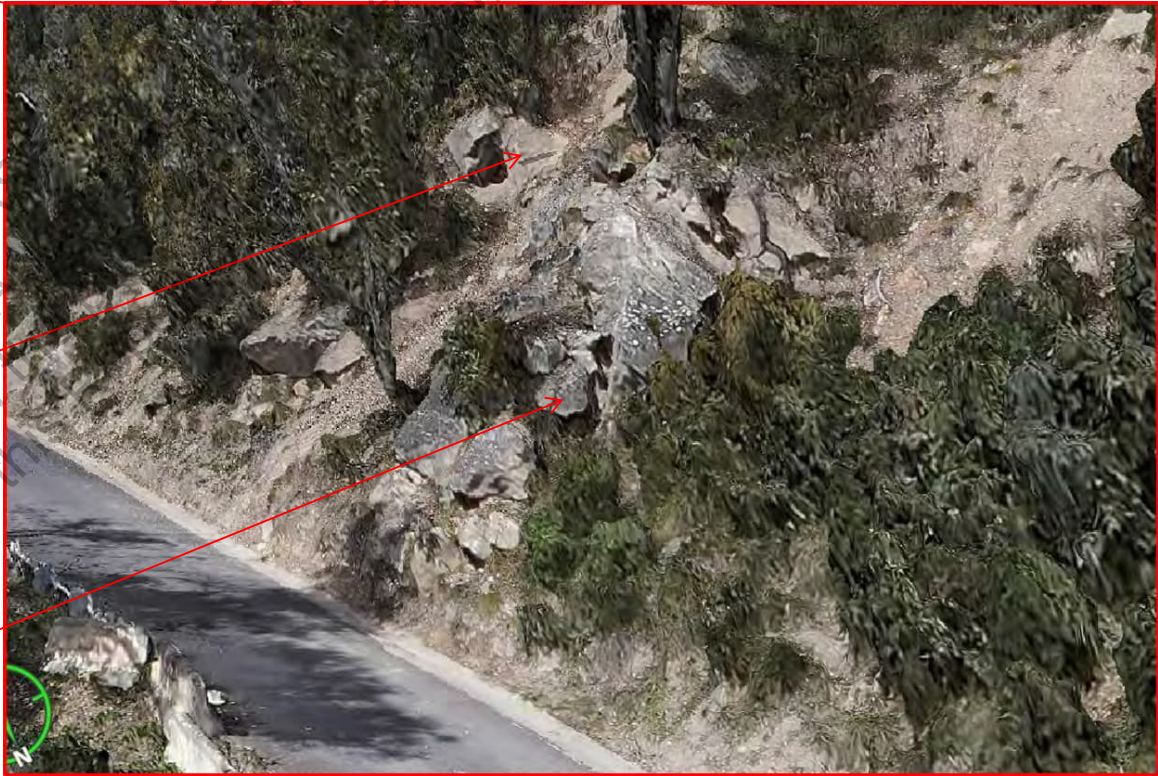
TITLE
Review of Wolgan Gap Slope Hazards 2022
Figure B3 - Example H1.1.1 and H1.1.2 Rockfall Hazards Domain 1 - Road Cut Crest Zone

Example H1.1.2 Rockfall (re-mobilisation) Hazard (Approx. diameter 3 m)

Example H1.1.1 Rockfall (re-mobilisation) Hazard (Approx. diameter 0.5 m)

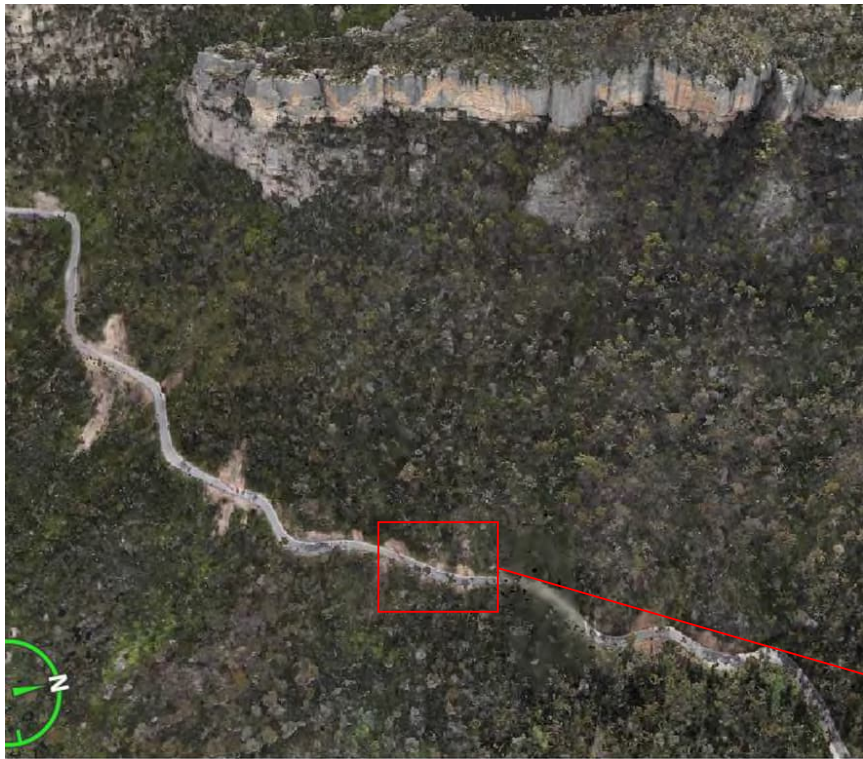
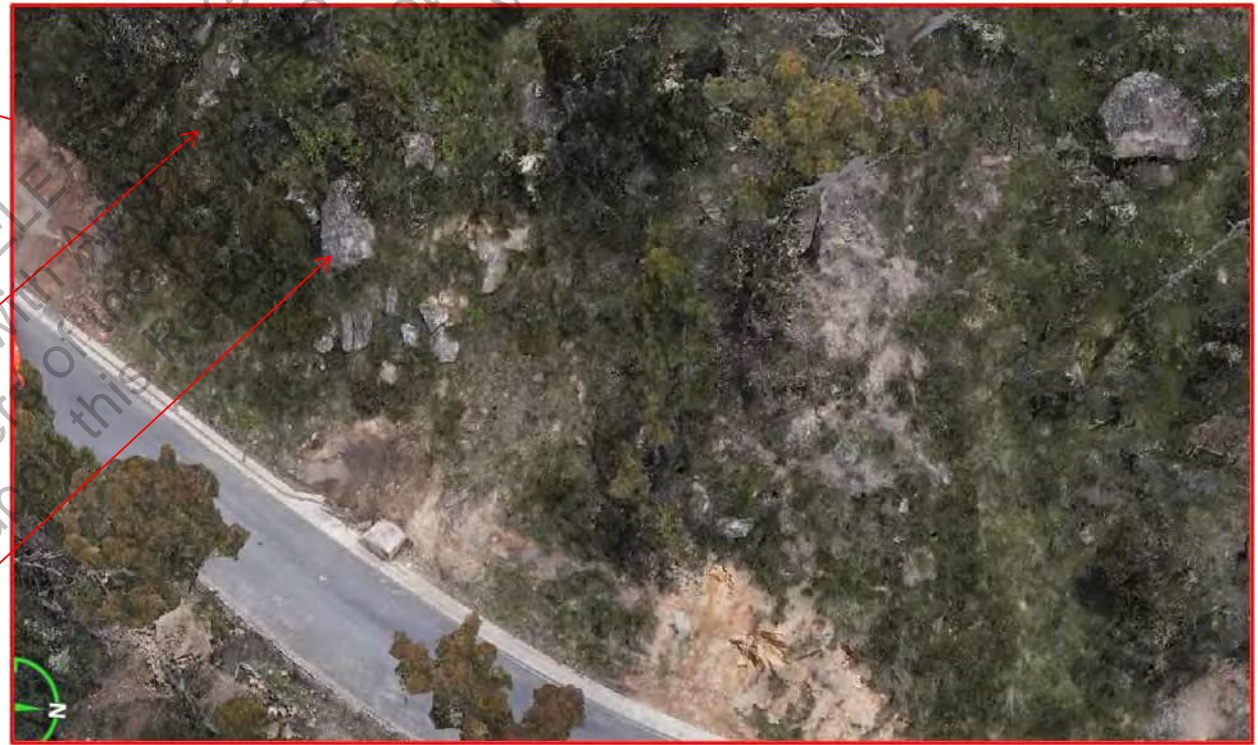
Figure B4 - Example H1.1.1 and H1.1.2 Rockfall Hazards Domain 2 - Road Cut Crest Zone

Example H1.1.1 Rockfall (re-mobilisation) Hazard (Approx. diameter 0.5 m)

Example H1.1.2 Rockfall (re-mobilisation) Hazard (Approx. diameter 3 m)

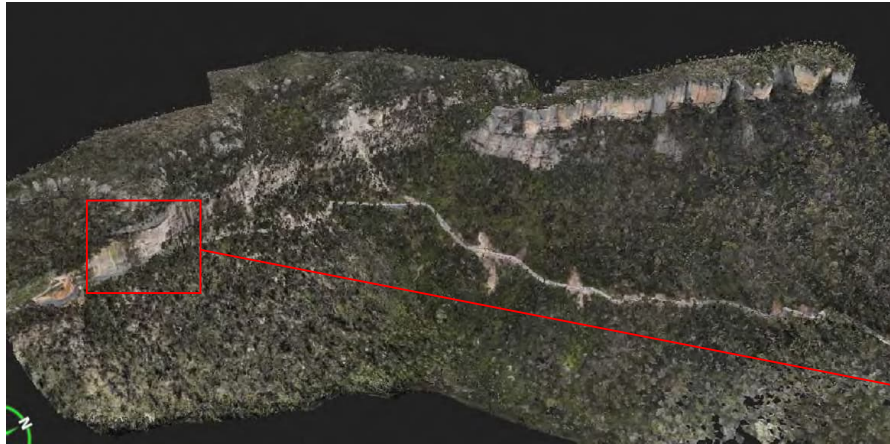
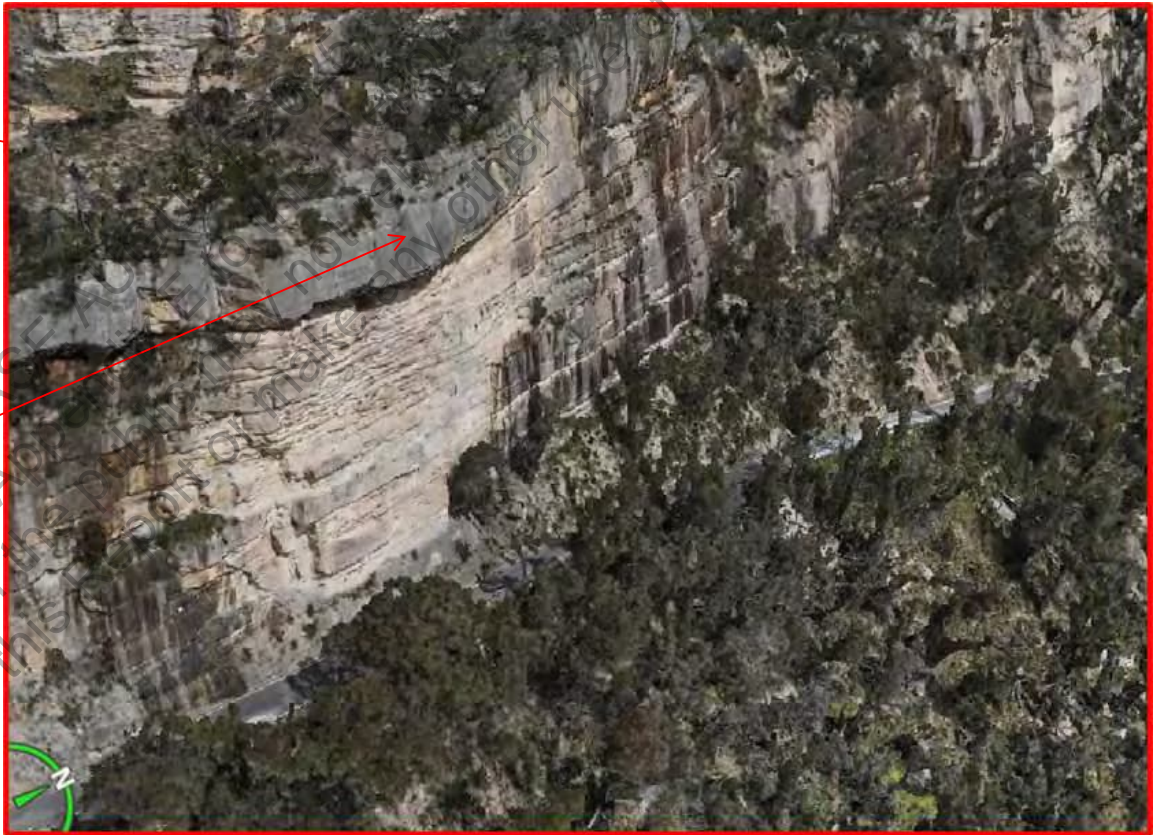
TITLE
Review of Wolgan Gap Slope Hazards 2022
Figure B5 - Example H1.2 Rock Topple Hazards Domain 1

Example H1.2 Rock Topple Hazard (Approx. 65 m long)

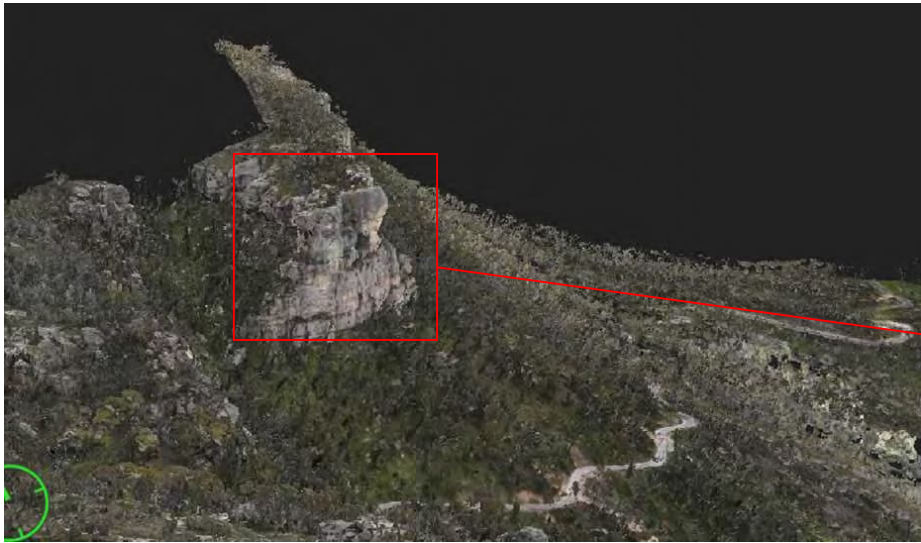
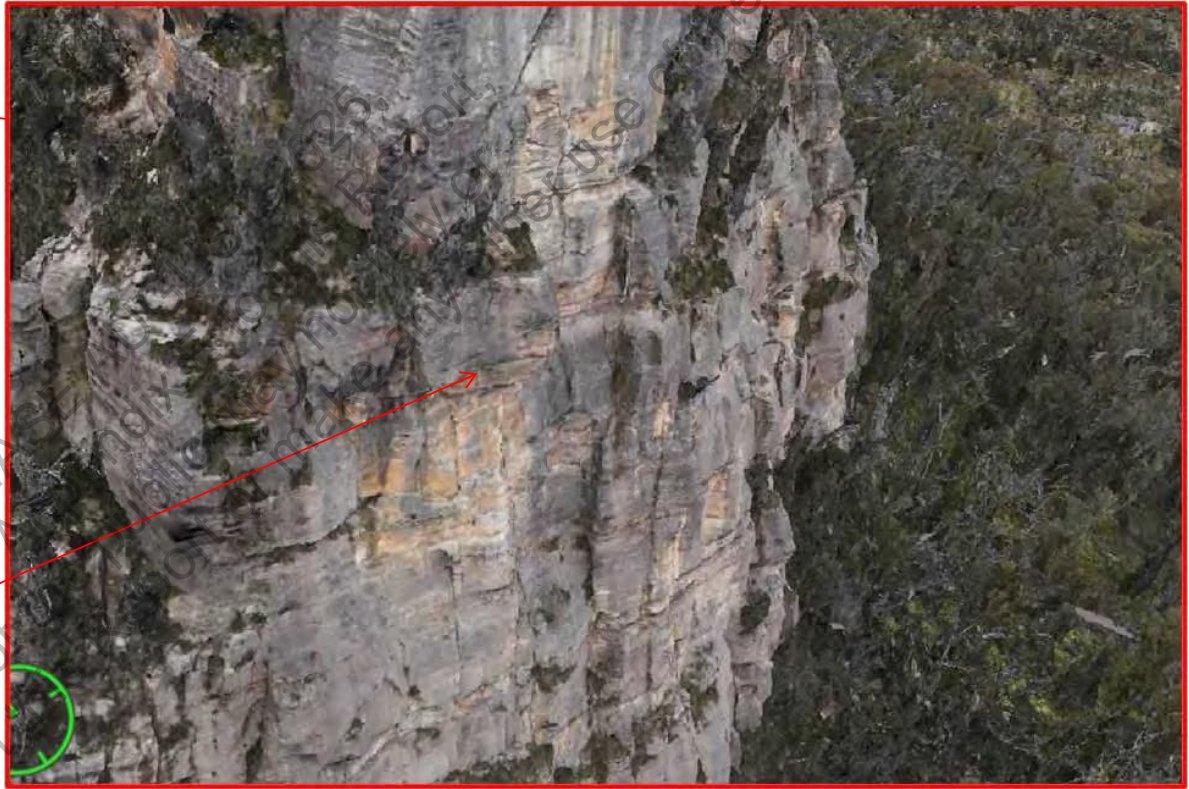
TITLE
Review of Wolgan Gap Slope Hazards 2022
Figure B6 - Example H1.2 Rock Topple Hazards Domain 2

Example H1.2 Rock Topple Hazard (Approx. 10 m minimum dimension)

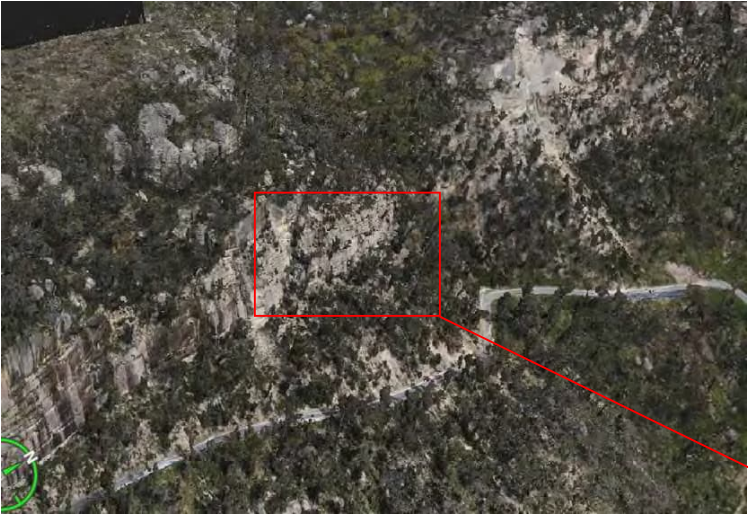
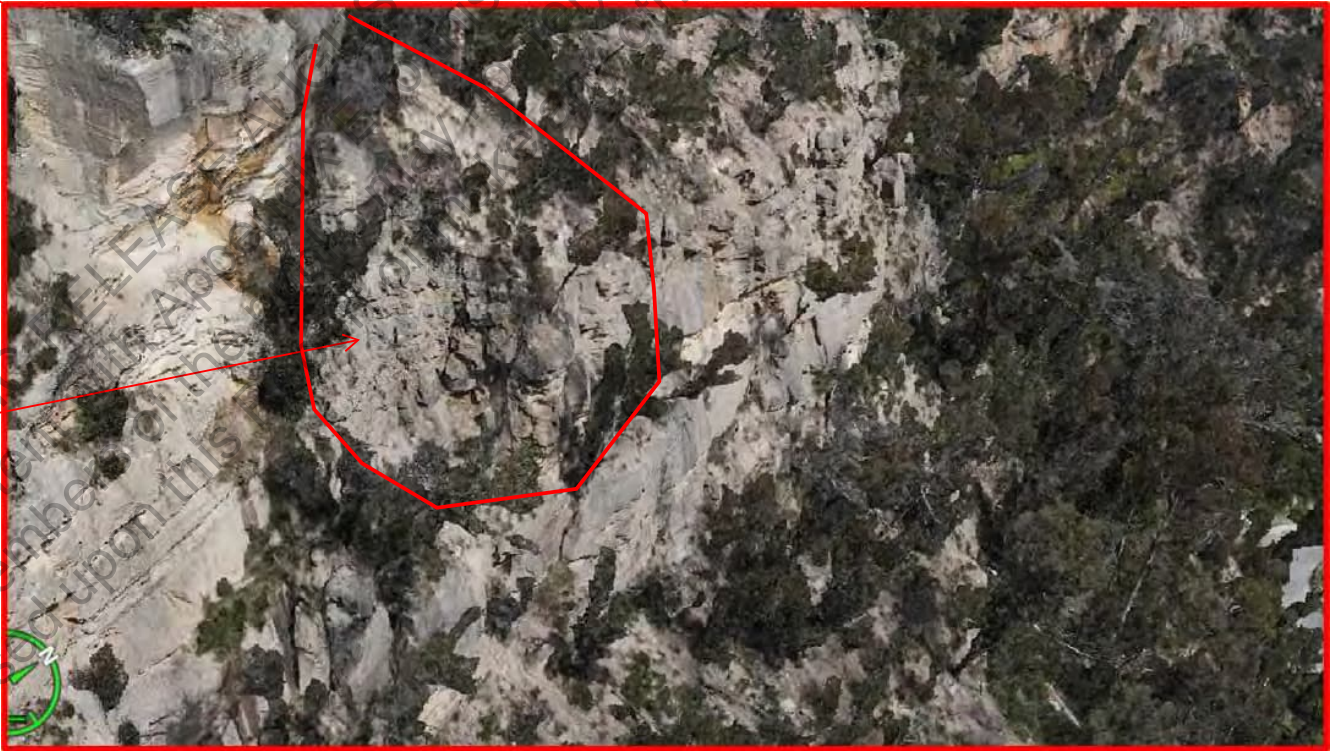
TITLE Review of Wolgan Gap Slope Hazards 2022 Figure B7 - Example H1.3 Rock Slide Hazards Domain 1		
YYYY-MM-DD	2023-1-17				
DESIGNED	NS				
PREPARED	GW				
REVIEWED	GKS				
APPROVED	GKS	PROJECT NO	DOC	REV.	FIGURE
		PS129742	001	0	B7

Example H1.3 Rock Slide Hazard (Estimated >5,000 m³)

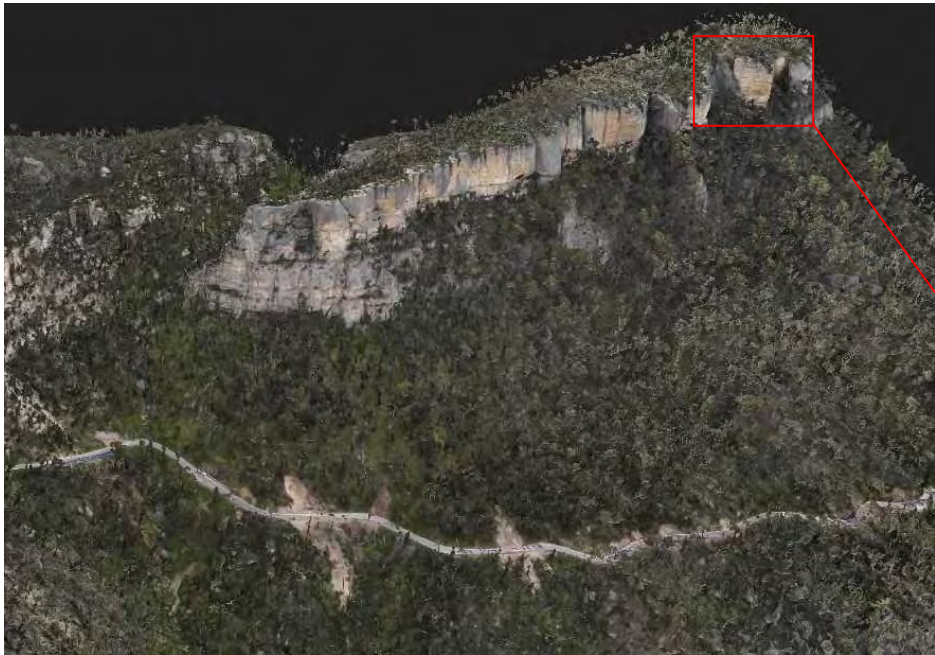
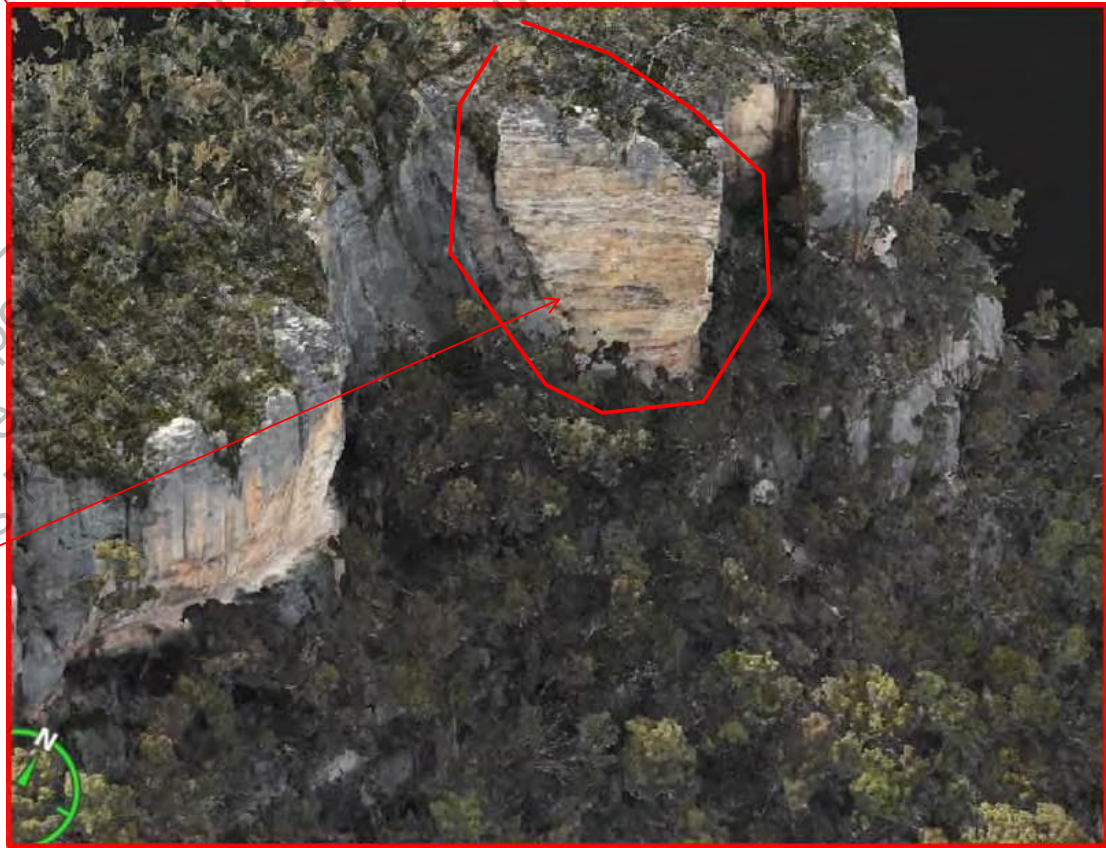
TITLE
Review of Wolgan Gap Slope Hazards 2022
Figure B8 - Example H1.3 Rock Slide Hazards Domain 2

Example H1.3 Rock Slide Hazard (Estimated >5,000 m³)

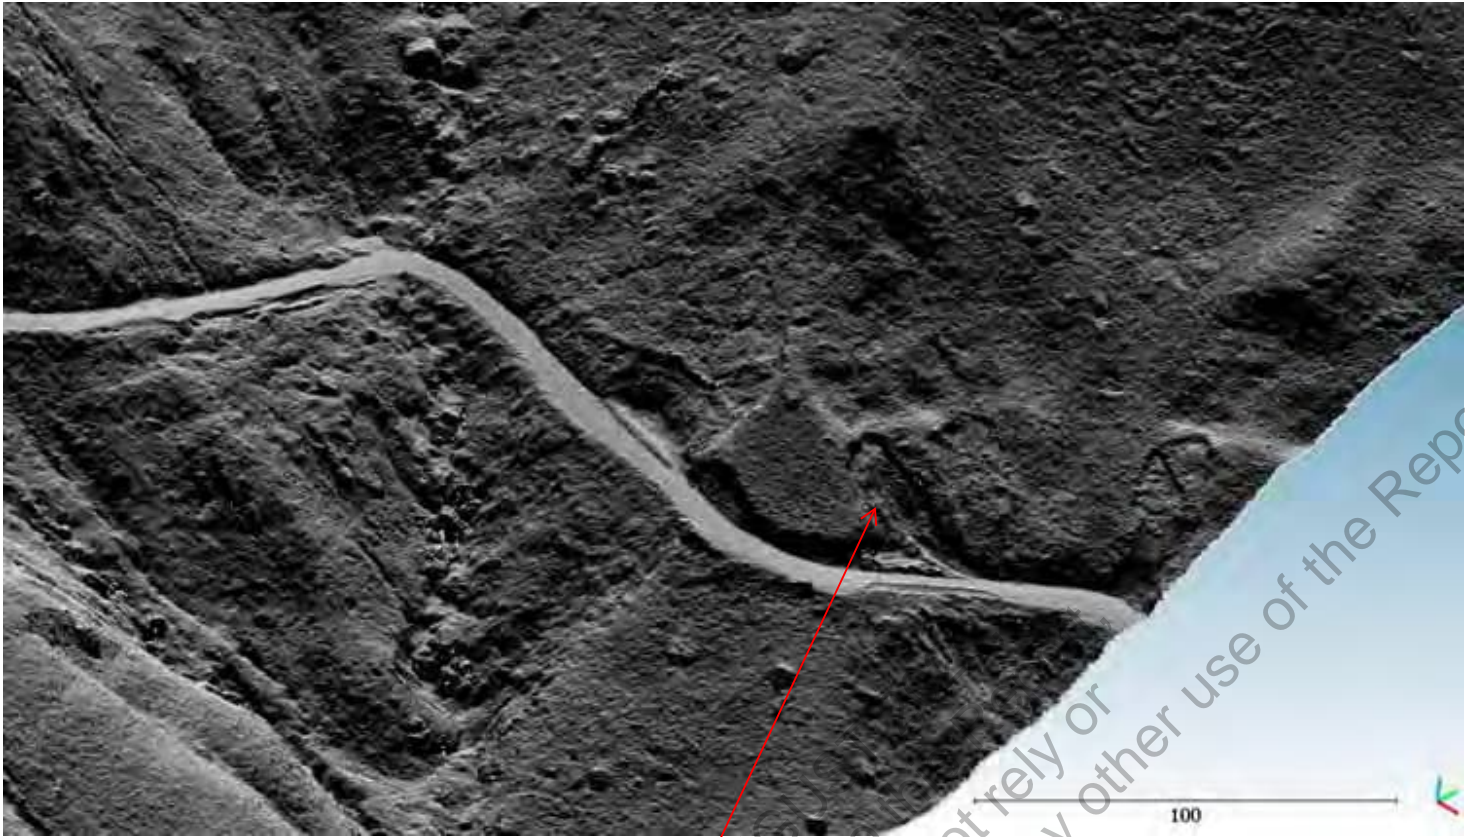
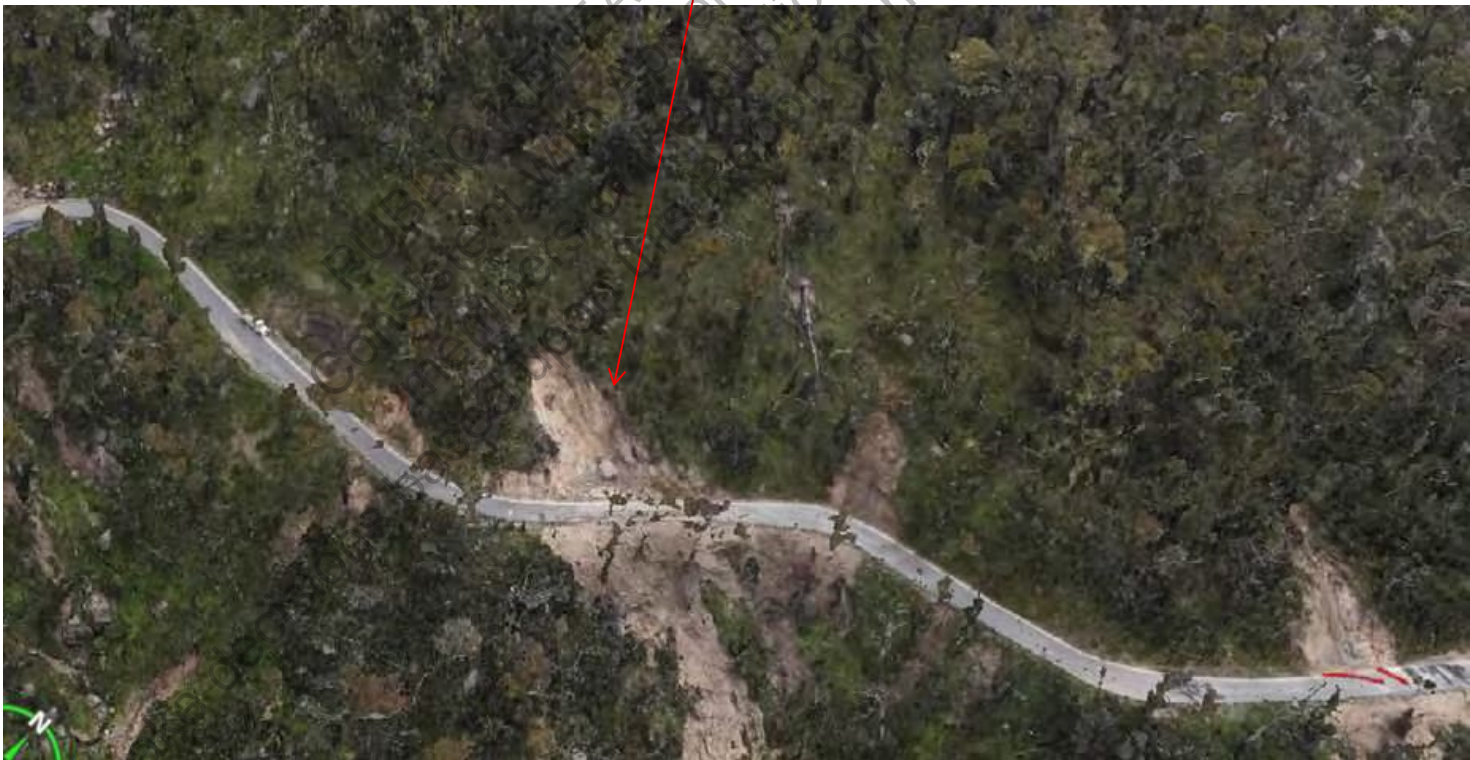
TITLE
Review of Wolgan Gap Slope Hazards 2022
Figure B9 - Example H2.1 Upslope Debris Flow

Example H2.1 Upslope Debris Flow Hazard, left flank
(Approx. 40 m wide, 40 m long, 2 m deep)
