Wolgan Road, NSW

Review of Wolgan Gap Slope Hazards 2022

Lithgow City Council

PS129742-SYD-GEO-REP-001-REV 0

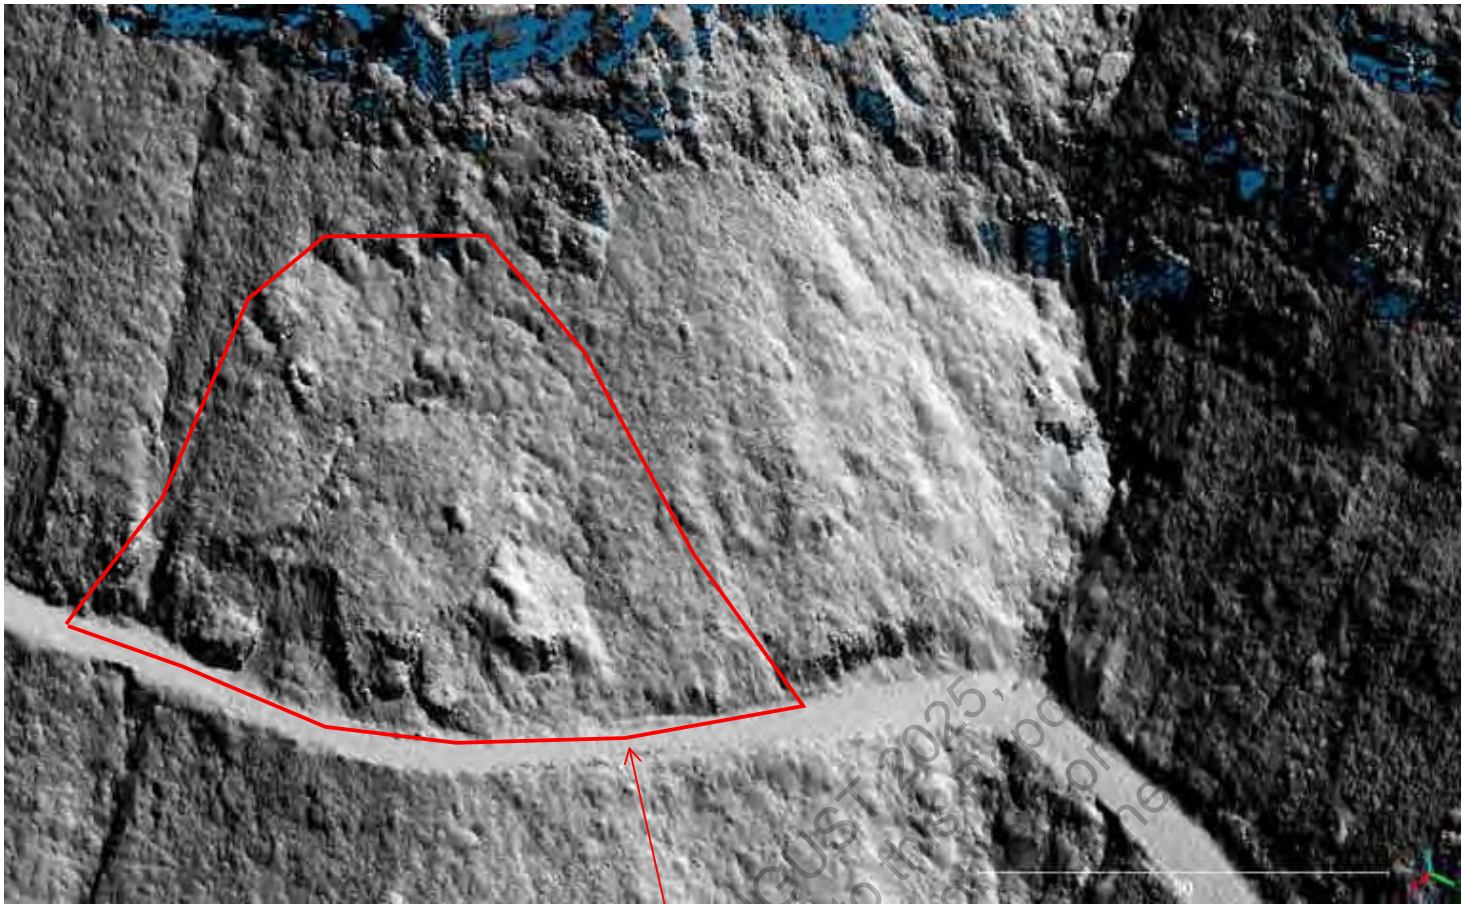
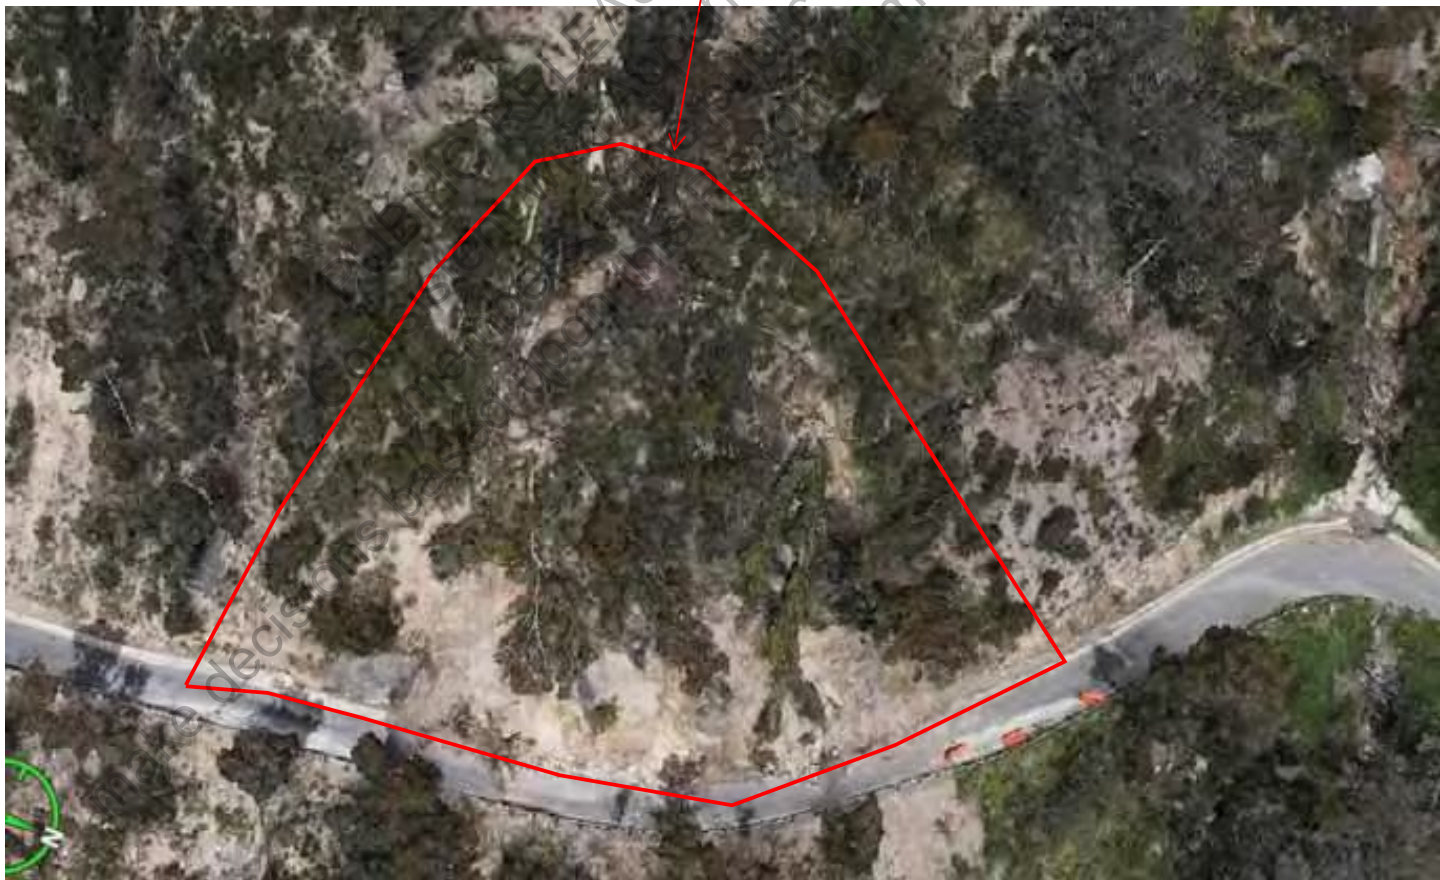
PROJECT NO	DOC	REV.	FIGURE
PS129742	001	0	B10

Example H2.1 Upslope Debris Slide Hazard, enlarging
(Approx. 60 m wide, 60 m long)

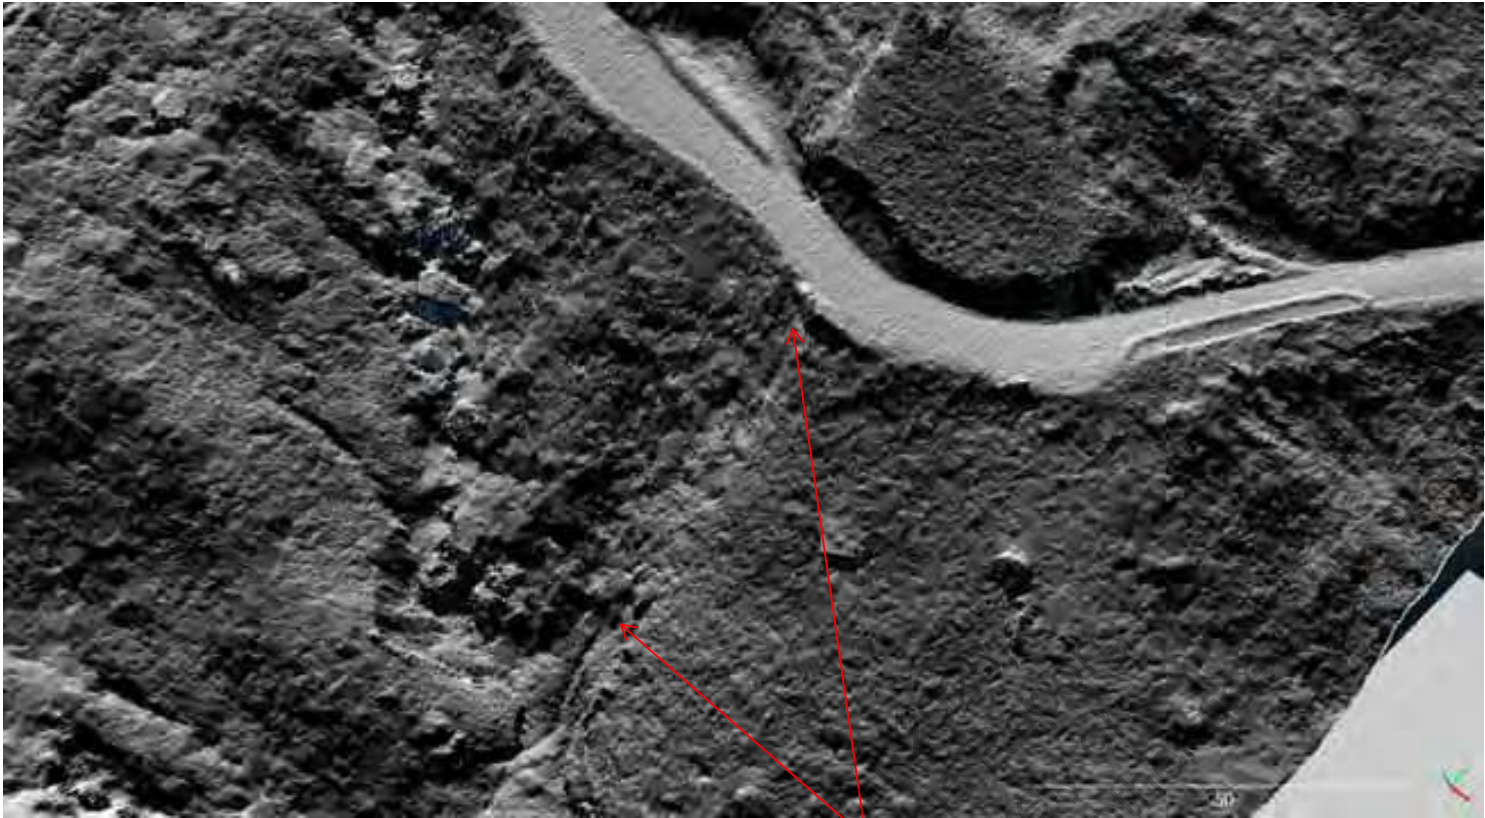
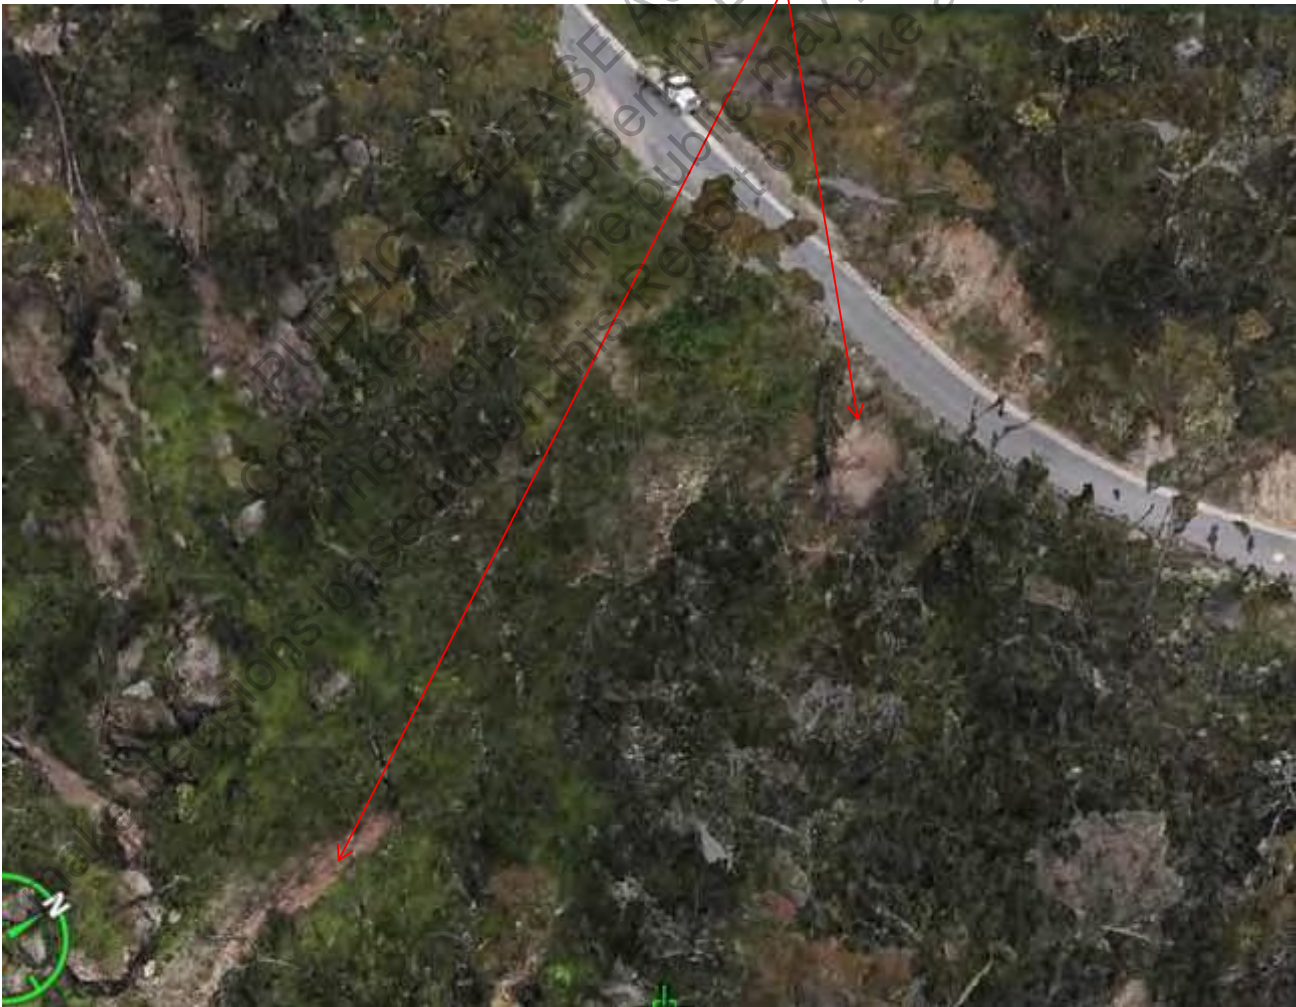
PROJECT NO	DOC	REV.	FIGURE
PS129742	001	0	B11

Example H3.1 Downslope Debris Flow Hazard, right flank
(Approx. 5 m wide, 10-20 m long, 2 m deep)

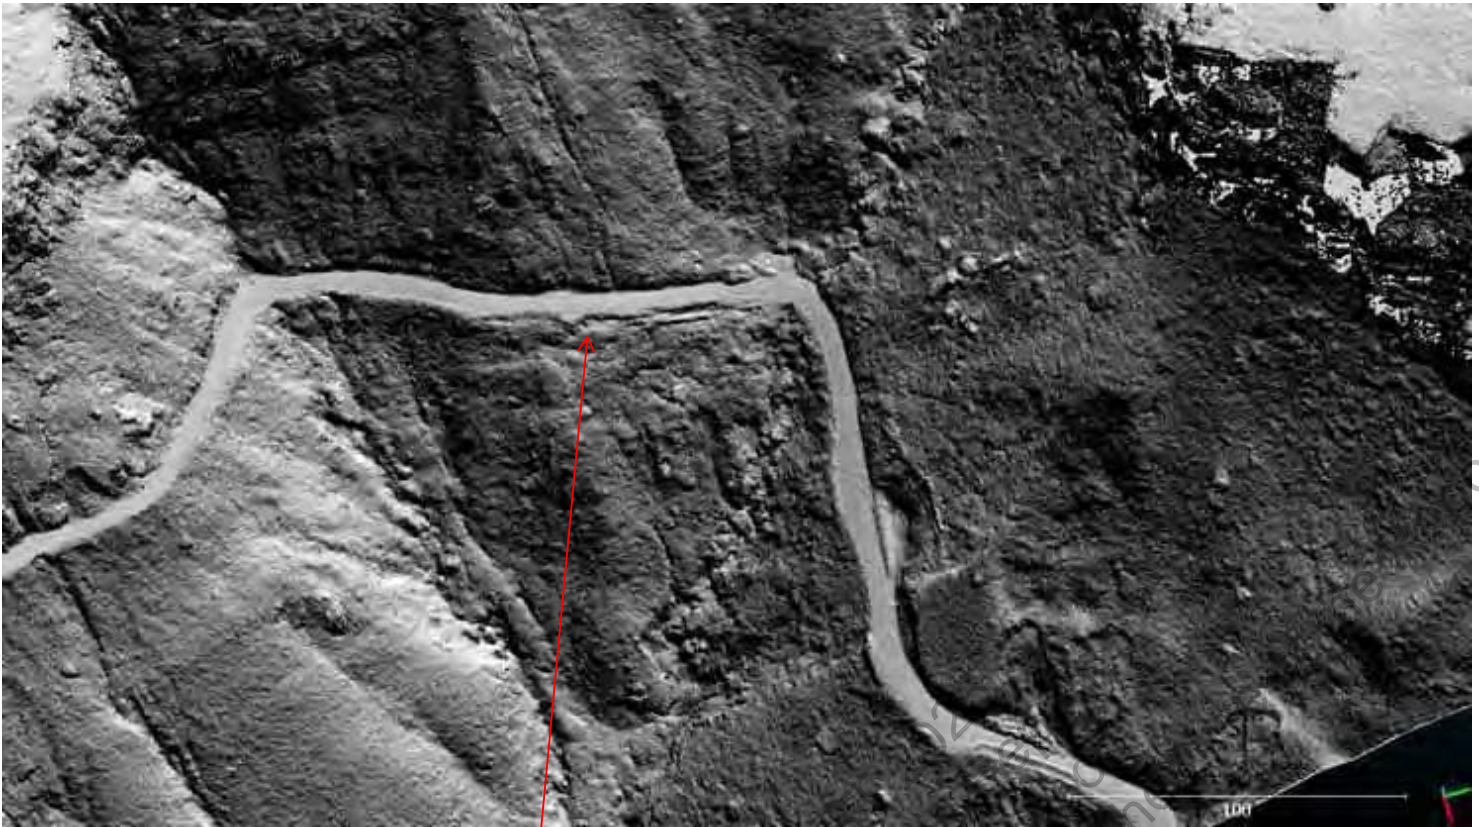
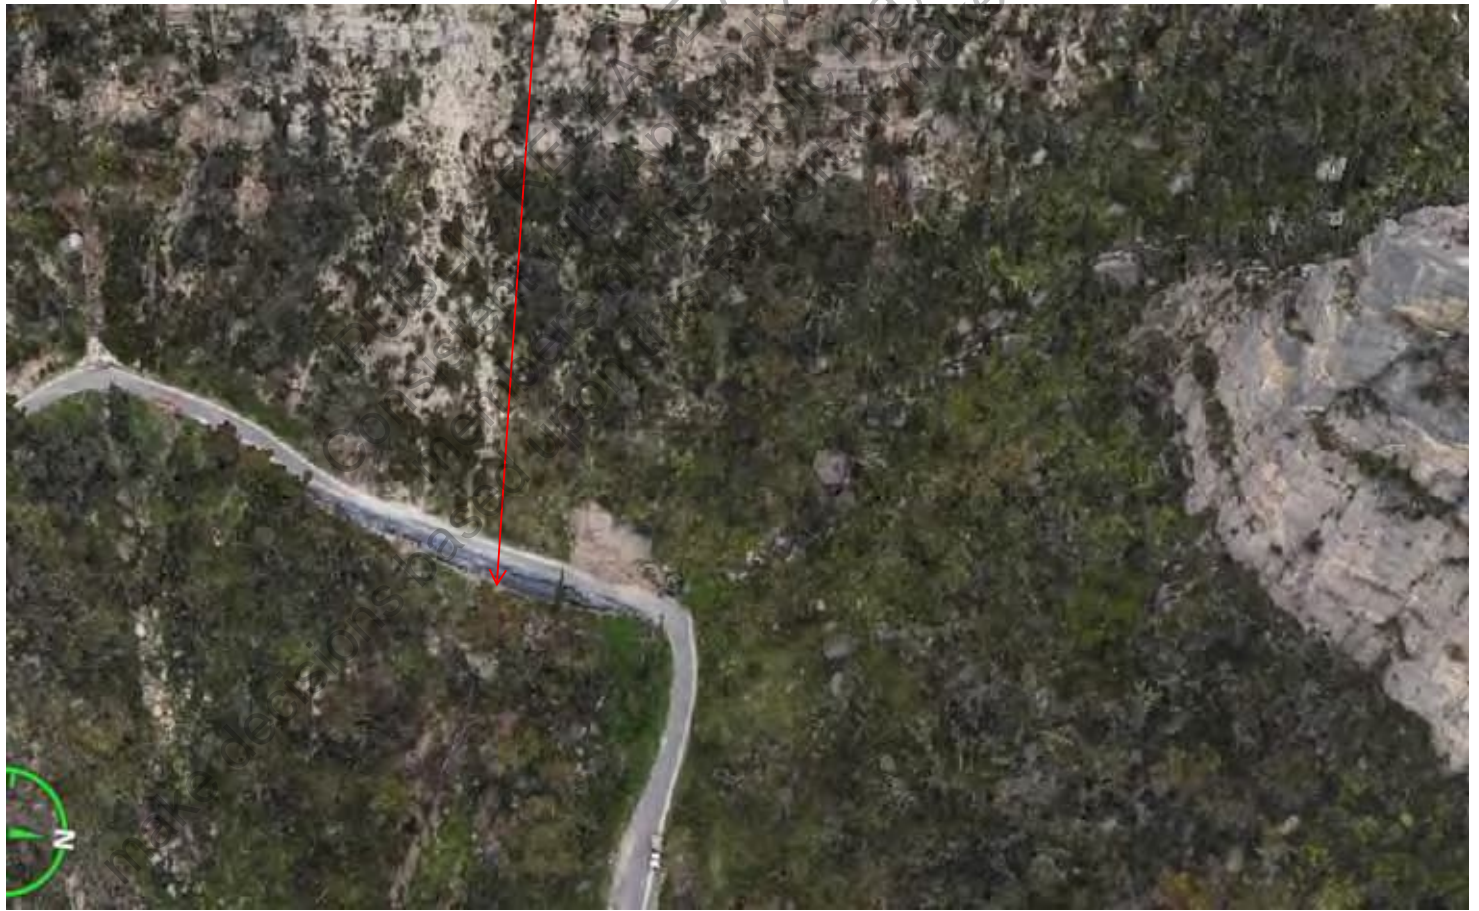
PROJECT NO	DOC	REV.	FIGURE
PS129742	001	0	B12

Example H3.2 Downslope Debris Slide Hazard, (Approx. 100 m wide)

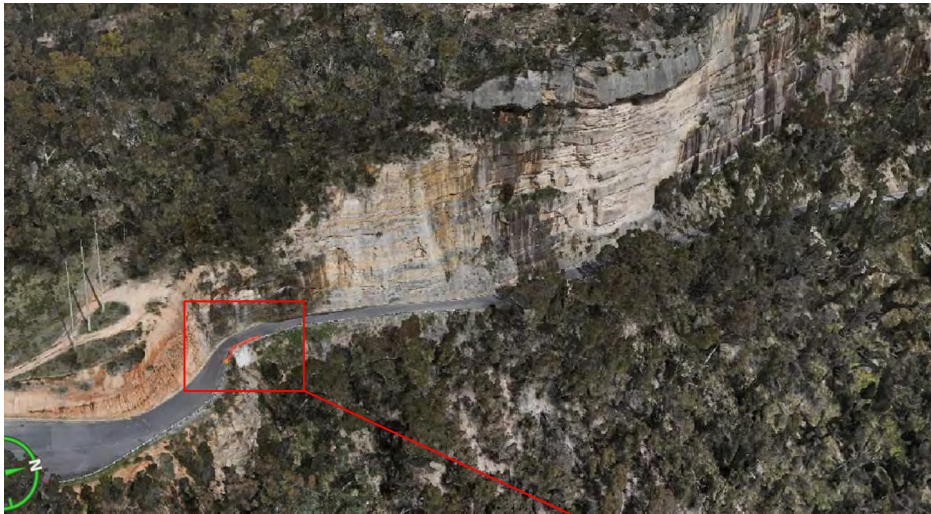
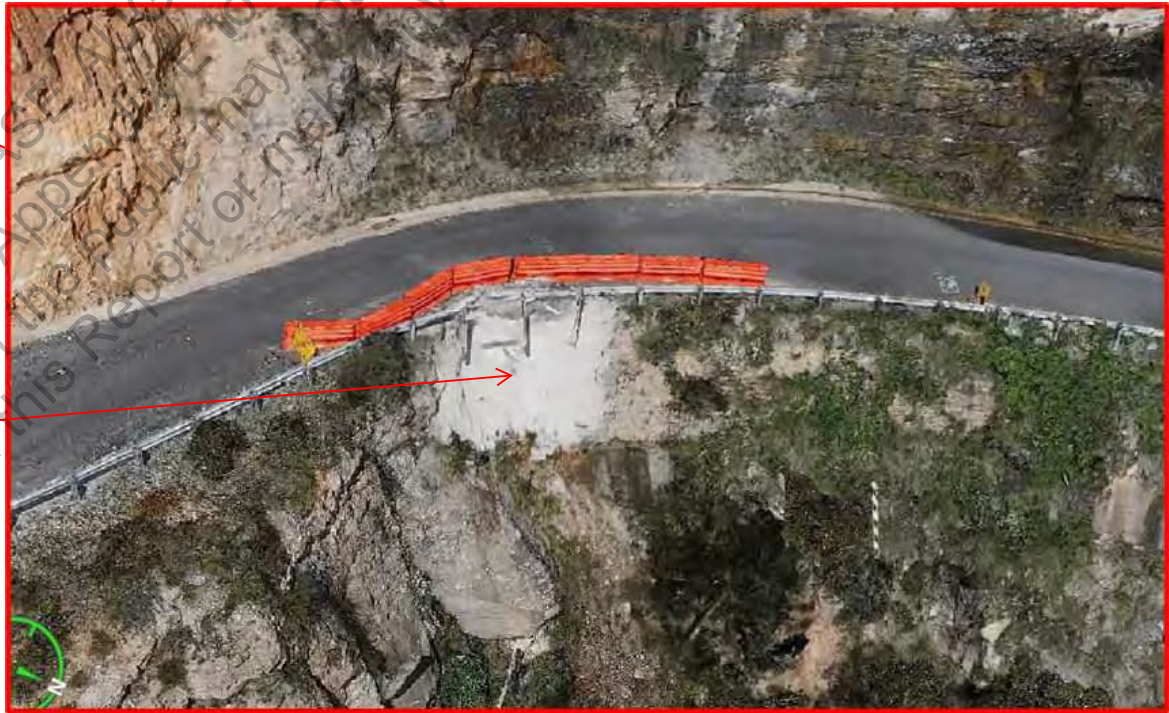
PROJECT NO	DOC	REV.	FIGURE
PS129742	001	0	B13

Example H4.1 Retention Element Failure Hazard, (Sandstone block wall approximately 5 m high and 20 m long). Temporary fibrecrete and mesh treatment in place.

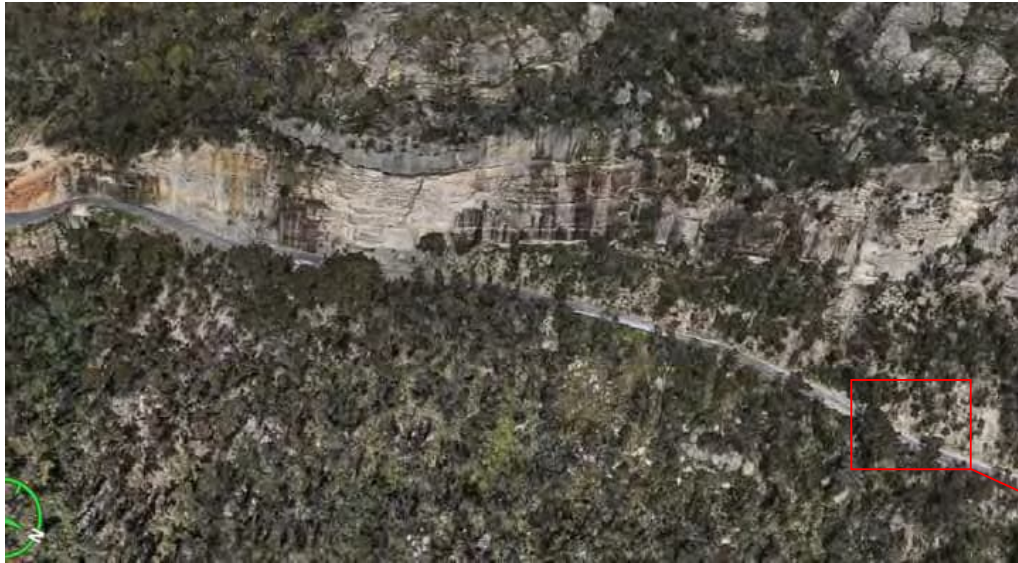
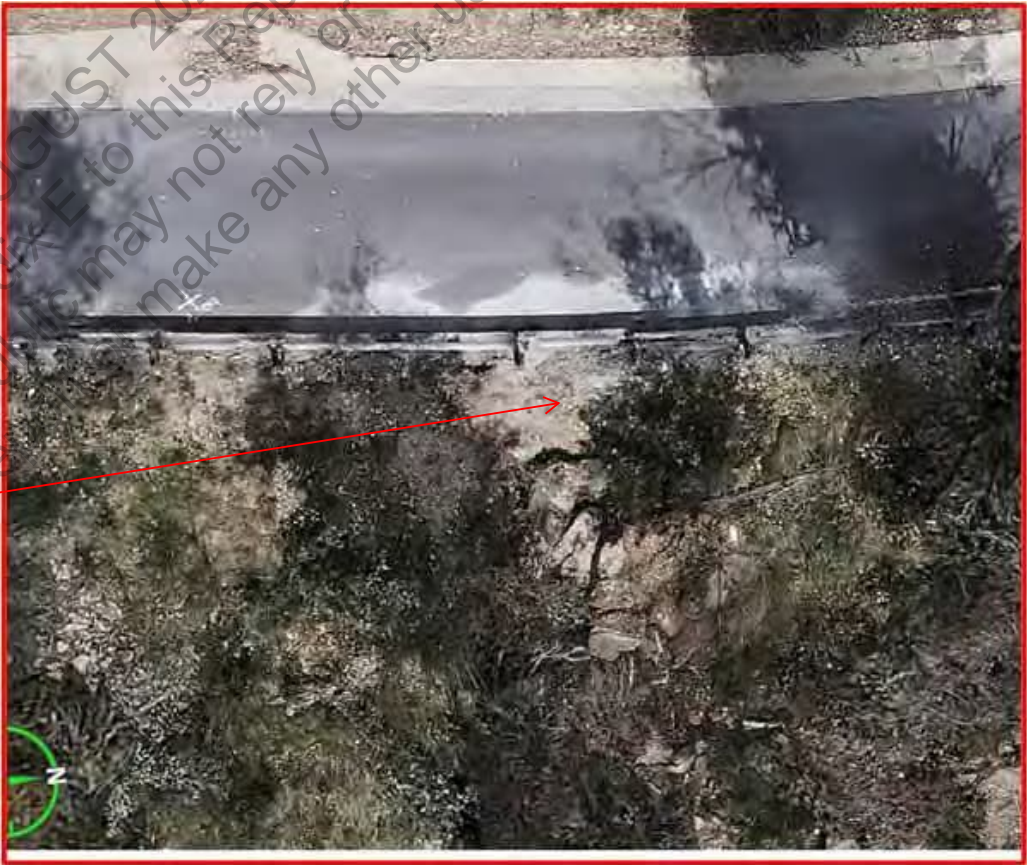
Example H4.2 Drainage Element Failure Hazard
Culvert has lost integrity and headwall has 'blown out'
