FINAL REPORT

Stage 1 Environmental Site Assessment

Lithgow Mountain Bike Park, State Mine Gully Road, State Mine Gully, Lithgow NSW

11 August 2025

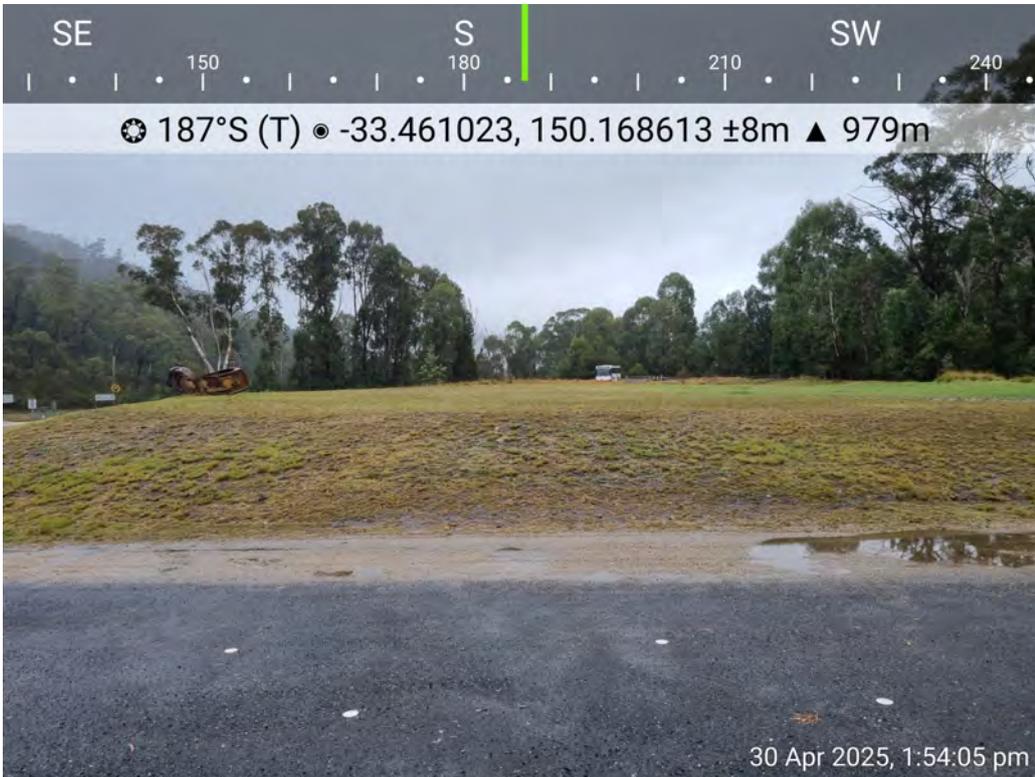
Plate 3: View of southern area of Site on the southern area of the State Mine Heritage Park – elevated mounded area, where proposed carpark and amenities are to be located – looking S

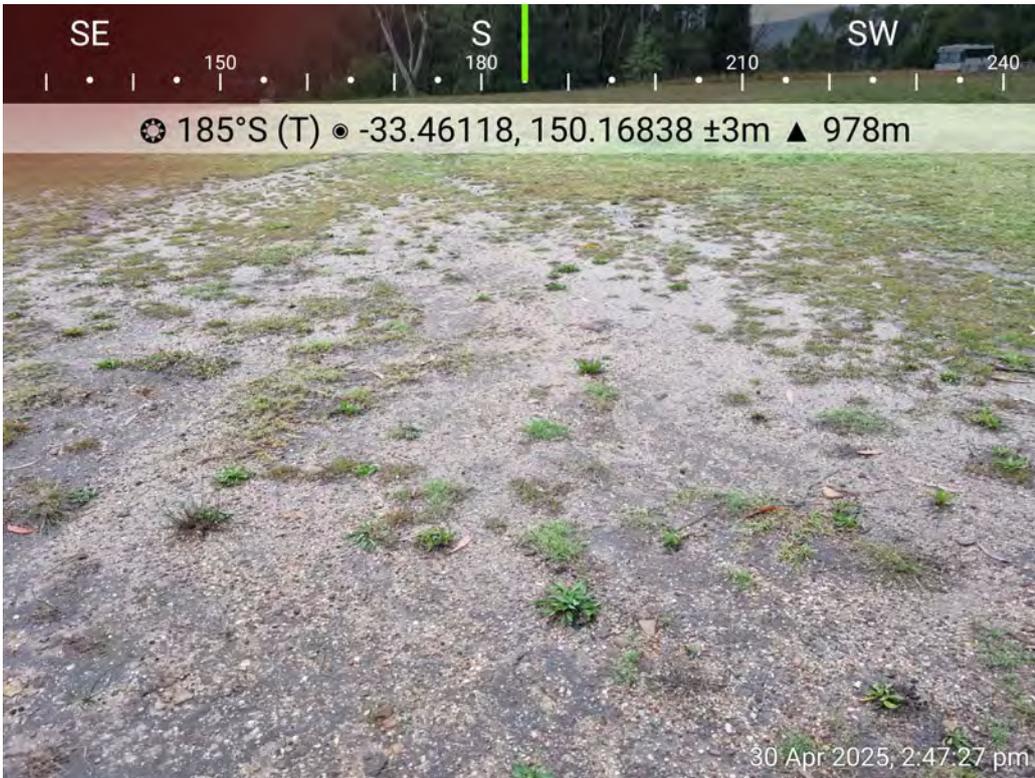
Plate 17: View of sparse grass cover on part of southern part of Site on mounded area

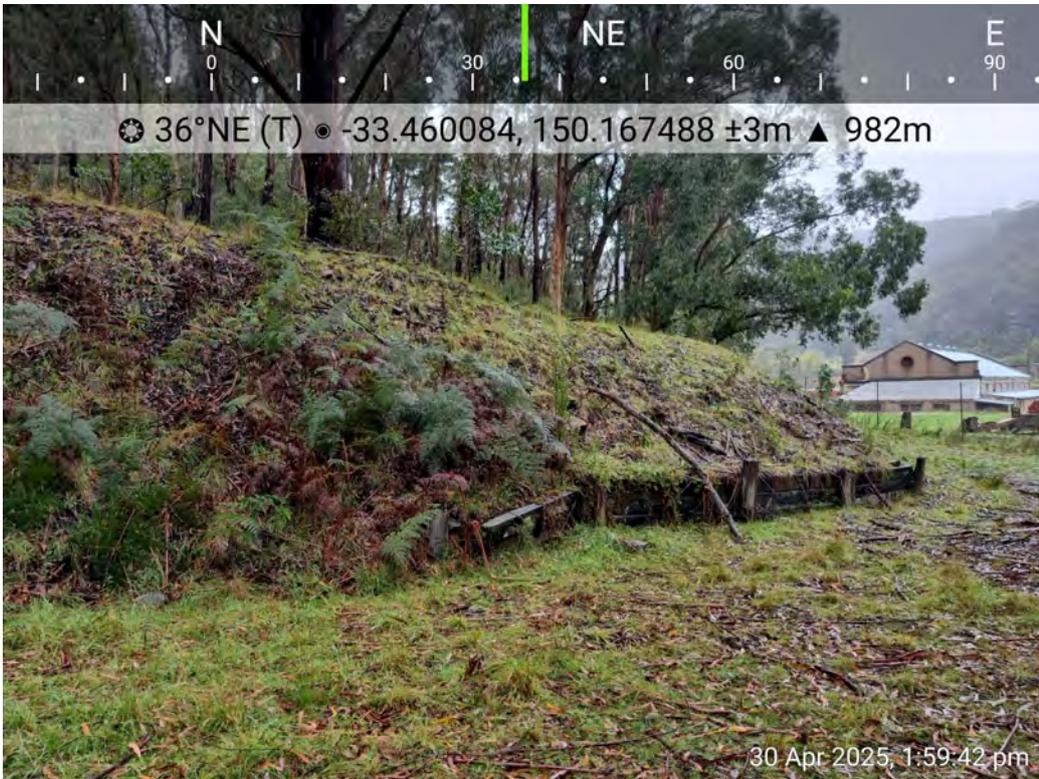
Plate 25: View of mound understood to comprise coal chitter, sandstone rocks, shales and raw coal proximal to the magazine huts – looking NE

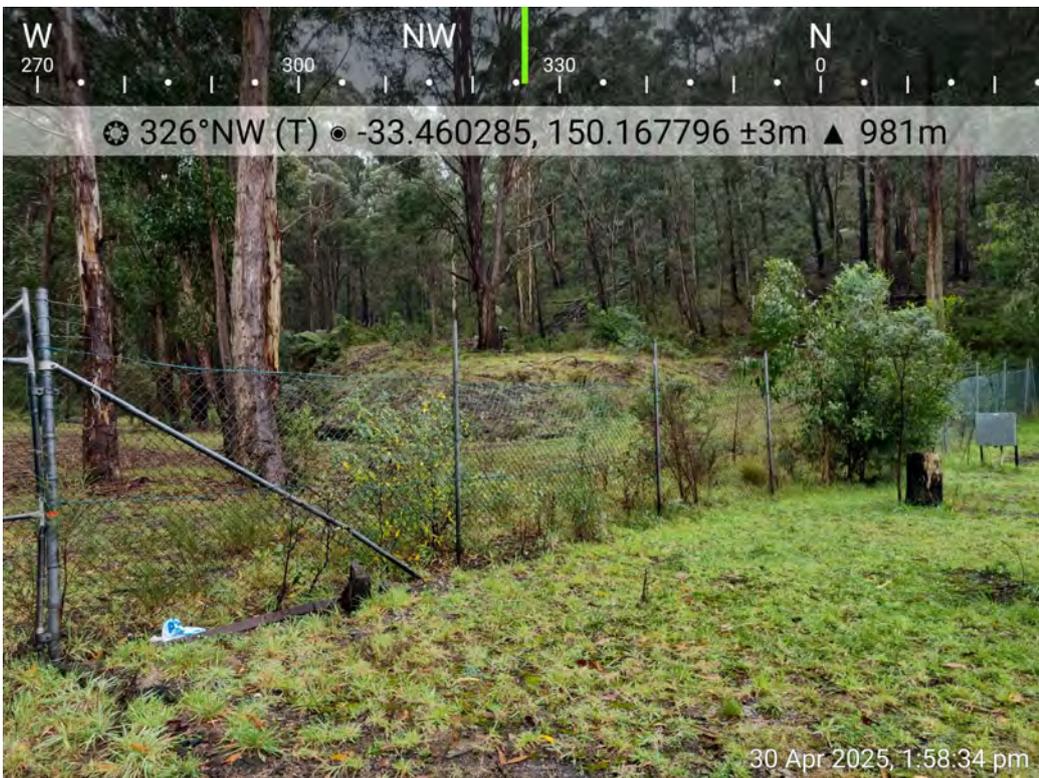
Plate 26: View of mounded area seen in Plate 25 – looking NW

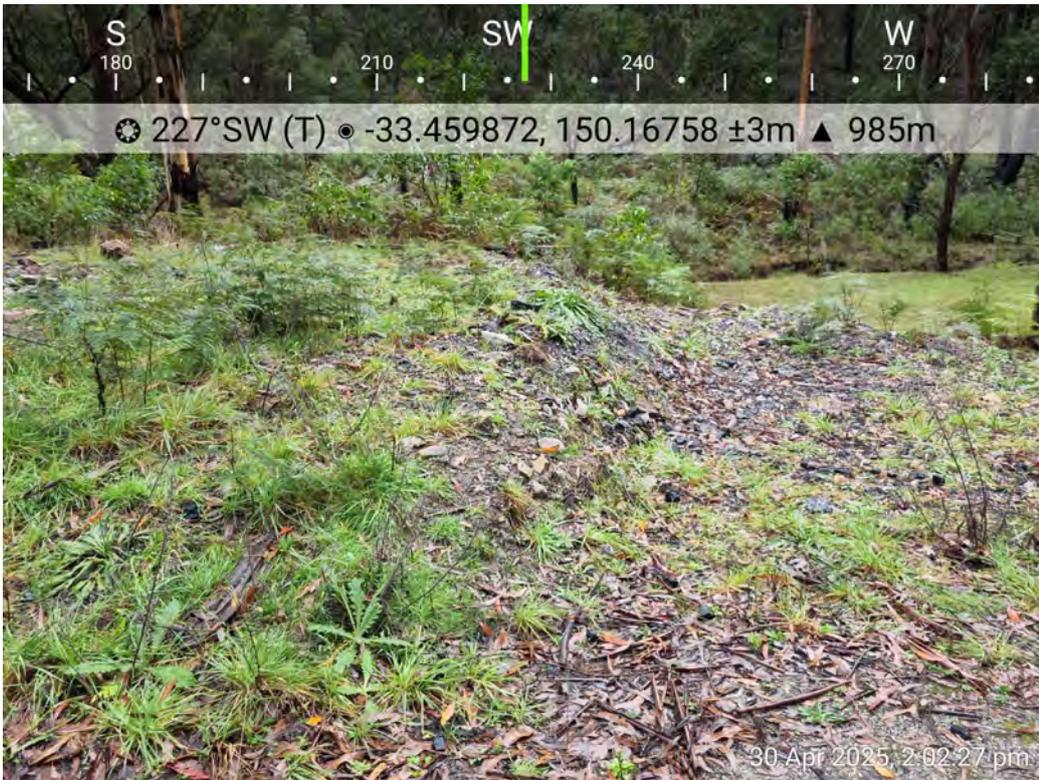
Plate 27: View of top surface of mounded area seen in Plates 25 and 26 – looking SW

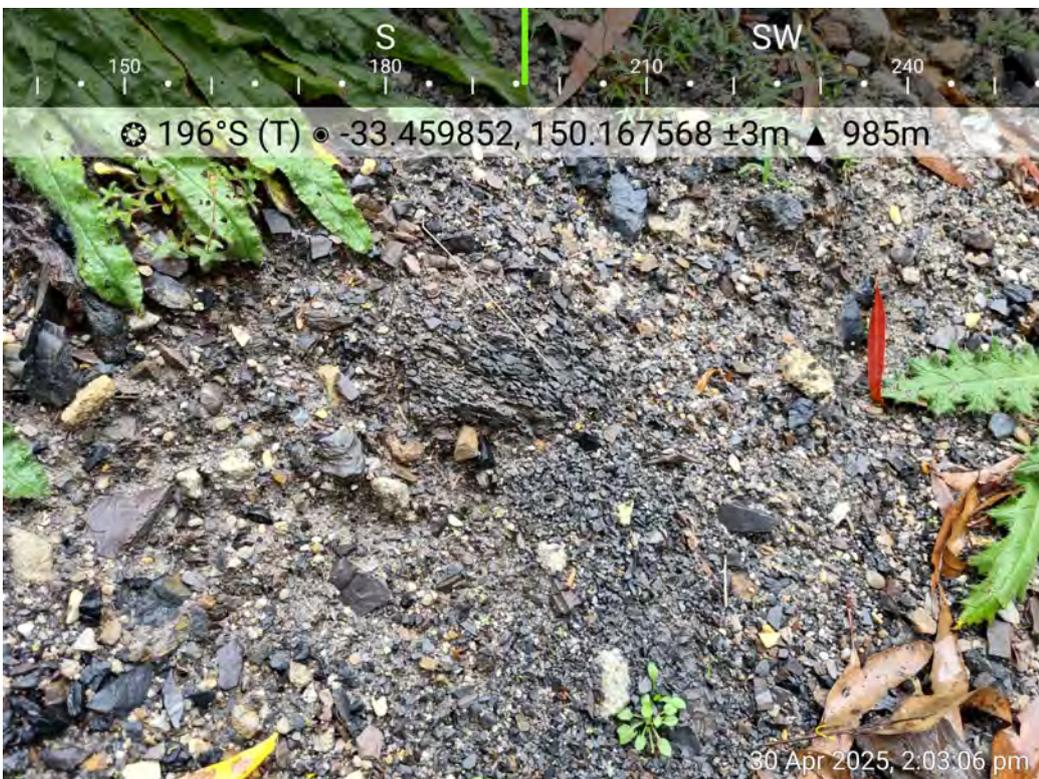
Plate 28: View of exposed materials seen in Plate 27

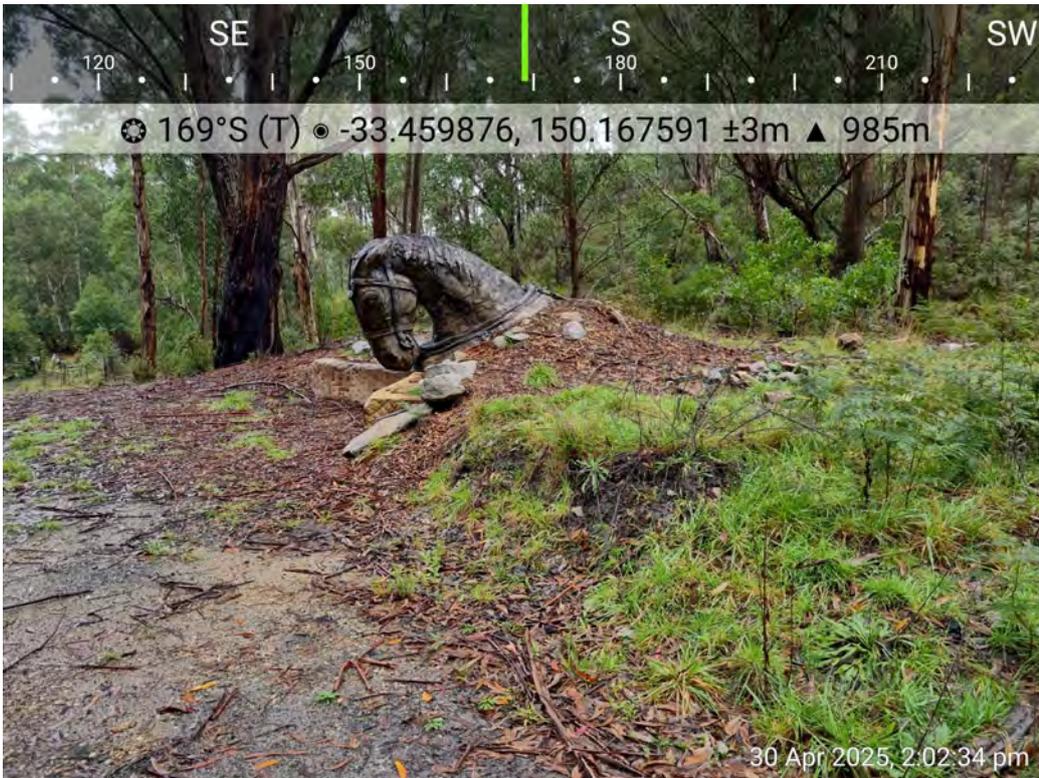
Plate 29: View of View of top surface of mounded area seen in Plates 25 and 26 – looking S
