DESKTOP GEOTECHNICAL AND MINE SUBSIDENCE ASSESSMENT

Lithgow Mountain Bike Park

Prepared for Central Tablelands Mountain Bike Club

RCA ref 17539-201/2

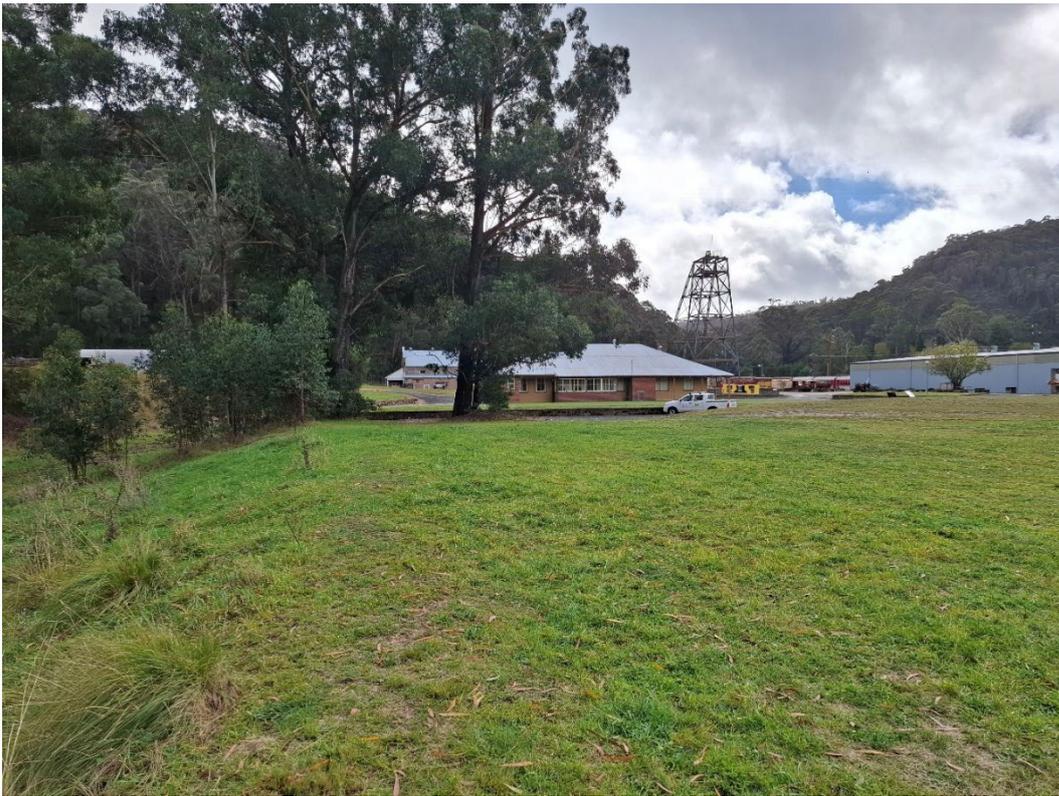
Photograph 1 *View to the north across the area proposed for the starting point of the trail network. Visible in the background are the Park Museum Building with the poppet head over the colliery downcast shaft behind (shaft is 80m deep, fully lined and capped with concrete)*

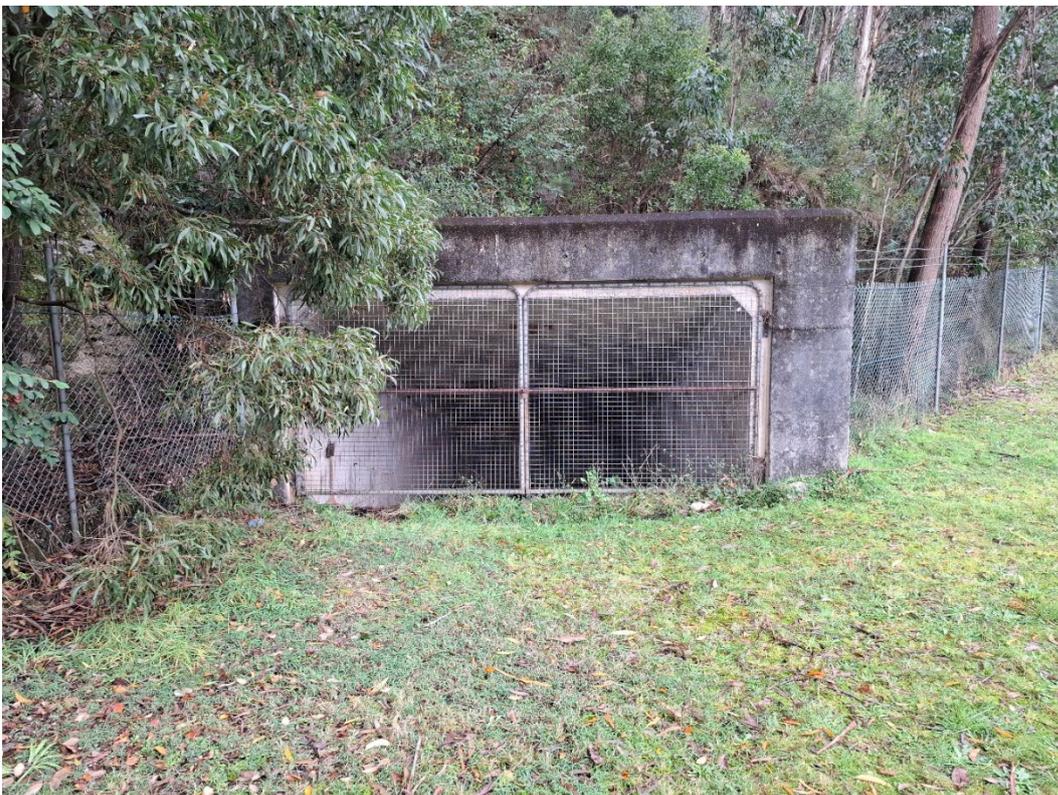
Photograph 4 *The entry portal to the mine drift within the Heritage Park area.*

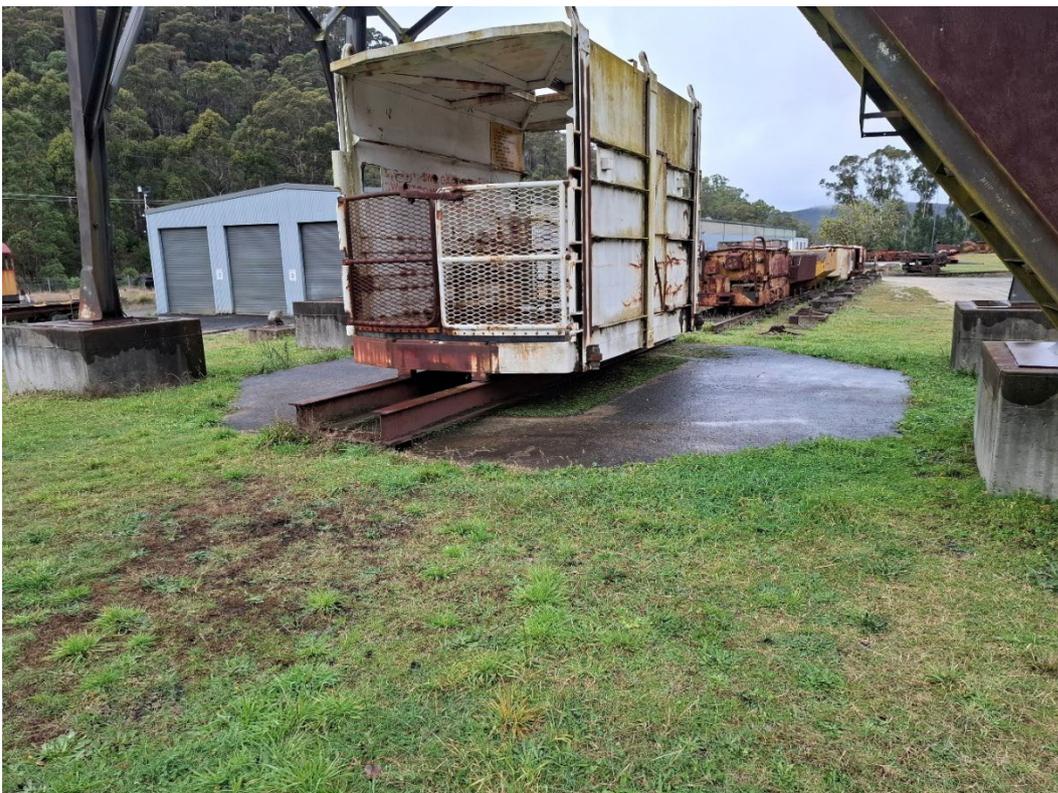
Photograph 5 *The concrete cap of the downcast shaft beneath the poppet head.*

The location of four shafts is identified on **Drawing 3** in the general area of the trail starting area. The trail alignments and associated facilities are no closer than 100m to the shafts and the shafts are not considered to cause a risk to the trail infrastructure. RCA has been informed by Ray Christison, President of the City of Greater Lithgow Mining Museum Inc (Member of MPHA and BA Hon. Archeology and Paleoanthropology, specialising in coal mining history) that the shafts proximate to the mountain bike park track alignments are all capped.

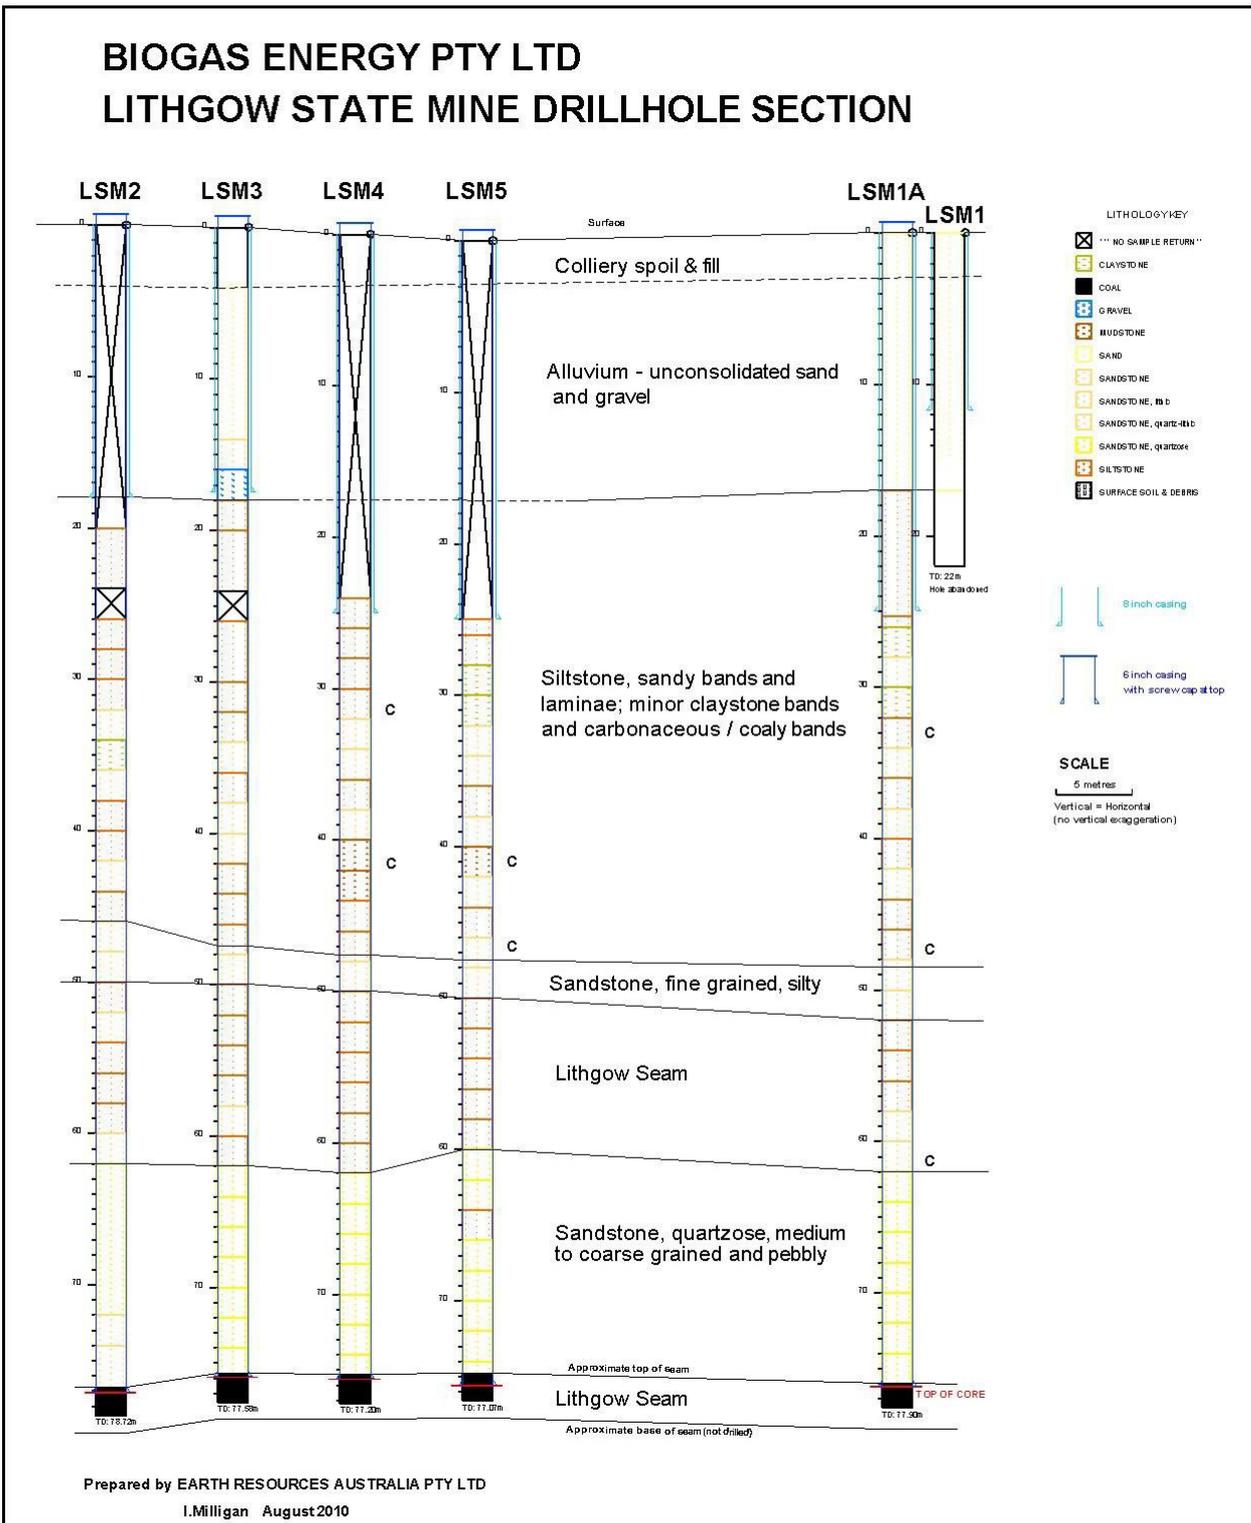
Figure 1 Lithgow State Mine Drillhole Section

A series of bores were undertaken in 2010 within the Heritage Park grounds to assess biogas and the drill section from the resulting report is attached in **Figure 1**. The section indicates that in the general area of the Heritage Park and the proposed trail starting area the subsurface comprises 3m of colliery spoil over alluvium to 17m over rock to the mined seam at a depth of about 78m. The mined seam (the Lithgow Seam) lies at a depth of about 78m beneath the trail starting area and becomes deeper to the north as the topography rises.

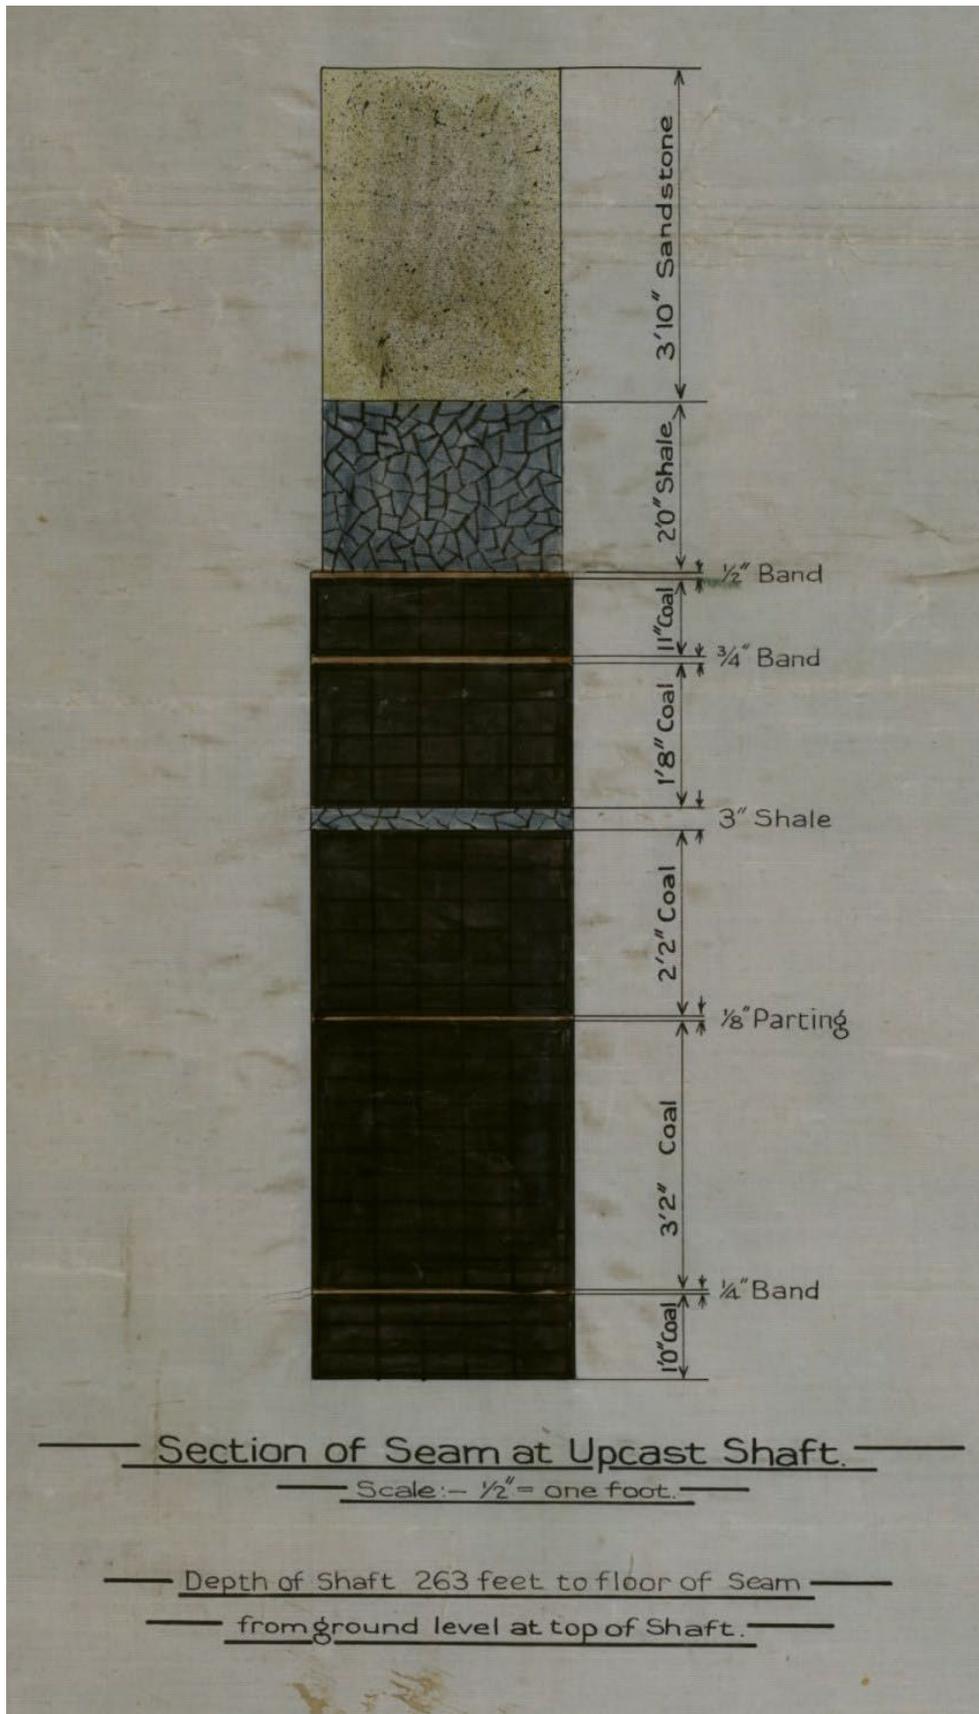
Figure 2 Colliery Seam Section (RT587)

RT20 includes a seam section at the upcast shaft location within the State Heritage Park area adjacent to the museum building (beneath the poppet head visible in **Photograph 1**). The seam section is reproduced in **Figure 2**. The seam section shows a full seam thickness of 9' 3" (2.8m) at a depth of 263' (80.16m). It is understood that the colliery generally left the roof coal above the 3" shale band in place resulting in a mined seam of closer to 6' 4" (1.93m) in this area. Elsewhere in the Colliery the seam thickness is up to 14'-15' with the roof coal left in place.

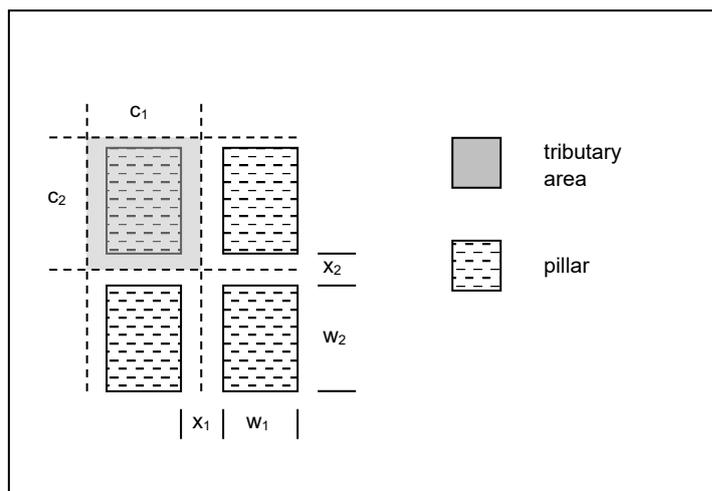
Figure 3 Pillar Geometry

- Full seam mined (2.8m)
- Pillar dimensions $w_1=34\text{m}$, $w_2=45\text{m}$, $x_1=5.5\text{m}$, $x_2=4.0\text{m}$ (pillar geometry is defined in **Figure 3**).
- Depth to seam 80m

An assessment of the pillar stability of the identified pillar has been made using the procedure presented by Ref [1]. A factor of safety for the pillar of the order of 16 is calculated. There is no credible risk of pillar failure and subsidence in the general area of the proposed trail starting point infrastructure.

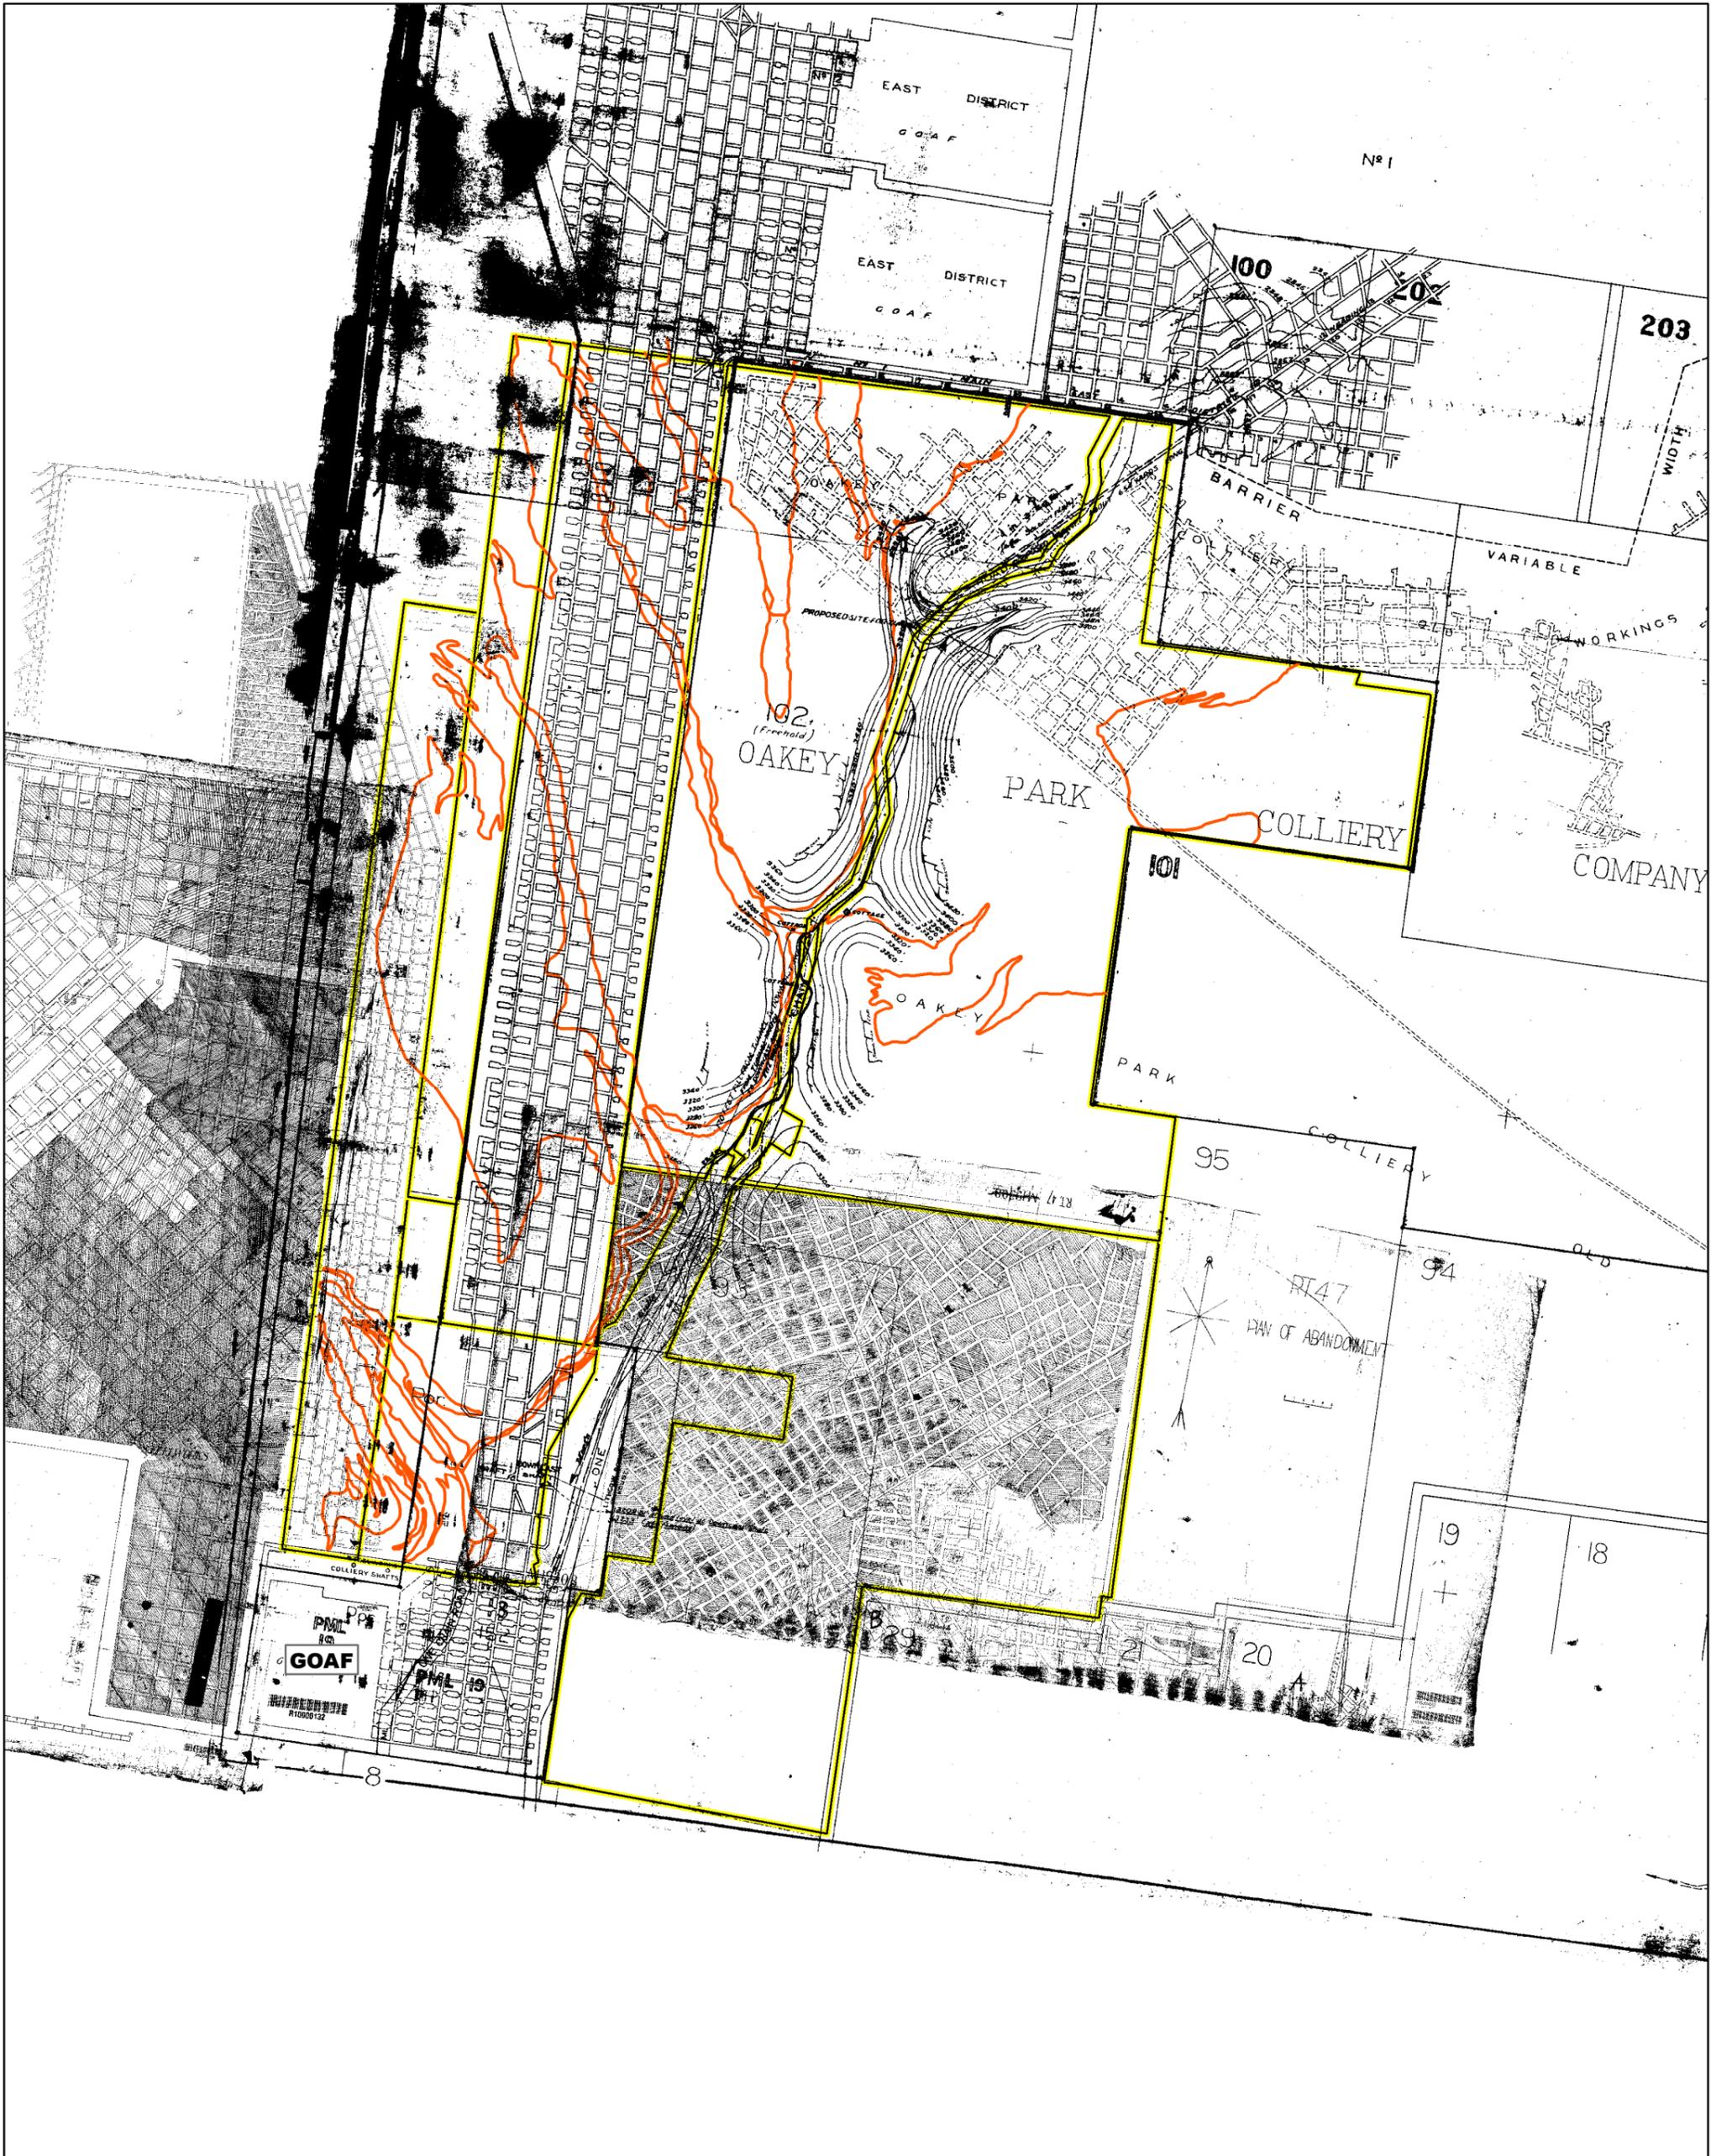
**MINE OVERLAY PLAN
LITHGOW MBT**

Widespread bord and pillar coal mine workings in the Lithgow Seam by the State Mine Colliery lie under much of the proposed area of the trail network. A mine overlay plan of the trail network area has been prepared using mine record traces (RTs) obtained from the Mine Regulator and is provided on **Drawing 2**. **Drawing 3** provides a bigger scale view of the mine overlay at the trail starting area.

- In the general area of the trail network start point and the Heritage Park the workings comprise first worked rectangular pillars of a regular form.
- Widespread bord and pillar mine workings in the Lithgow Seam lie under much of the proposed area of the trail network.
- Uncrosshatched pillars on the mine overlay represent pillars left in place while crosshatched pillars, and pillar areas, represent areas where pillars have been removed.
- RT20 which includes workings under the trail network site shows the Lithgow Seam dip to be 1V:16H approximately 60° east from north.

Elsewhere across the area of the trail network where pillars are crosshatched and shown to have been removed there is the possibility of trough subsidence occurring through pillar collapse and seam closure with resulting subsidence. With reference to the mine overlay plan in **Drawing 2** and **Drawing 3** the only location where the trails cross extensive areas of second workings and potential goaf is in the area starting about 360m NNW of the trail starting area where three trails cross over goaf (subsided ground) and there may be ground surface cracking present.

Likelihood of mine subsidence events – the likelihood of mine subsidence events occurring across the site is low. Workings are in excess of 80m depth, and all shafts are remote from trail infrastructure. A length of trail traverses potential goafed ground over second workings and should be inspected for cracking and the surface remediated if necessary. The risk to user safety associated with any surface cracking is not considered to be greater than the risks associated with the proposed site use normally.
