20170640 6th August 2020

RE: Access Road Inspection – Caloola Halt Road, Megalong Valley NSW 2785

At your request we have inspected Caloola Halt Road in respect of Section 5.3.6 Access and Traffic in your current DA 114/19 Development Assessment Report with Lithgow City Council and provide the following report:

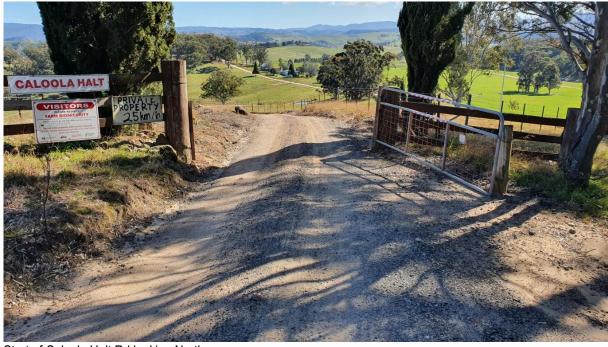
Start of Caloola Halt Rd looking North.

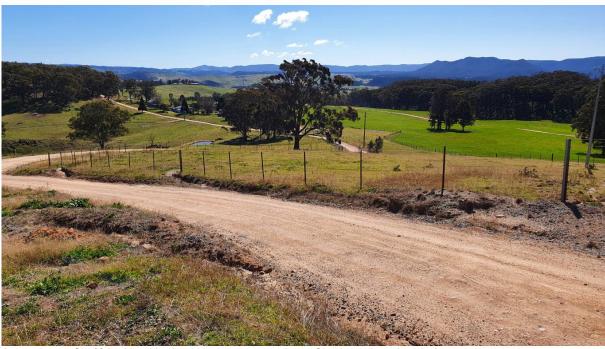
The maximum longitudinal grade measured was 9.1 degrees at chainage 40 at the start of the road which is well within the required limits. Several other grade checks confirmed that all of the road is well within the required grades for longitudinal a crossfall shape.

Approximate Ch 40 looking North with minor corrugations. Good regular mitre drains.

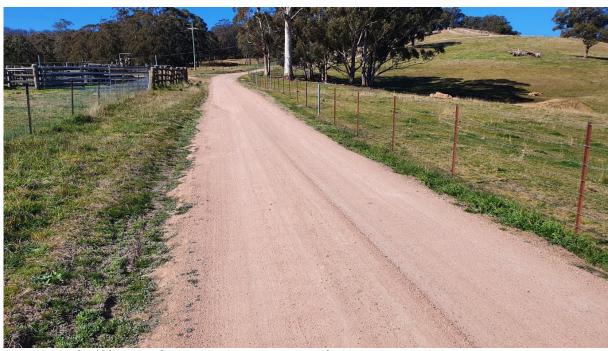
Approximate Ch 400 looking South with minor corrugations. Stable verges and drains.

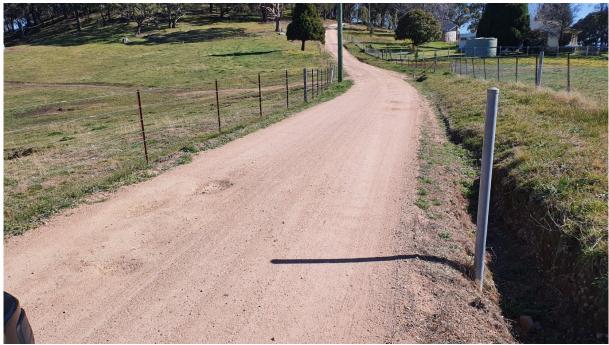
- 0 Entrance gate. 3.1m Good. Drainage & mitre drains good.
- 40 Longitudinal grade 9.1 degrees.
- 200 4.0m Good. Drainage & shape good with minor rutting & corrugated sections within the first 100m.
- 350 Longitudinal grade 7.8 degrees.
- 400 4.0m Good. Drainage good. 40m flat section & potholing requires correctional shaping. 225mm PCV culvert good condition.
- 400-600 Minor pavement & drainage erosion in some sections. Correctional shaping of pavement and drainage required.
- 500 Longitudinal grade 6.6 degrees.
- 700 4.9m Good. No scour, good shape, minor drainage correction/maintenance required. Longitudinal grade 5 degrees.
- 750 4.0mm Good. 375mm RCPC. Inlet good, outlet 10% sediment.

Approximate Ch 400 looking North with several potholes.

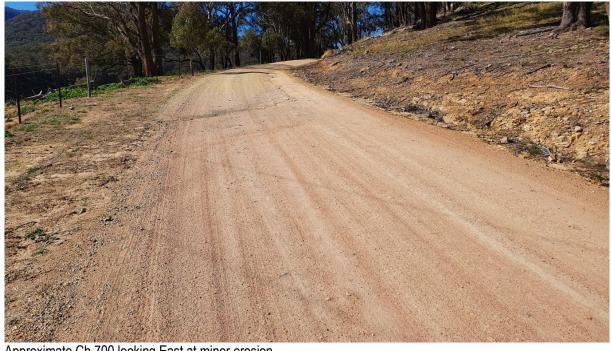
Approximate Ch 700 looking East at minor erosion.

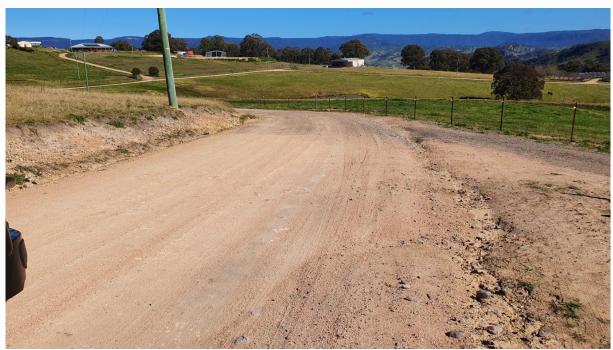
Approximate Ch 700 looking West at minor erosion.

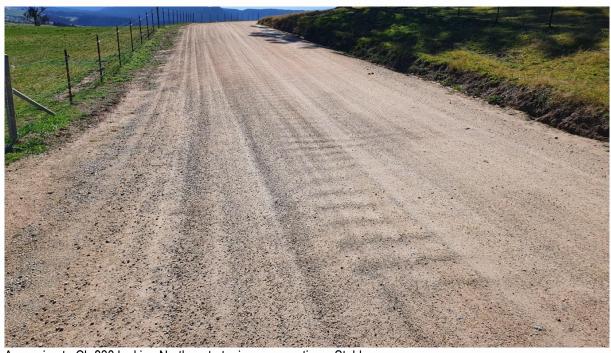
Approximate Ch 830 looking Northeast at minor corrugations. Stable verges.

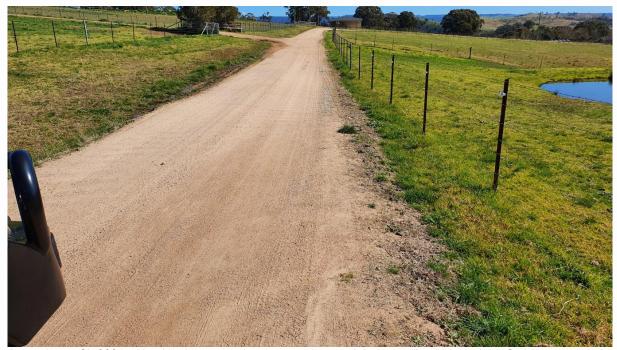
Approximate Ch 900 looking Northwest at minor corrugations and drainage shaping required. Stable verges and runoff.

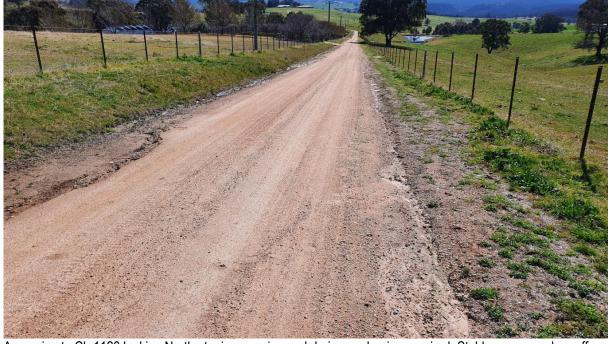
Approximate Ch 1120 looking North at minor erosion and drainage shaping required. Stable verges and runoff.

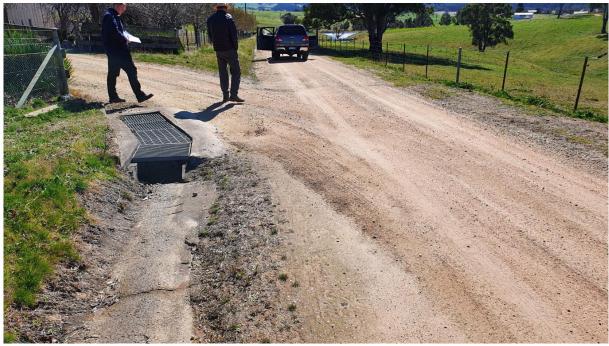
Approximate Ch 1200 looking North at very good stable drainage, road and verge areas.

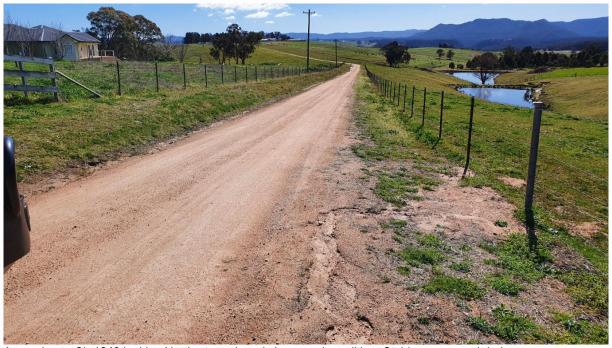
Approximate Ch 1240 looking North at good road shape and condition. Stable verges and drainage.

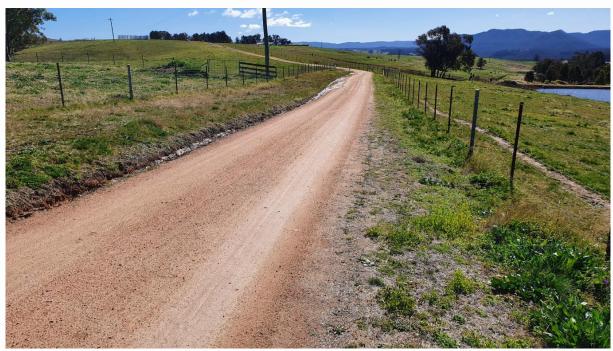
Approximate Ch 1500 looking North at minor drainage scour LHS. Good road shape & condition, stable verges.

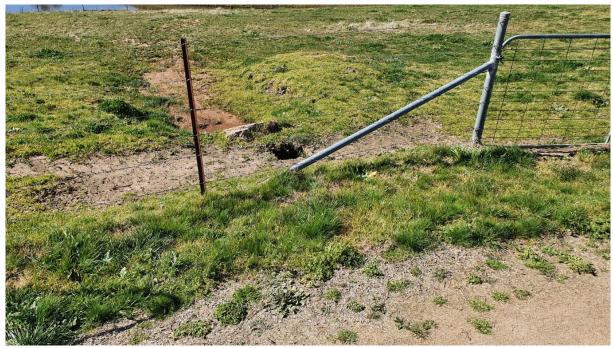
sediment. 250mm plastic culvert. Inlet good, outlet good in paddock with tunneling behind headwall

Approximate Ch 1620 looking East at tunneling behind culvert stone headwall in property. Stable verge.
