APPENDIX 2 PORTLAND CEMENT WORKS CONSERVATION MANAGEMENT PLAN

Portland Cement Works

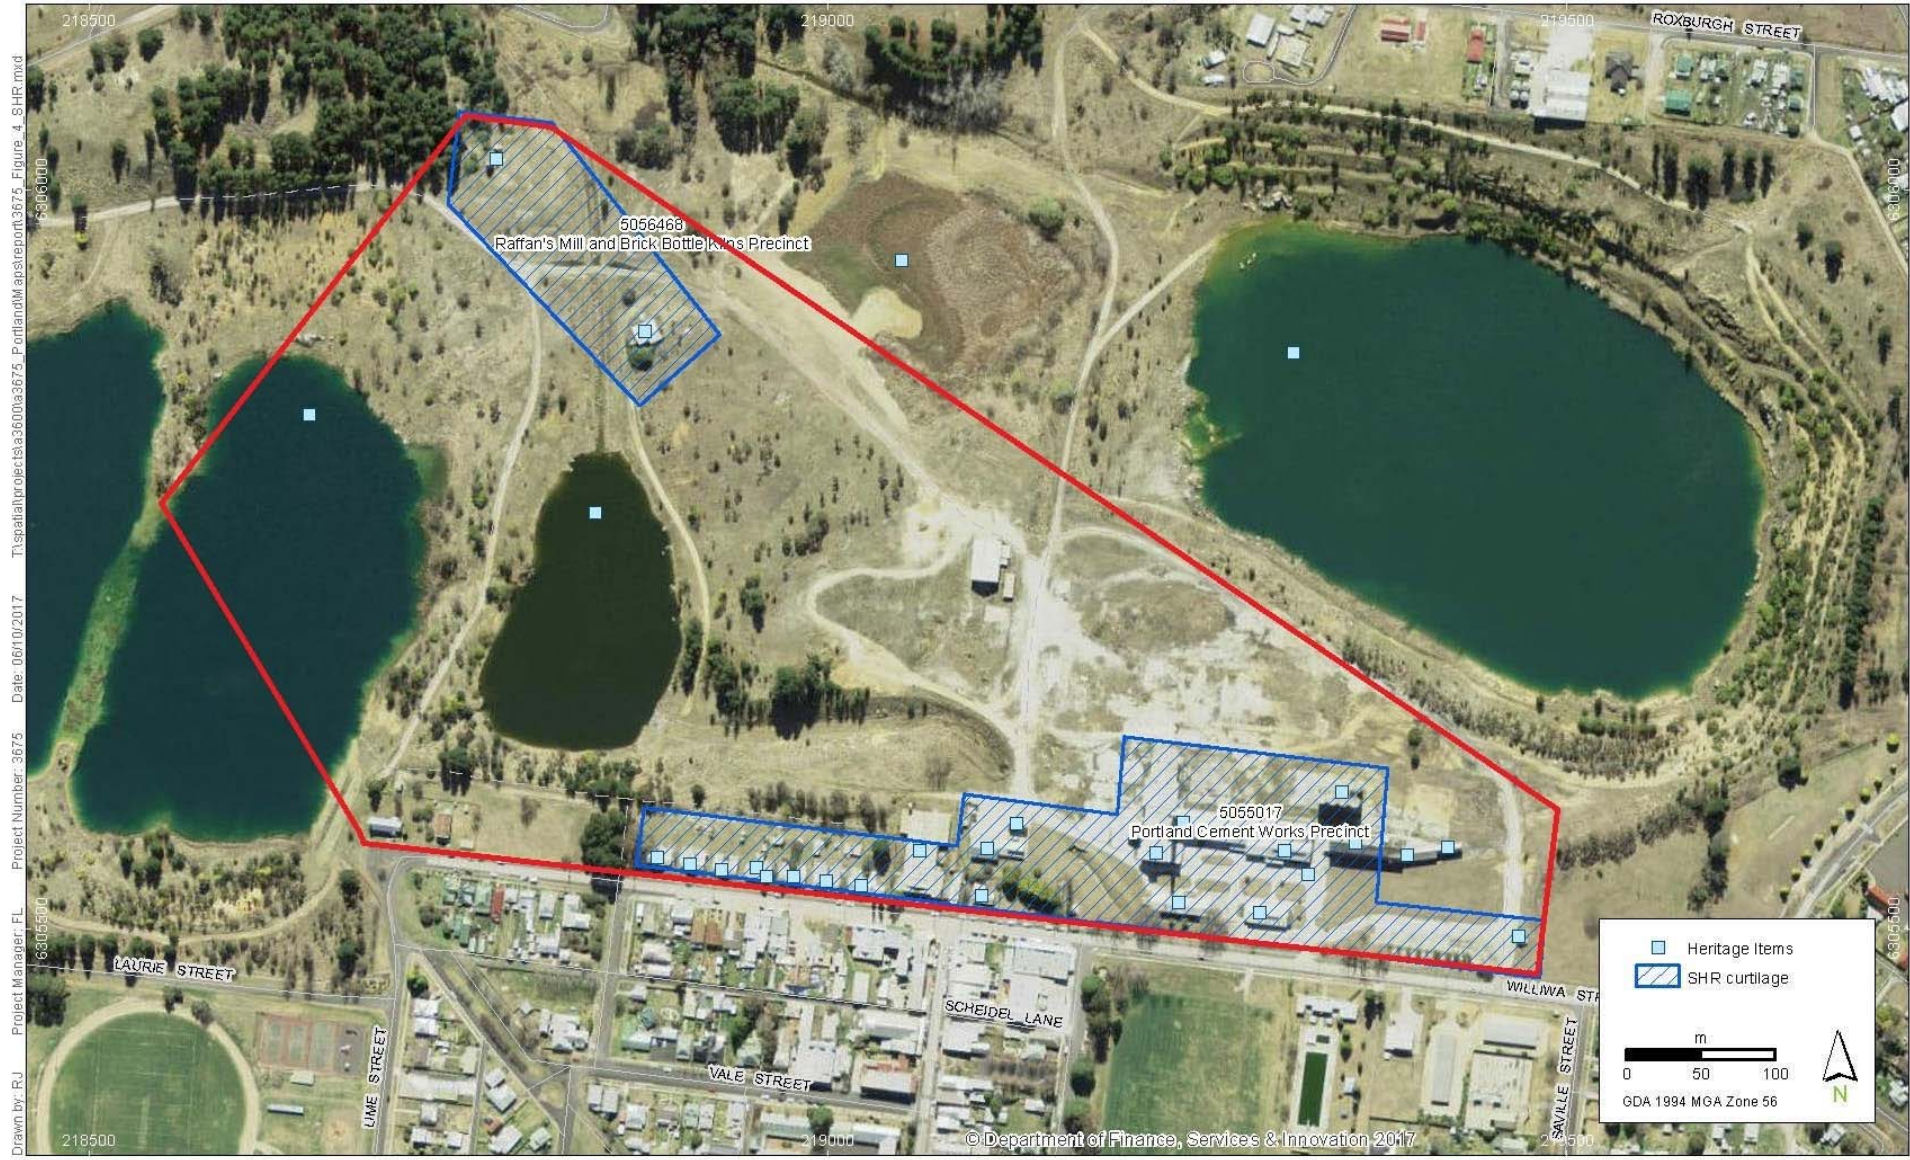
Drawn by: R.J. Project Manager: F.L. Project Number: 3675 Date: 06/10/2017. This spatial project is a 36000na3675_PortlandM.apxreport3675_Figure 4_SHR.mxd

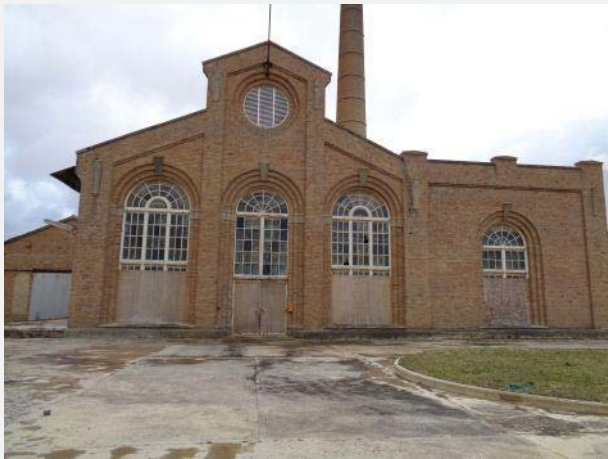
<p>Plate 1: Powerhouse south elevation showing face brickwork and arched windows partly boarded up and missing glazing.</p>																				
Description:	The Powerhouse building is a Federation Classical style with its southern façade being the most distinctive feature. The building is constructed of face brickwork with arched openings. The building has been altered in the early 20 th century and these areas are easily identified by way of varying characters in brickwork. The interior consists of one large main room with a Switchboard room (located south), Eastern room and Machinery room (located west).																				
Condition:

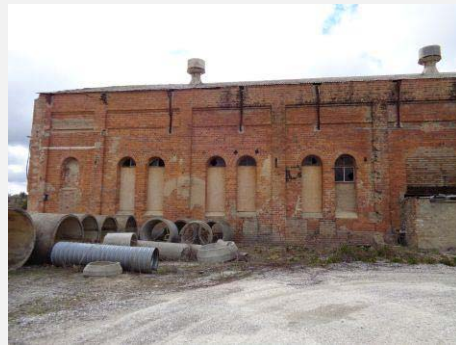
Plate 5: Part west elevation showing original building with some discolouration on brickwork caused by moss.

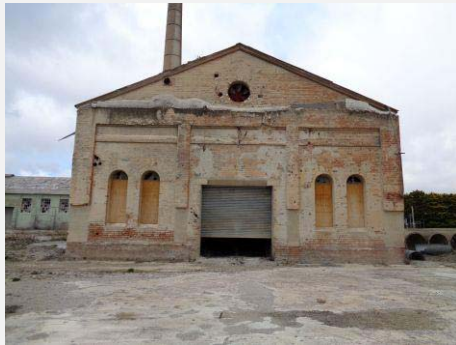
Plate 6: North elevation showing original building.

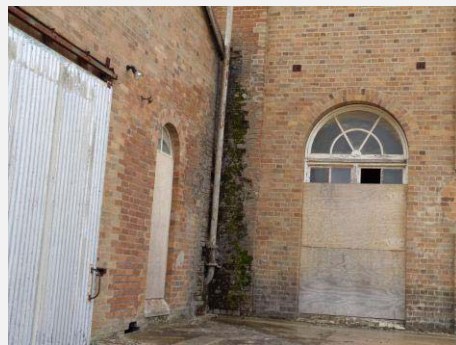
Plate 9: South western corner of building showing moss on wall.

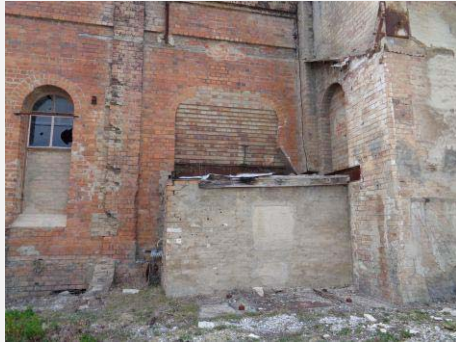
Plate 10: Detail area of west elevation showing damage to brickwork, infilled openings, brick plinth and broken glazing.

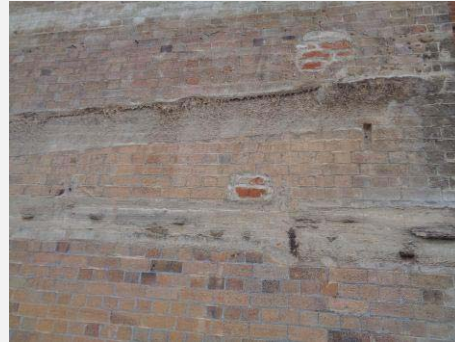
Plate 11: Detail area of west elevation showing unsympathetic patchwork to bricks.

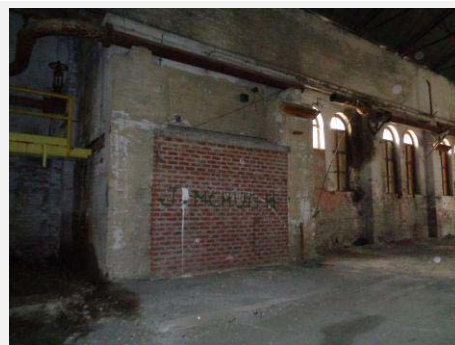
Plate 17: Interior eastern wall showing unsympathetic infill brickwork.

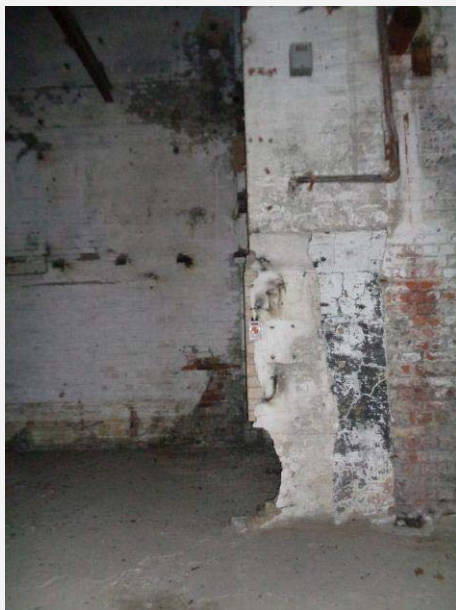
Plate 20: Broken and missing brickwork on column.

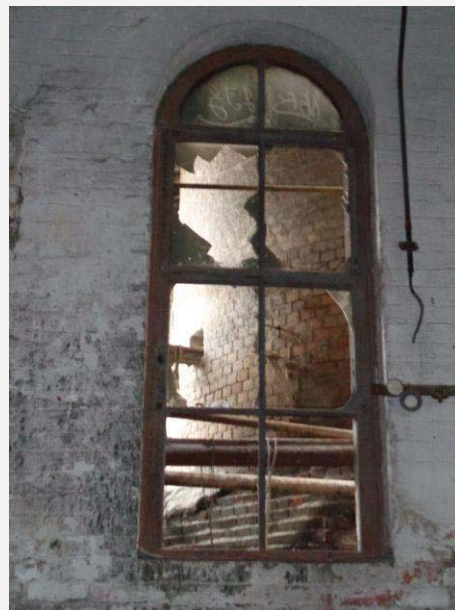
Plate 21: Broken and missing glazing.

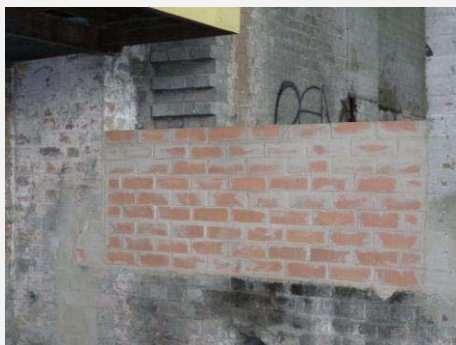
Plate 22: Machinery room (located south west) shows unsympathetic infill brickwork.

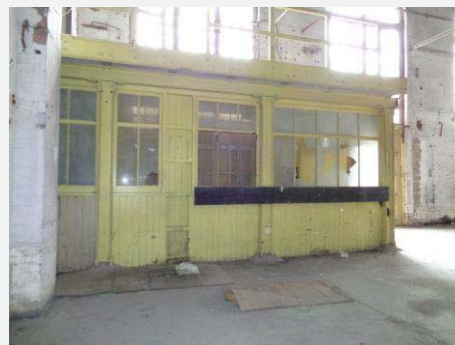
Plate 23: Switchboard room showing painted timber panelling and glass panels.

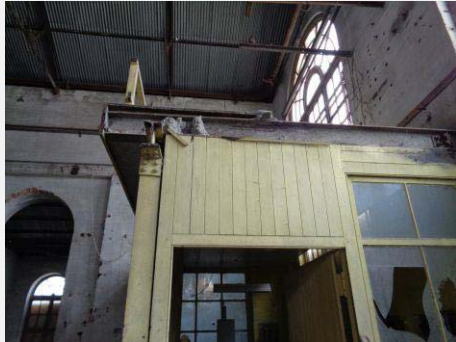
Plate 24: Switchboard room showing steel frame floor above and broken glazing.

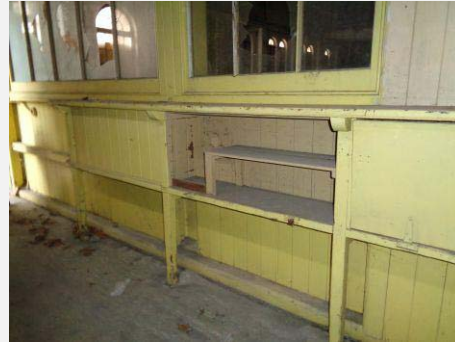
Plate 25: Switchboard room showing timber joinery.

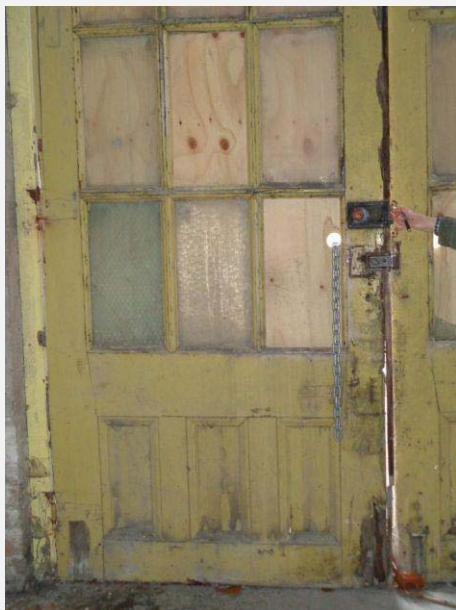
Plate 26: Entry door to south elevation showing missing glazing panels and damage to timber door.

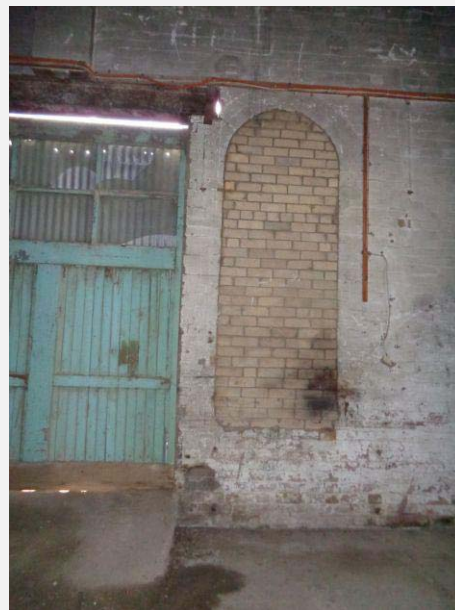
Plate 27: Machinery room showing unsympathetic brick infill to window opening, timber service door with concrete ramp.

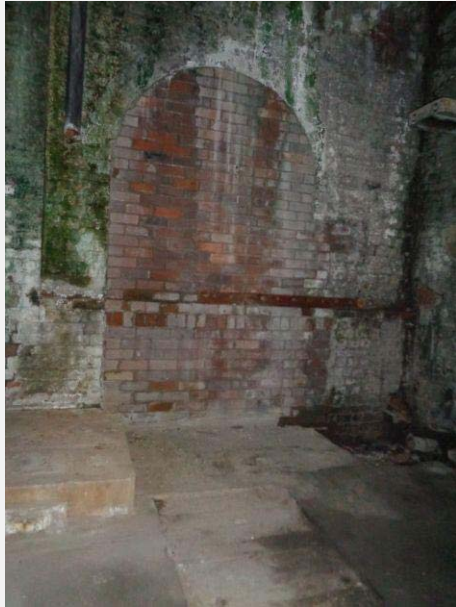
Plate 28: Machinery room showing unsympathetic brick infill to archway and severe moisture issues to west wall.

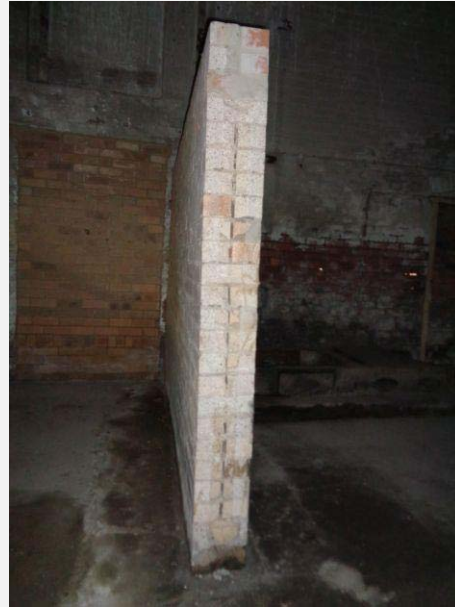
Plate 29: Machinery room showing unsympathetic brick wall additions and moisture issue to floor.

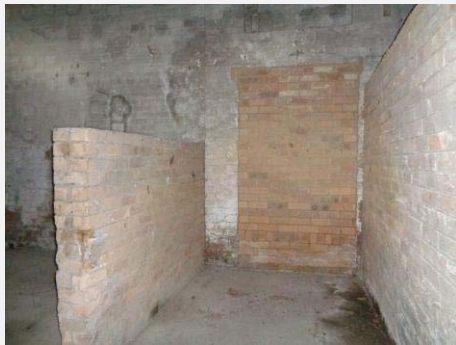
Plate 30: Machinery room showing unsympathetic brick wall additions and infills.

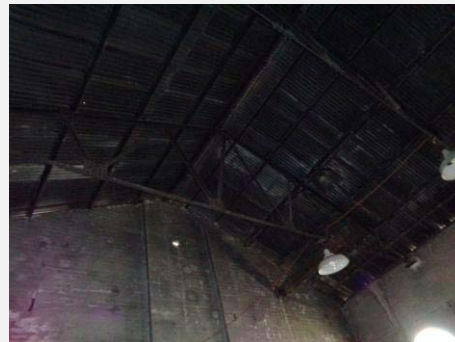
Plate 33: Machinery room showing open steel truss roof.

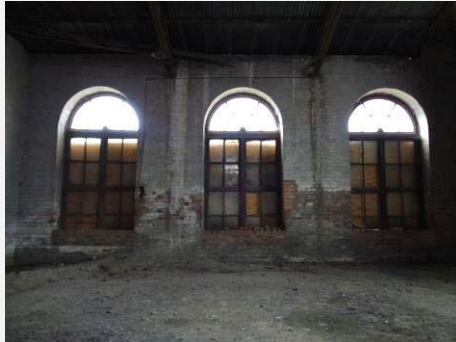
Plate 34: Eastern room showing damage to brickwork, timber framed windows and rubble floor.

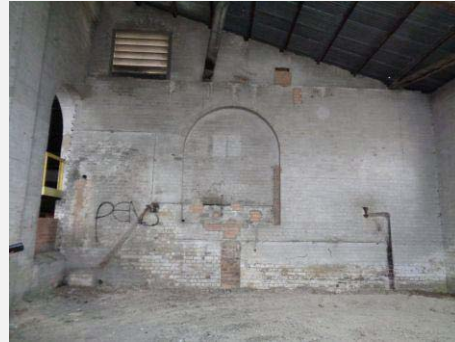
Plate 35: Eastern room showing

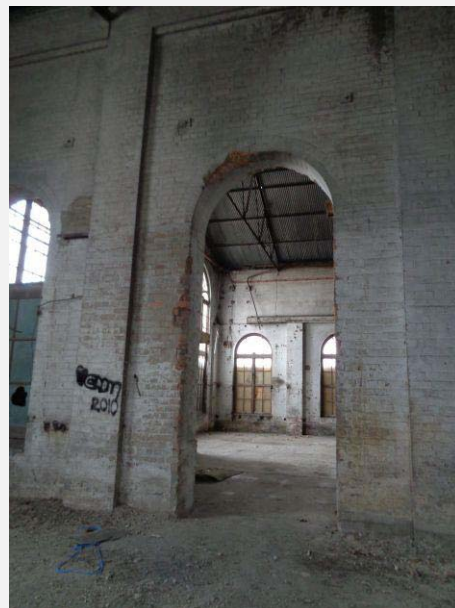
Plate 37: Eastern room showing damage to brick openings.

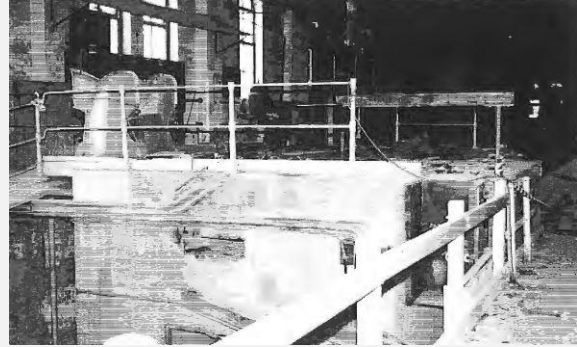
Plate 46: Foundations for 3000 Kilowatt Turbo Alternator (Source: Fenwick 1993:P53)

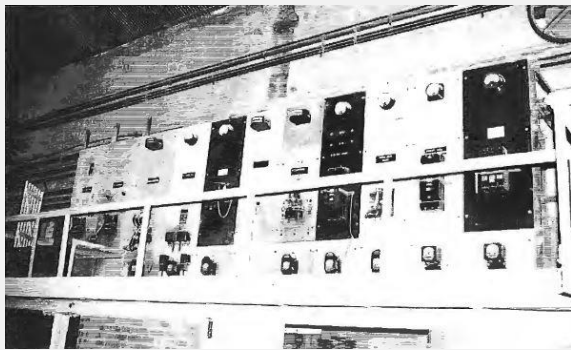
Plate 47: Elevated 6600 Volt Marble Switchboard (Source: Fenwick 1993:P52)

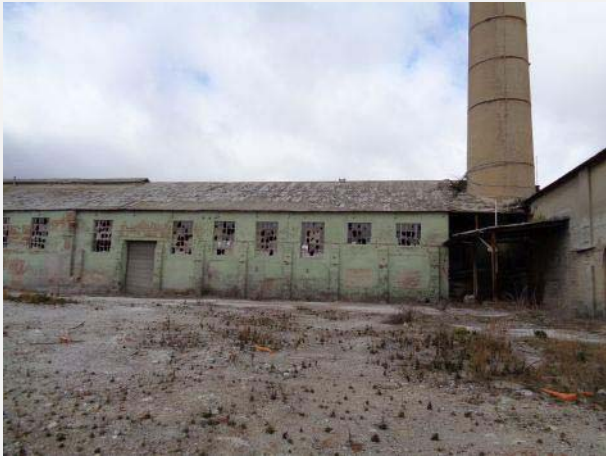
Condition Assessment		
Item No: 2	Item Name: Boilerhouse and Chimney

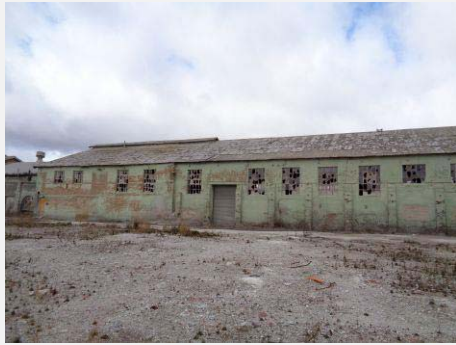
Plate 49: Boilerhouse north elevation showing roof, walls and windows in poor condition.

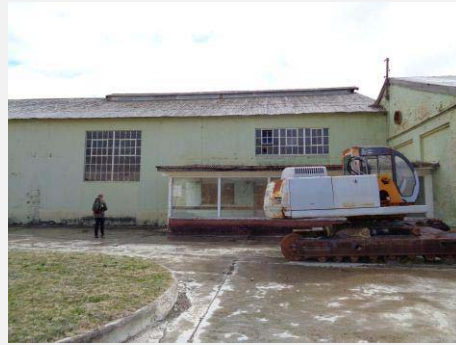
Plate 50: Boilerhouse part south elevation with later addition (single storey building in front).

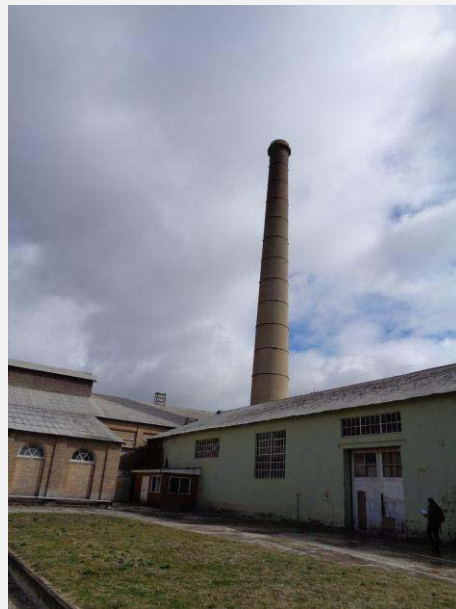
Plate 54: Part south elevation of Boilerhouse and Chimney (right).

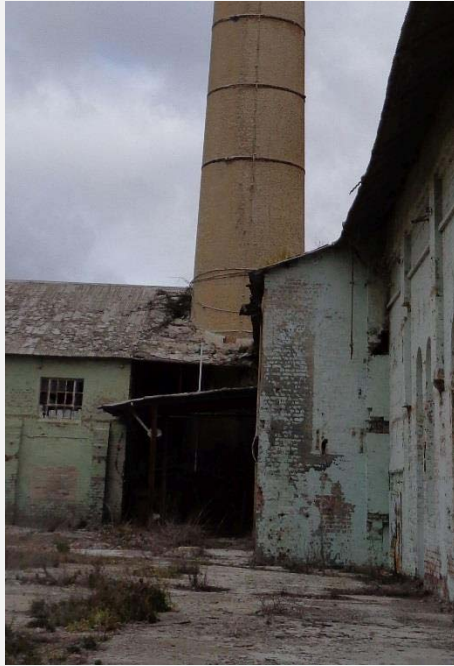
Plate 55: Part north elevation of Boilerhouse and Chimney showing access to Chimney base and roofs to Chimney area in poor condition.

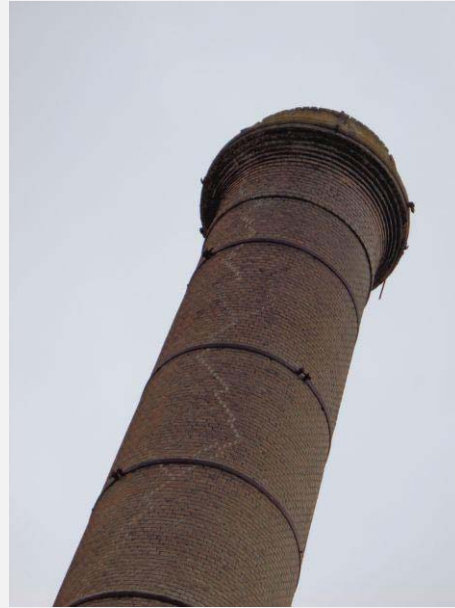
Plate 56: Detail view of Chimney showing iron banding and brick corbelling.

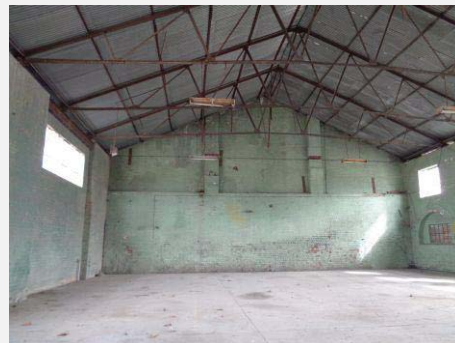
Plate 60: Interior of Western room showing exposed steel truss roof and west wall.

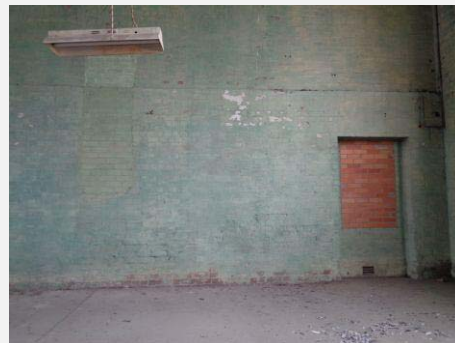
Plate 66: Interior of Central room showing unsympathetic brick infill to opening in central eastern.

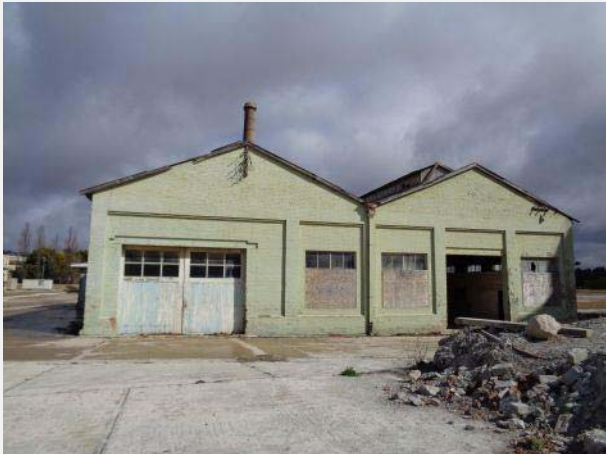
<p>Plate 75: Boilermaker's / Blacksmiths Shop east elevation showing broken timber barge boards.</p>																										
Description:	The Boilermaker's / Blacksmiths Shop is a combination of Federation Classical industrial and Interwar Functionalist style. The building is constructed of painted brickwork with mainly rectilinear openings. The building has been altered in the early 20 th century and these areas are fairly identifiable by way of varying characters in brickwork and window treatment. The interior consists of two large rooms; Machine Shop (located east), Blacksmith's Shop (located west).																										
Condition:

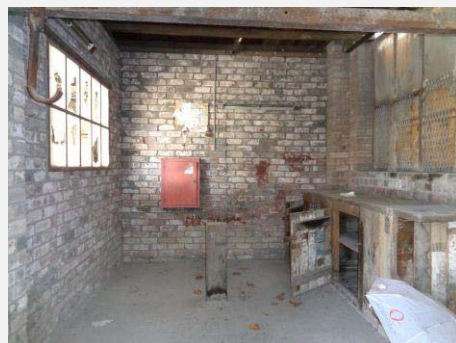
Plate 83: Interior of Fitting and Machine Shop room (eastern room) showing office and amenities room.

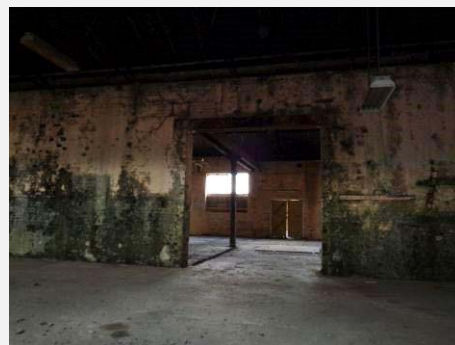
Plate 91: Interior showing Boilermaker's / Blacksmith's Shop with severe moss growth on walls.

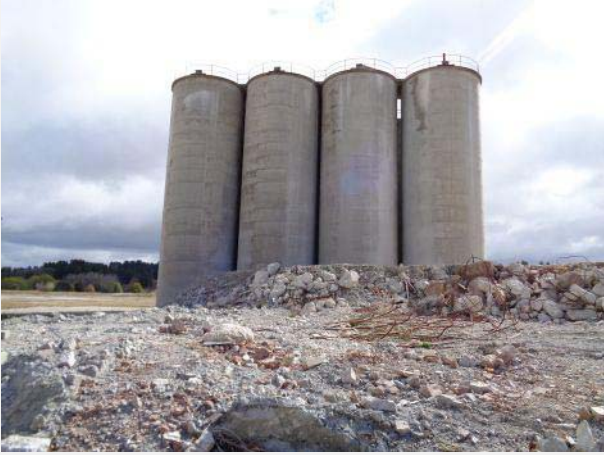
Condition Assessment													
Item No: 7	Item Name: Cement Silos (8)

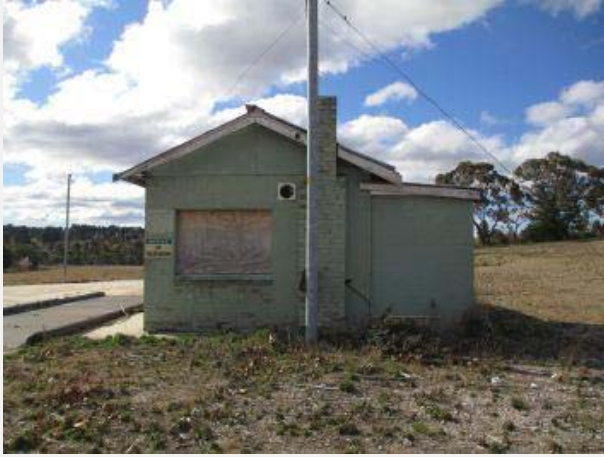
<p>Plate 104: Weighbridge Office and Weighbridge south elevation (weighbridge left).</p>																										
Description:	The Weighbridge Office is a small painted brick building with gable ends to the north and south elevations. The Weighbridge is a timber rail and deck platform located immediately to the west of the Weighbridge Office.																										
Condition:

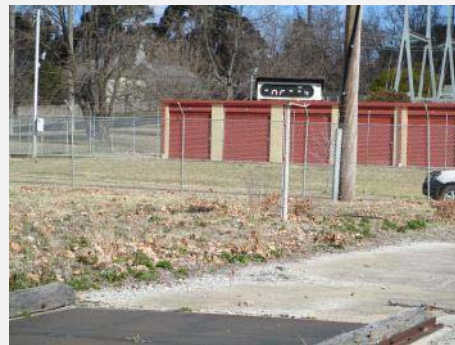
Plate 108: Part west elevation showing original building with some discolouration on brickwork caused by moss.

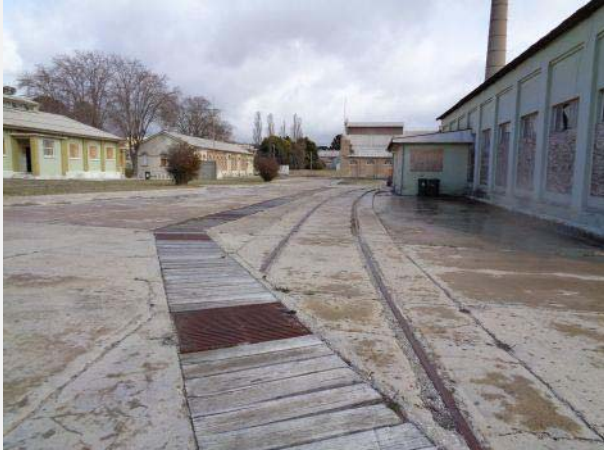
Condition Assessment																	
Item No: 9	Item Name: Rail line and alignment

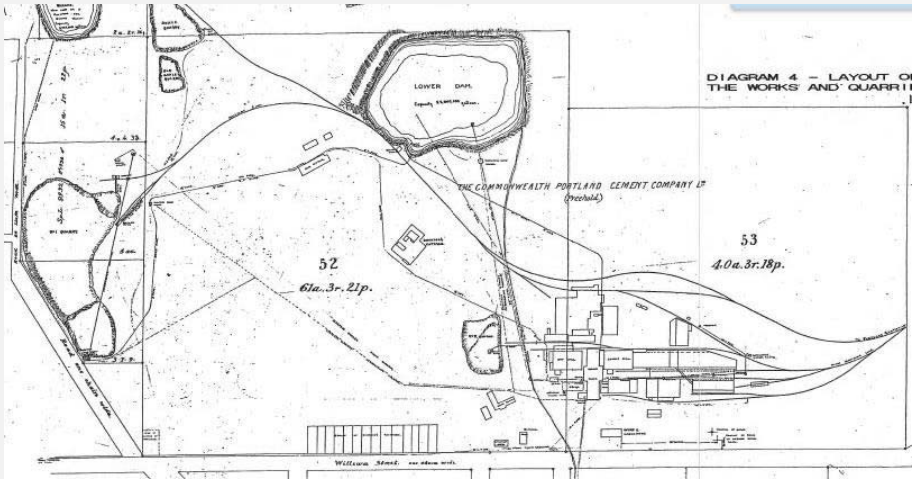
Documentary Evidence	
Item No: 9	Item Name: Rail line and alignment
Building modifications:

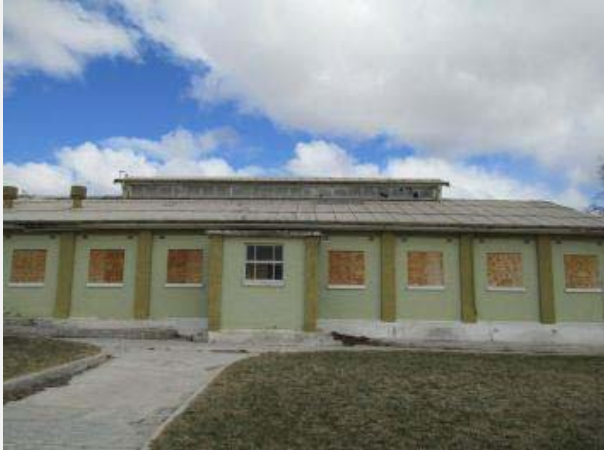
<p>Plate 117: Shower and Bath house north elevation.</p>																								
Description:	The Shower and Bath house is constructed in the Inter war industrial style and is a single storey painted brickwork building with a distinct pattern of brick piers to its elevations. The building has an east west orientation with a gable roof, with corrugated iron sheeting and a clerestory roof above. A room located to the west end appears to be a later addition.																								
Condition:

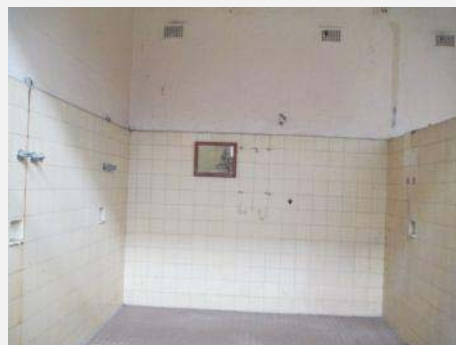
Plate 125: Interior showing typical tiled shower room.

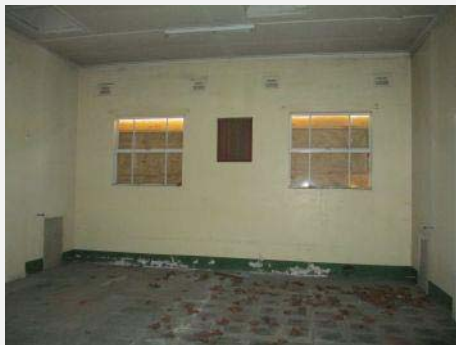
Plate 128: Interior showing room to east end with damage to linoleum floor finish.

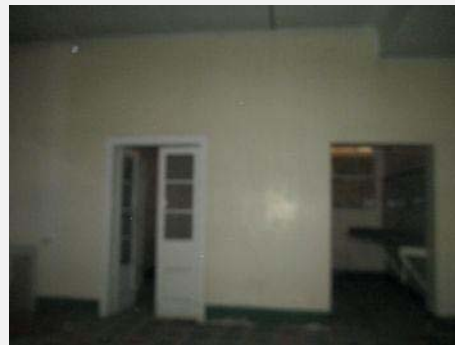
Plate 129: Interior showing room to east end locker areas.

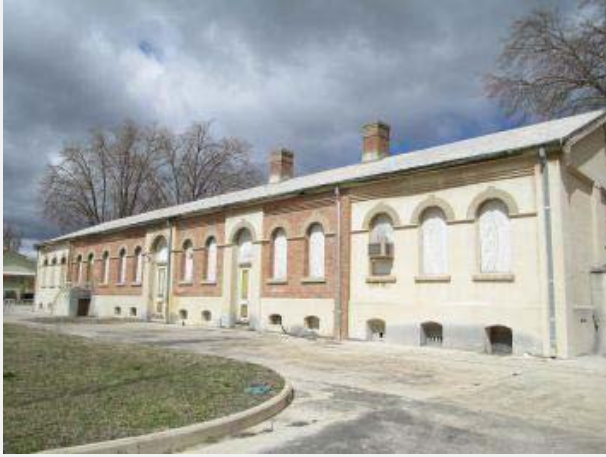
<p>Plate 131: Administration Office north elevation.</p>																								
Description:	The Administration Office building is a Federation Classical style building constructed in and east west orientation. The building is single storey with a basement and has both face brick and rendered brickwork. There building has a gable roof with corrugated iron sheeting and two brick chimneys. Arched openings are located on the principal elevations.																								
Condition:

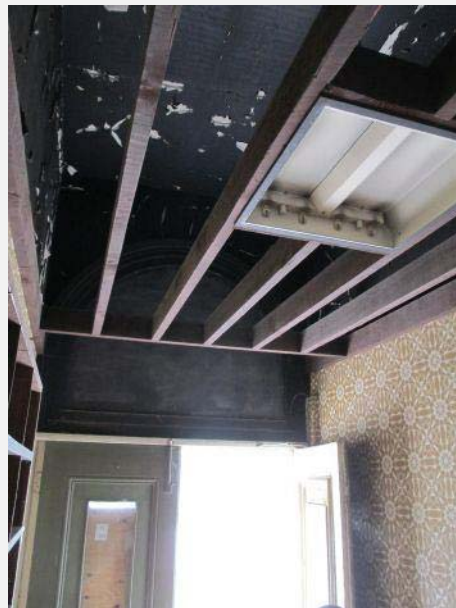
Plate 137: Interior showing ceiling at south entrance and missing ceiling, unsympathetic wall finish.

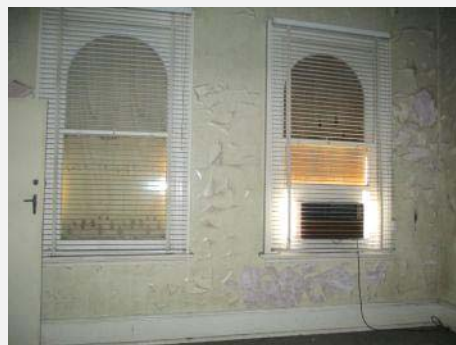
Plate 141: Interior showing paint peeling on walls, unsympathetic air conditioning unit addition.

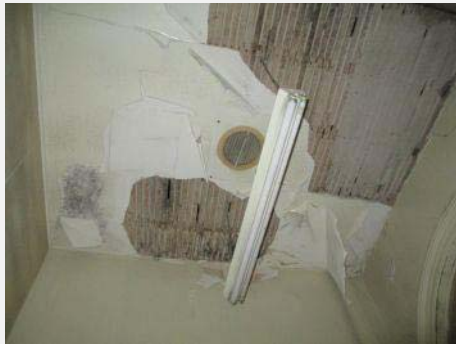
Plate 142: Interior showing lath and plaster ceiling.

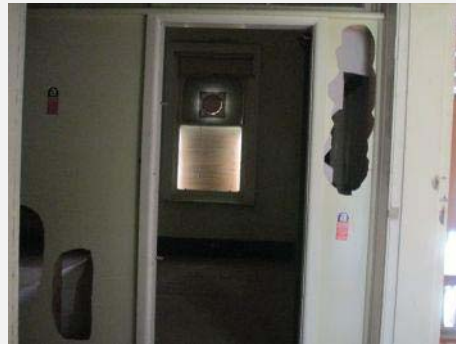
Plate 143: Interior showing damage to walls.

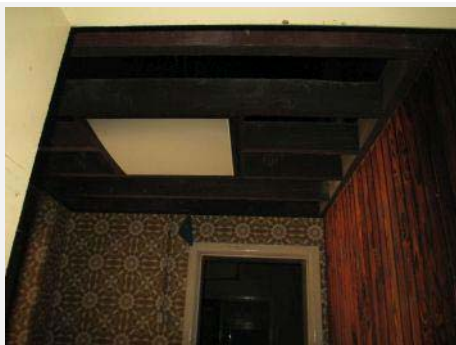
Plate 144: Interior showing missing ceiling, unsympathetic wall finish including timber panelling.

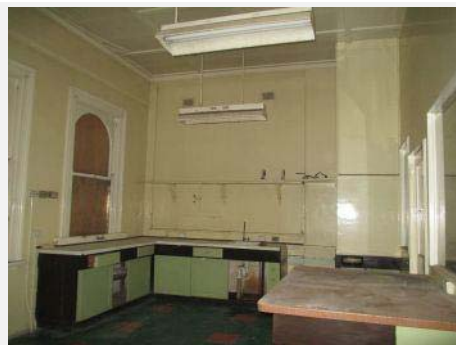
Plate 145: Interior showing kitchen area with timber joinery and linoleum flooring.

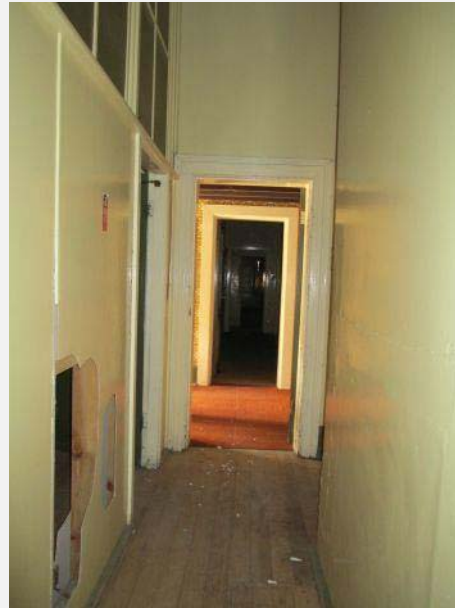
Plate 147: Interior showing damage to walls and stripped floor finish. Unsympathetic addition beyond (carpet finish).

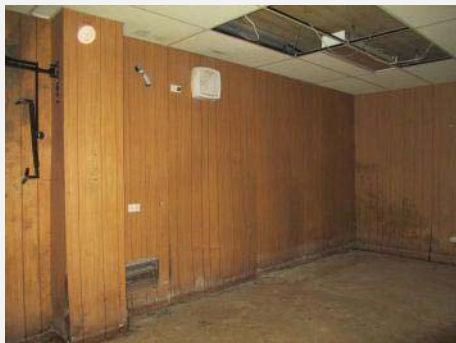
Plate 148: Interior showing unsympathetic additions, timber panelled walls, ceiling grid and electrical services. Note: Evidence of mould on walls.

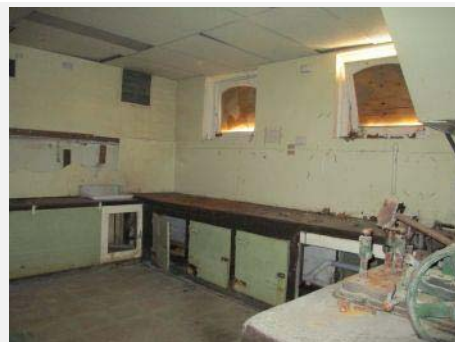
Plate 151: Interior showing room at basement level, awning style windows, timber joinery and old equipment.

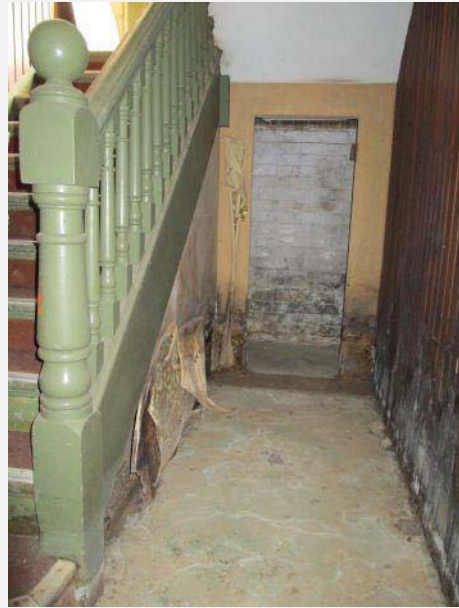
Plate 152: Interior to basement showing unsympathetic wall finish (timber panelling, right) and brick infill and damage to walls.

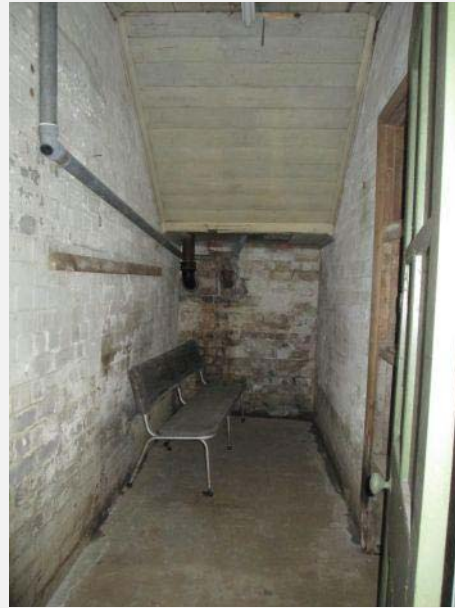
Plate 153: Interior to basement level under stairway showing timber panelling to stair and evidence of mould on walls.

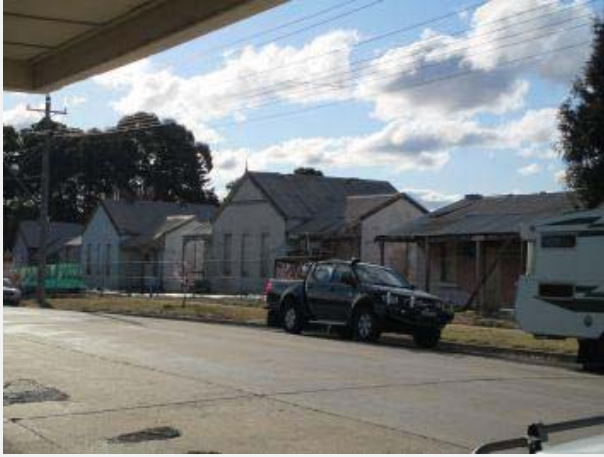
<p>Plate 157: Williwa Street Cottage Group south from Williwa Street.</p>														
Description:	<p>The Williwa Street Cottage group consists of Federation style cottages. The cottages are generally constructed of brickwork and corrugated iron roofs.</p> <p>Cottages 1 & 2 (Former Post Office), Cottages 5 & 6, Cottages 7 & 8, Cottages 9 & 10, Cottages 11 & 12 and Cottages 13 & 14.</p> <p>Note: Cottages 3 & 4 (Former Bachelors Quarters) – Demolished</p>														
Condition:

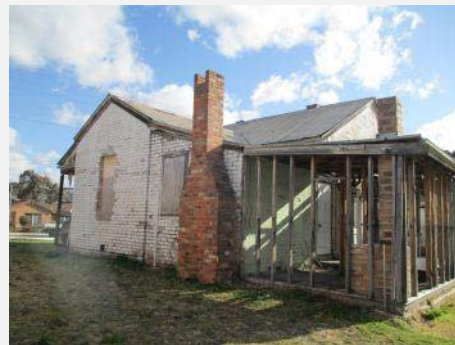
Plate 165: Cottages 9 & 10 east elevation.

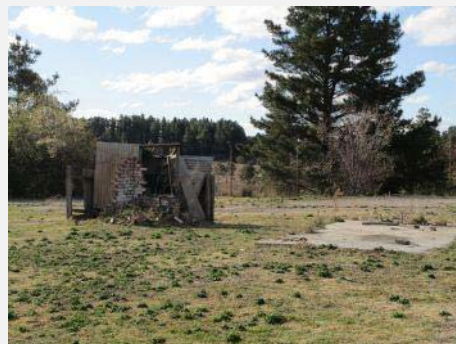
Plate 173: Area north of Cottages showing remnant outbuildings.

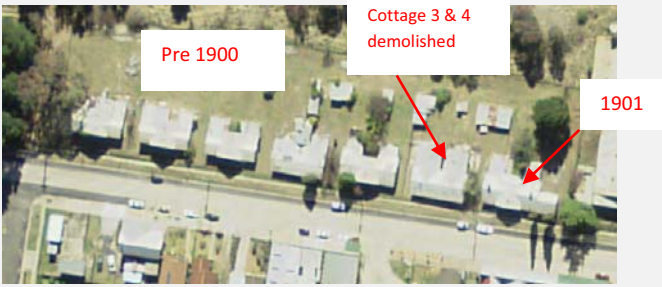
<p style="text-align: center;">Plate 176: 2017 Aerial photograph (Source: https://maps.six.nsw.gov.au/)</p>
<p><i>Dr Scheidel wrote in his letter dated January 24th 1901 that when the site was purchased by the Commonwealth Portland Cement Company there were already cottages on the site. He stated 'the houses acquired with the old works and leases need to be put into habitable conditions.'</i> (CMP NBR5 2010:30)</p>	
Building timeline:	
c1890	First set of workers' accommodation built along Williwa Road, being the old Bachelors' Quarters (No. 3 & 4 Williwa Street) and No. 7 & 8 Williwa Street. They are built during the Cullen Bullen Lime and Cement Company operations, as simple three-room single-storey terrace cottages. The Bachelors' Quarters are constructed as four three-room apartments with shared amenities at the rear.

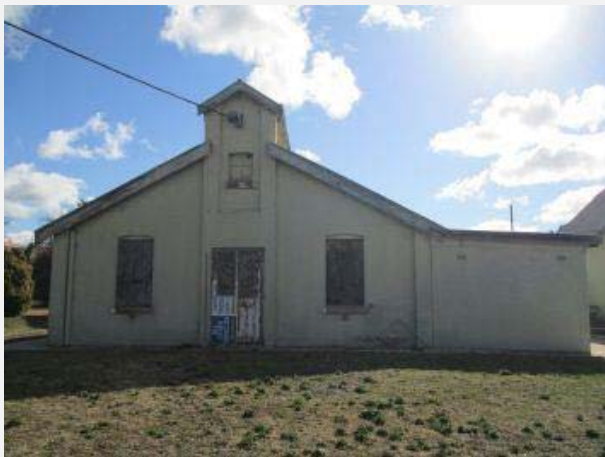
Condition Assessment																							
Item No: 13	Item Name: Workshop (Small store)

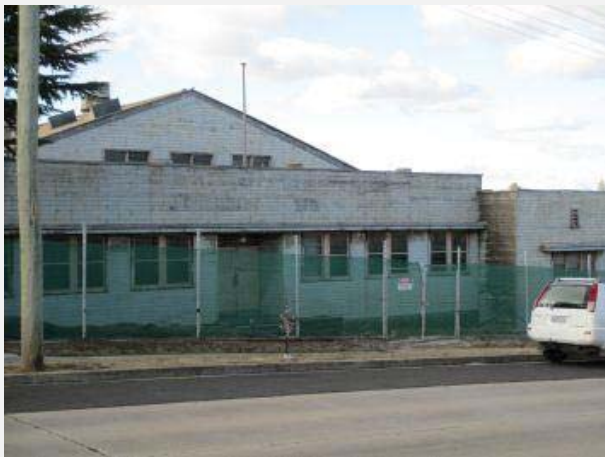
<p>Plate 193: Annex south elevation.</p>																												
Description:	The Annex is constructed on a masonry base with timber clad walls above. The roof is gabled with corrugated iron roof sheeting. The building is oriented in a north south direction and includes secondary rooms to the east and north east corners. A mixture of timber framed double hung and glass louvre windows are located in each elevation. The roof includes a number of vent shafts.																												
Condition:

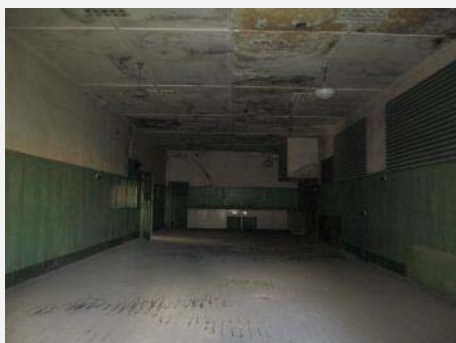
Plate 200: Interior showing water damage to floors and ceilings.

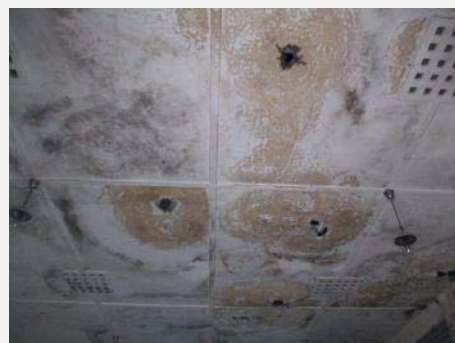
Plate 201: Interior showing water damage to ceilings.

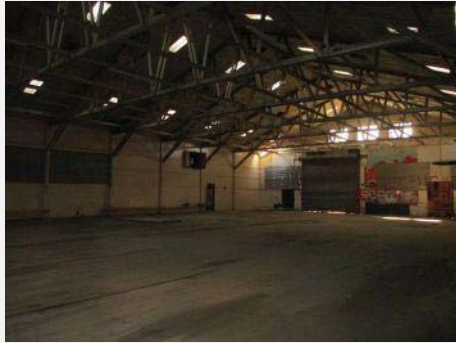
Plate 202: Interior of main room showing water damage to floor boards.

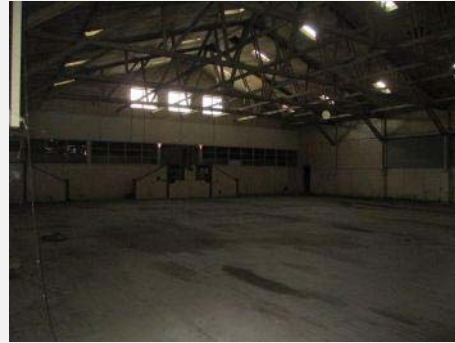
Plate 203: Interior of main room showing water damage to floor boards.

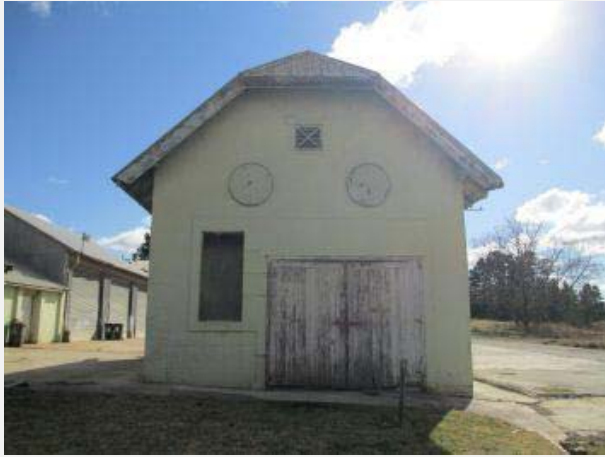
<p>Plate 205: Ambulance station east elevation.</p>																												
Description:	The Ambulance Station is a single storey, painted masonry building with a Dutch-hipped roof. The building is oriented in an east-west direction and includes timber framed sash windows and a corrugated iron roof. A large timber double leafed door, two circular features (most likely clocks) and louvered opening mark the principal elevation. The brickwork/stone in a stretcher bond pattern.																												
Condition:

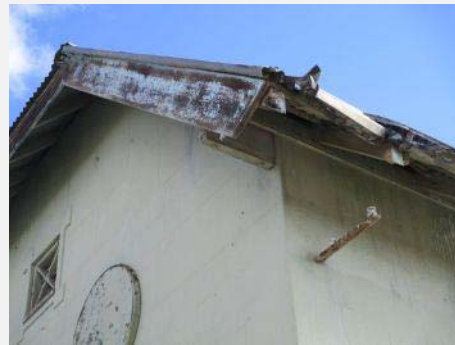
Plate 209: Detail at north west corner of roof showing damage to gutters and timber roof trims.

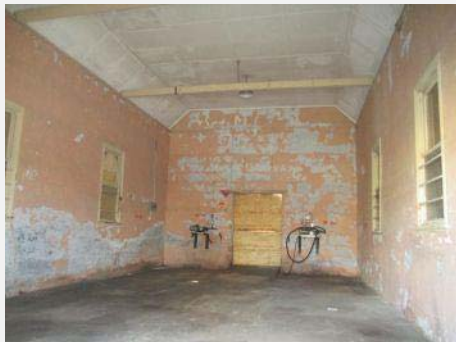
Plate 210: Interior looking west.

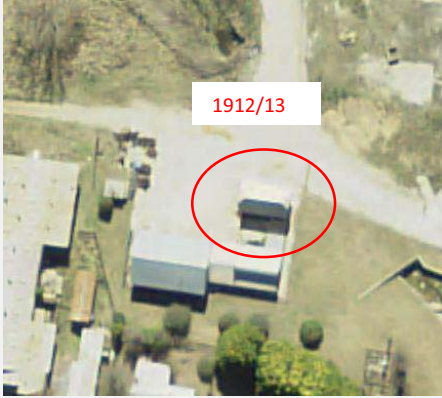
<p>Plate 212: 2017 Aerial photograph (Source: https://maps.six.nsw.gov.au/)</p> <p><i>1912/13 built, west of the Power House. A small building, in a group with the Bathroom and the Electrical Repair shop, two of these buildings remain in 1993 (Fenwick 1993).</i></p>
Building timeline:	
1912/1913	Ambulance Store built.
1993	Building used as in Oil Store
Early plans/photographs:

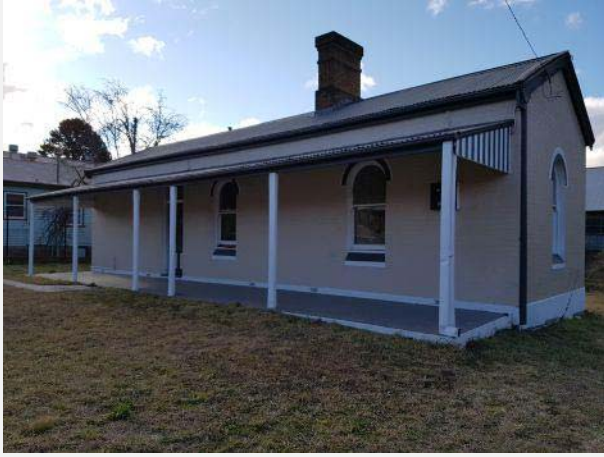
Condition Assessment																									
16	Item Name: Casino (Officer's Mess)

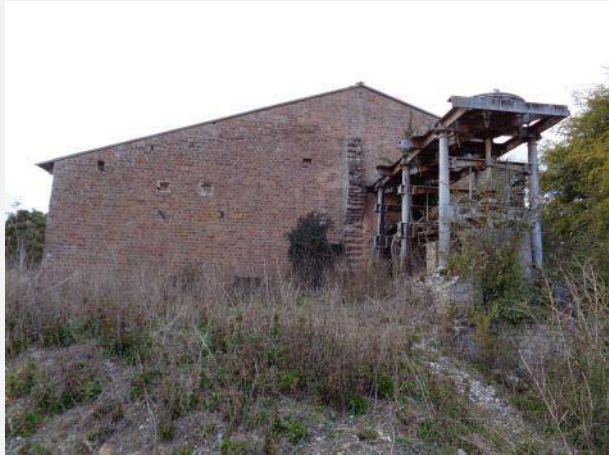
Condition Assessment		
Item No: 18 and 19	Item Name: Raffan's Mill and Brick Bottle Kilns

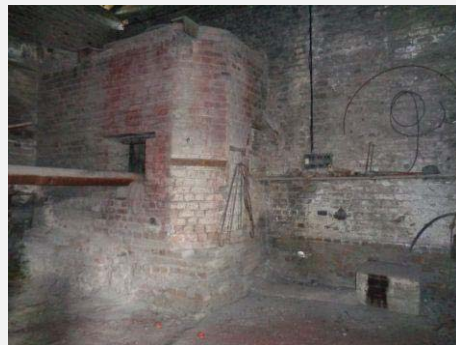
Plate 229: Interior main room showing remnant limewash.

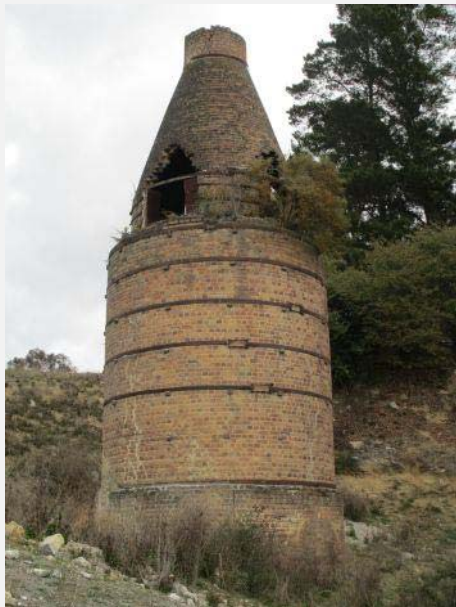
Plate 234: Brick Bottle Kiln (south) showing broken and missing bricks and weed growth.

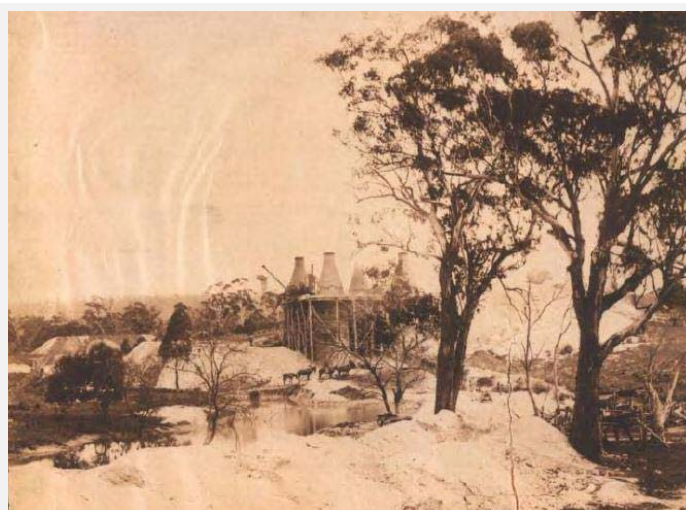
Plate 236: Date unknown Group of four Bottle Kilns (Source: Blue Circle Maldon Archives as cited in NBRIS 2010).
