**APPENDIX 8 GEOTECHNICAL REPORT**

# KEIGHRAN GEOTECHNICS

**Re: Geotechnical Land Use Stability Assessment  
Lot 1 DP 1130700 , Lot 1 Section 60 DP 758855, Lot 1 DP 922029, Lot 1 DP 9223398 and Lot 1 DP 115461  
No. 2 and No.23 Williwa Street – Portland**

**GEOTECHNICAL INVESTIGATION**

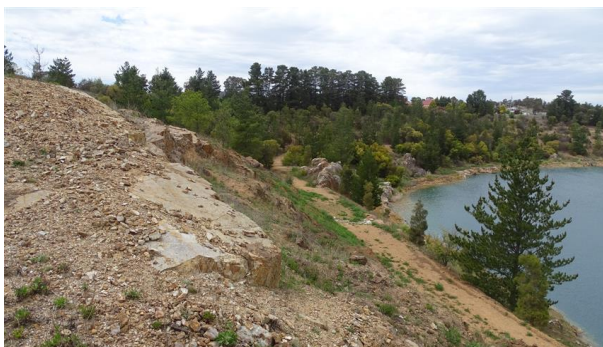
Conglomerate and mudstone in the Escarpment in NE Corner      Limestone Exposed in Access Road on centre north

The exposures from the Dam below up to the north eastern corner boundary exposed shallow conglomerate and mudstone bedrock to the crest of the R5 Zone.

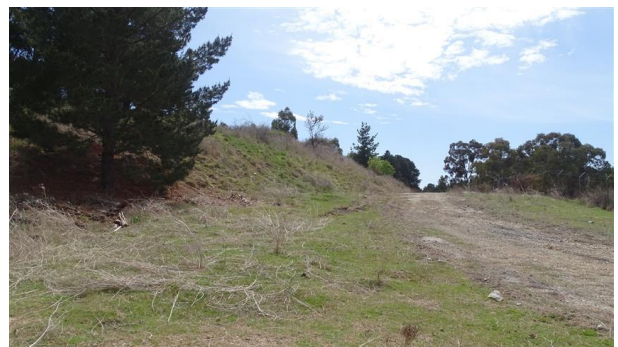
The current access roadway to the east of the overburden stockpile exposes natural soil and rock materials on the surface which present and VERY LOW risk of Instability, However, the Western Side of the R5 Zone North is elevated by up to 10 metres with stockpiled overburden materials removed from the Quarries on the property. This area is considered to be a MEDIUM Risk of Instability which can be reduced to a LOW RISK with significant bulk earthworks to

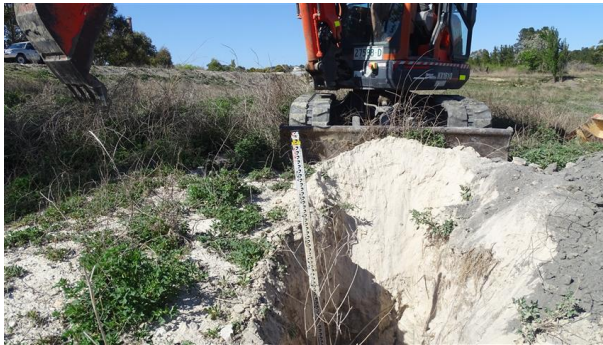
**FILL (2):** ash, fine grained trace some concrete gravel, dark grey and grey in colour, dry to wet with depth and loose to medium dense with depth. Encountered below FILL (1) in the above detailed test pits and from the surface in TP 5 to TP 9 and TP 11 to TP 13 to depths ranging from 1.0 metres in TP 10 and TP 11 to 3.6 metres in TP 1 and TP 2. The eastern corner around TP 1 and TP 2 was the deepest and the southern side around TP 10 and TP 11 was the shallowest with about 1.7 to 2.0 metres across the western and northern sides. .

The slope stability risk is there for VERY LOW, however the presence of the uncontrolled ash and limestone gravel fill materials provide a High Risk of differential settlements across any proposed building platform and will require significant bulk earthworks to create a stable Very Low Risk building platform suitable for the proposed R2 Residential Development including dwellings, roads, services

0	0.8	FILL:	Limestone gravel and clayey sand cream, dry to moist and loose
0.8	3.6	FILL:	ash, fine grained, trace concrete gravel Dark grey and grey Dry to moist and loose
3.6	3.8	RESIDUAL:	sandy clay, medium plasticity Yellow and grey , moist and stiff
3.8		Discontinued

The recommended bulk earthworks treatment is to win suitable FILL materials from elsewhere on the property and strip back the existing uncontrolled FILL materials to the RESIDUAL sandy clays. The uncontrolled FILL materials may be stockpiled and blended where suitably uncontaminated and be blended with the site won materials before being placed and compacted on a Level 1 basis (AS 3798-2007) to provide a 98% Standard Compaction compacted fill to a suitable design level.

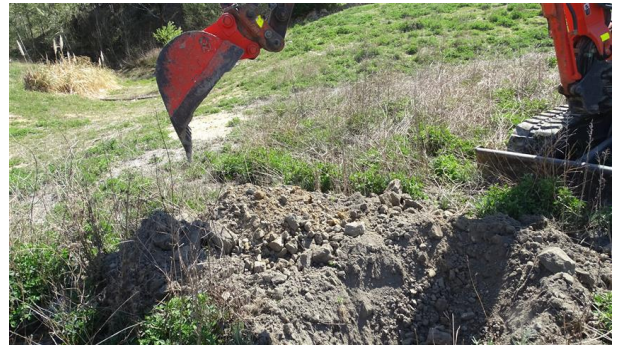
TP 7

0.0	1.1	FILL:	ash, fine grained, Dark grey and grey Moist to wet and loose
1.1	1.2	RESIDUAL:	sandy clay, medium plasticity Yellow orange, Moist and stiff
1.2		Discontinued

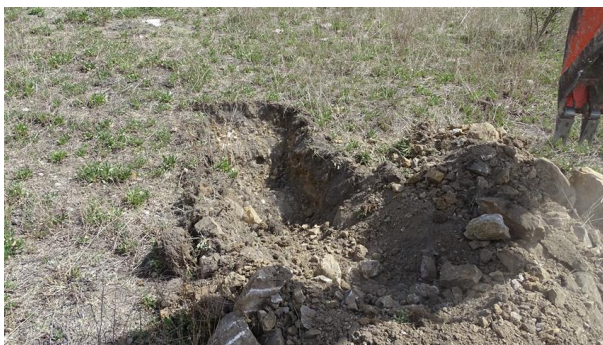
TP 16

**FILL:** limestone / conglomerate cobbles in sandy matrix, cream to yellow grey, dry and loose to medium dense. Encountered from the surface to well over 0.5 metres where refusal of the 5 tonne excavator occurred in TP 14 to TP 16.

The existing slopes are currently less than 1V:2H which is considered to be stable for the long term, however, the presence of the uncontrolled fill materials presents the MEDIUM RISK of instability and as indicated earlier will require significant bulk earthworks to be suitable for Residual subdivision development.

remove the existing uncontrolled overburden materials which can then be replaced and reshaped into a suitable R5 Residential subdivision.

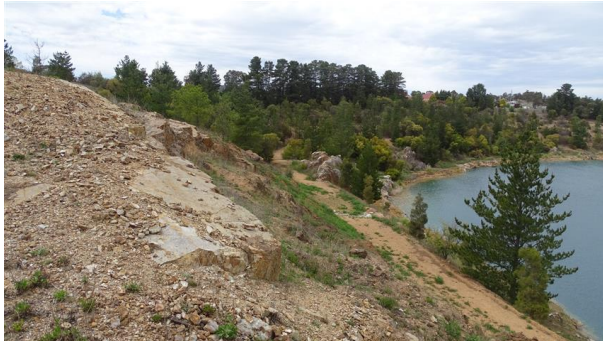
This area was visually inspected by our principal geotechnical engineer and no test pits were undertaken due to the shallow exposure of parent bedrock present in the exposures within 0.5 metres of the surface.

The R5 Zone in the North Eastern Corner is located on shallow residual soils with limited if any uncontrolled FILL materials overlying the parent bedrock at depth up to 0.5 metres. The presence of the shallow bedrock provides a VERY LOW Risk of instability from both a slope stability point of view and Site Classification to AS 2870 – 2011.

We consider that the R5 Zone in the North Eastern Corner of the property is suitable for residential subdivision at the present time with no significant bulk earthworks other than standard subdivision construction operations.
