APPENDIX 5 DESKTOP STORMWATER STUDY

DESKTOP STORMWATER STUDY

THE FOUNDATIONS PORTLAND

WILLIWA ST, PORTLAND NSW 2847

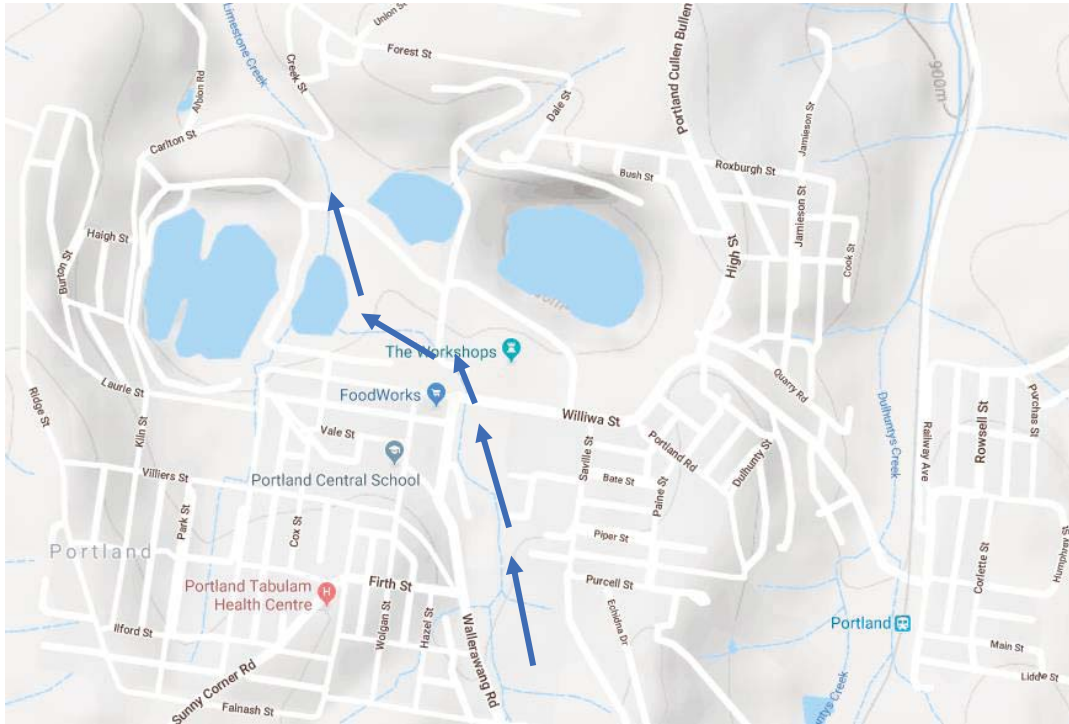
Figure 2 - Topography

As outlined in Figure 2 below, the site is situated at the natural low point of the town. During heavy rain events, stormwater has the potential to exceed the capacity of the council's pipework under Williwa St creating an overland flow across Williwa St adjacent to Saville Park.

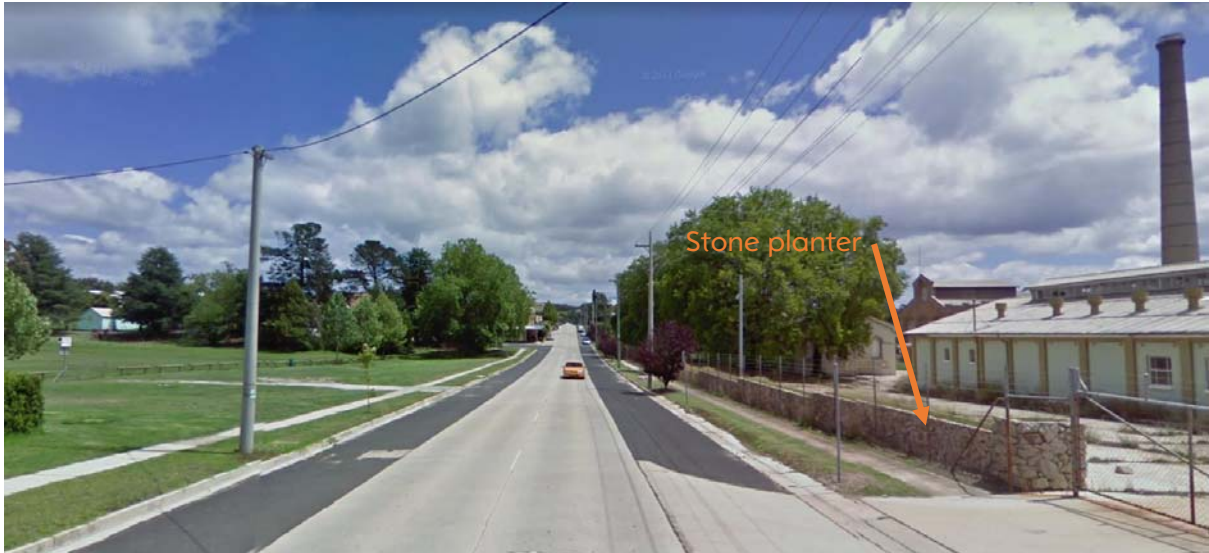
Figure 4 – Stone Planter Wall

To manage the impact of the overland flow from Saville park into the Heritage Precinct, Portland Cement company constructed a stone planter box and installed a bund to direct overland flow downhill towards the drainage channel through the site to eventually flow into limestone creek.

It is evident that the construction of the planter box and installation of the earth bund has successfully managed the overland flow into the site and the heritage precinct.
