**ANNUAL ENVIRONMENTAL MANAGEMENT REPORT
LITHGOW SOLID WASTE FACILITY – EPL 6004
OCTOBER 2013 - SEPTEMBER 2014**

**PREPARED FOR
CITY OF LITHGOW COUNCIL**

NOVEMBER 2014

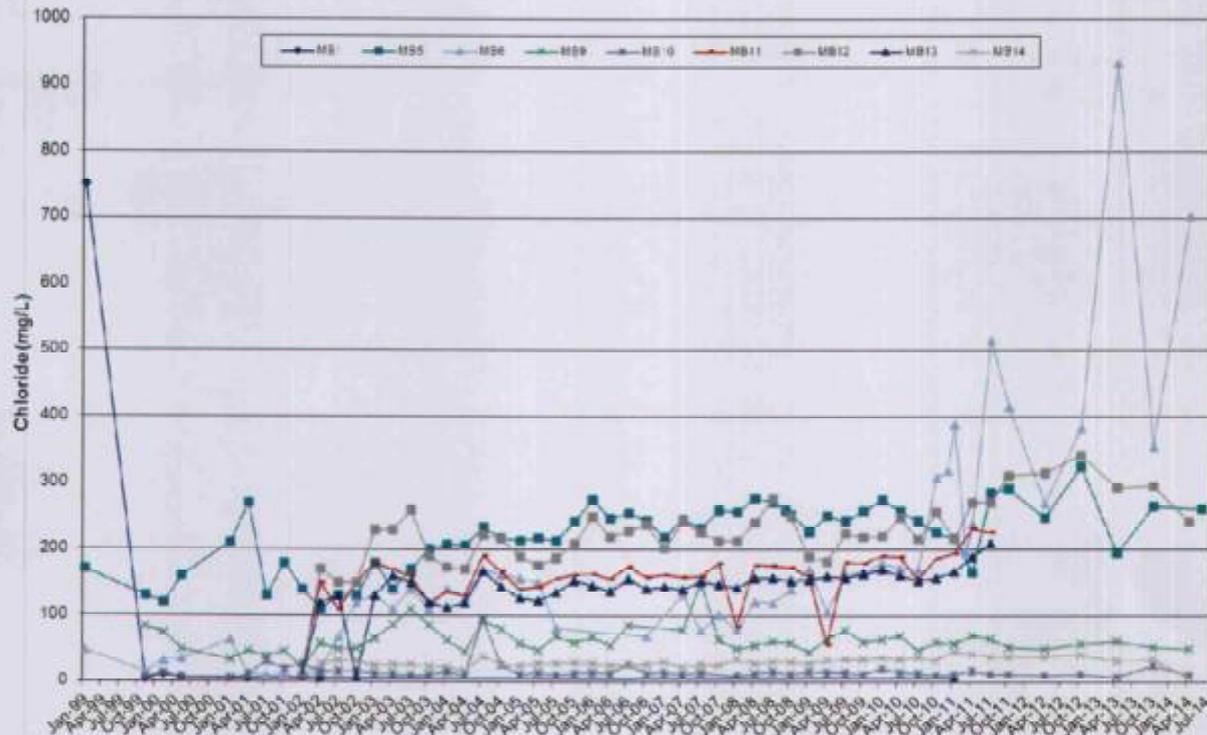
All detected levels except the 702mg/L recorded at MB6 in April 2014 remained below the guideline value of 700mg/L for irrigation to moderately tolerant crops (ANZECC & ARMCANZ, 2000).

Figure 6: Groundwater Chloride – Lithgow Solid Waste Facility, January 1999 to June 2014

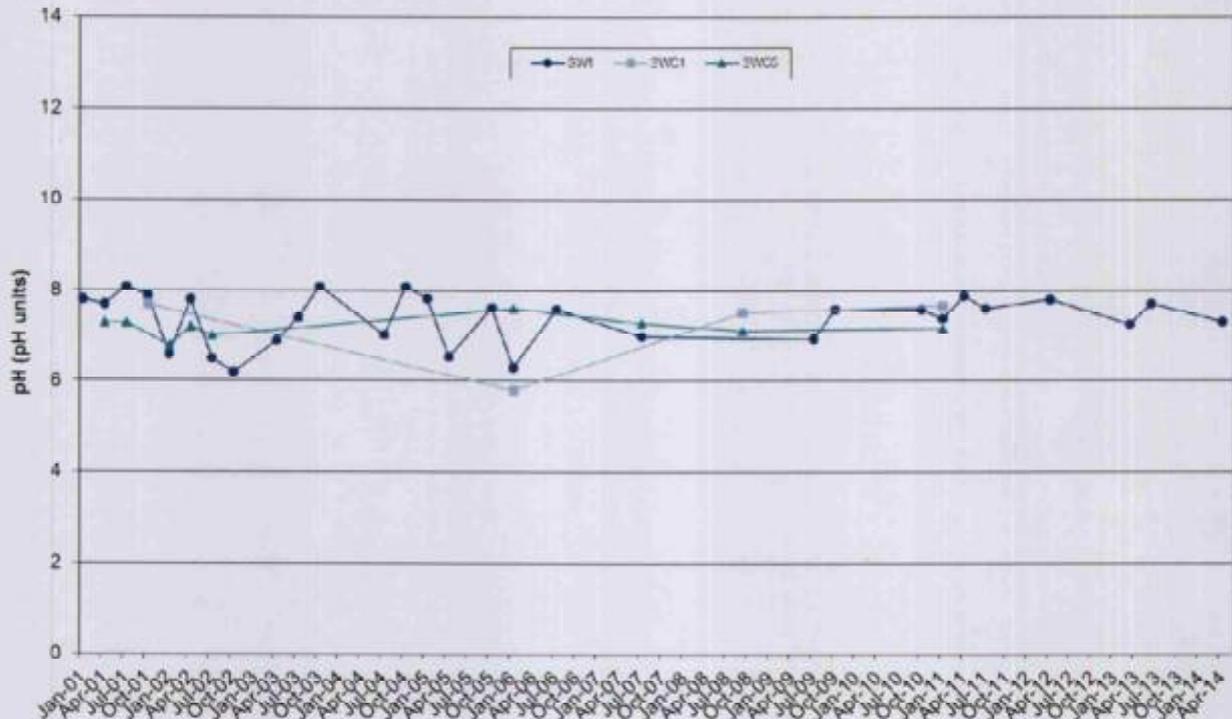
pH remained consistent with historical results and within the established range, with a value of 7.32pH units recorded. This value is considered suitable for consumption by livestock (ANZECC & ARMCANZ, 2000) and were within the EPL limit of 6.5-8.5pH units.

Figure 14: Surface water pH – Lithgow Solid Waste Facility, January 2001 to April 2014

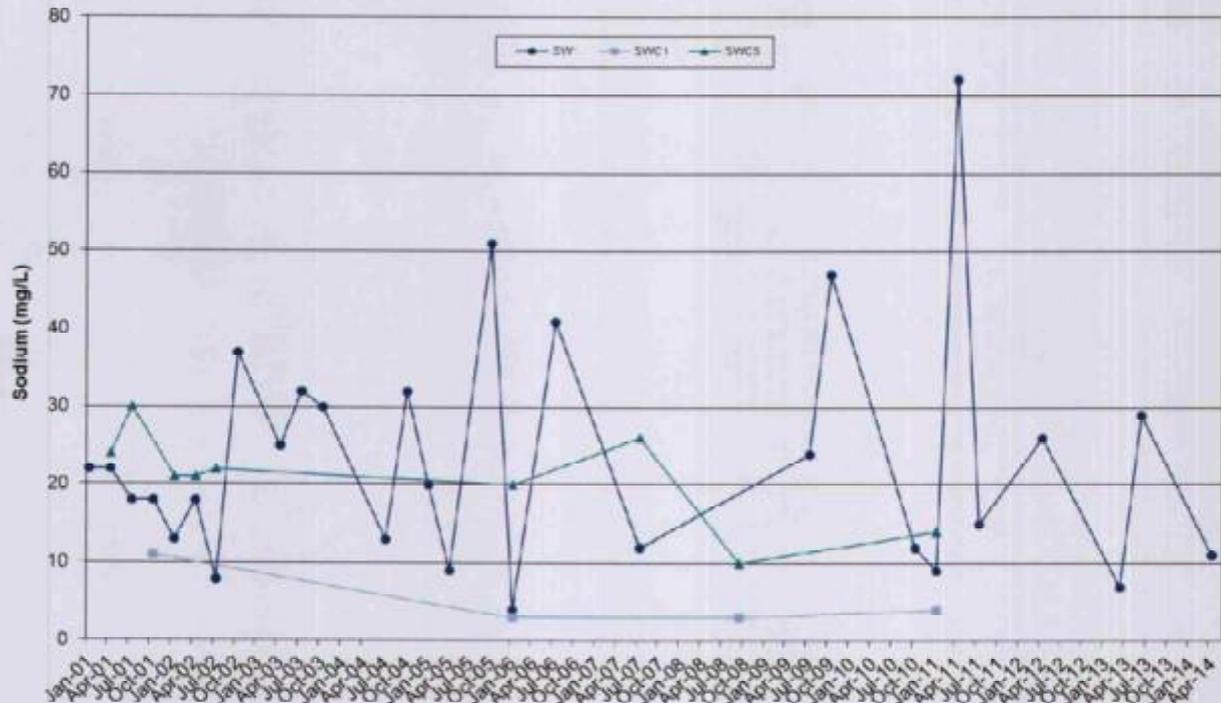
The sodium concentration in April 2014 was measured to be 12mg/L, which is consistent with the established range and significantly lower than the crop irrigation guideline value of 460mg/L for moderately tolerant crops (ANZECC & ARMCANZ, 2000).

Figure 22: Surface water sodium – Lithgow Solid Waste Facility, January 2001 to April 2014

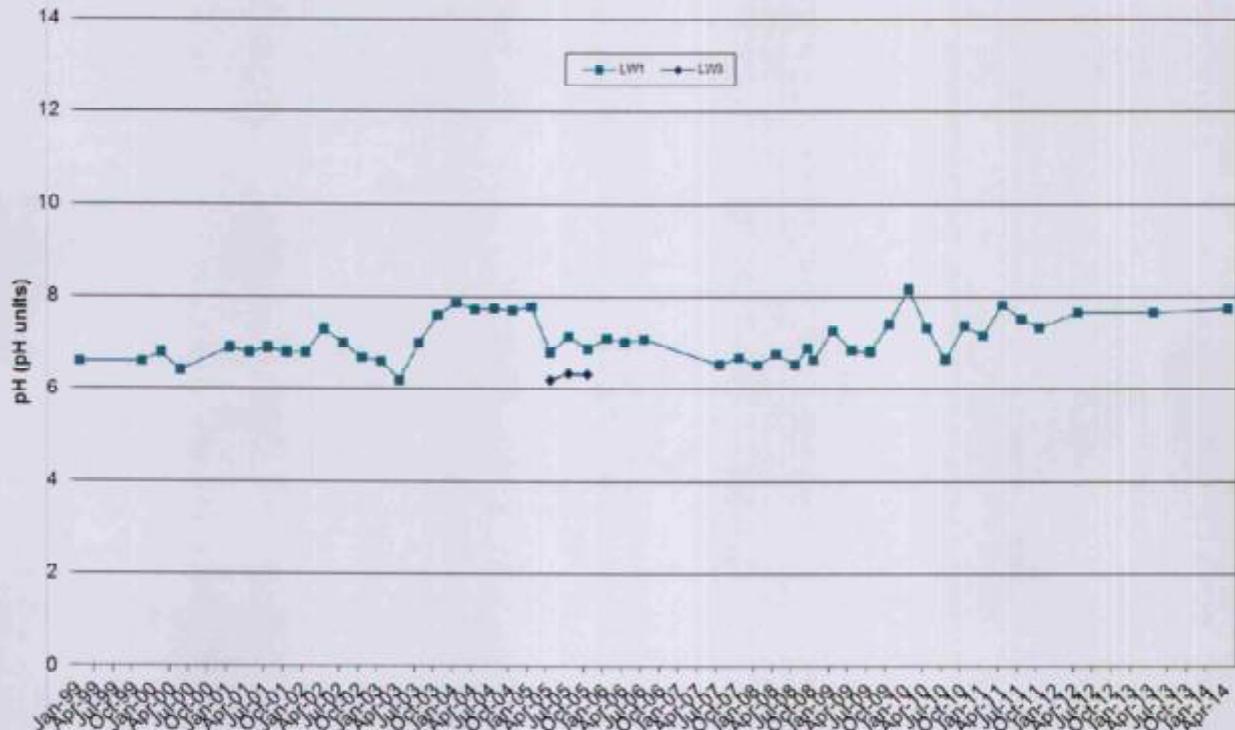
pH levels in the sample collected from LW1 was 7.74pH units. The value was relatively neutral and within the guideline range recommended for livestock drinking water (6.5-8.5pH units, ANZECC & ARMCANZ, 2000). The value was also within the established historical range.

Figure 26: Leachate pH – Lithgow Solid Waste Facility, January 1999 to April 2014

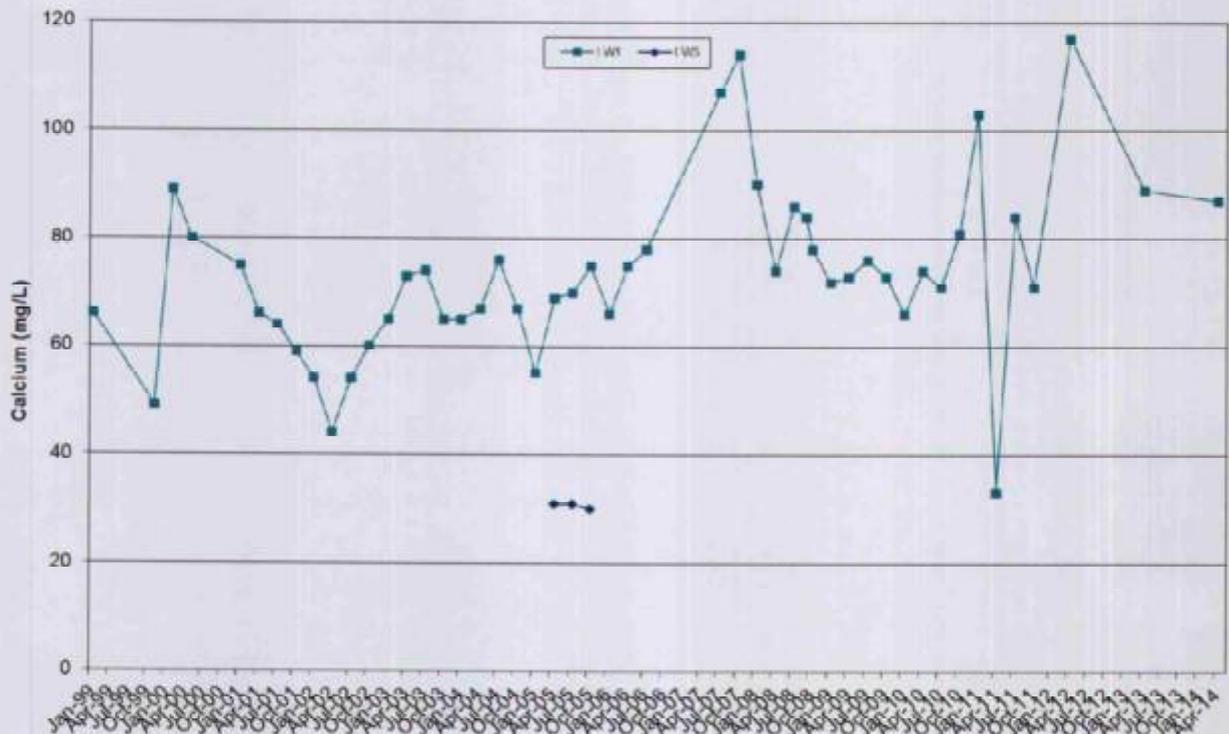
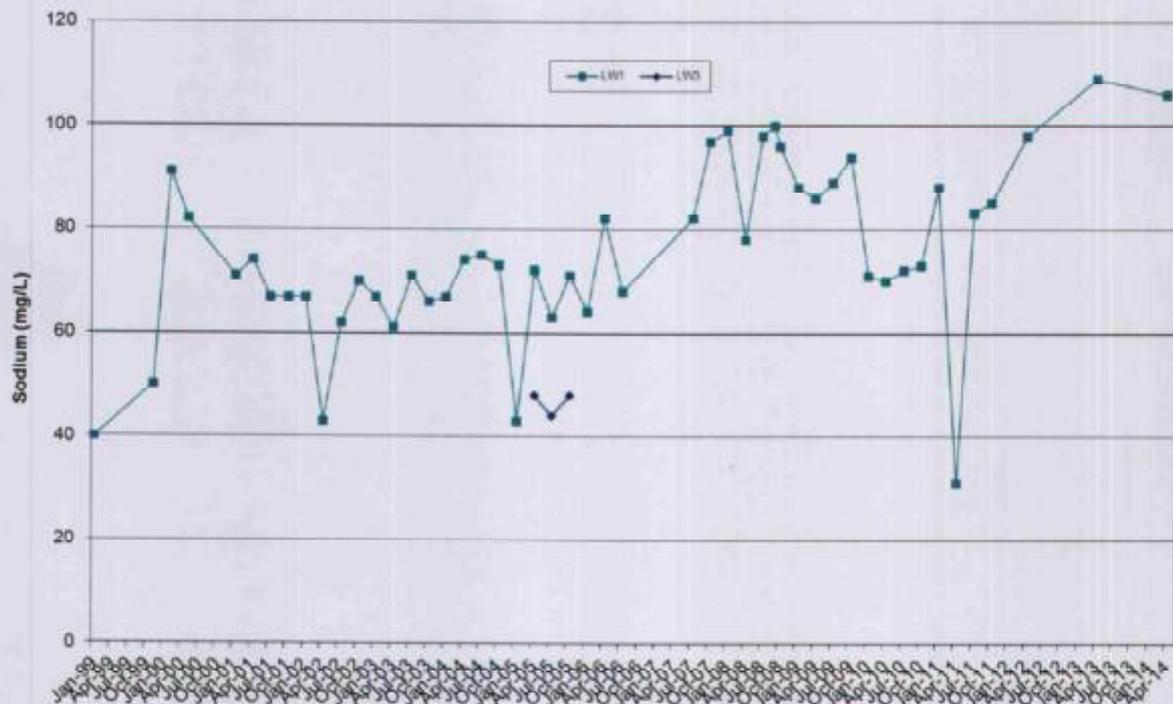
Calcium remains significantly lower than the livestock drinking water guideline value of 1000mg/L (ANZECC & ARMCANZ, 2000). Sodium concentrations are considered low when compared to the crop irrigation guideline value of <460mg/L (ANZECC & ARMCANZ, 2000).

Figure 30: Leachate Calcium concentrations – Lithgow Solid Waste Facility, January 1999 to April 2014

Figure 31: Leachate Magnesium concentrations – Lithgow Solid Waste Facility, January 1999 to April 2014

Figure 32: Leachate Potassium concentrations – Lithgow Solid Waste Facility, January 1999 to April 2014

Figure 33: Leachate Sodium concentrations – Lithgow Solid Waste Facility, January 1999 to August 2013
