REVIEW OF ENVIRONMENTAL FACTORS

Addendum #2

Crown Creek Bypass, Glen Davis

Prepared for: Lithgow City Council

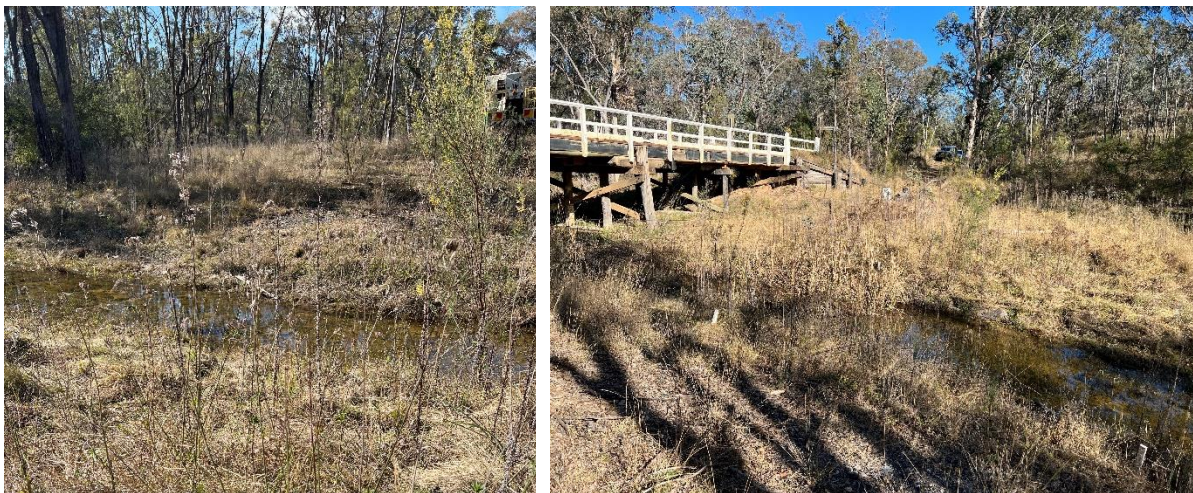
Plate 1 Subject Site for Bypass and temporary crossing of Crown Creek, looking west (left) and east (right)

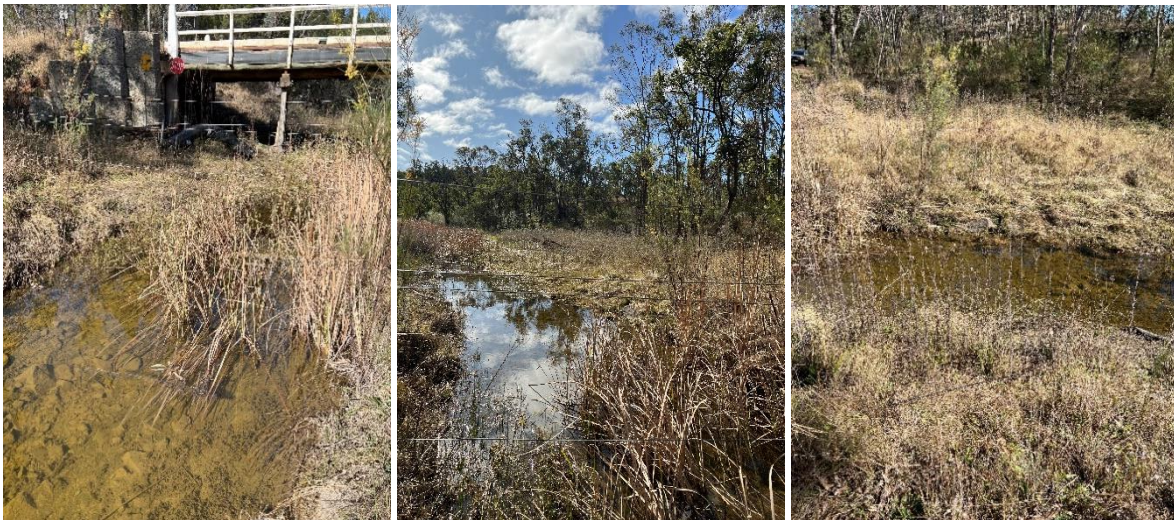
Plate 2 Left to right. Downstream habitat of Crown Creek, upstream habitat of Crown Creek, Crown Creek at the site of crossing. Clear water with muddy creekbed and some riparian vegetation.

Crown Creek contained slow flows at the time of survey (July 2022) with downstream pools and swampy areas, washed up logs (flood debris, snags) and other debris scattered around and within the waterway (refer **Error! Reference source not found.** and **Error! Reference source not found.**). Water flows were slow with a depth of approximately 35 cm at the point of the bypass crossing. The creekbed was muddy with some aquatic vegetation. The gradient is gentle, with the banks of the creek slight.

Water quality was observed as good with low turbidity, although no standardized water quality tests have been completed as part of this assessment. The creek up and downstream of the subject site supports a variety of aquatic habitats in varying conditions, including swampy grassland, washed up decaying trees with hollows, rocky pools and snags.

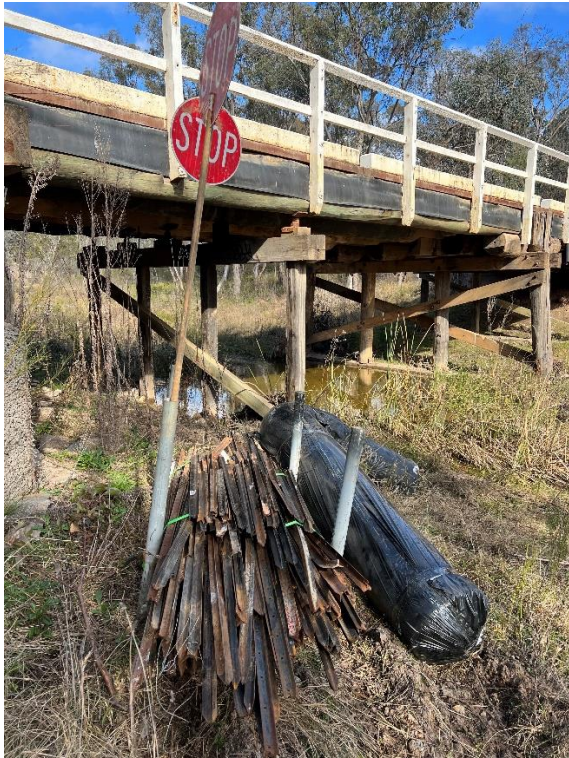
Plate 3 Materials stockpiled below Crown Creek bridge – for use during construction

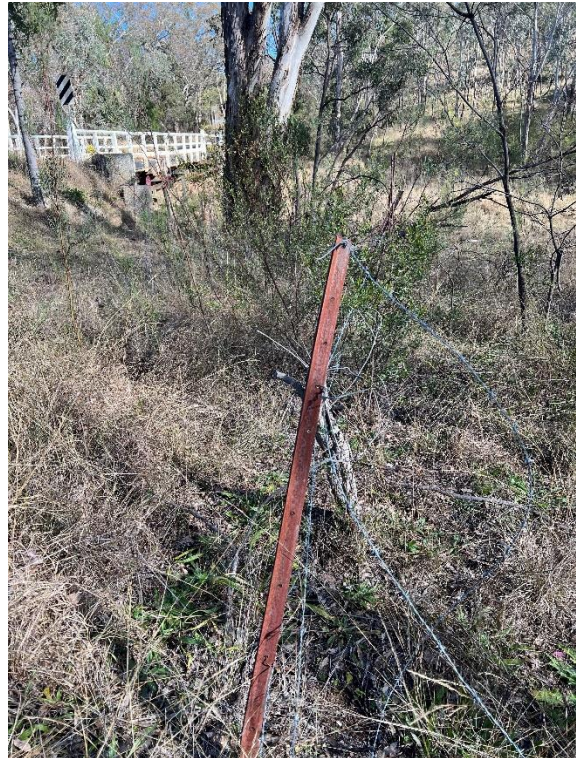
Plate 4 broken and discarded fences along bypass – to be upgraded following removal of bypass

- Continue to liaise with landholders regarding bypass works and ensure involvement throughout the process.
- Ensure any complaints are promptly addressed.
- Reinstatement of infrastructure - damaged/removed fences are to be reinstated to equal or better condition following removal of bypass. Consultation with the landholder to occur regarding fencing.
- Liaison and contact with Telstra services to ensure works in the area can be safely undertaken in the proposed timeframe.

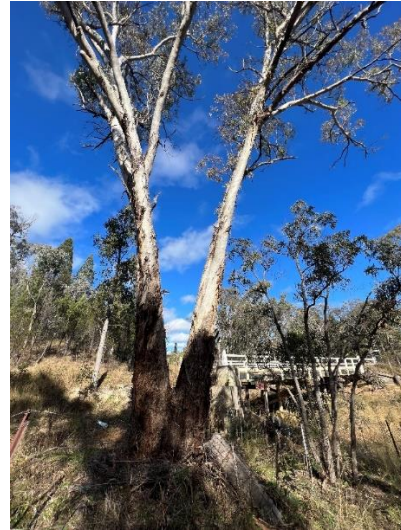
Plate 5 Remnant PCT 281 (left) along bypass subject site, and remnant tree to be retained (right)

The eastern and western banks of Crown Creek addendum subject site contained remnant woodland (Figure 1, **Error! Reference source not found.**) and was dominated by native vegetation including a mixture of canopy species including *Angophora floribunda* (Rough-barked Apple), *Eucalyptus blakleyi* (Blakley's Red Gum), *Eucalyptus melliodora* (Yellow Box), *Eucalyptus albens* (White Box), and *Brachychiton populneus* (Kurrajong). A scattered shrub layer was present consisting of *Dodonaea viscosa* (Sticky Hop-bush), *Dodonaea heteromorpha* (Maple-fruited Hop-bush), *Acacia subulata* (Awl-leaved wattle), *Bursaria spinosa* (Blackthorn), *Indigofera australis* (Australian Indigo), *Cassia laevis* (Cough Bush), and *Haloragis serra*. Native groundcover species including grasses *Poa labillardieri* (Tussock), *Microlaena stipoides* (Weeping Grass), *Aristida ramosa* (Purple Wiregrass), *Chloris ventricosa* (Plump Windmill Grass), *Austrostipa* sp. (Speargrass), *Bothriochloa macra* (Red-leg Grass), *Themeda australis* (Kangaroo Grass), *Gahnia aspera* (Rough Saw-sedge), and forbs including *Vittadinia cunneata* (Fuzzweed), *Veronica* sp., *Dichondra repens* (Kidney Weed), *Hydrocotyle laxiflora* (Stinking Pennywort), and *Geranium solanderi* (Native Geranium).

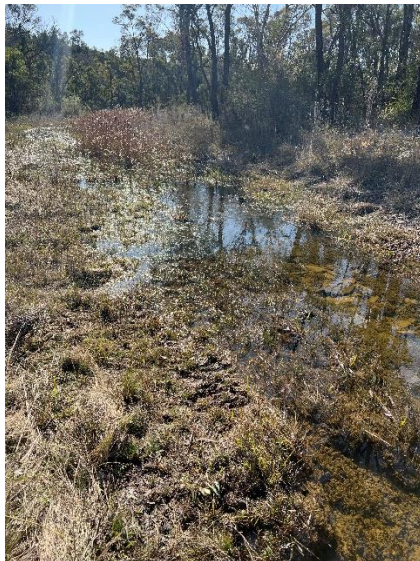
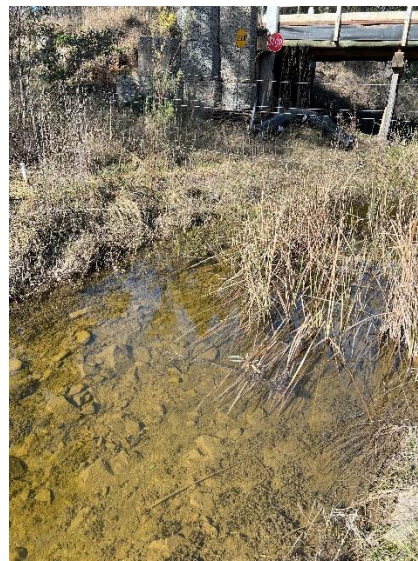
Plate 6 Instream vegetation looking north (left) and south (right)

Instream vegetation within the creek line included common waterway species including *Typha orientalis* (Bulrush), *Ranunculus amphotrichus* (Small River Buttercup), and *Eleocharis acuta*, being largely absent within the impact area of the bypass, with areas of greater density of rushes immediately north and south of the subject site (**Error! Reference source not found.**).

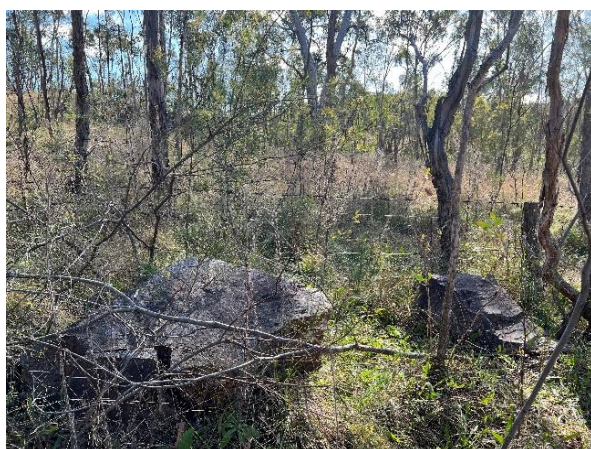
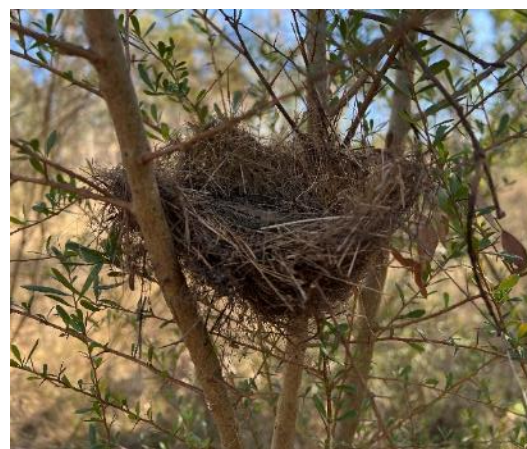
Plate 7 Habitat attributes present within subject site: rocks (left) and abandoned nest (right)

A small number of rocks and logs occur on the site, along with one small nest (Plate 7). Inspections of these during surveys showed no sign of habitation. The nest was relocated outside the impact area after close inspection and placed in nearby suitable shrubby vegetation. The vast tracts of intact vegetation within the surrounding locality, and avoidance of direct impacts to habitat trees result in an overall limited direct impact on flora and fauna.

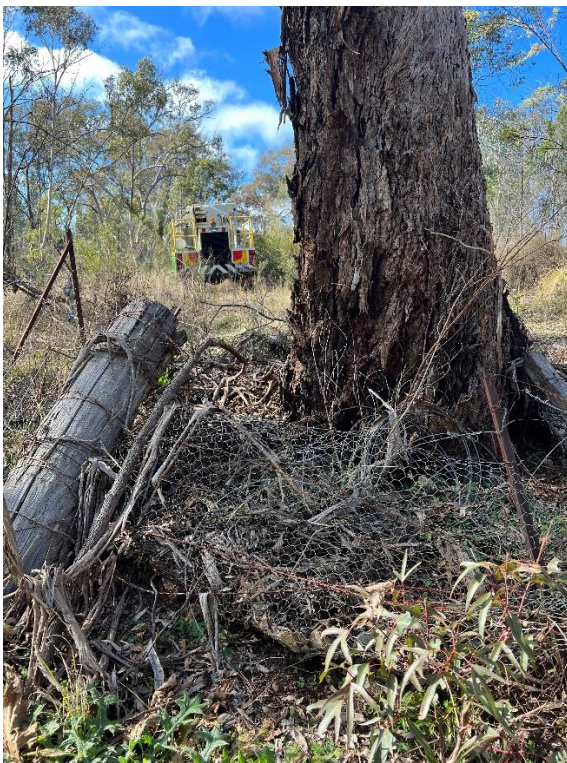
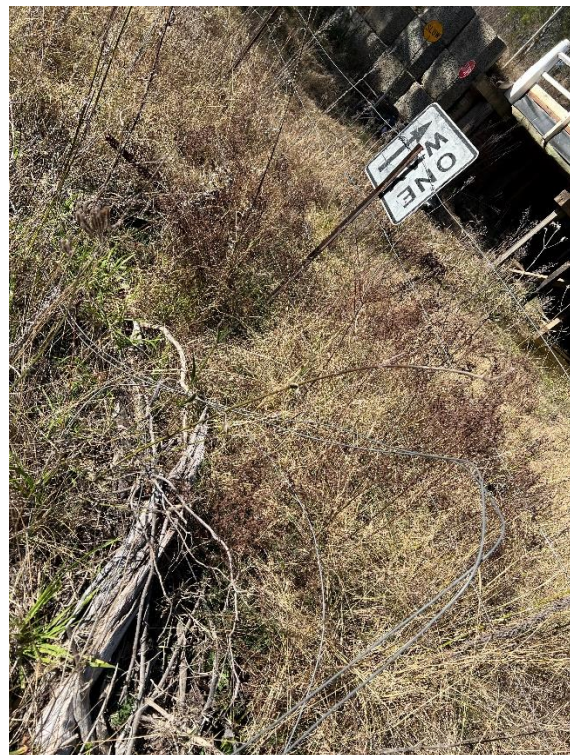
Plate 8 Old fencing materials and loose wires within the bypass site. To be removed and disposed of as part of works

The existing environment was described in Chapter 4 of the Project REF. During the July 2022 site inspection, additional discarded waste (food wrappers, plastic) was observed within the bypass footprint area. In addition, old and discarded fencing material including wire and mesh was observed within the creekbed.

Potential impacts associated with the new study area are consistent with those described in the REF. Additional waste in the form of old and discarded fencing will be generated. Bitumen, road base and pipe used for the bypass will add to the total waste impacts generated by the proposal. All waste is to be discarded at the local tip.

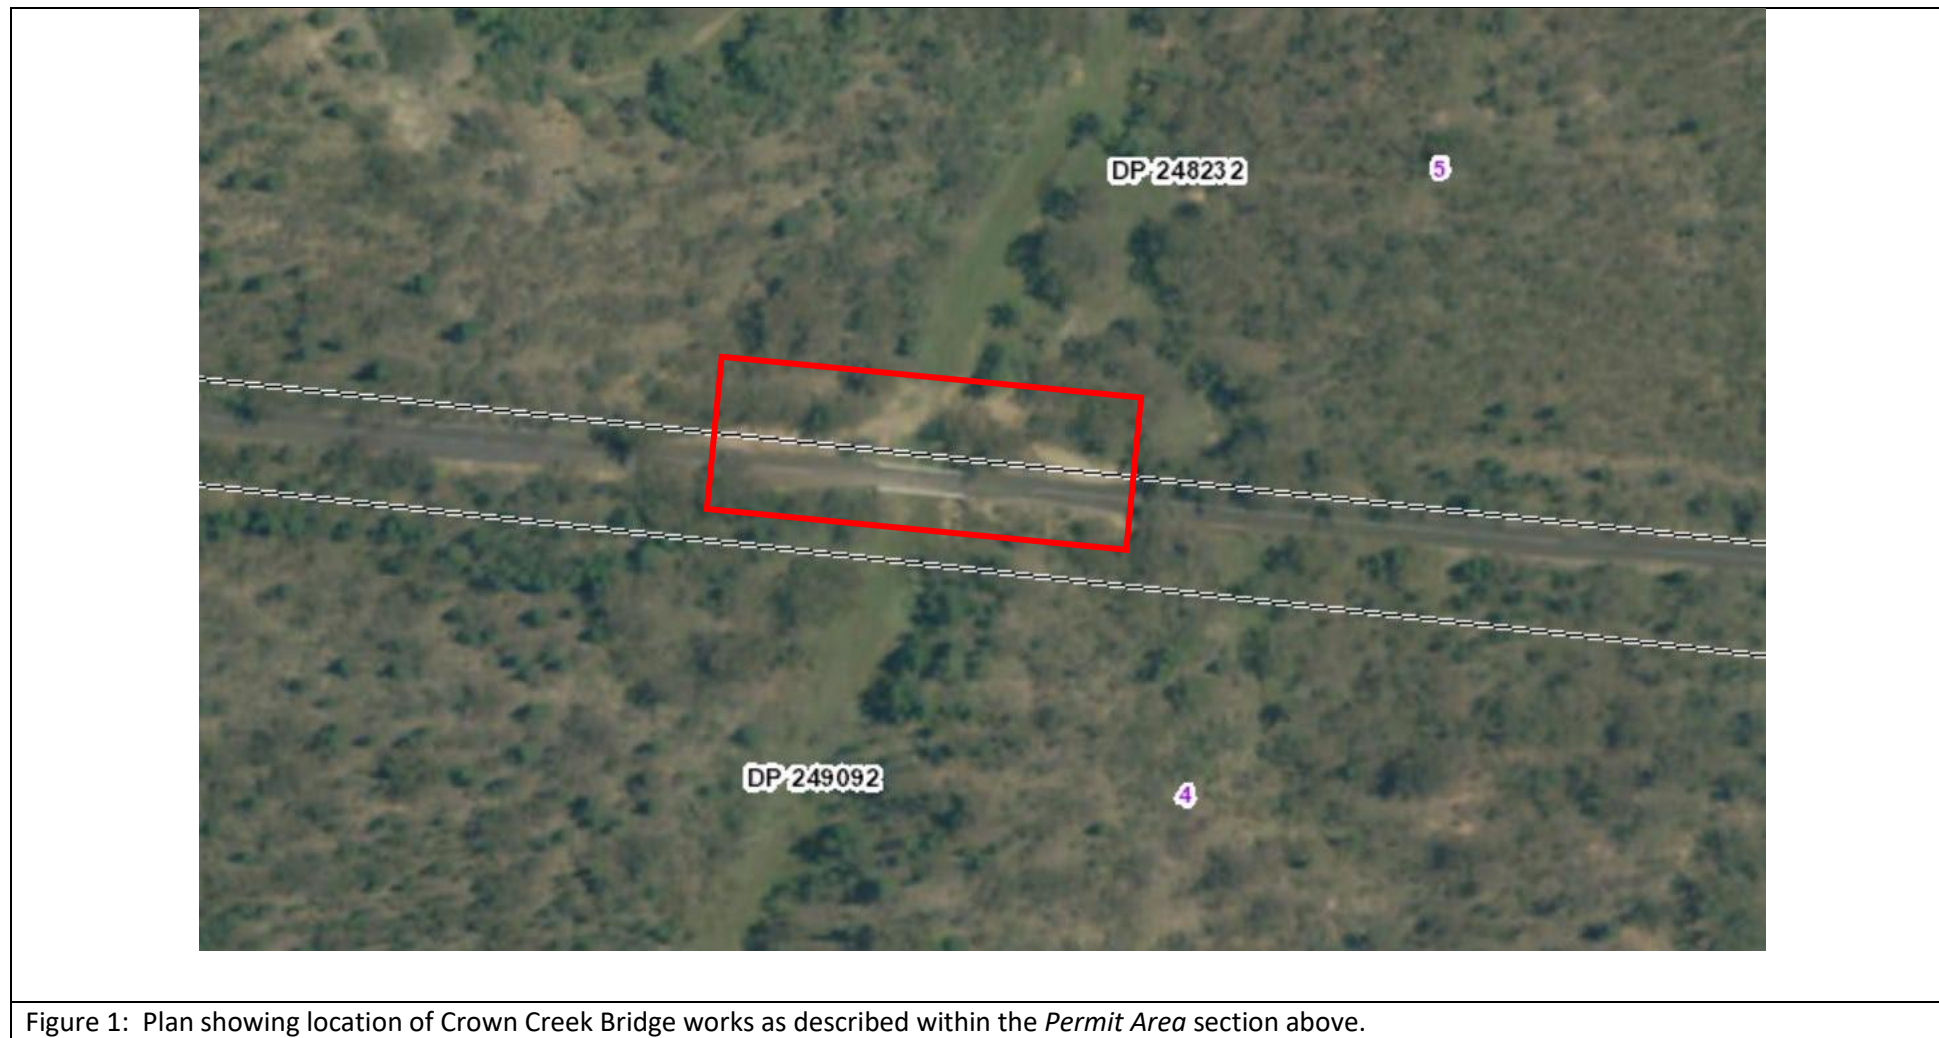
Attachment 1

Figure 1: Plan showing location of Crown Creek Bridge works as described within the *Permit Area* section above.

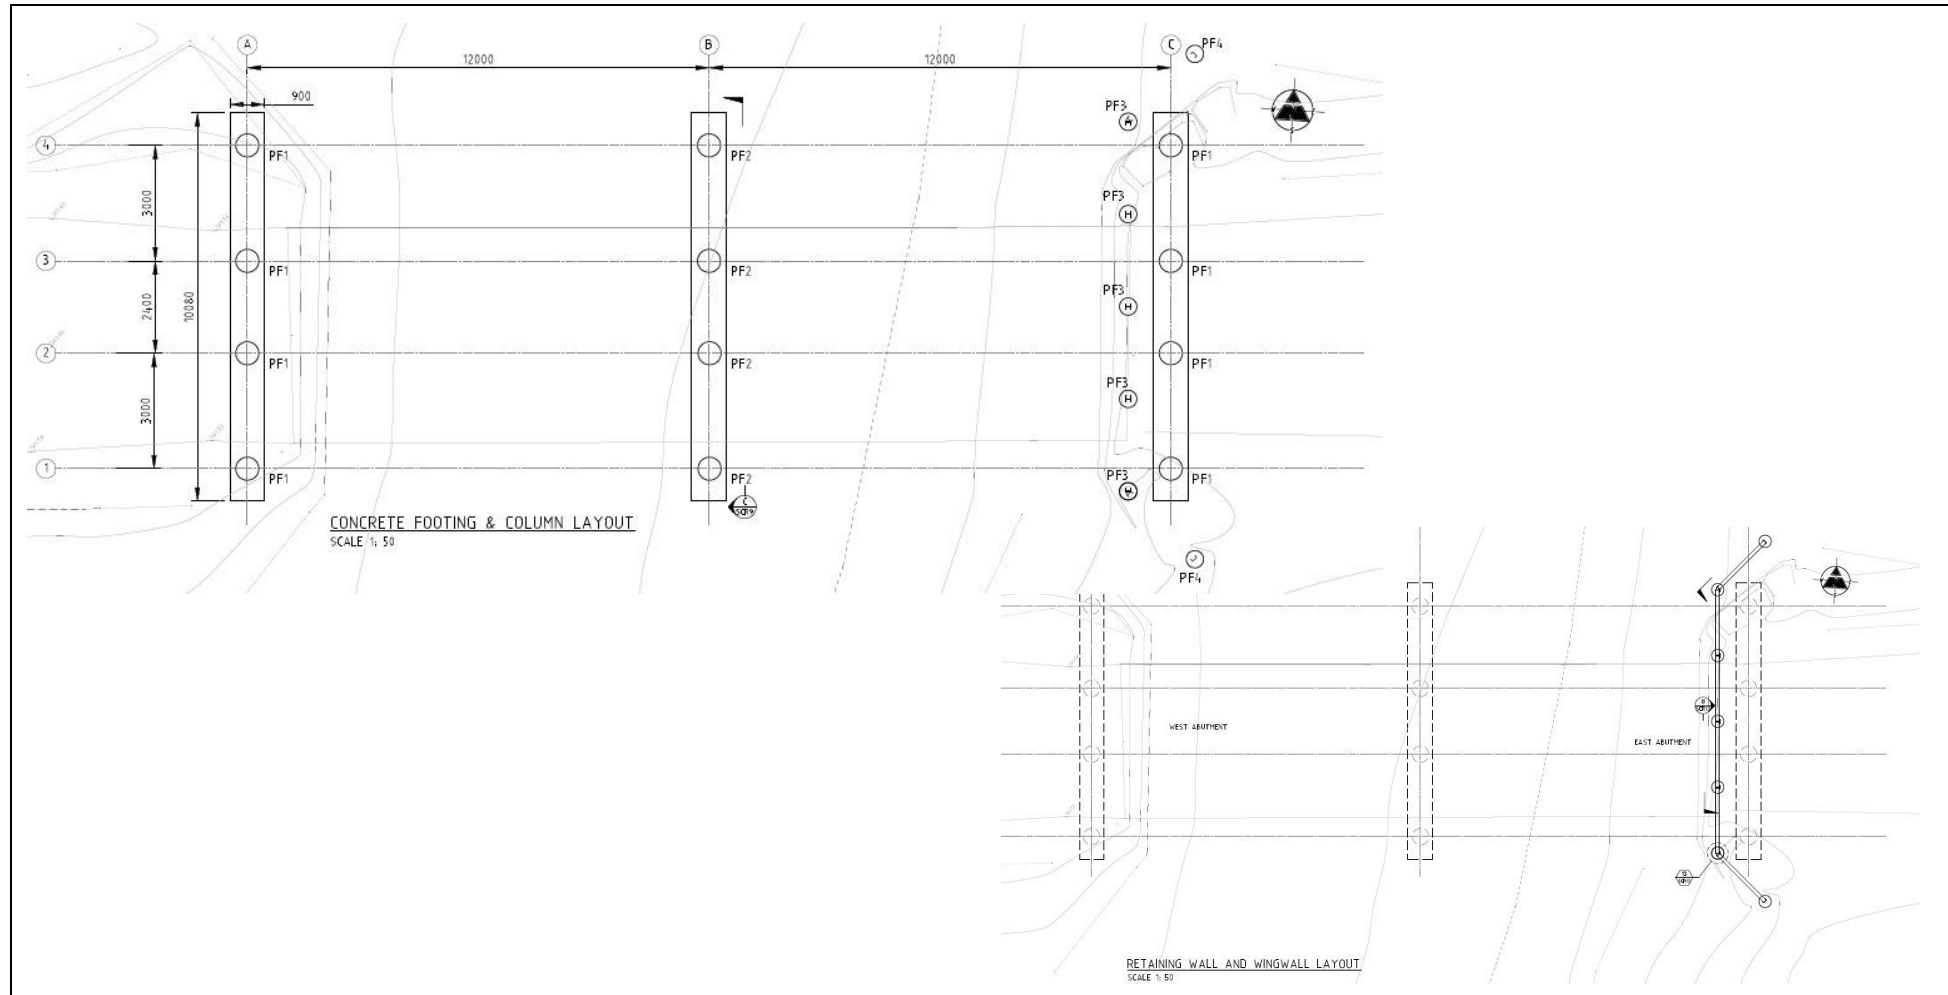
Attachment 2

Figure 2: Plan views of Crown Creek Bridge design including piling and east abutment as described within the *Permit Activity* section above.

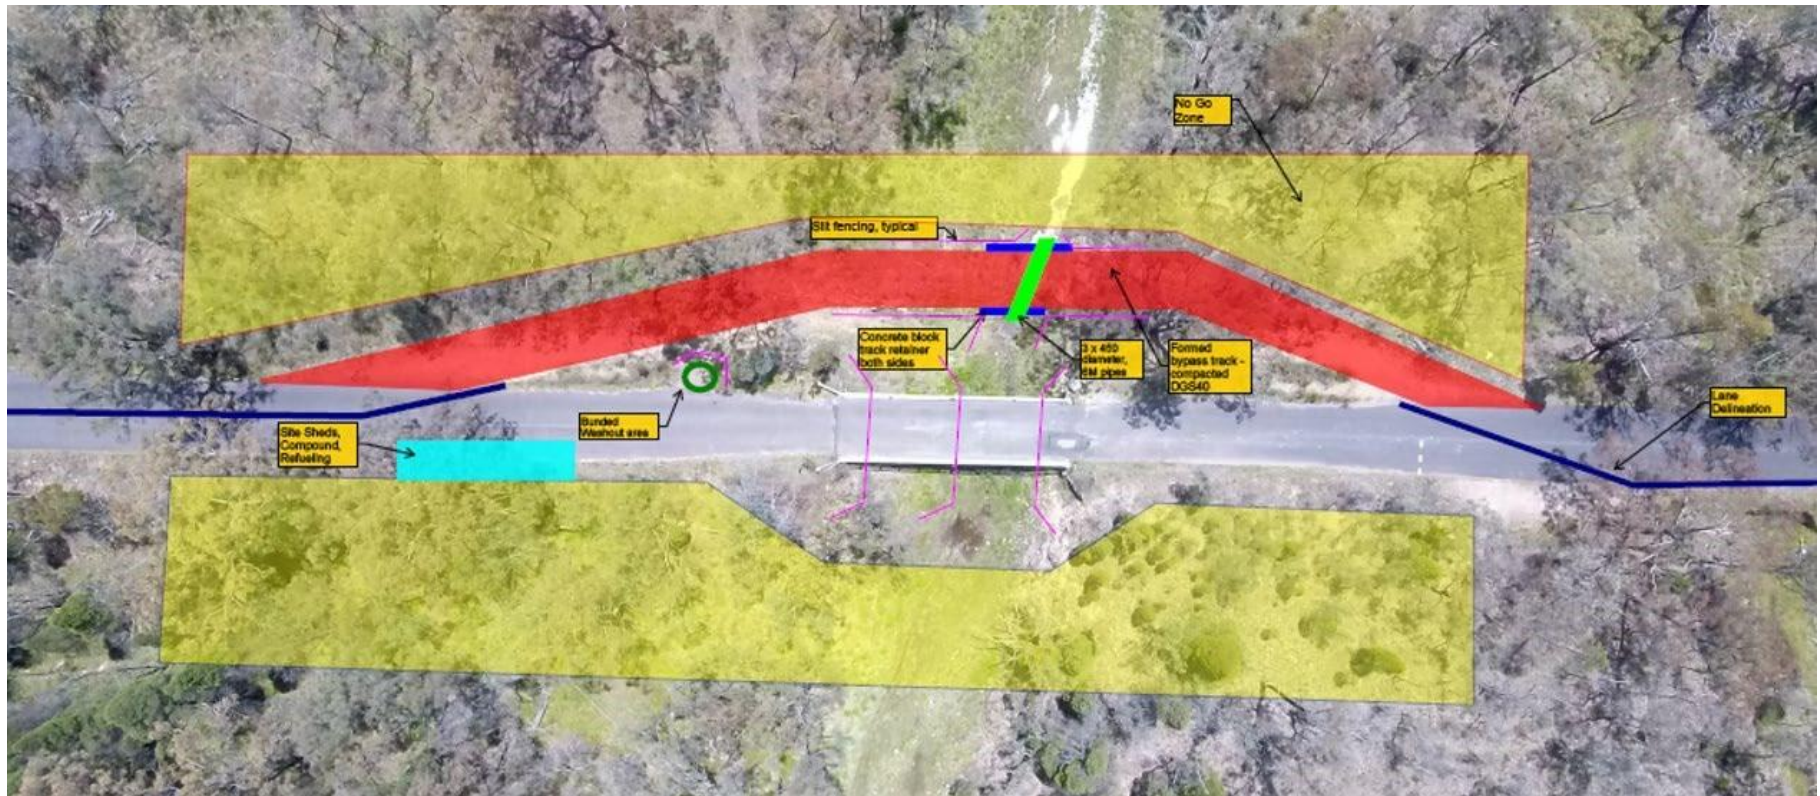
Figure 4: Site layout plan for Crown Creek Bridge works including minimum sediment and erosion control actions as described within the *Permit Activity* section above.

6. Erosion and sediment mitigation devices are to be erected in a manner consistent with the diagram shown in Attachment 4 of this permit and currently accepted Best Management Practice (i.e. Landcom [2004], *Managing Urban Stormwater: Soils and Construction* [4th Edition]) to prevent the entry of sediment into the waterway, or mobilisation of sediment within the waterway, prior to any earthworks being undertaken. These erosion and sediment devices are to be maintained in good working order for the whole duration of the bridge replacement works and subsequently until the worksite has been stabilised and the risk of erosion and sediment movement from the site is minimal.
