Bush Fire Assessment Report

19 Barton Avenue, Wallerawang

Proposed Subdivision

December 2022

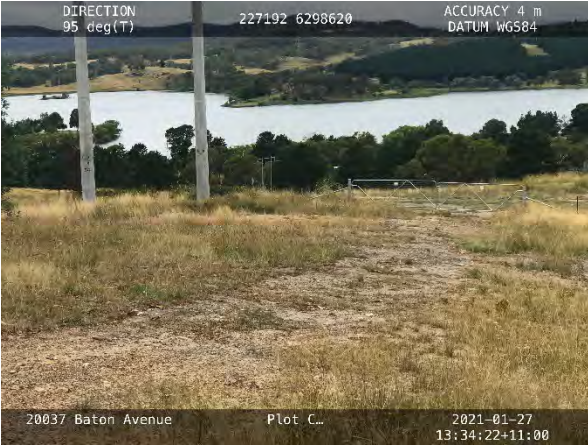
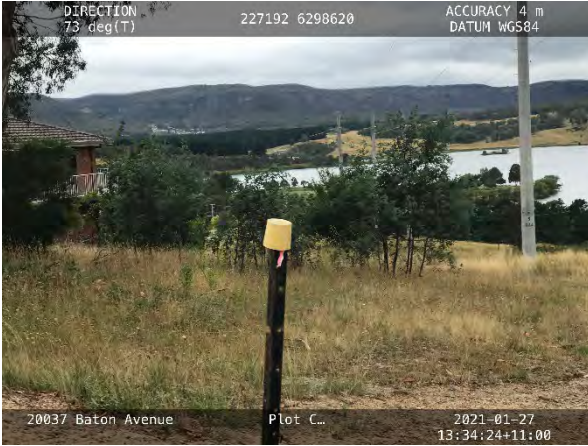
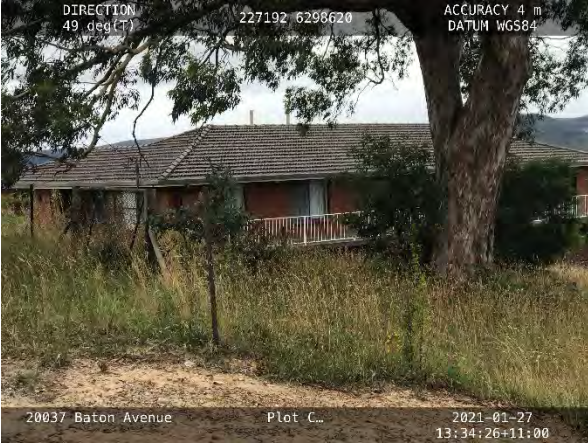
Plate 17: Plot 5	Plate 18: Plot 5

Plot 5	
Vegetation Description	Mainly grass under powerlines with some exotic bushes, small trees and one large gum. Under the powerlines is all grass and unvegetated but to the north there is small exotic trees and a large gum. The area doesn't appear to be managed, however given powerline easement, it is not expected that the vegetation would evolve into woodland or forest vegetation.
Existing Classification	Grassland
Post Development Classification	Grassland

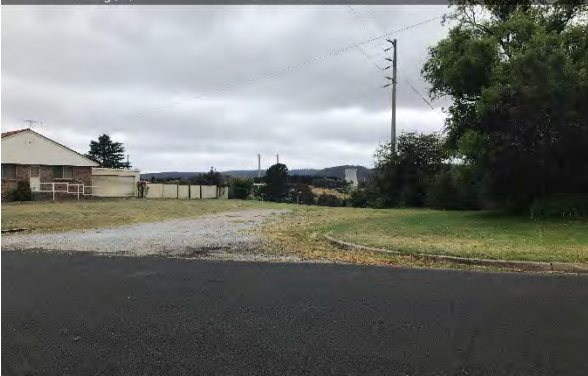
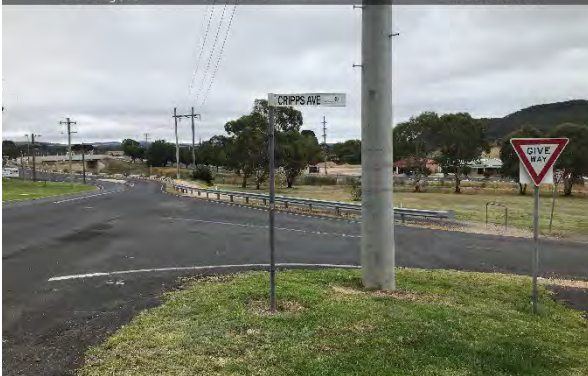
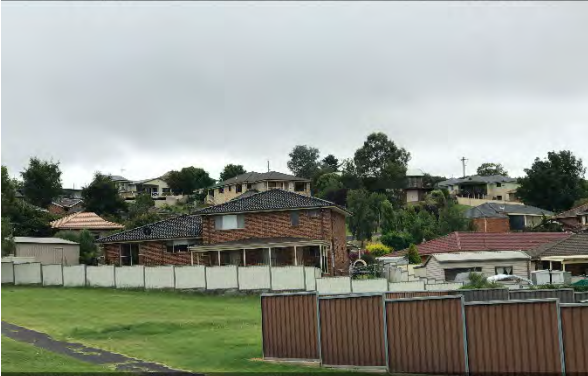
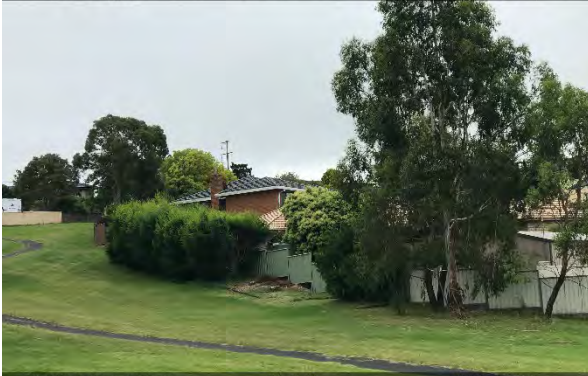
Plot 6	
Vegetation Description	Existing managed urban area with hard paved surfaces and managed vegetation
Existing Classification	Low Threat Vegetation - Exclusion A1.10
Post Development Classification	Low Threat Vegetation - Exclusion A1.10
<p>DIRECTION 60 deg(T) 227200 6299123 ACCURACY 6 m DATUM WGS84</p>

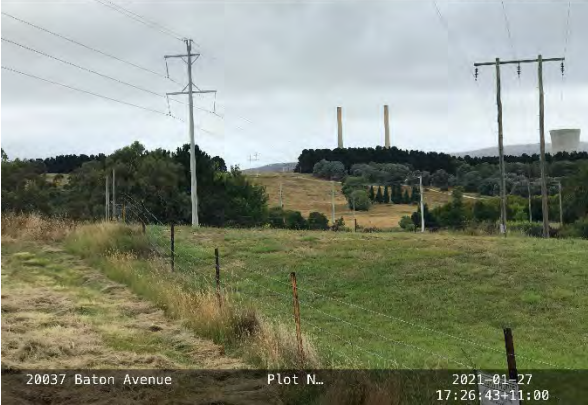
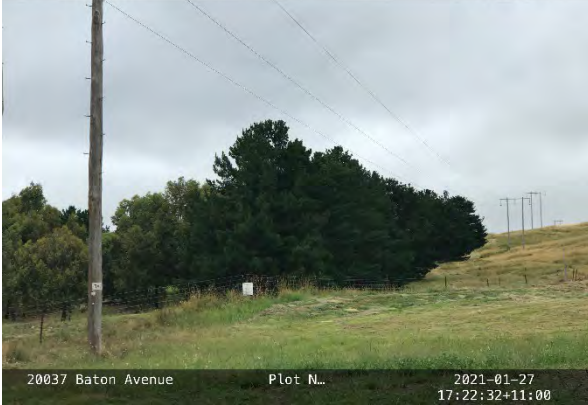
<p>20037 Baton Avenue Plot N... 2021-01-27 17:22:32+11:00</p>
Plate 30: Plot 7	Plate 31: Plot 7

Plot 7	
Vegetation Description	Unmanaged grassland under powerline easement
Existing Classification	Grassland
Post Development Classification	Grassland
<p>DIRECTION 48 deg(T) 227530 6298693 ACCURACY 8 m DATUM WGS84</p>

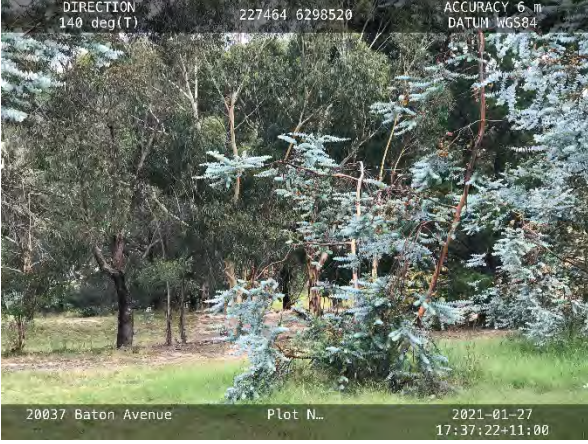
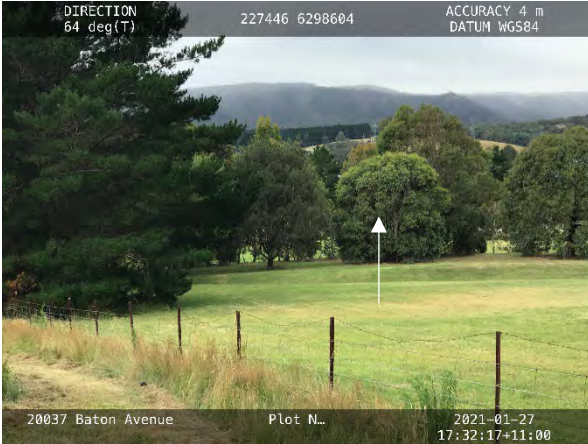
Plate 34: Plot 8	Plate 35: Plot 8

Plot 8	
Vegetation Description	Stand of planted tree varieties which directly contacts the unmanaged grassland to the south and provides a conduit for fire to reach the subject site. Consists mainly of small gum, exotic trees and pinus variatals with a semi managed grass understorey. Contains a large row of pines along the south eastern common boundary of the development site.
Existing Classification	Woodland
Post Development Classification	Woodland
semi

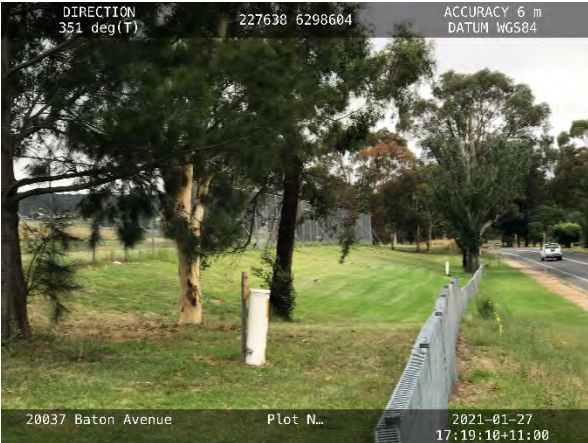
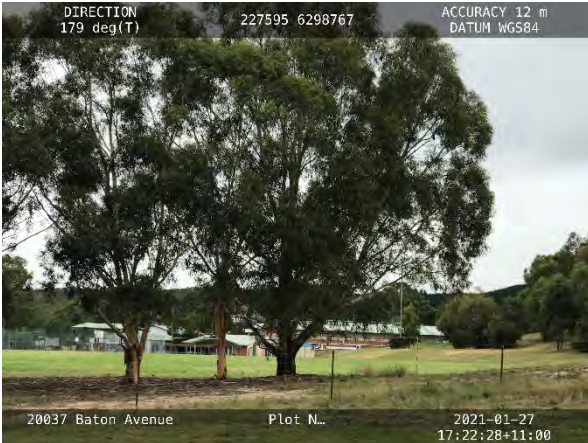
Plate 36: Plot 9	Plate 37: Plot 9

Plot 9	
Vegetation Description	Existing area of managed gardens and lawns within curtilage of buildings and non-vegetated road areas. Includes school football pitch and play areas all, lawn. Also contains non vegetated road area.
Existing Classification	Low Threat Vegetation - Exclusion A1.10
Post Development Classification	Low Threat Vegetation - Exclusion A1.10

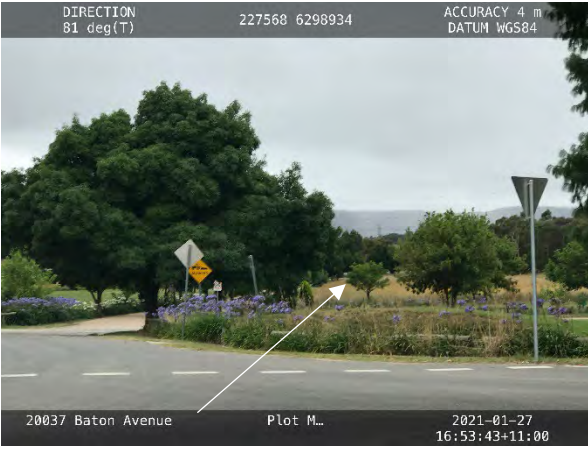
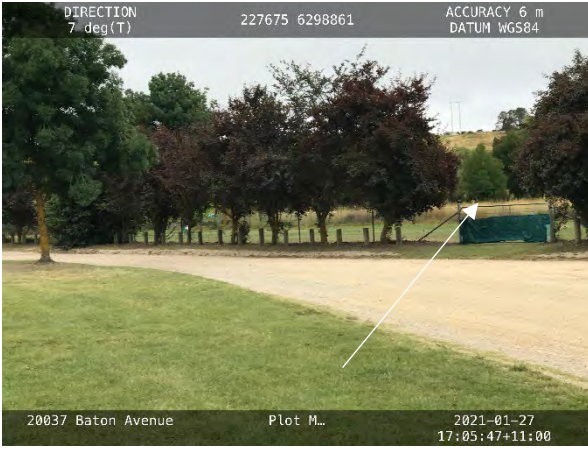
<p>20037 Baton Avenue Plot M... 2021-01-27 17:05:47+11:00</p>
Plate 48: Plot 11	Plate 49: Plot 11

Plot 11	
Vegetation Description	Unmanaged grassland
Existing Classification	Grassland
Post Development Classification	Grassland
<p>DIRECTION 81 deg(T) 227568 6298934 ACCURACY 4 m DATUM WGS84</p>

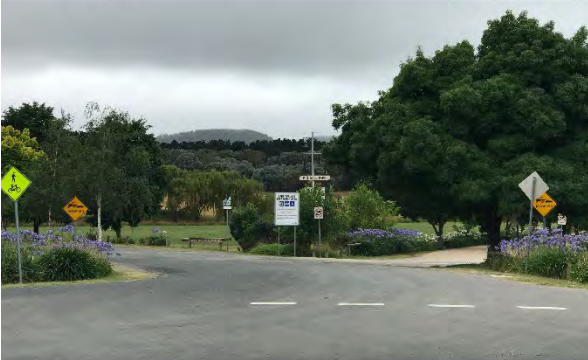
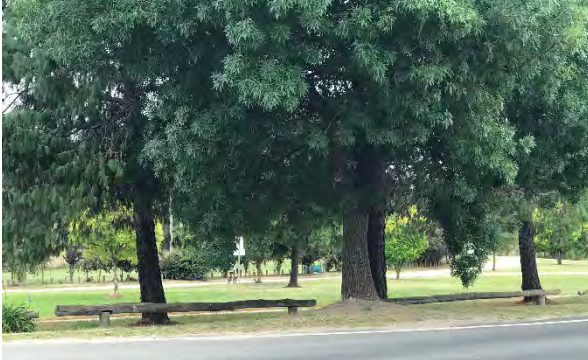
<p>20037 Baton Avenue Plot M... 2021-01-27 16:53:45+11:00</p>
Plate 56: Plot 12	Plate 57: Plot 12

Plot 12	
Vegetation Description	Reserve/parkland area maintained in a low fuel load state. Typically mown grass understorey with a scattered trees both exotic and natives (predominantly eucalypt).
Existing Classification	Low Threat Vegetation - Exclusion A1.10
Post Development Classification	Low Threat Vegetation - Exclusion A1.10
<p>DIRECTION 65 deg(T) 227568 6298934 ACCURACY 4 m DATUM WGS84</p>

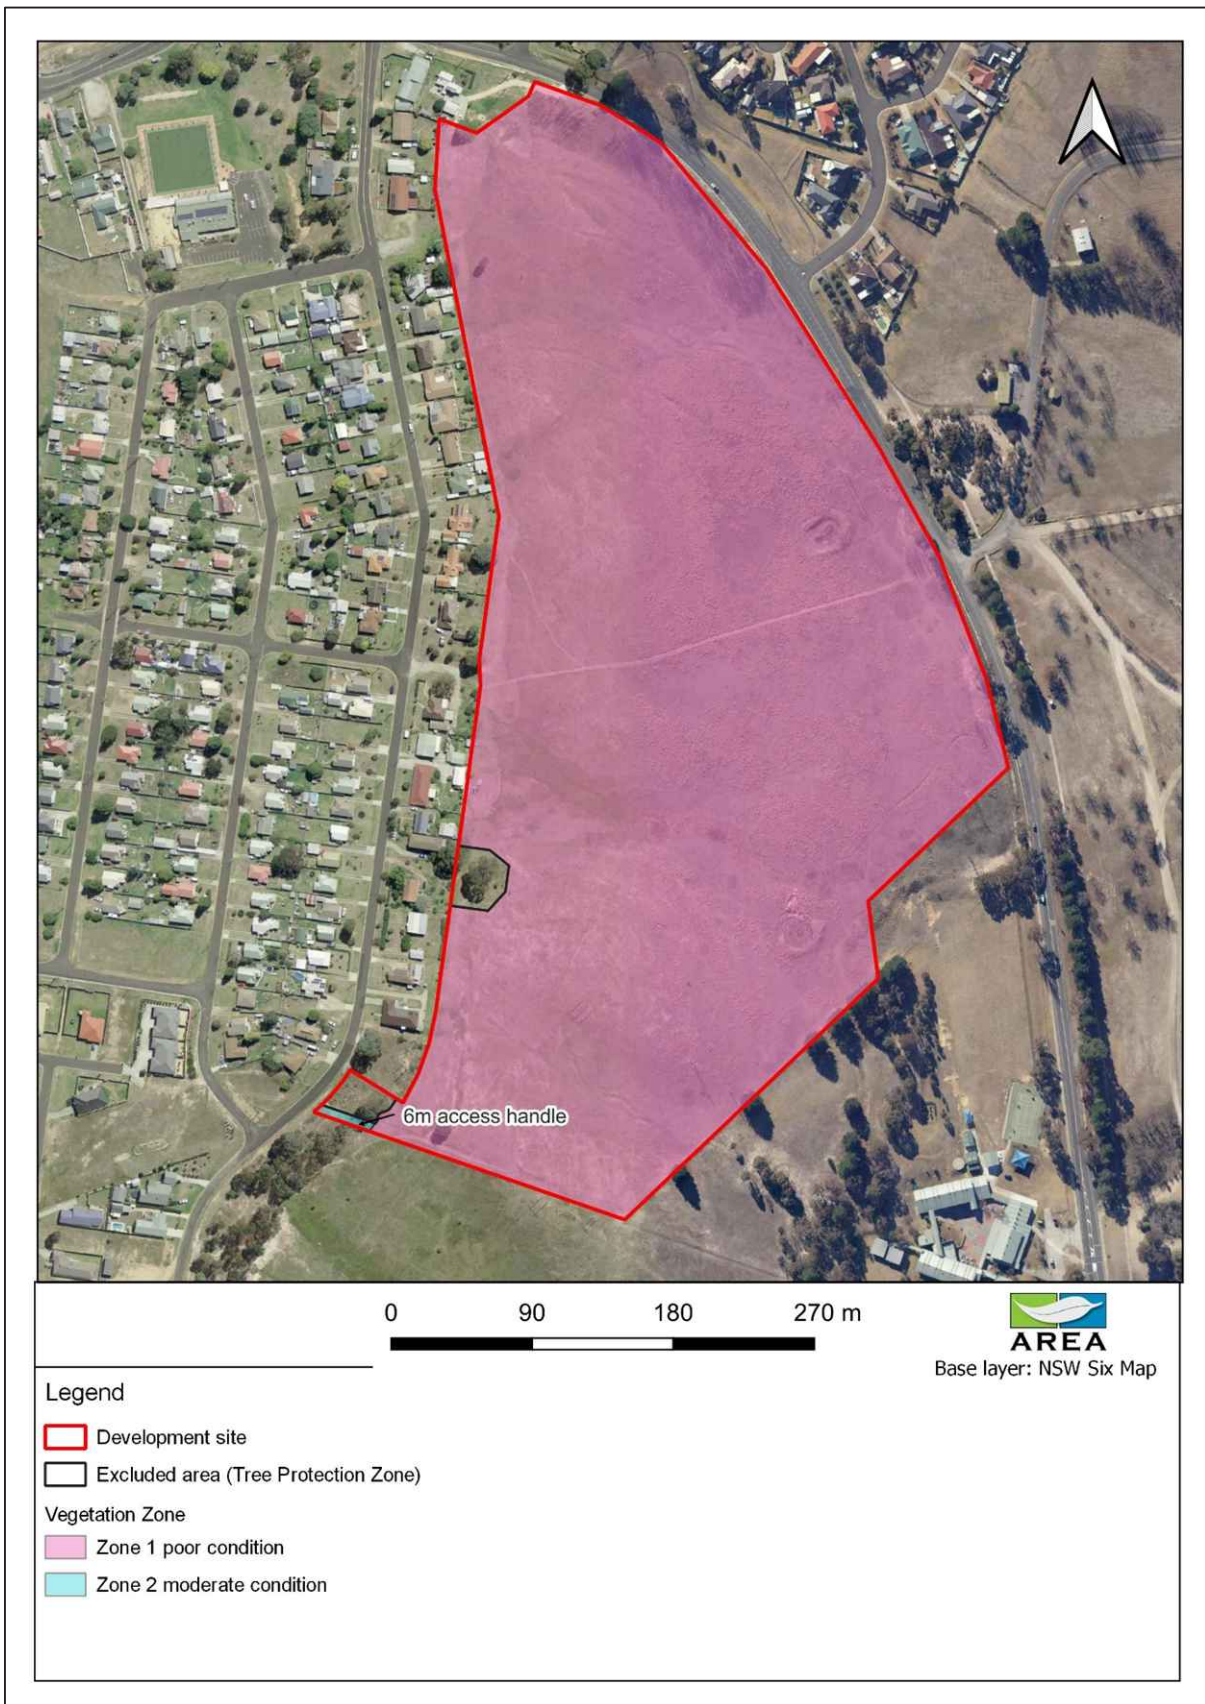
Figure E1

Of the native vegetation that would be impacted, 17.20 hectares is of poor condition (Zone 1) and 0.02 hectares is of moderate condition (Zone 2) (Figure E1). An offsetting requirement is triggered for impacts to Zone 2 vegetation. A summary of offset requirements is provided in Tables E2 and E3.

The proponent would avoid impact to the Black Gum by establishing a temporarily fenced tree protection zone excluding it from the development footprint thereby prohibiting tree clearing or inadvertent impact. Impacts to moderate condition PCT351 vegetation would be minimised by limiting the impact area to a 6-metre access handle and installing temporary fencing to prevent impact during construction (Figure E1). Impacts to the moderate condition PCT351 vegetation would trigger one ecosystem credit.

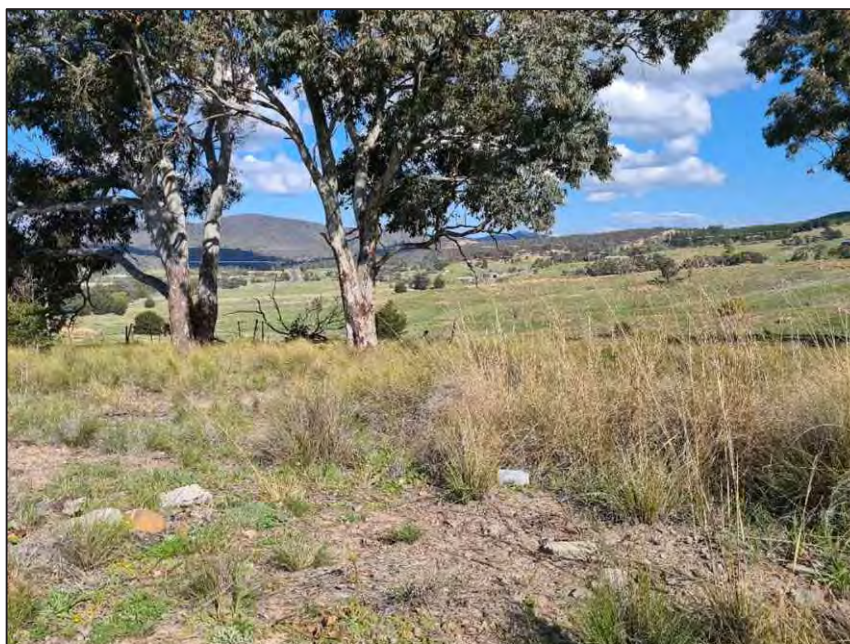
Photo 1 PCT351 – Moderate condition

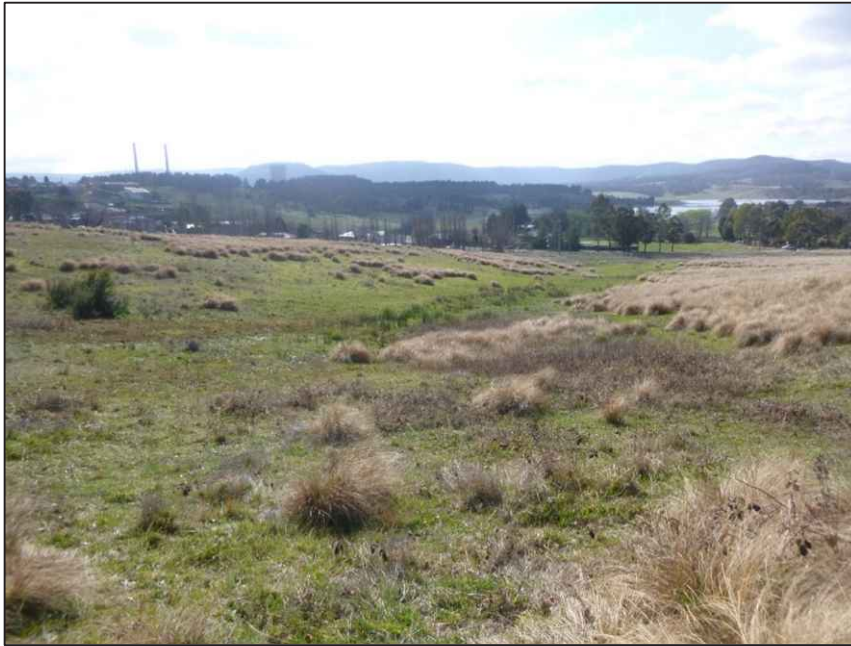
Photo 2 PCT351 – Poor condition

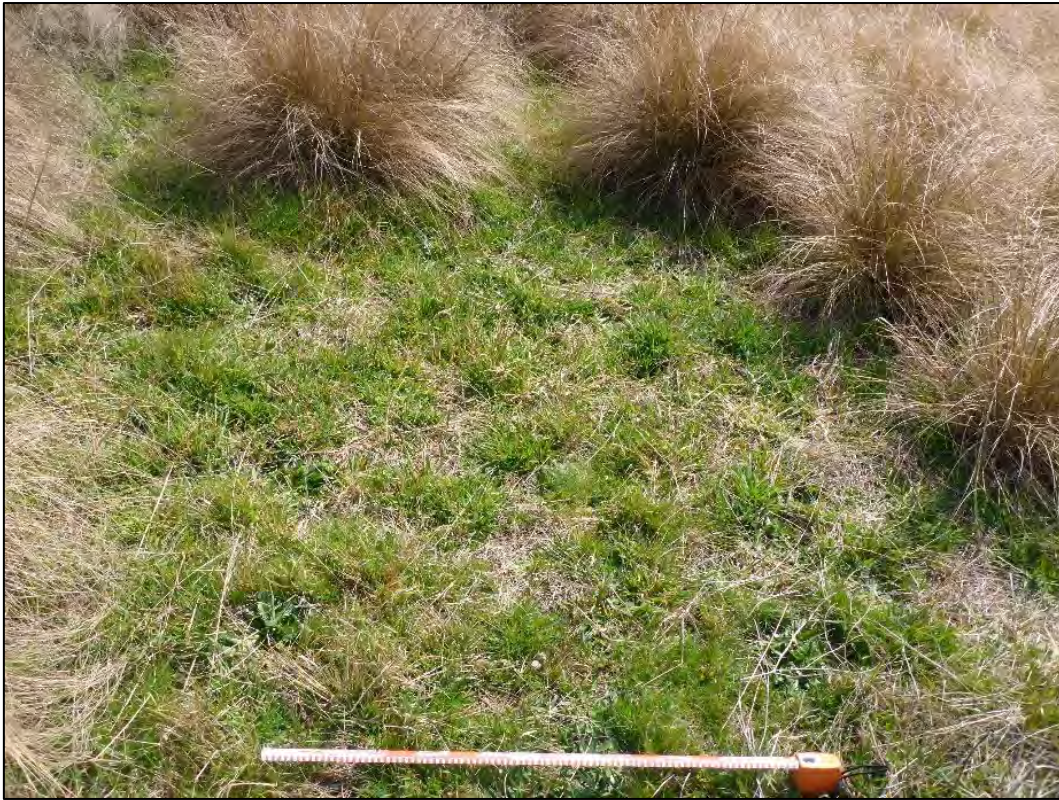
Figure 3-1: Example of low GSV in the study area

The landscape within the study area consisted of moderate to steep slopes with crests appearing along the western edge of the study area (Figure 3-1: Example of low GSV in the study area)

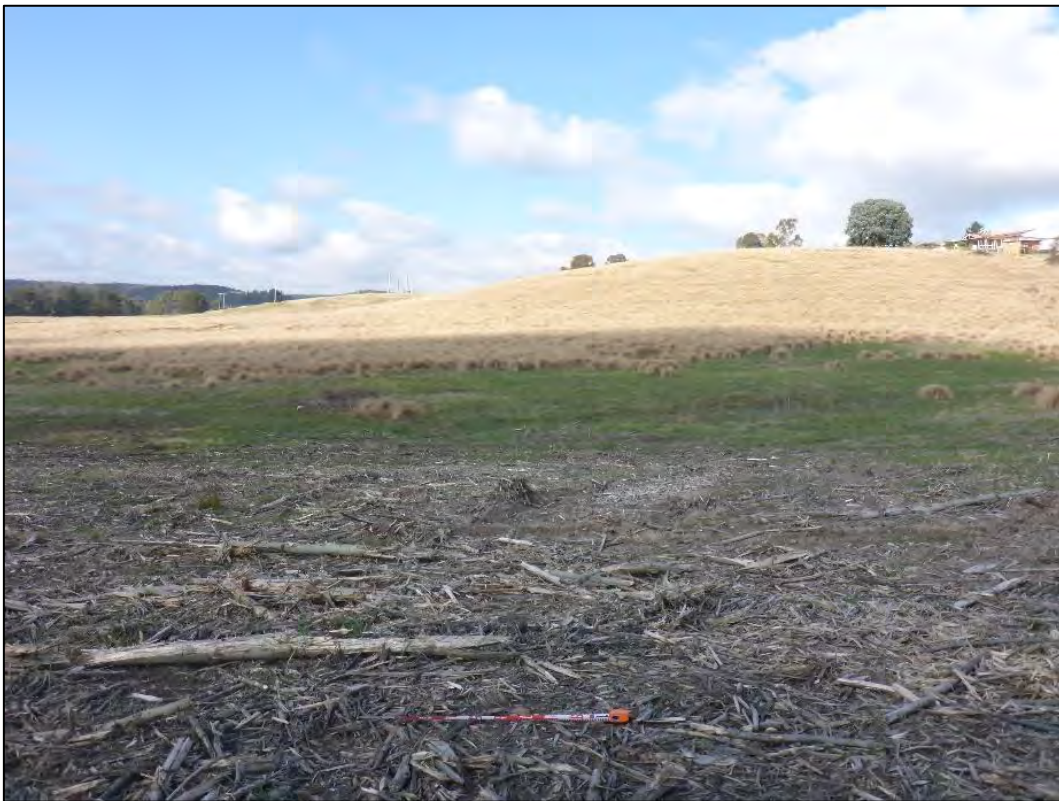
Figure 3-2: View south west across the study area from the northern boundary

Figure 3-2 and Figure 3-3). The area adjacent to the western boundary of the study area has been built up for residential development. The south west corner of the study area almost protrudes to Lyon Parade (Figure 3-4).

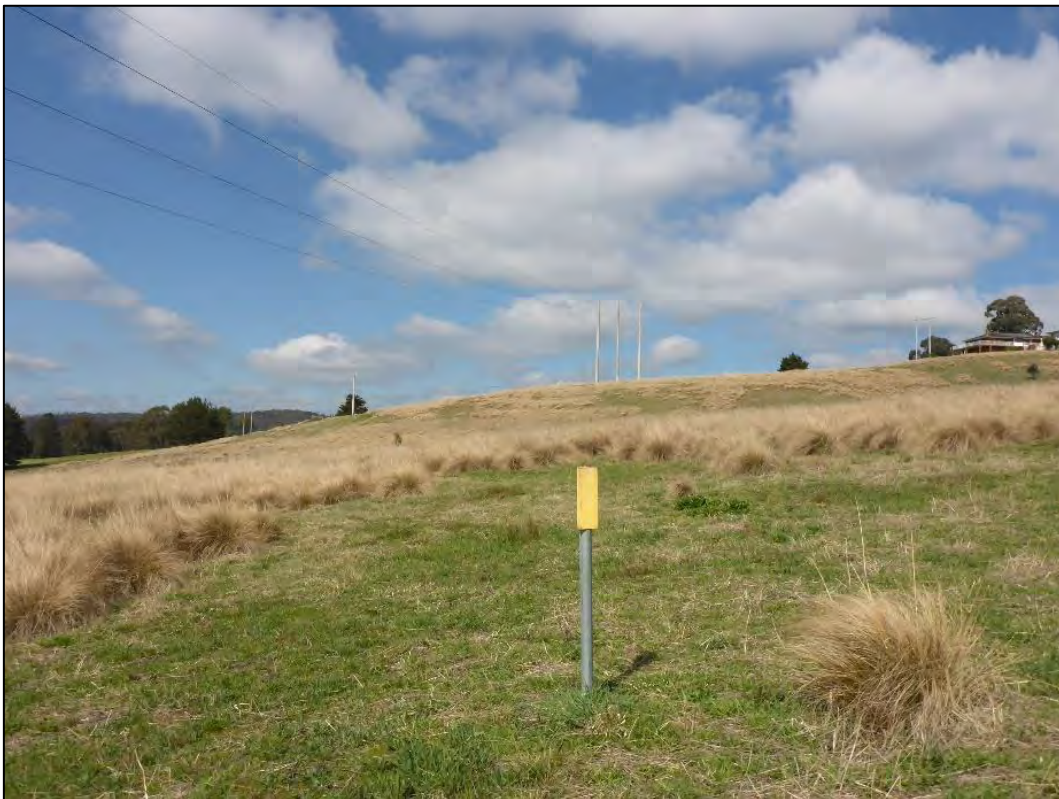
Figure 3-5: View south across the study area showing the powerlines and underground cable

The study area contained moderate to high amounts of disturbance as evidenced by the large-scale clearing of the open woodland, powerlines and underground cable.

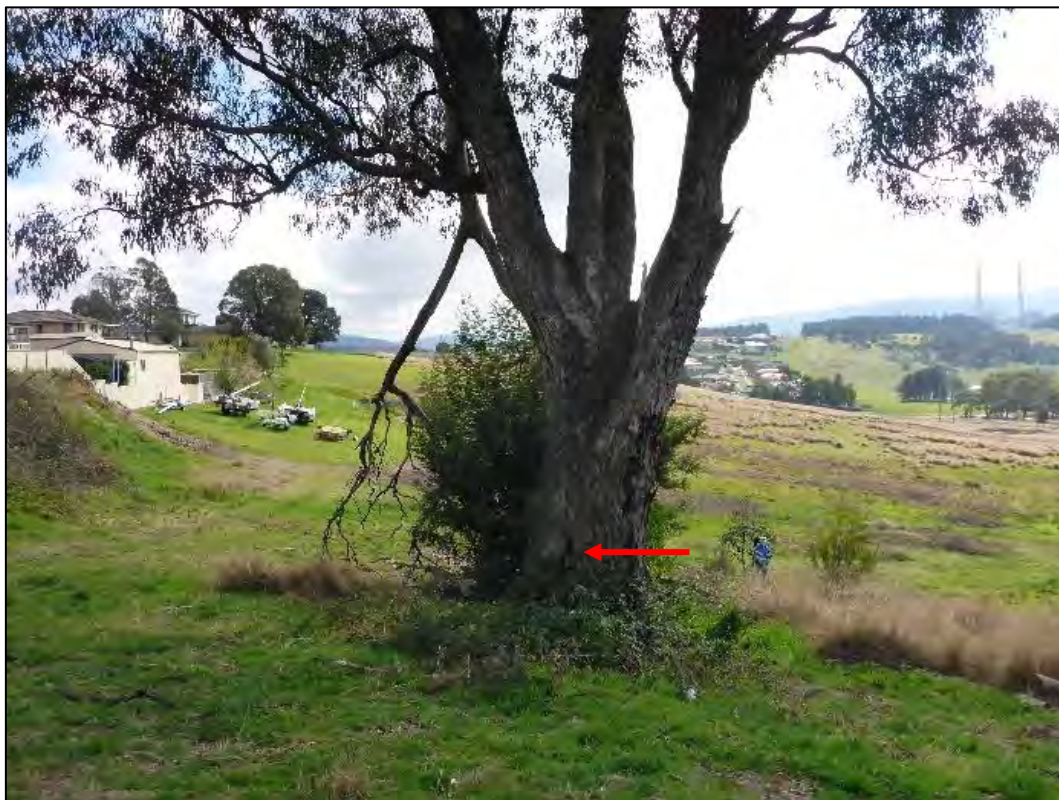
Figure 3-7: View north towards the Black Gum, arrow indicates scar

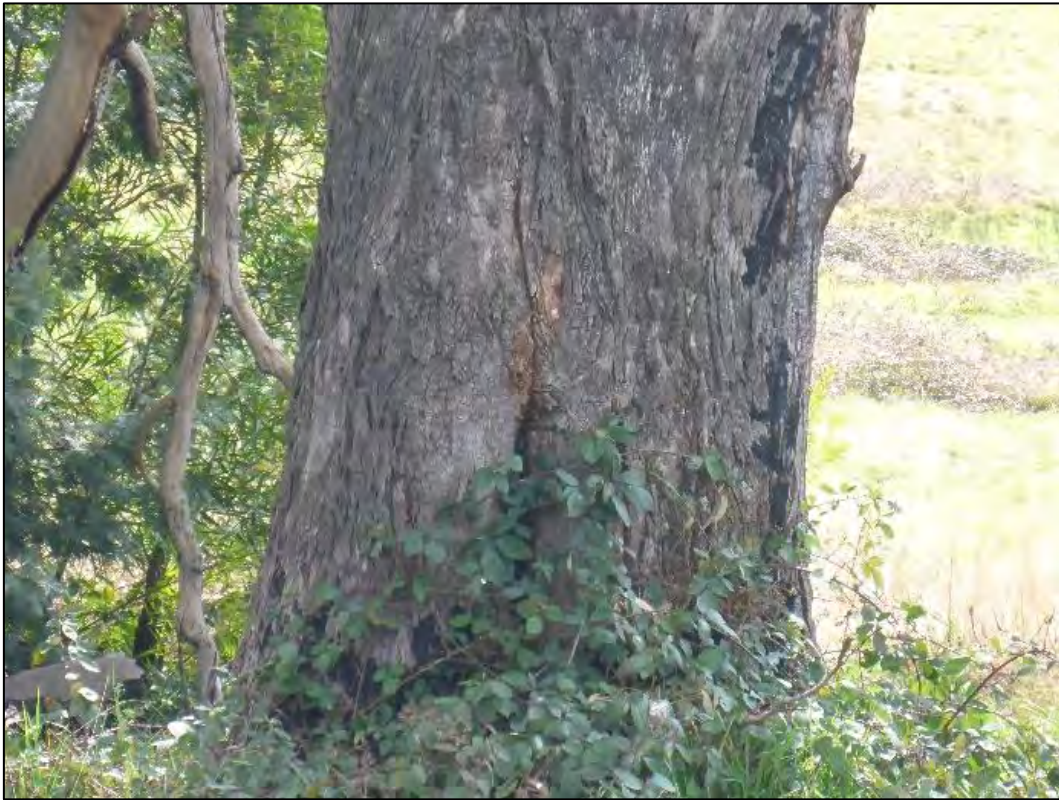
Figure 3-8: Close up of the scar, facing north

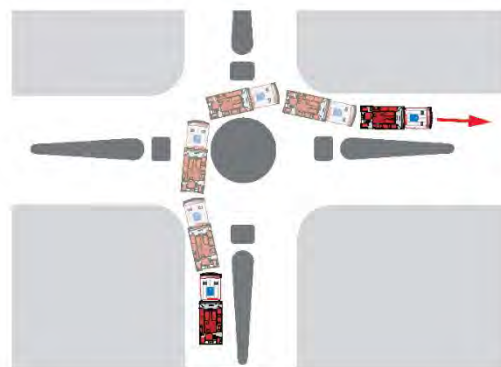
Figure A3.2b

Roundabout swept path.

Example of a swept path as applied to a roundabout. The distance between inner and outer turning arcs allows for expected vehicle body swing of front and rear overhanging sections (the swept path).

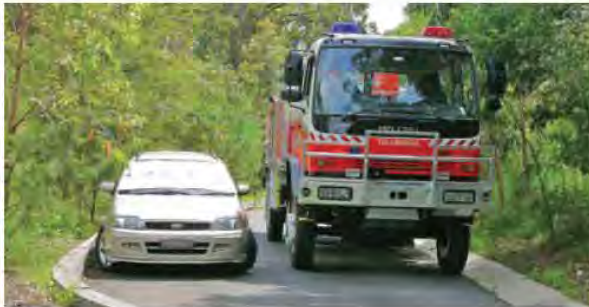
Figure A3.4

Passing bays can provide advantages when designed correctly. Poor design can and does severely impede access.

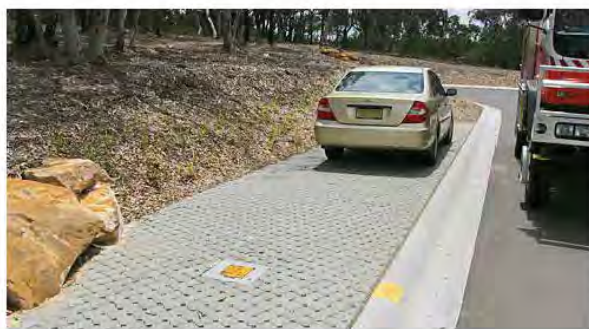
Figure A3.5

Parking can create a pinch point in required access. The location of parking should be carefully considered to ensure fire appliance access is unimpeded. Hydrants shall be located outside of access ways and any parking areas to ensure that access is available at all times.

Hydrants and parking bays.

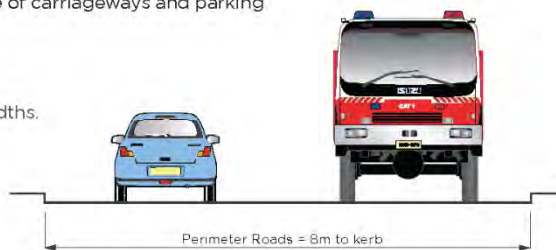
Figure A3.9a

Perimeter road widths.
