Lake Lyell Geotechnical and Hydrogeological Drilling Program

Aboriginal heritage due diligence assessment

Prepared for EnergyAustralia
February 2023

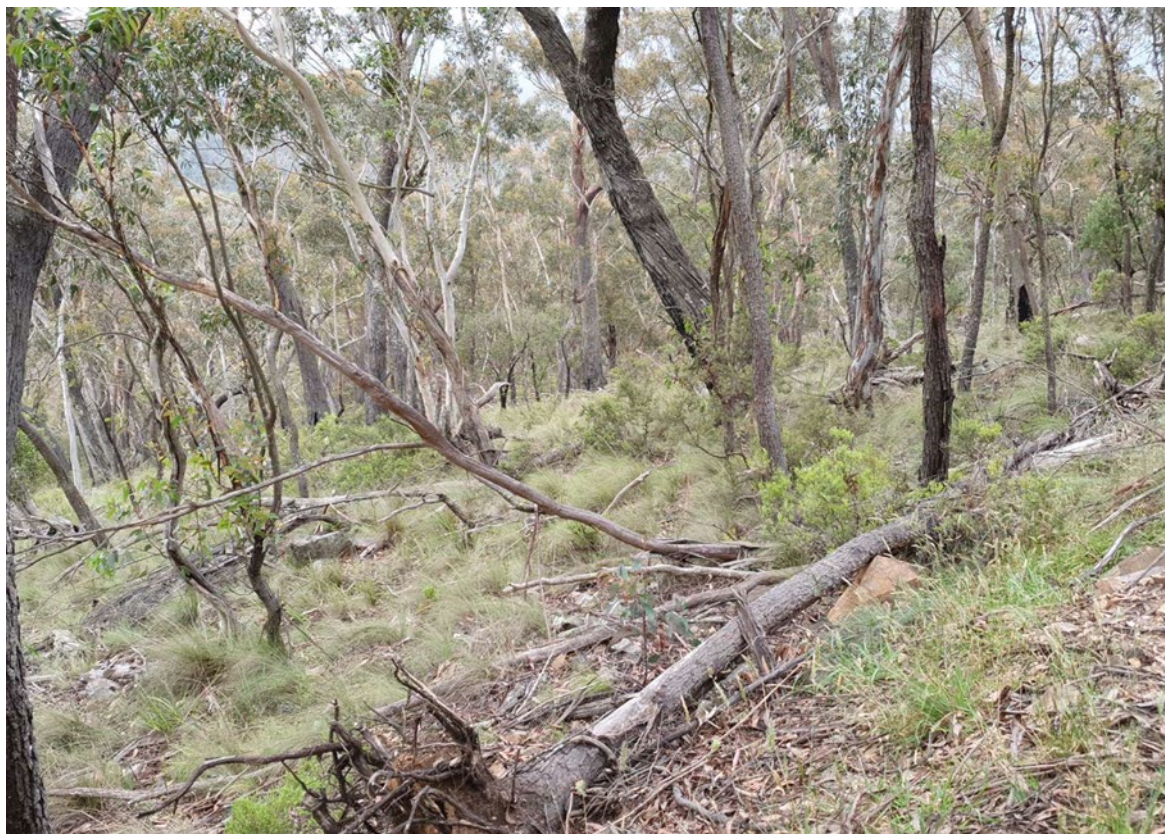
Plate 4.1 View north-west showing vegetation and ridgeline (running left to right) in the study area

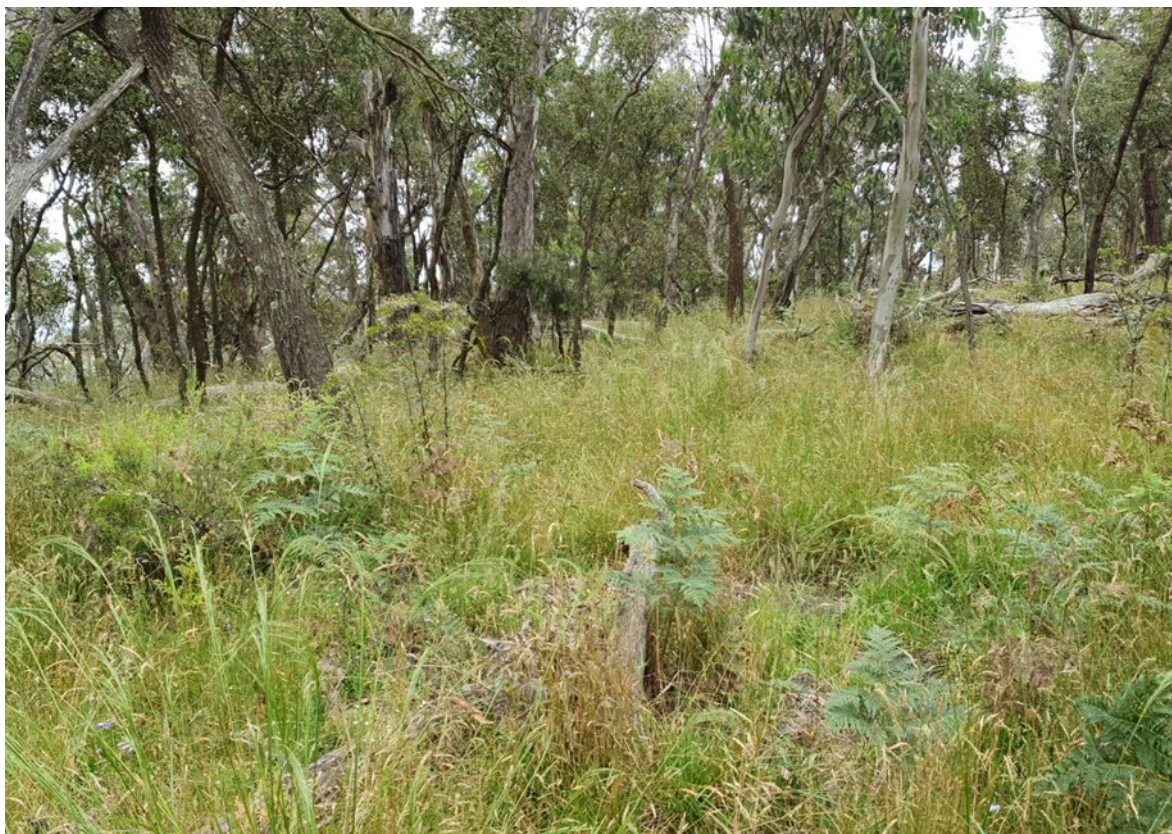
Plate 4.2 View south along ridgeline showing poor visibility caused by vegetation cover in the study area.

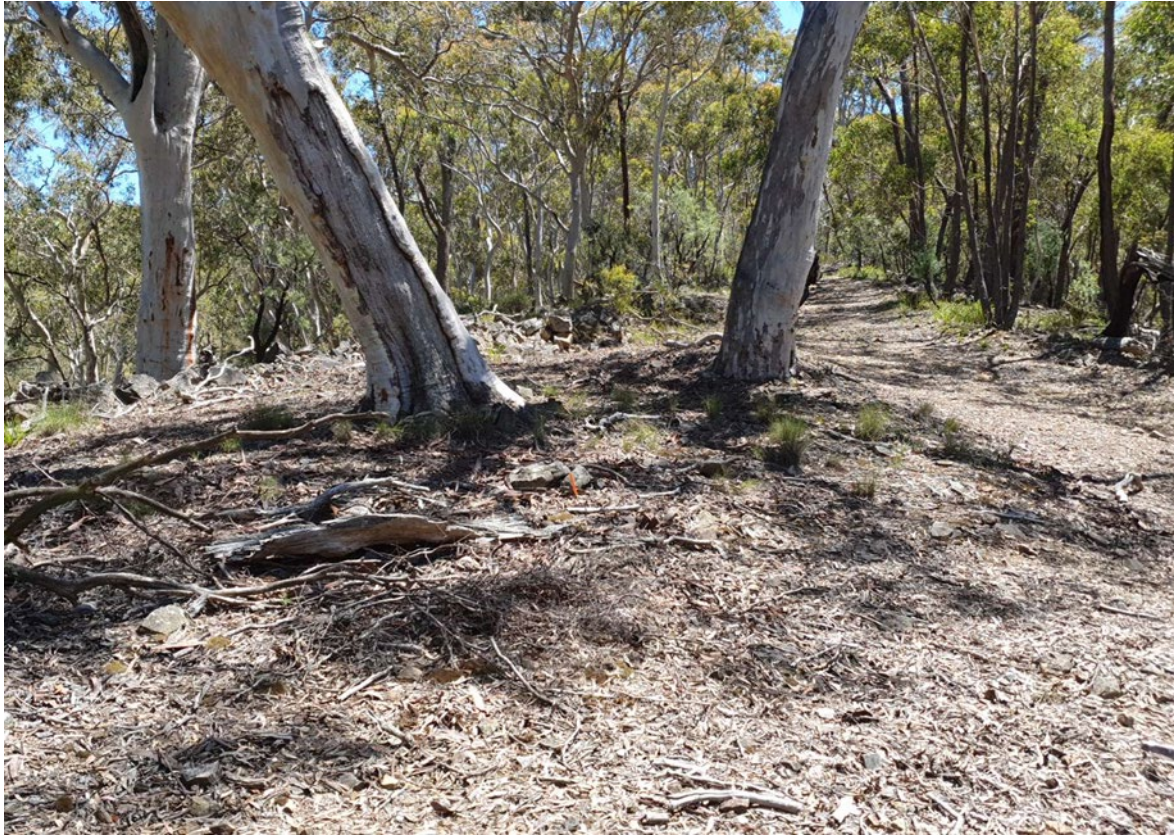
Plate 4.3 View north showing location of BH106 on eroded access track. Tree to left contains a non-cultural scar (ie scarred by insect and/or vehicle damage).

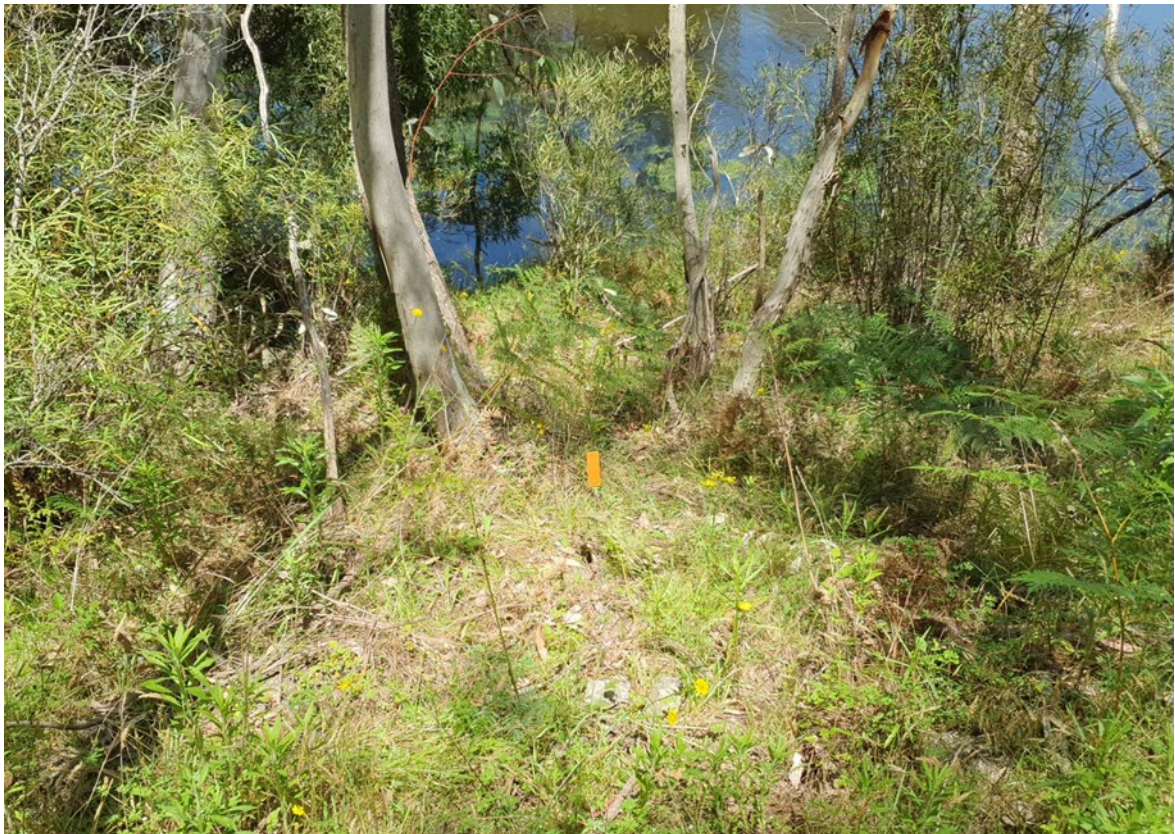
Plate 4.4 View west showing location of BH108 on northern bank of Farmers Creek/Lake Lyell

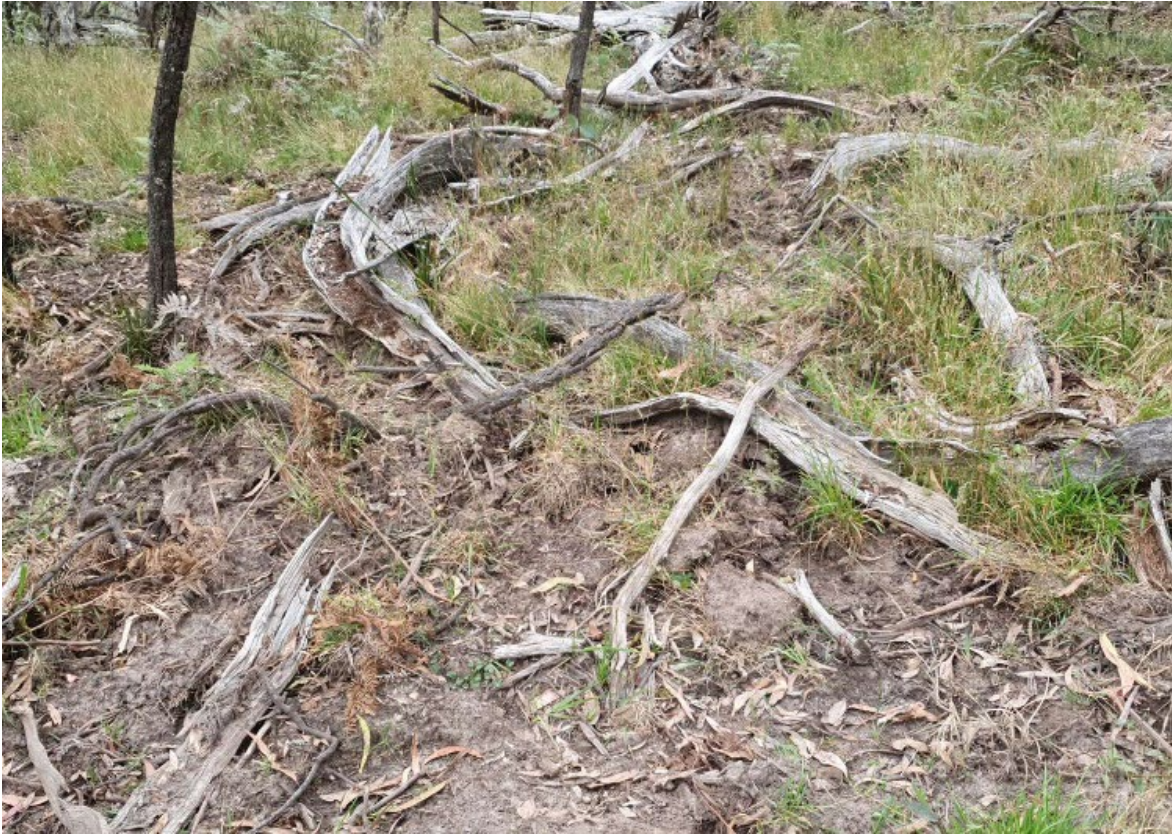
Plate 4.5 Pig disturbance encountered in the study area. This exposure showed some remnant topsoil

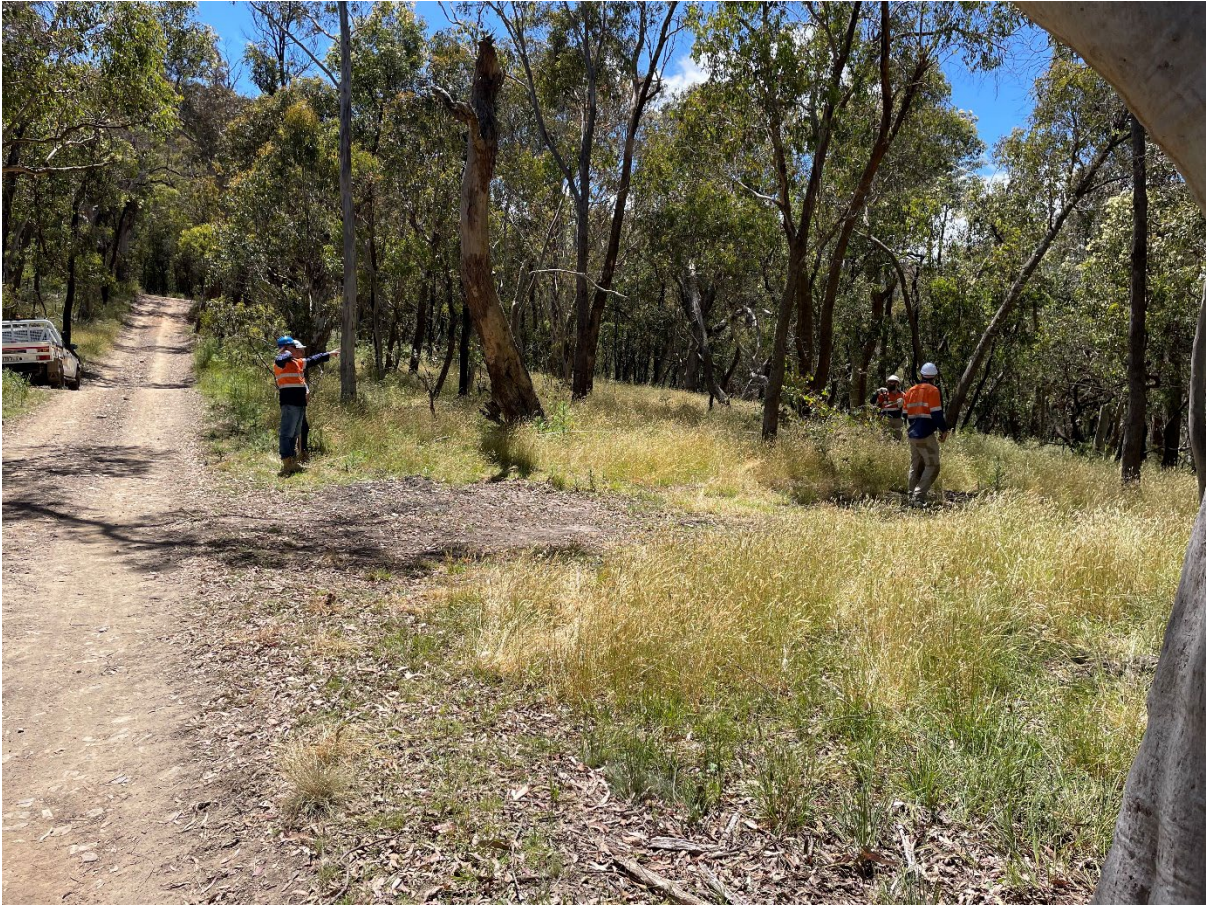
Plate 4.6 Proposed drill pad location MB2204 located immediately adjacent to the existing access track. The undisturbed vegetation cover is characterised by eucalypts, blackwattle trees and grasses.

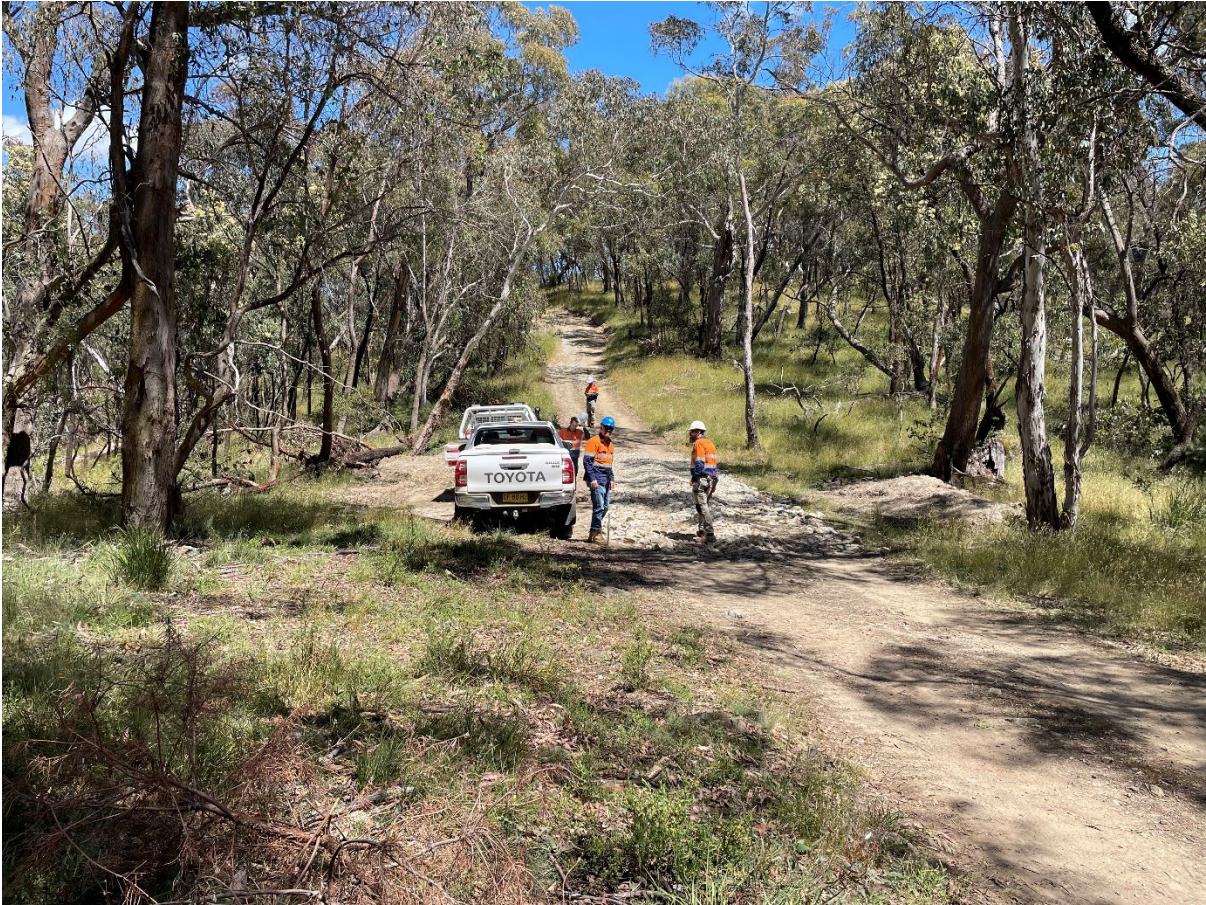
Plate 4.7 Proposed drill pad location MB2205 located immediately adjacent to and located across the existing access track

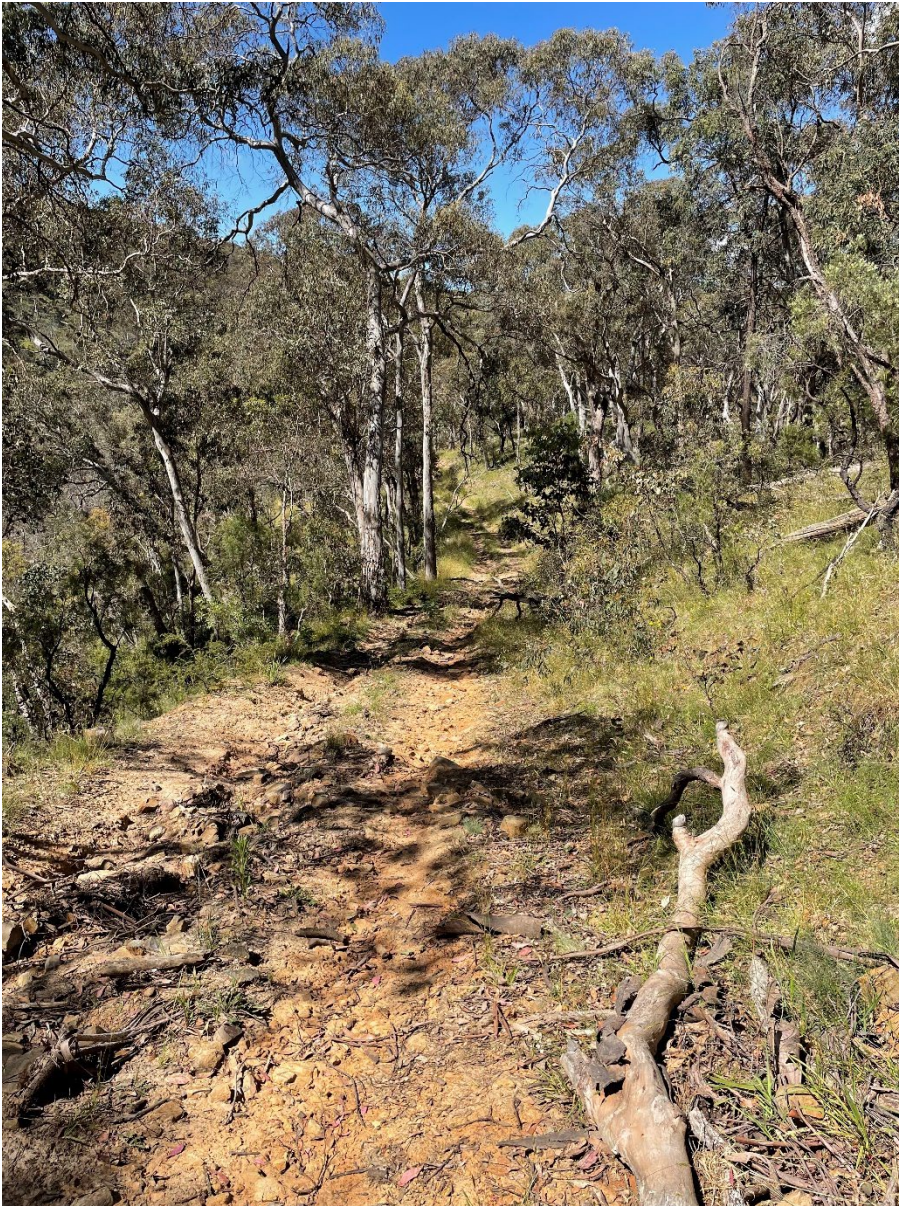
Plate 4.8 Proposed drill pad location MB2206 located across the existing access track. Soil deposits are extensively rutted by slope wash
