Wolgan Road, NSW

Review of Wolgan Gap Slope Risk Assessments

Lithgow City Council

05 March 2025

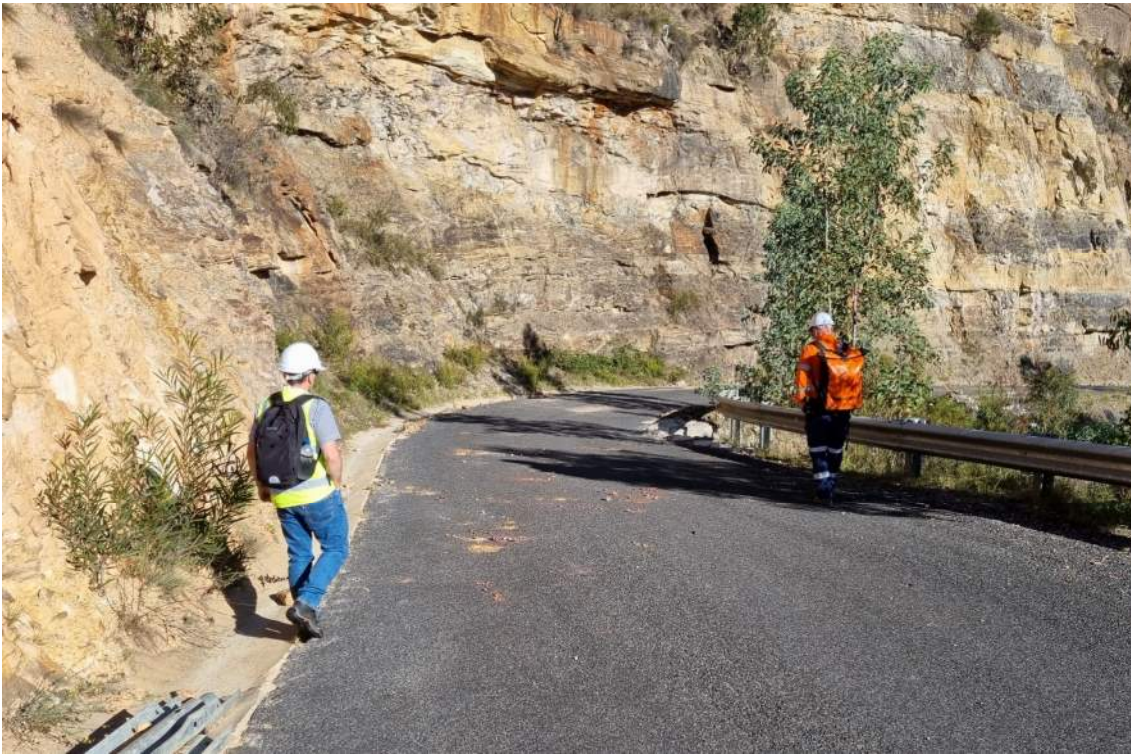
- The largest rockfalls observed on the road comprised gravel sized fragments of rock (up to about 40 mm diameter) below the section of road that traverses near-vertical cliffs at the top of the pass (Figure 1). No other rockfalls were observed on the road for the remainder of the approximately 2.7 km section of road. We are not aware whether the road is regularly being cleared of rockfall debris.

Figure 1 *Example of small gravel sized rockfalls observed on road, February 2025.*

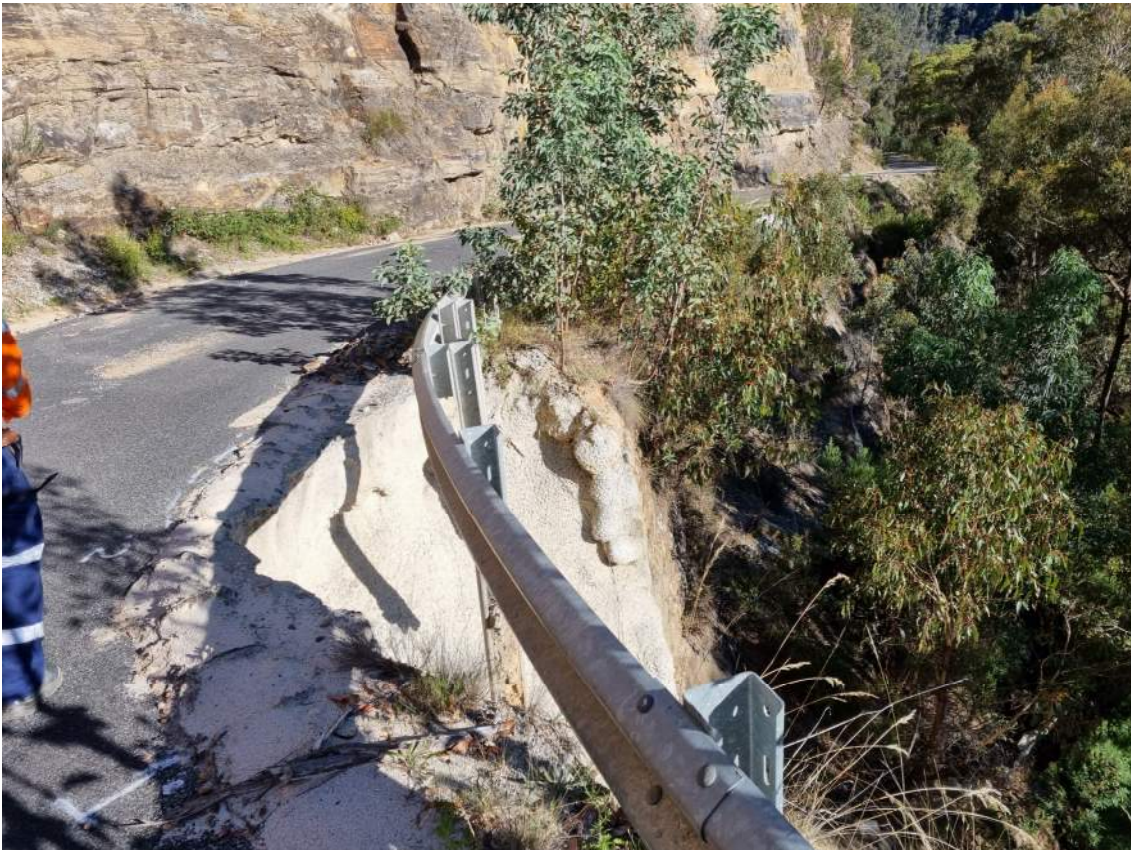
- A small downslope failure of a 'drystone' retaining wall near the top of the pass appears to have been temporarily treated with shotcrete (Figure 2).

Figure 2 *Localised failure of drystone wall.*

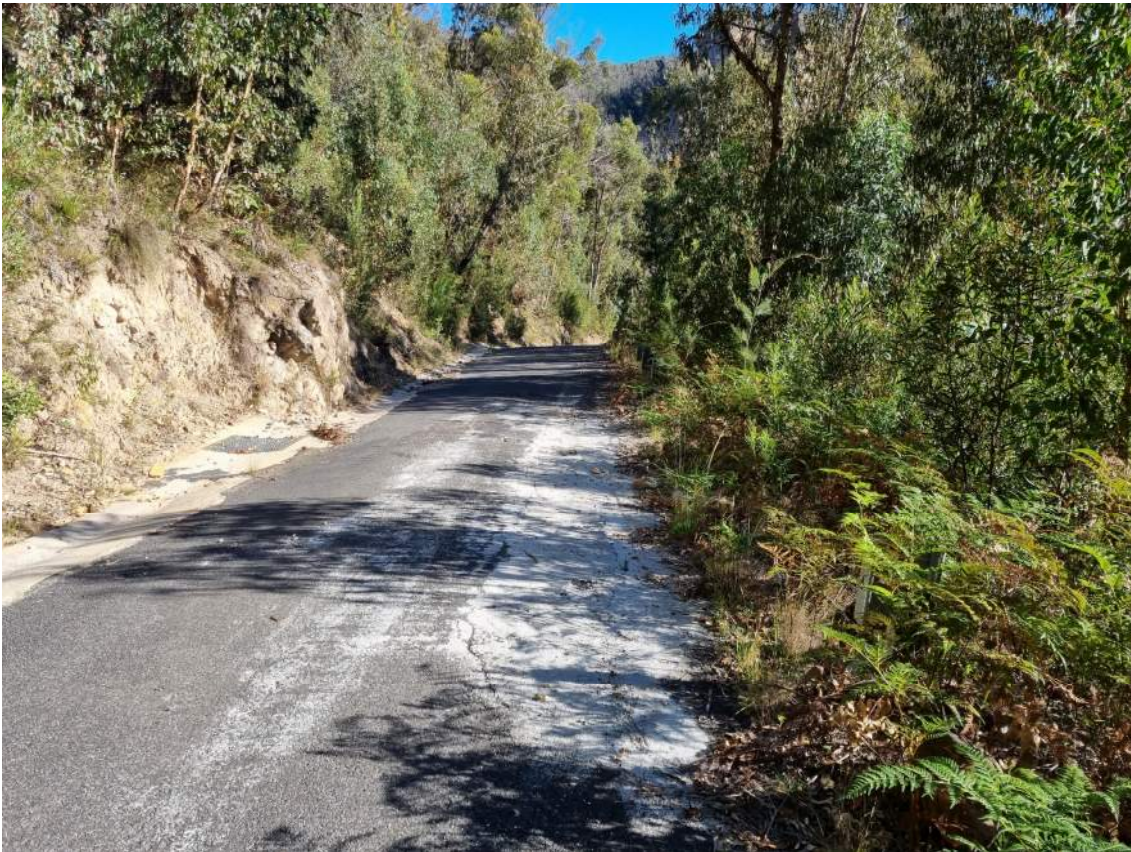
- The upper sections of the road (i.e. first few hundred metres) appear to be constructed with relatively little side-cast embankment fill. Rock shelves are visible on the downslope side at several locations below the road. Localised tension cracking of the pavement was observed in the downslope lane at some locations across this length of road, suggestive of instability of the fill embankments (Figure 3). No prominent tension cracks suggestive of large-scale landsliding were observed in the pavement.

Figure 3 *Localised tension cracking in downslope lane.*

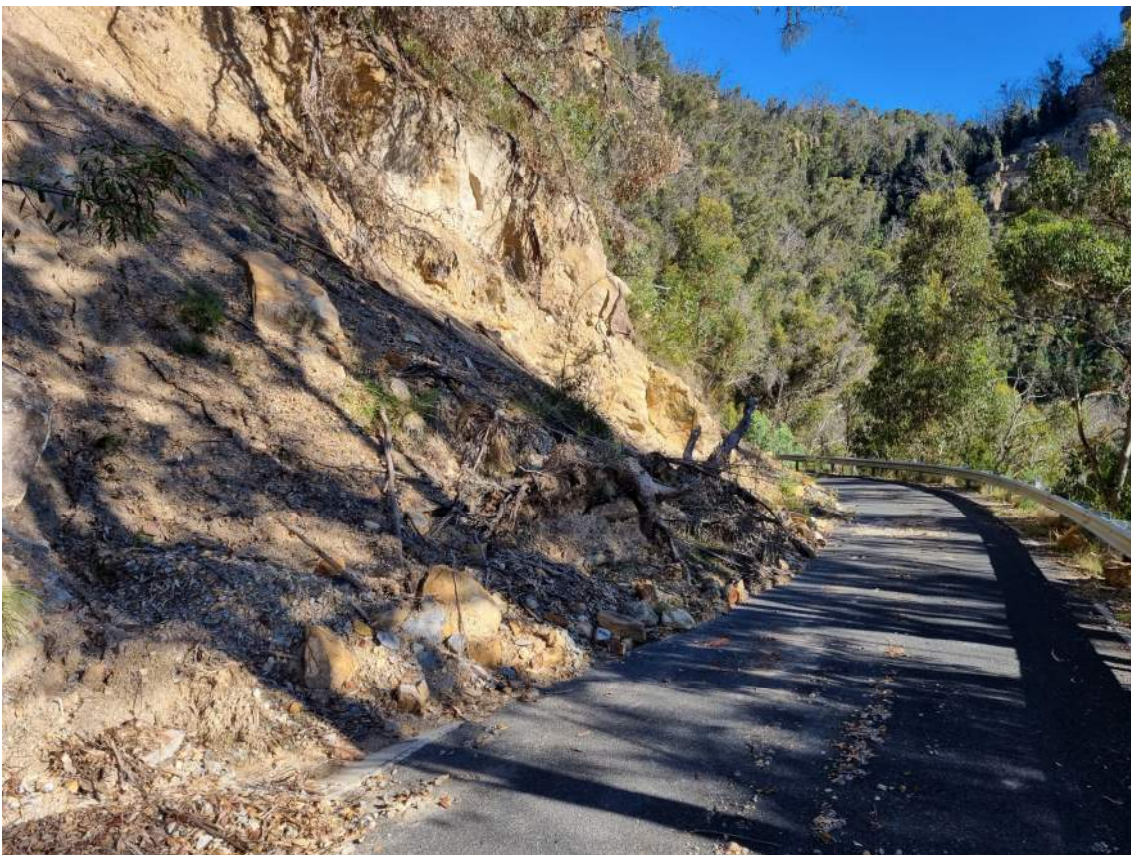
- Several small slides of the upslope batters occur along the first few hundred metres of the road (Figure 4). The debris appears to have been mostly cleared from the road however it is not known when this occurred. The slides are predominantly in colluvial soils, talus and weathered rock. The slides are all relatively shallow failures and have often exposed weathered rock, suggesting the colluvial soil thickness is quite shallow (i.e. a few metres).

Figure 4 *Upslope batter failure in colluvium, talus and weathered rock.*

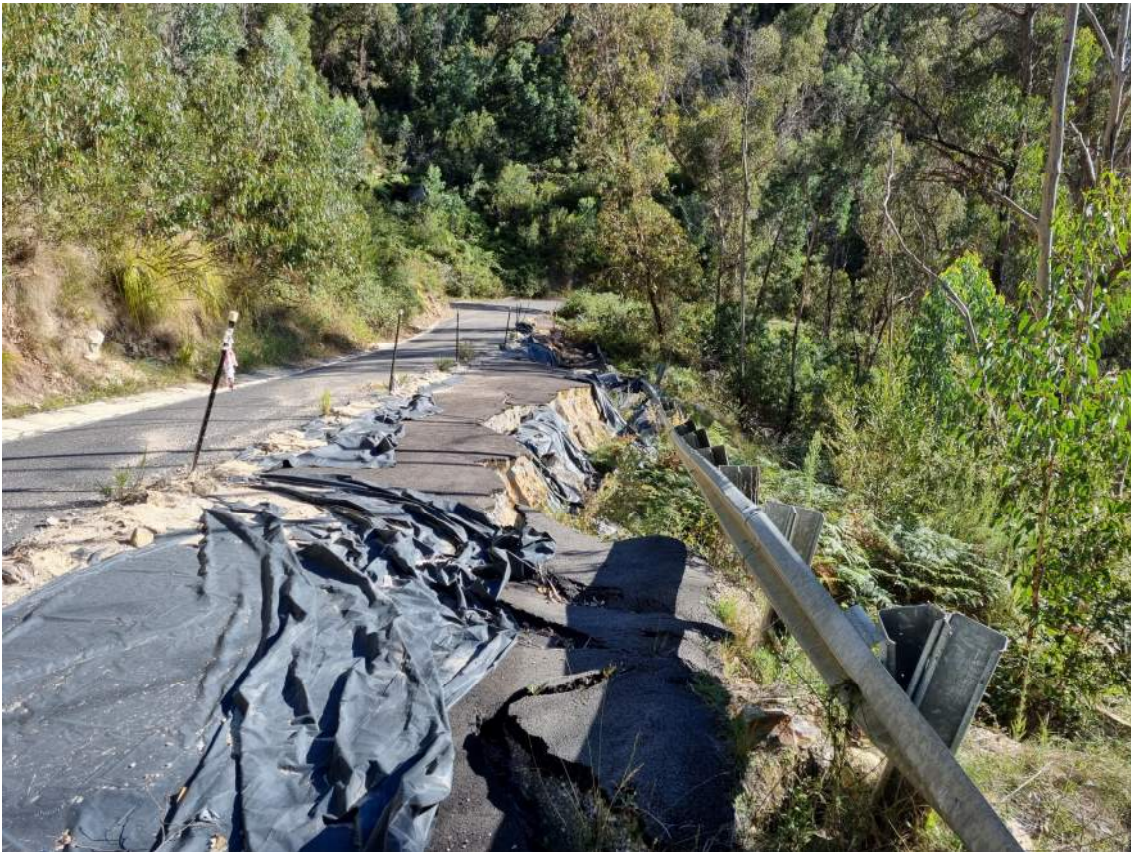
- Approximately 650 m from the lookout there is a series of coalescing downslope embankment failures which extend along an approximately 100 m length of road (Figure 5). The failures appear to have involved retrogressive slumping of the outer side-cast embankment fill. It appears that this could have been due to scouring exacerbated by poor road drainage. It is important to note that the failures have only affected the downslope lane, with the upslope lane still trafficable. The failures appear to be shallow and have only occurred in fill materials, with the upslope lane likely constructed at or near grade. The upslope pavement was not observed to contain obvious tension cracks.

Figure 5 *Embankment failure comprising slumping of fill materials below downslope lane. Upslope lane remains trafficable.*

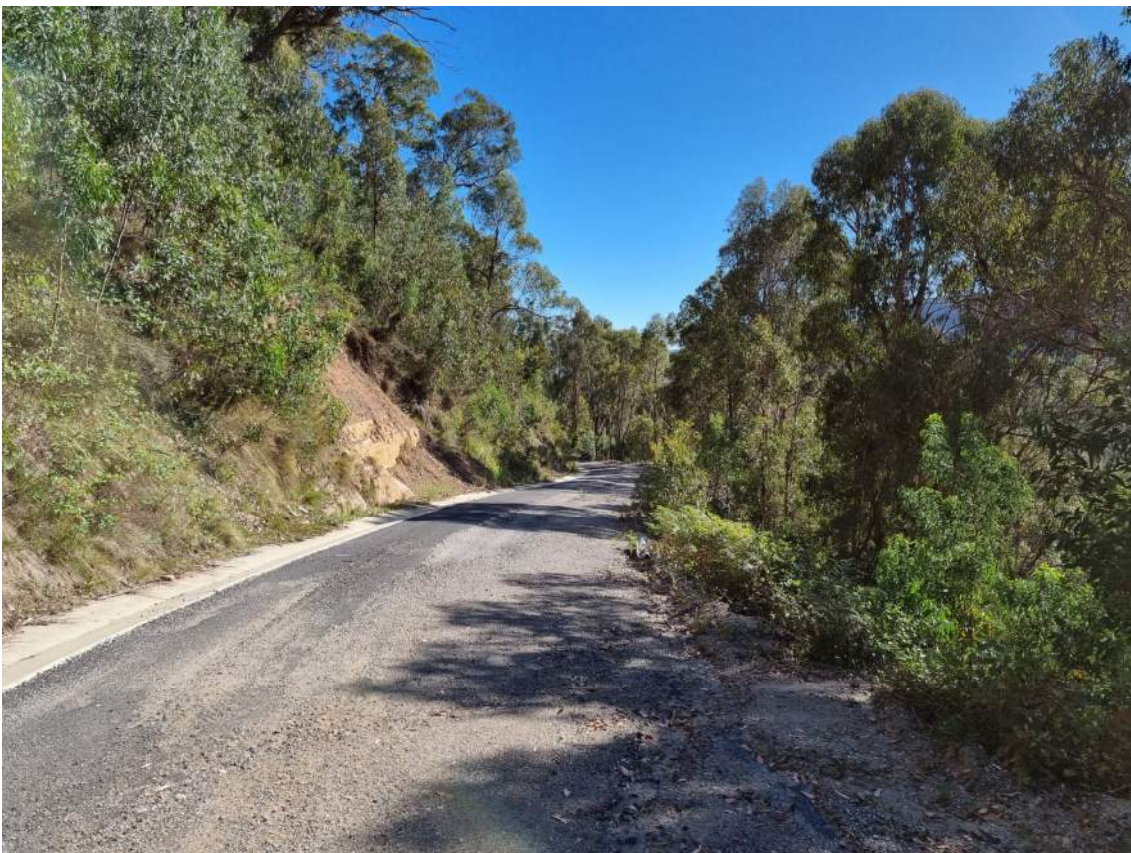
- The section of road below the abovementioned embankment failure descends down the mid to lower sections of the escarpment talus slope and becomes progressively further away from the upper escarpment cliff-line. The pavement and some of the base layers have been removed in several places along this section of road. We understand this was to supply material to sheet the Donkey Steps track. Despite this, the road and remaining sections of pavement appear to be in good condition (Figure 6), with no tension cracking or other obvious signs of instability observed.

Figure 6 *Example of lower section of Wolgan Road in apparent good condition. Asphalt and subbase removed for reuse on Donkey Steps track.*

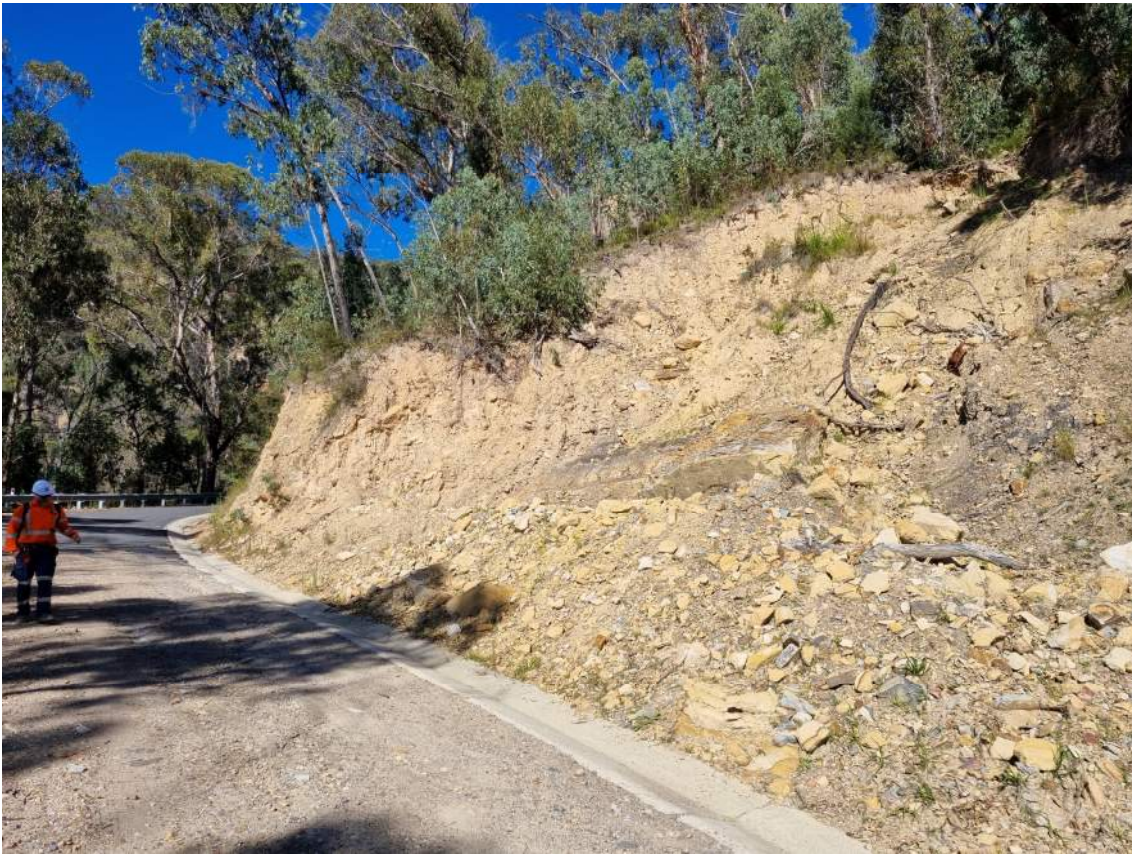
- The first few hundred metres of road, below the section of embankment failure contains several scarps associated with upslope batter slides (Figure 7). The failures appear to have comprised relatively shallow slides in colluvium and weathered rock. Bedrock is exposed in the failure scarps, again suggesting the thickness of colluvium and talus is relatively shallow. The failure material has since been cleared off the road.

Figure 7 *Example of upslope batter failure in colluvium, talus and weathered bedrock along of lower section of Wolgan Road.*

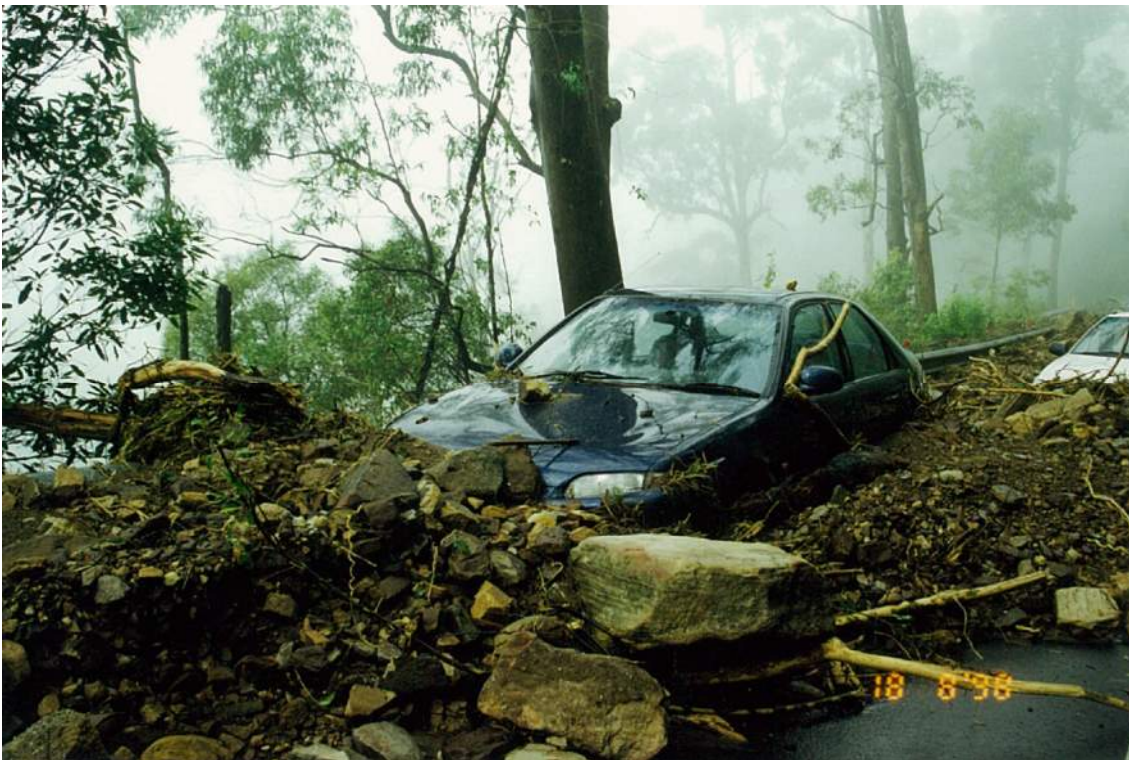
Given the low vehicle speeds, our project experience with vehicle accidents associated with direct impacts from landslides suggests a value of 0.9 is also too high. For example, on 17 August 1998, the Princes Highway near Wollongong was affected by more than 30 of debris flows and numerous rock falls along a section of the highway at Bulli Pass. The landsliding was initiated by an extreme rainfall event, resulting in debris flow landslides flowing down the escarpment slopes and across the road. Approximately 15 cars were trapped amongst the debris, with some cars becoming partially inundated up to bonnet level (Figure 13). People were forced to flee their vehicles in an attempt to escape the debris. One car was swept over the downslope embankment by a debris flow. Despite these hazards, there were no fatalities.

Figure 13 Vehicle partially inundated by debris flow on Princes Highway, Bulli Pass - 18 August 1998.

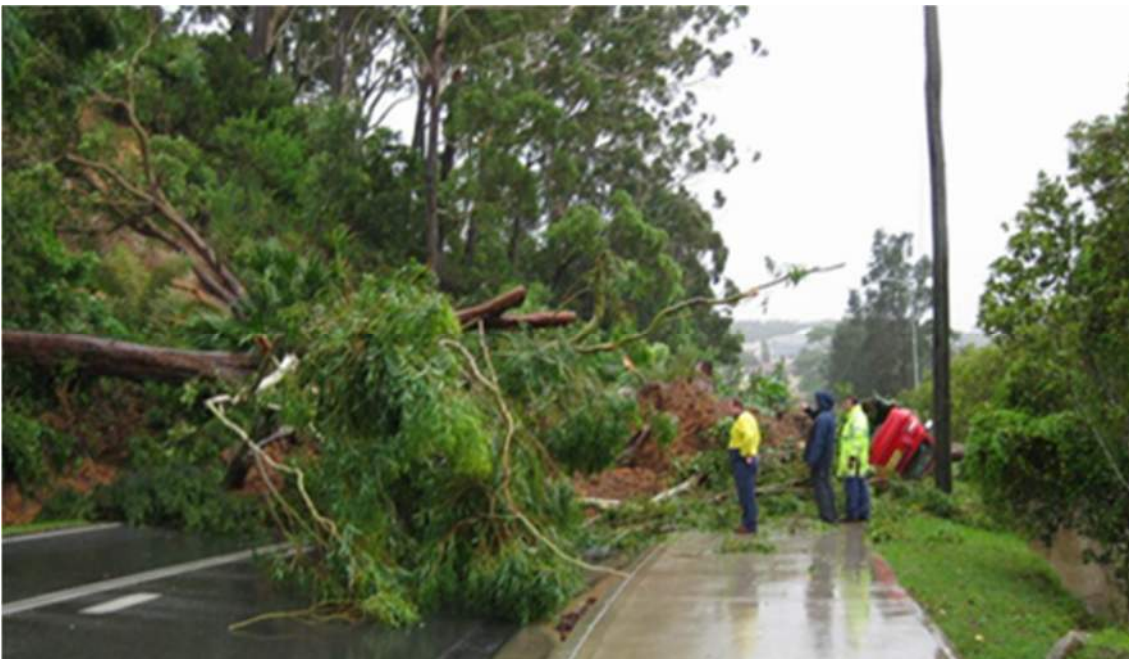
In 2009, an elderly driver was driving along Riverside Drive in Nambucca Heads, NSW when the vehicle was directly impacted by a large landslide originating from a steep hillside above the road (Figure 14). The vehicle was rolled over and came to rest on a riverbank. Despite the drivers advanced age, they were able to climb out of the vehicle without injury.

Figure 14 Landslide in Nambucca Heads that directly impacted a vehicle in 2009.
