STATEMENT OF HERITAGE IMPACT

LITHGOW MOUNTAIN BIKE PARK

LITHGOW LOCAL GOVERNMENT AREA

AUGUST 2025

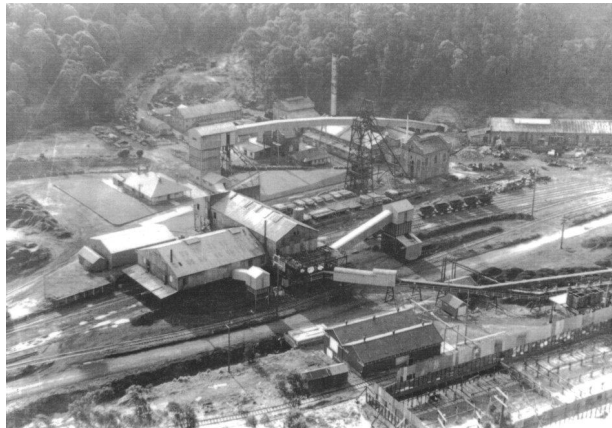
<p>3. Aerial image from the north showing the layout of the site in the 1950s.</p>	<p>4. View of the mine from the east in the 1960s prior to closure showing the maximum extent of the structures.</p>

The State Coal Mine closed in 1964 due to flood risk to the underground workings from the Zig Zag and Oakey Park underground workings. **Figure 3-1** shows views of the State Coal Mine through the early 20th century. **Figure 3-2** provides a historic aerial of the mine approximately five years after its closure. When compared to **Figure 3-1** image 4, the rapid deconstruction of the

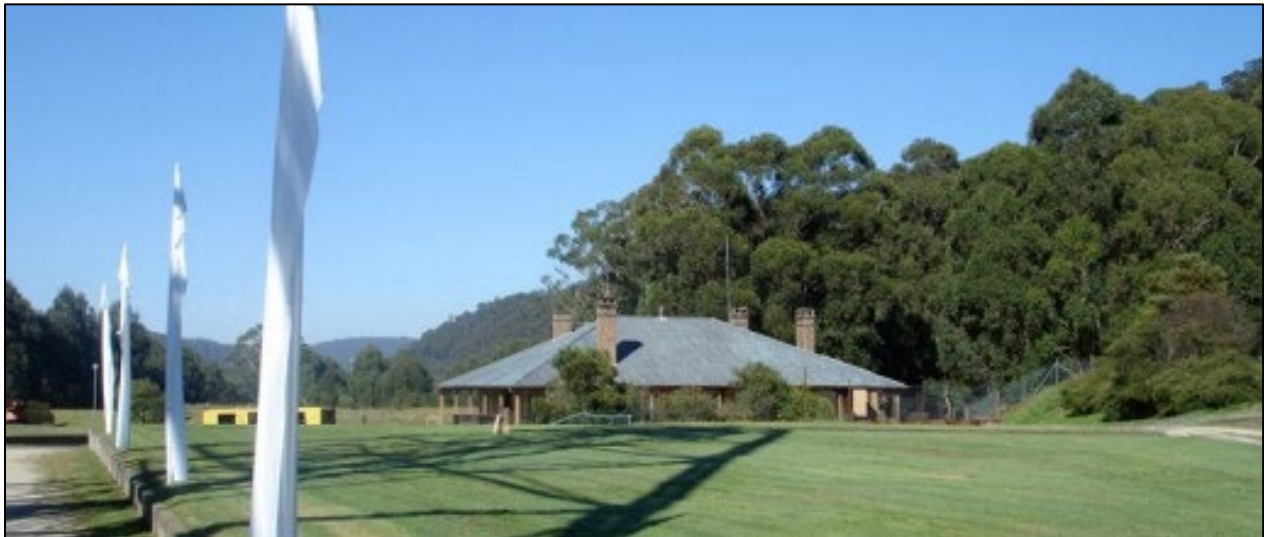
Figure 3-6: View towards the State Mine office building and the old horse paddock behind that is proposed to be used as a car parking area.

The CMP identified that the area related to the original horse paddock held no visible remains and was suitable for new development or structures.

Pratten and Irving (1994:48) note that the office building has always been at this location, however, according to the 1926 plan of the surface structures, a building labelled 'temporary offices' preceded the present one. At that time a large, fenced horse paddock existed to the south of the offices (**Figure 3-8**). The 1943 plan shows the building substantially as it is now: a weatherboard building, labelled 'general offices', encircled by a verandah and having at the rear or west end an ambulance room (**Figure 3-6**). A 1961 map plan indicates the road encircling the office building and its lawn (**Figure 3-7**). The single-storey building has the scale and character of a residence, and it was evidently planned to be located on the same north–south axis as the power house/bath house. In plan, it is a simple rectangle with projecting rooms on the west. It is the only building to have a domestic character of the Federation period and was possibly built as a house on some other site in 1905–1910 and later removed and erected at the mine, although that possibility remains to be investigated (Pratten and Irving 1994:50).

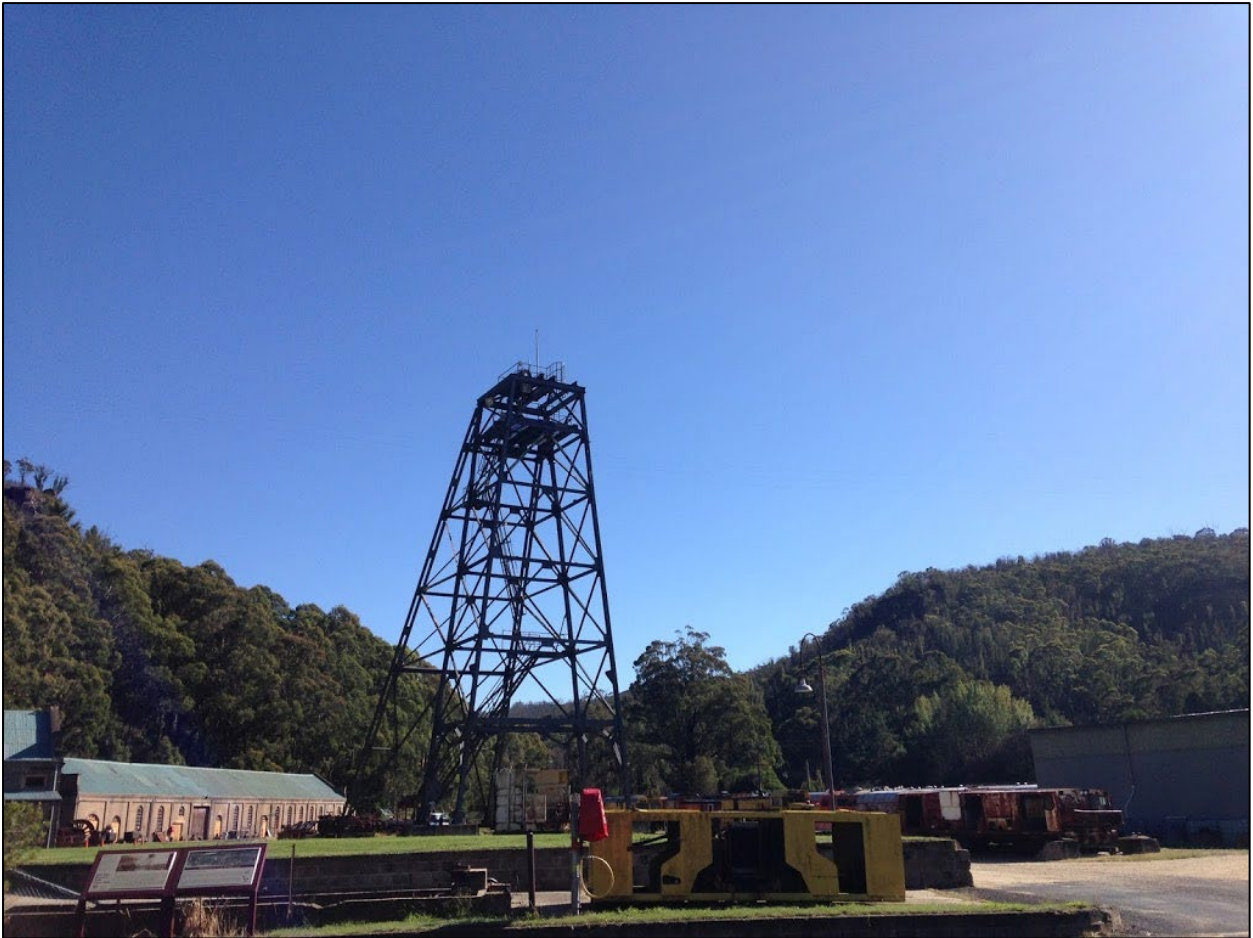
Figure 3-9: Views towards the restored 1923 poppet head.

In 1923, the temporary wooden upcast poppet head over No. 1. Shaft was replaced by the current lattice steel headframe, constructed at White Bay (**Figure 3-9**). It was erected over the wooden one to allow winding to be continued until the new frame was ready for work (Pratten and Irving 1994:11).

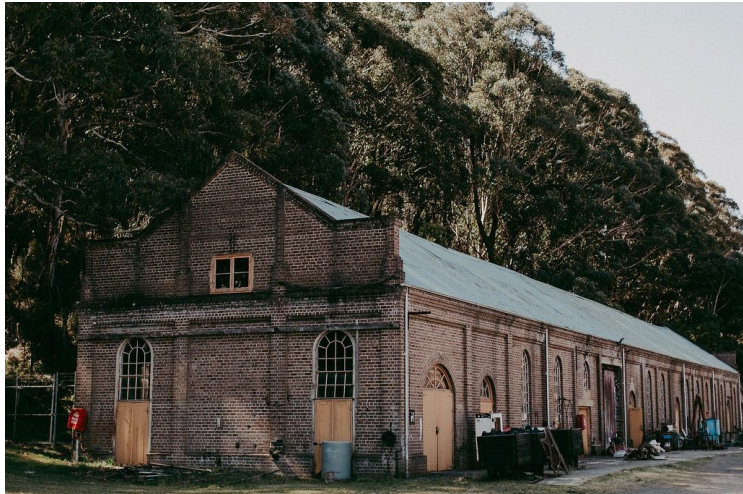
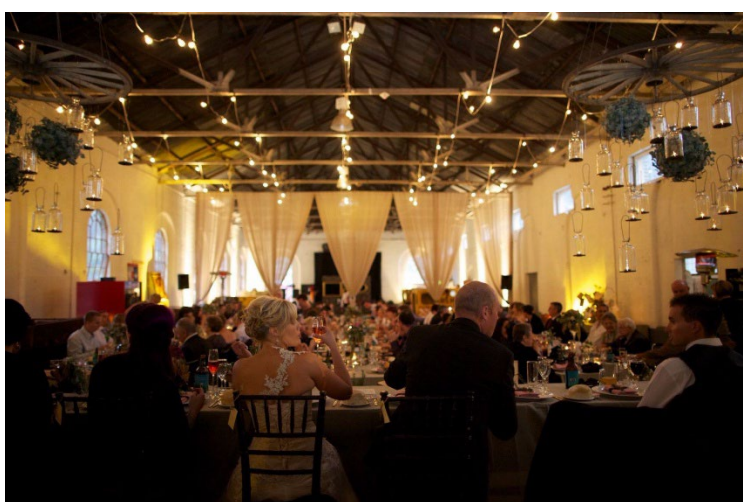
Figure 3-10: Old power house/bath house structure.

Pratten and Irving (1994:43) note that this building began its life as a simple rectangular power house and was converted into a bath house at some time prior to 1943 (**Figure 3-10**). The change in purpose required the addition of shower and toilet facilities built into appendages to the original building on the southern and western sides. The bath house has been sensitively restored and is currently being used as a museum and wedding and function venue.

<p>1. Exterior of old power house/bath house structure.</p>

<p>2. Interior of the old power house/bath house showing its current use as a function venue.</p>

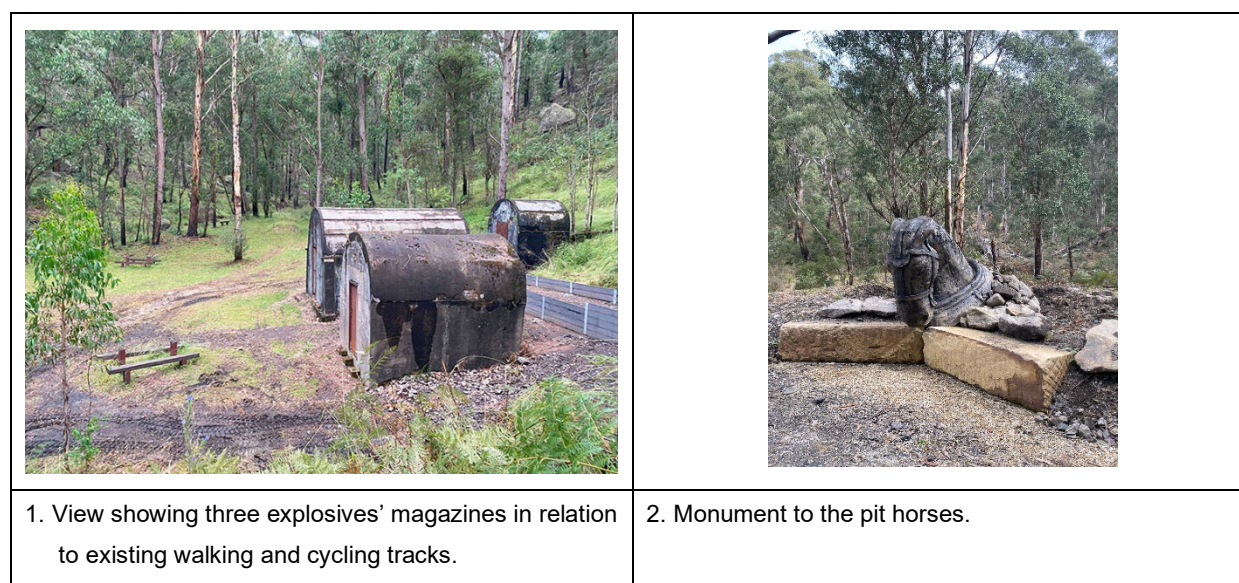
Figure 3-11: Views towards the mine explosives magazines and explosion barrier.

Pratten and Irving (1994:58) note that three explosives' magazines appear as additions to the site plan dated 1943, indicating that they were erected after that date. A 1991 drawing shows the present three buildings and labels them as 'powder, detonator, and cable magazines'. However, the architectural character of the structures suggests an earlier building date, possibly as early as the foundation of the colliery in 1917. The structures are comparatively small, the largest being about 6 m long and about 4 m wide. They have brick walls, semicircular vaulted brick roofs and timber floors (**Figure 3-11**). The vaults are of lesser thickness than the walls, so that an accidental explosion would generate more upwards blast than outwards blast, reducing potential damage. Each magazine has a door in the front end wall, fabricated of steel sheet, lined with plaster laid over birdwire, and hinged to swing outwards from steel jambs (Pratten and Irving 1994:59).

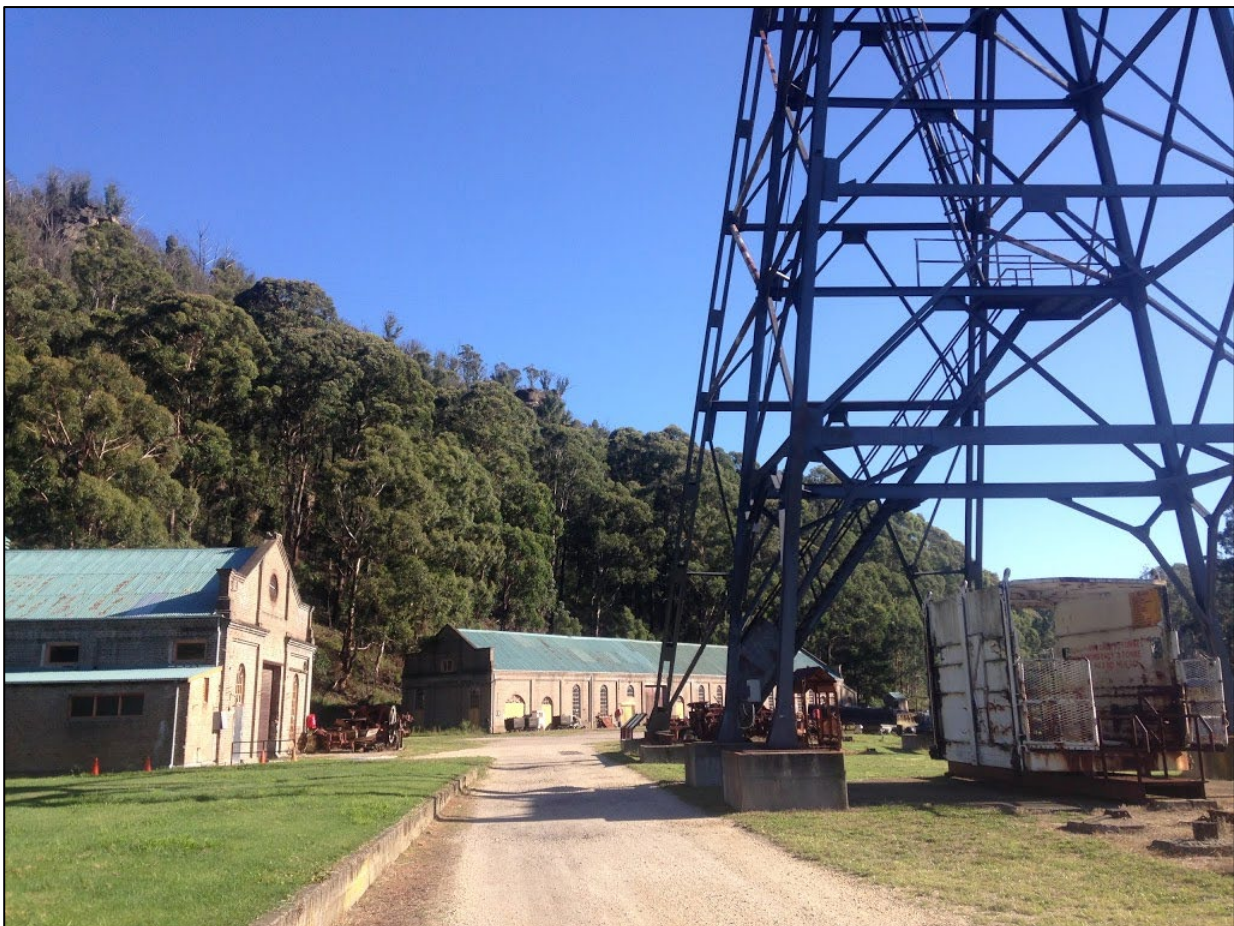
Figure 3-12: View towards the workshop and stores building.

Pratten and Irving (1994:43) note that the earliest available drawing of the mine shows this building substantially in its present form (**Figure 3-12**). It was labelled as 'Stores, carpenters, fitters, and blacksmiths shops'. Unlike the power house/bath house building, which is axially related to its neighbours, the workshop/store building is obliquely placed, along the contours of the site and at the foot of the western hill.

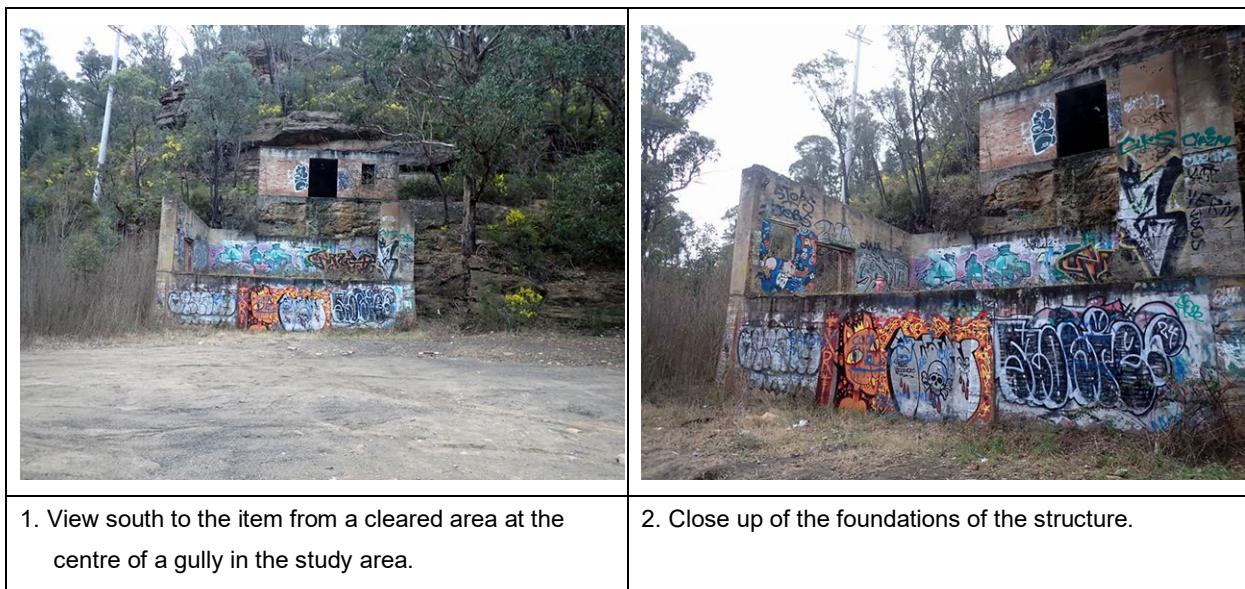
Figure 4-3: View of HS02: the Dobbs Drift.

Description of site: The item consists of a winding house, brick adit, and former bath house built in the late 1940s to support modernisation of the Lithgow State Coal Mine (**Figure 4-3**). The structures, which are located at a high point on the slope, are built on a concrete slab incorporated into the outcropping sandstone of the gully. The ruins are in good structural condition; however, they have been impacted by modern graffiti. Opposite this structure is the sealed entrance to a

The entry was named Dobb’s Drift after Jack Dobbs, a former State Mine Miner’s Federation Lodge Secretary. The original rope and skip haulage system, which was involved in numerous accidents, was replaced with a conveyor belt system in 1955/56 (Christison 2015:14).

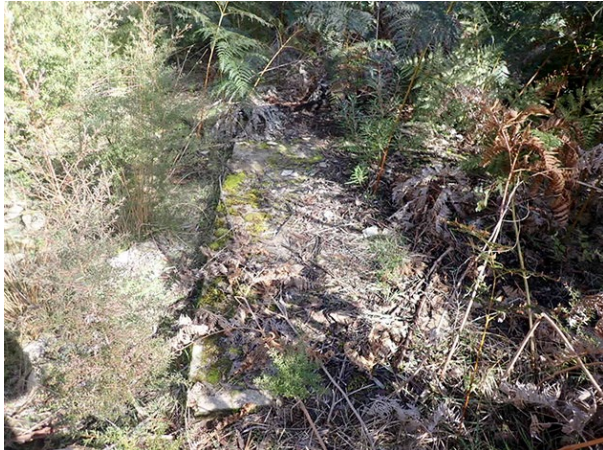
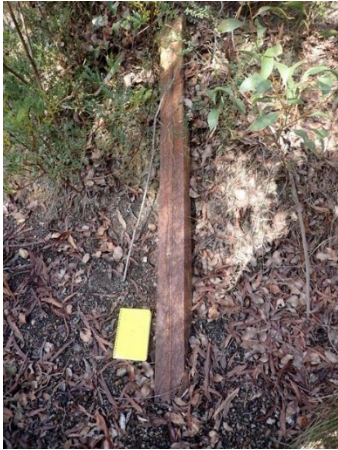
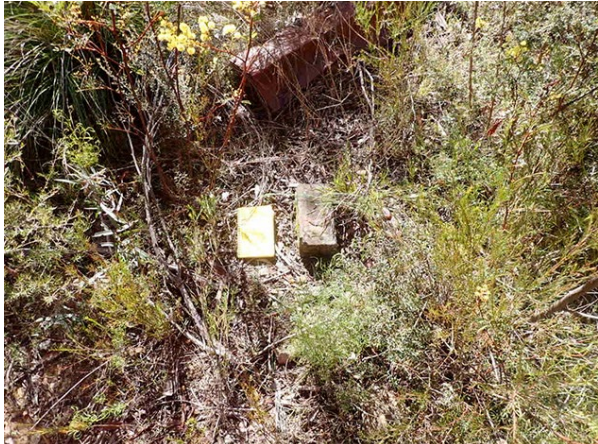
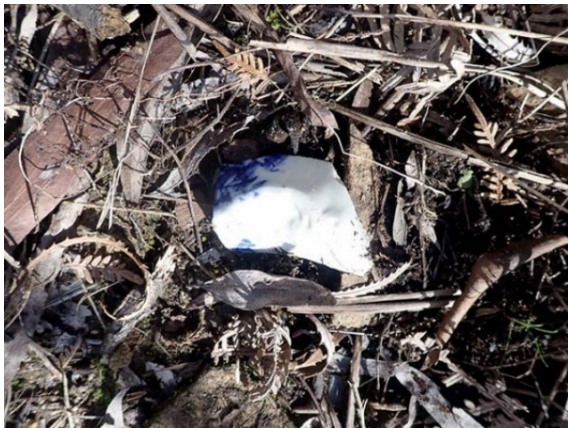
Figure 4-5: Views of HS04: potential house ruins.

Description of site: HS04 consists of an overgrown concrete slab with associated loose bricks and fibre cement panels (Figure 4-5). Broken glass and porcelain were also noted surrounding the concrete slab, perhaps suggesting a domestic, rather than industrial, background of the items. A historic aerial from 1970 does not show any structures at this location.

<p>1. View showing the edge of the concrete pad.</p>	<p>2. A piece of galvanised iron guttering at the location.</p>

<p>3. A loose brick at the location.</p>	<p>4. A small sherd of blue and white porcelain.</p>

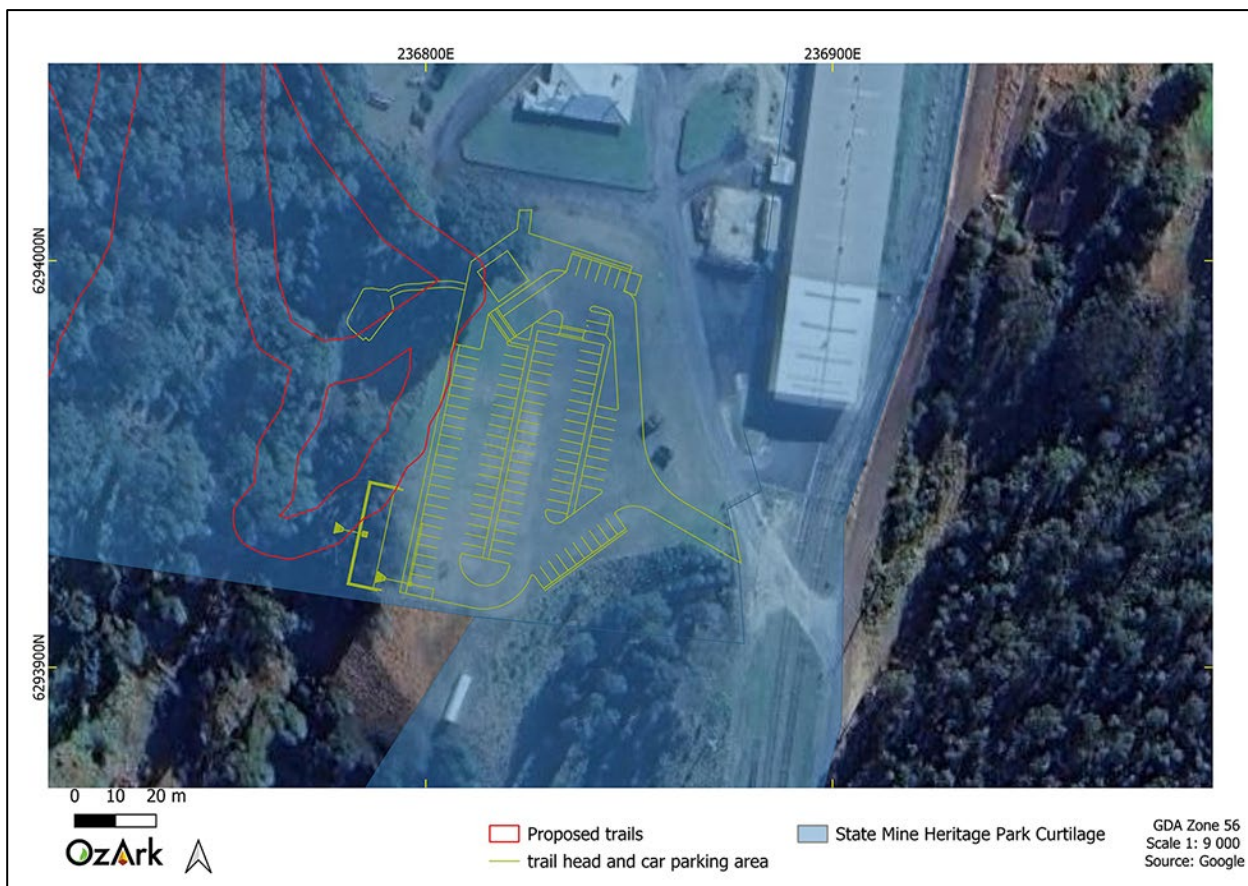
Figure 6-1: Proposed car parking area and trail head facilities.

It is proposed that a trail head and signage will be located south of the State Mine office building, servicing the southern end of the trail network (**Figure 6-1**). The trailhead facilities will be situated on top of a capped and re-vegetated chitter heap from the previous State Mine workings. Prior to being used as a chitter heap, the area was originally the horse paddock and has recently been used as a grassed car park. The proposed car parking area and shuttle pick up/drop off point will be developed in this area.

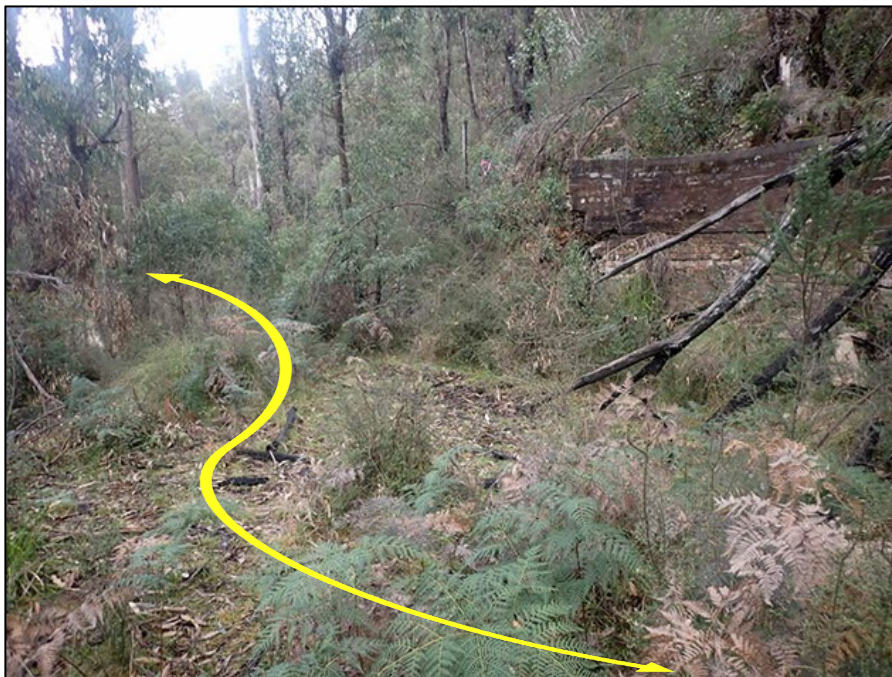
Figure 7-1: The approximate track alignment at HS01, Steelworks colliery features (right).

The recorded features within the study area are located within the footprint of the proposed trail alignment. However, this mapping is not accurate to closer than 3 m and the ground-truthing assessment of the trail alignments indicates that construction of the trails will not damage the fabric of these items. For example, the location of the trail near the Steelworks colliery features (HS01) will pass the items in front on previously disturbed, level land, rather than passing through the concrete structures as seen on **Figure 7-1**. Within the assessed 10 m wide corridor that comprises the study area, the trail alignment will be adjusted to retain the identified features within the landscape.

- Avoidance of impacts to the items will be achieved adopting a construction methodology that does not permit demolition of intact features. Intact brickwork or concrete slabs will not be disturbed
- Building up the track alignment using fill would be acceptable in these areas if track adjustment is not feasible due to, for example, slope pitch
- A 10 m buffer area on the recorded features will be supplied to the construction team to provide a location of the area in which additional caution must be taken.
- User guidelines provided at trail head advising riders to remain on established tracks and not interact with heritage items.
