# Proposed Lithgow Mountain Bike Project in Lithgow, NSW

## Traffic impact and parking assessment study

May 2025

### Central Tablelands Mountain Bike Club

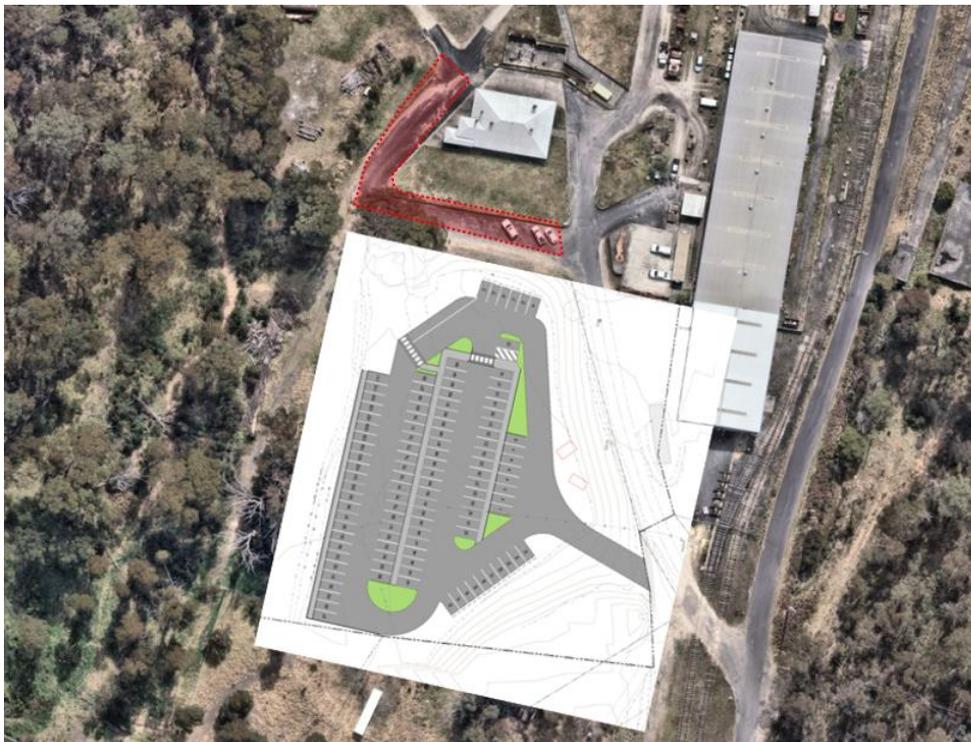
Since the car park is located near the proposed development's car park (refer to Figure 3.2), it is highly unlikely that visitors to the Workshop & Museum will use the newly proposed [adjacent] car park in any foreseeable circumstances (refer to Figure 3.2).

**Figure 3.2: Workshop & Museum's car park, adjacent to the proposed development's car park**  
(Source: nearmap & PMO 360)

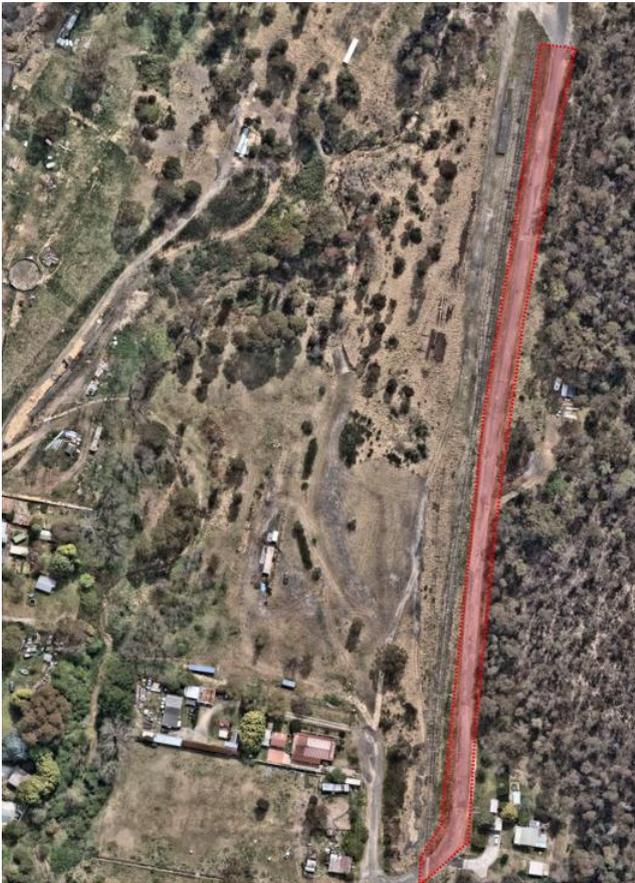
State Mine Gully Road is a less than 6.0m wide road between Atkinson Street and the development site (refer to Figures 3.3 to 3.6).

**Figure 3.3: Section of State Mine Gully Road between Atkinson Street and the development site**  
(Source: nearmap)

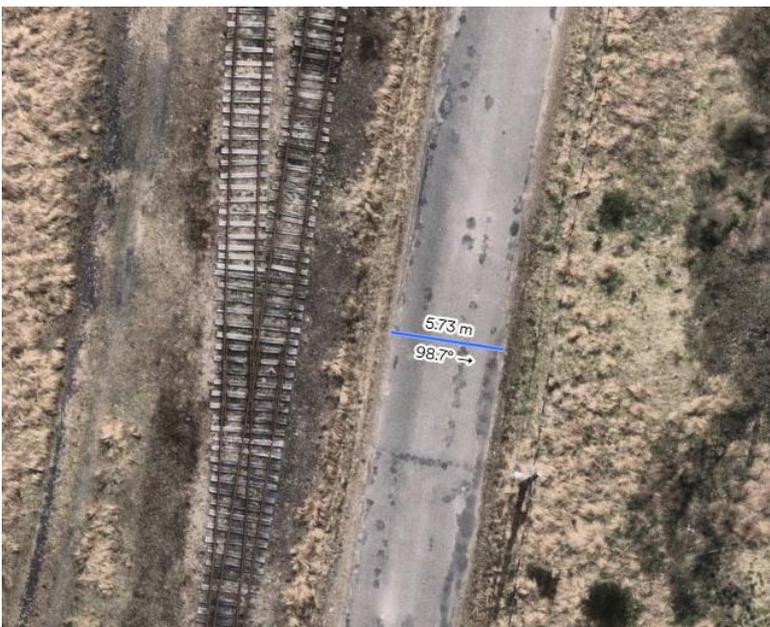
**Figure 3.4 Carriageway width of State Mine Gully Road, measured at a random location between Atkinson Street and the development site**  
(Source & measurement: nearmap)

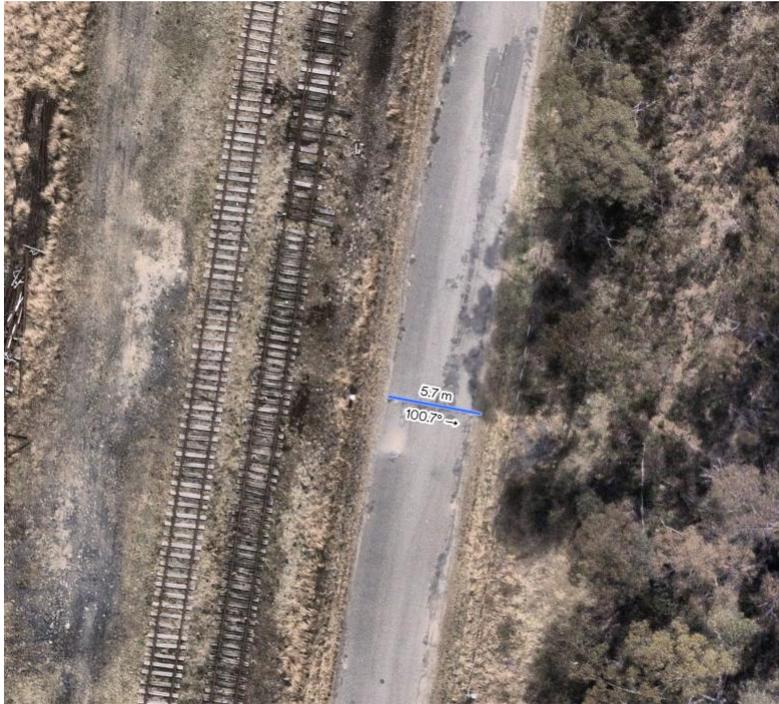
**Figure 3.5 Carriageway width of State Mine Gully Road, measured at a random location between Atkinson Street and the development site**  
(Source & measurement: nearmap)

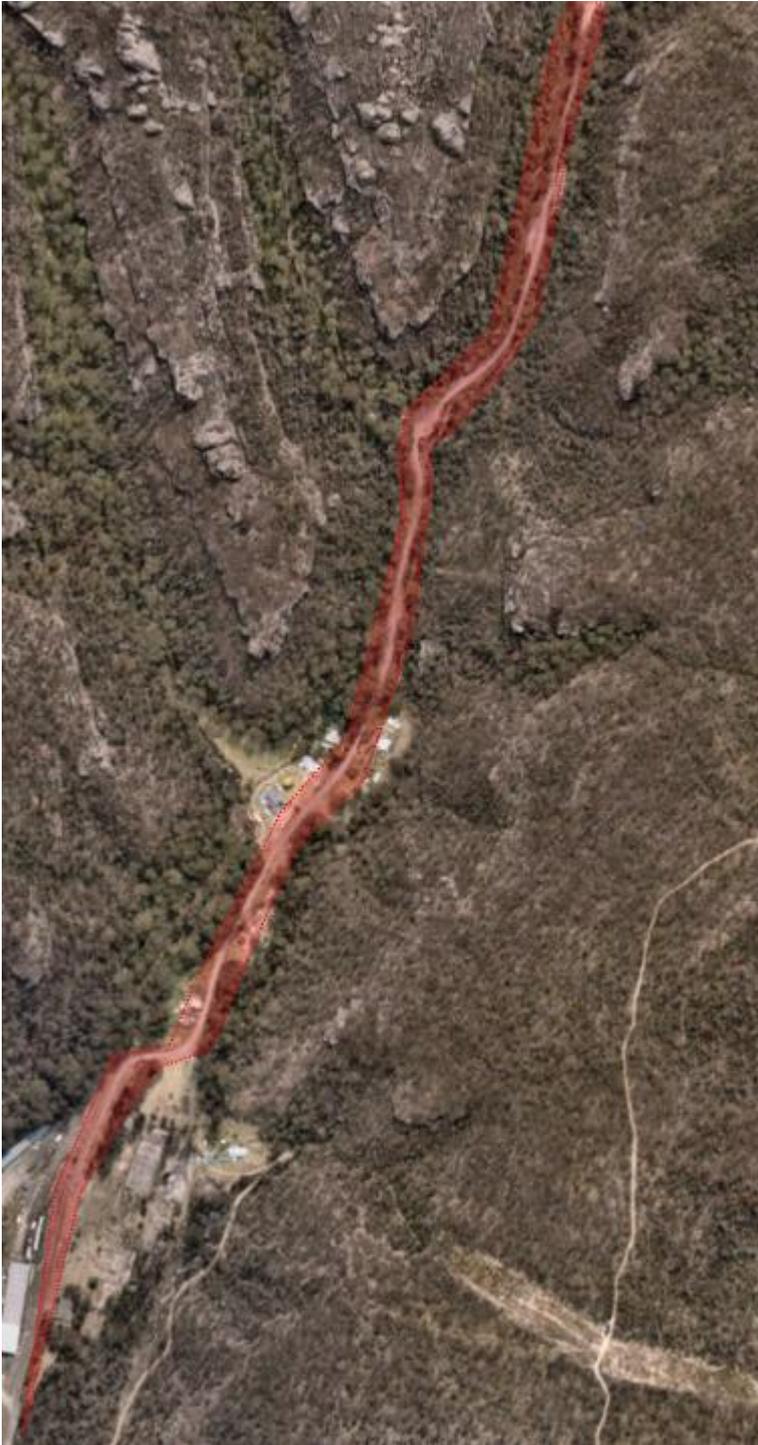
The remaining section of State Mine Gully Road (refer to Figure 3.7, and Photos 3.5 & 3.6), to be used by shuttle buses, is also narrower than 6.00m (refer to Figures 3.8 & 3.9) with a signposted narrow road section (refer to Photo 3.7) and a signposted one-way bridge (refer to Photo 3.8).

**Figure 3.7: Section of State Mine Gully Road between the development site and the northern end of the study area**  
(Source: nearmap)

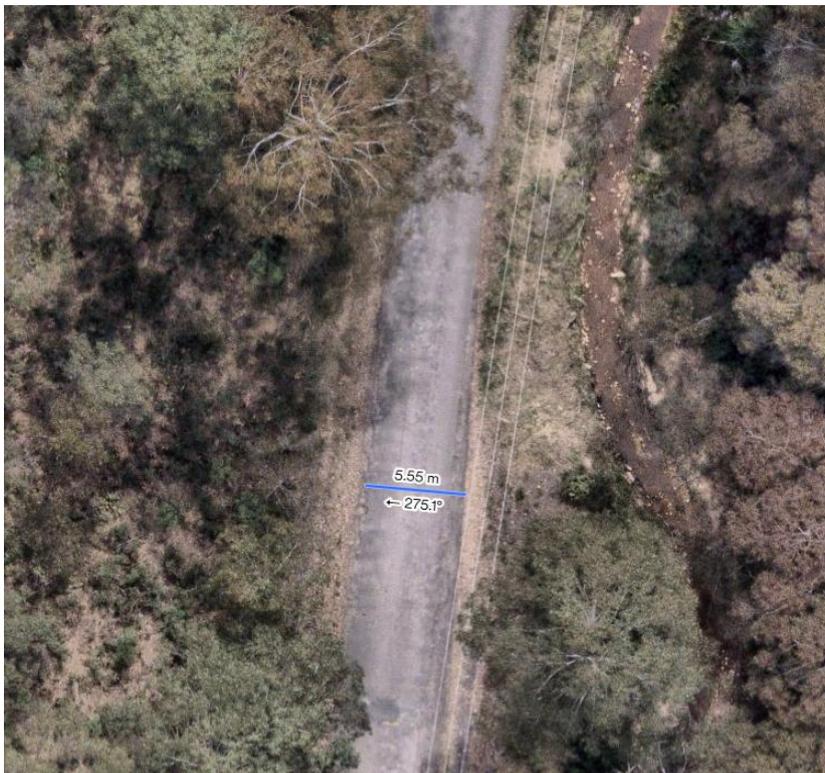
**Figure 3.9 Carriageway width of State Mine Gully Road, measured at a random location between the development site and the northern end of the study area**  
(Source & measurement: nearmap)

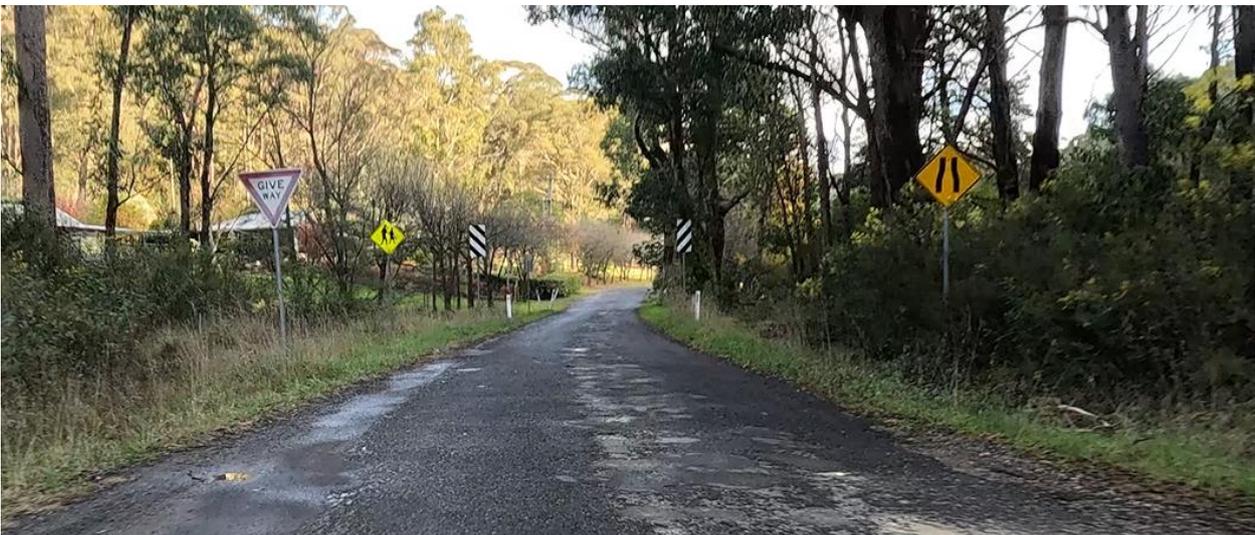
**Photo 3.7: State Mine Gully Road, at signposted narrow road section (looking southbound)**  
[Photo: Traffic Engineering Centre Pty Ltd]

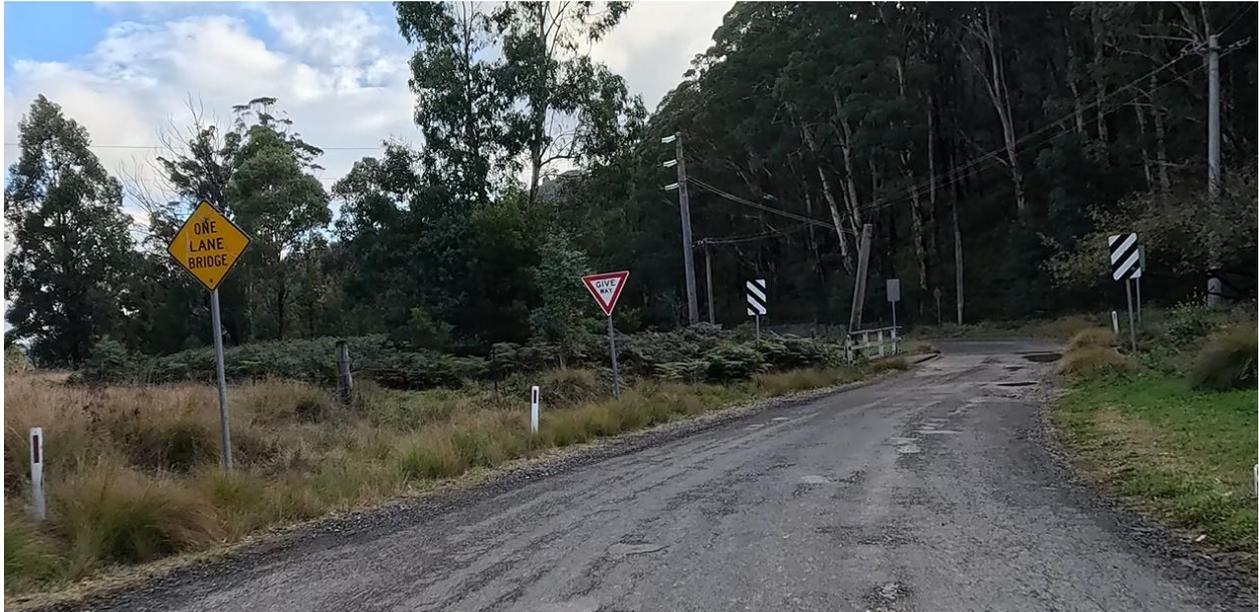
**Photo 3.8: State Mine Gully Road, at one-way bridge (looking southbound)**

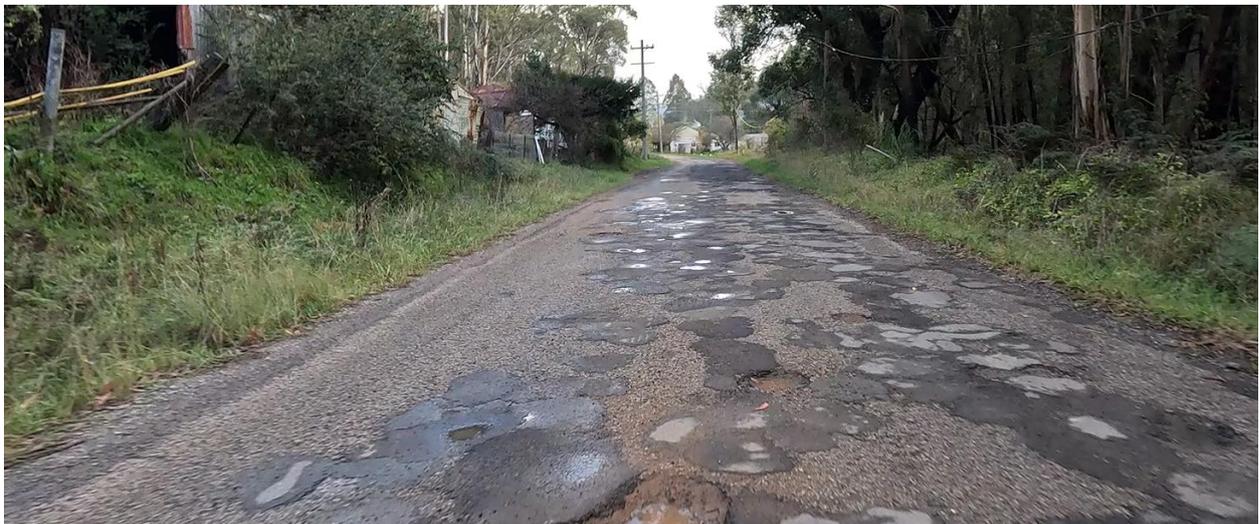
There are a lot of potholes, and the overall of the road surface is in a very bad condition, along the entire section of State Mine Gully Road, between Atkinson Street and the northern end of the studies section (Photos 3.10 & 3.11 show the poor road conditions at only a couple of random locations).

**Photo 3.9: Typical condition of the road surface of State Mine Gully Road, between the development site and the northern end of the studied road section**

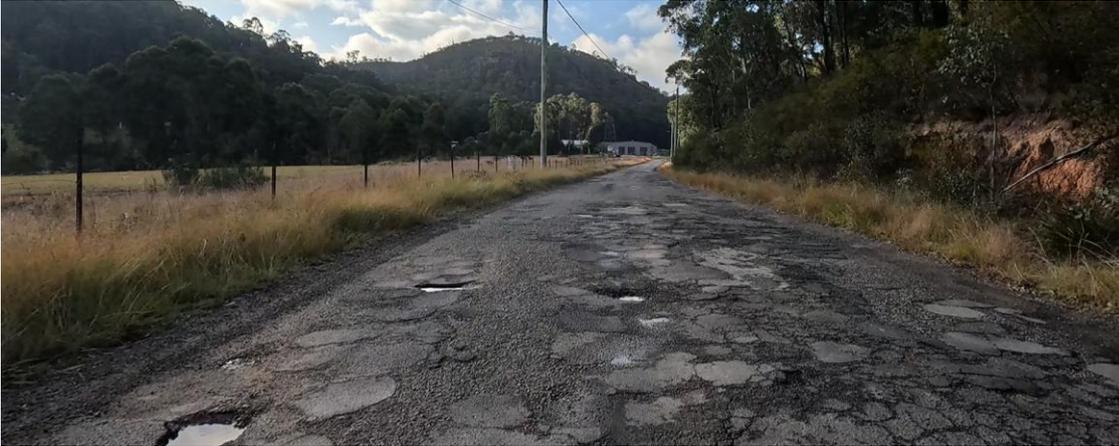
**Photo 3.10: Typical condition of the road surface of State Mine Gully Road, between Atkinson Street and the development site**

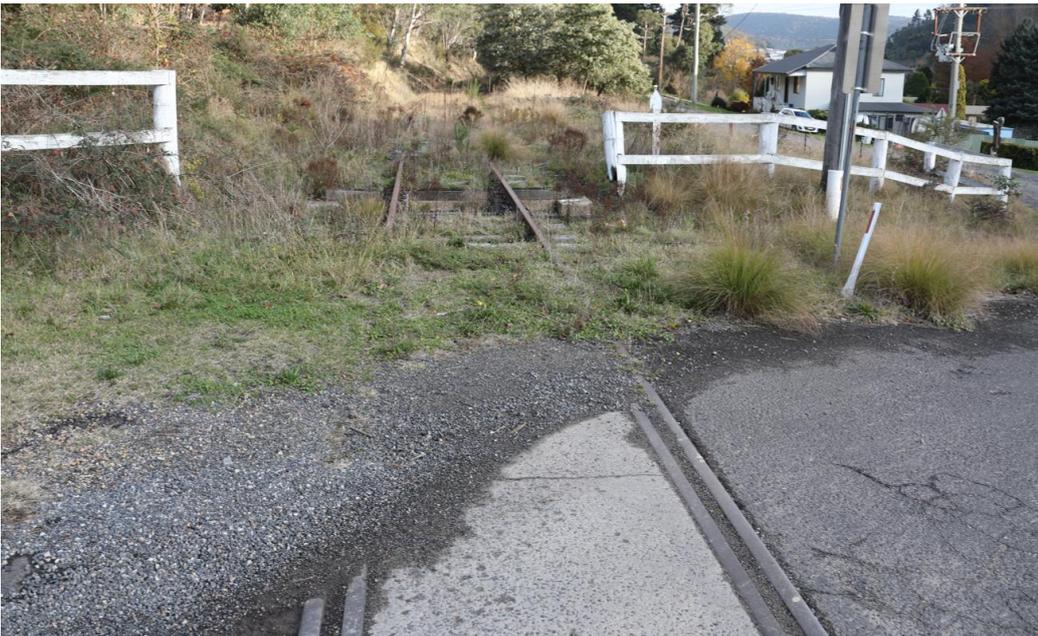
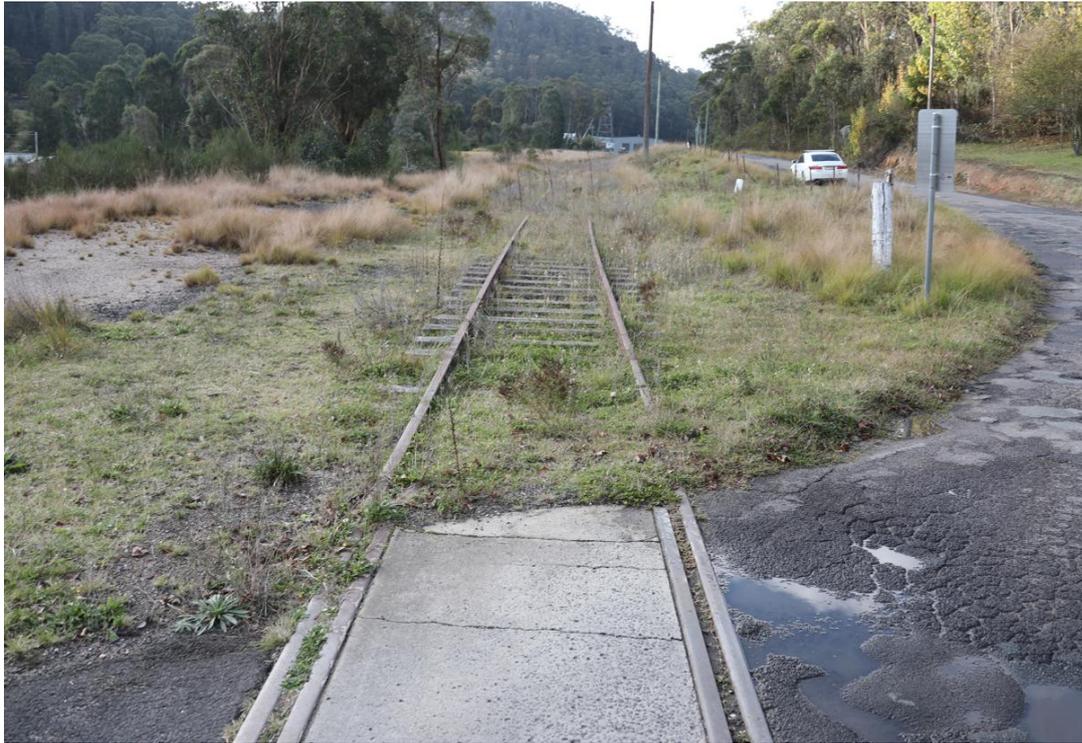
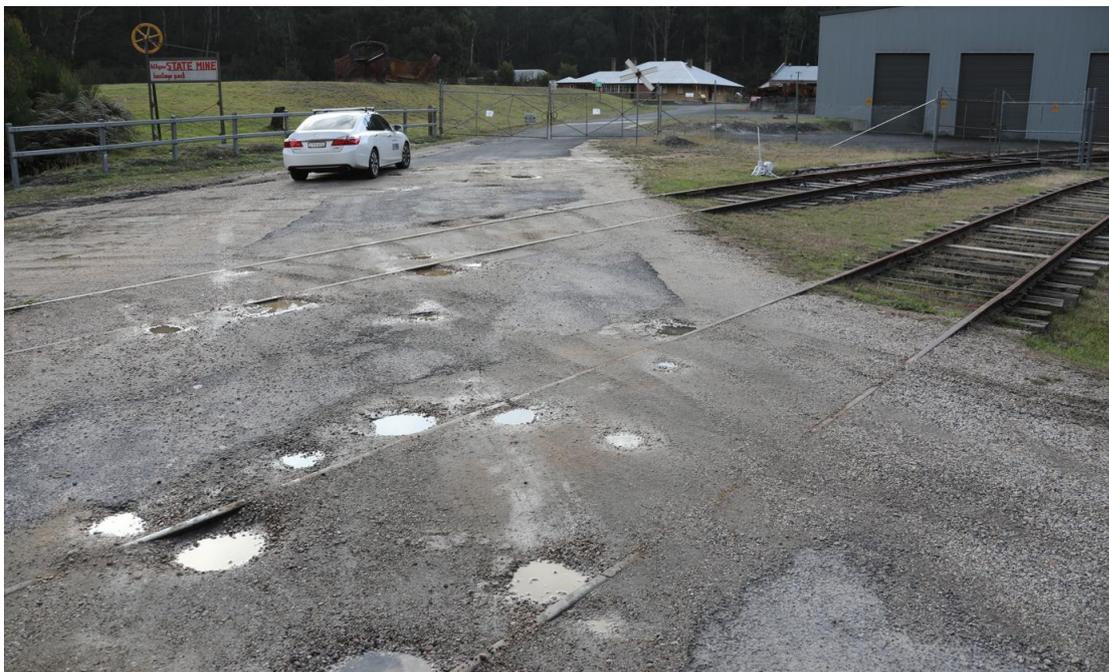
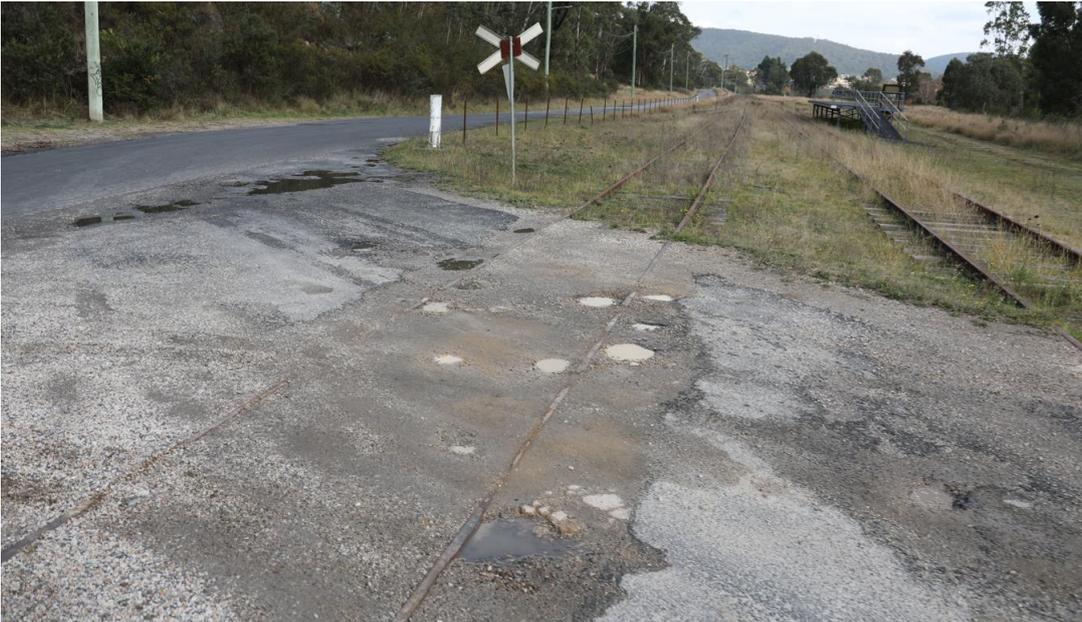
The observed poor condition of the railway tracks indicate that the section of the railway network is no longer in regular use or has even been decommissioned.

- Rust and Corrosion: seemingly, the tracks were not used for long periods, as rust developed, weakening their structural integrity
- Overgrown Vegetation: grass and weeds growing between and around the tracks suggest a lack of maintenance.
- Sediments, gravel, and loose material between tracks
- Lack of Recent Repairs: no signs of fresh ballast, welding, or track realignment indicate abandonment.

**Photo 3.10: The poor condition of the railway tracks indicates that the section of the railway network is no longer in regular use or has even been decommissioned**

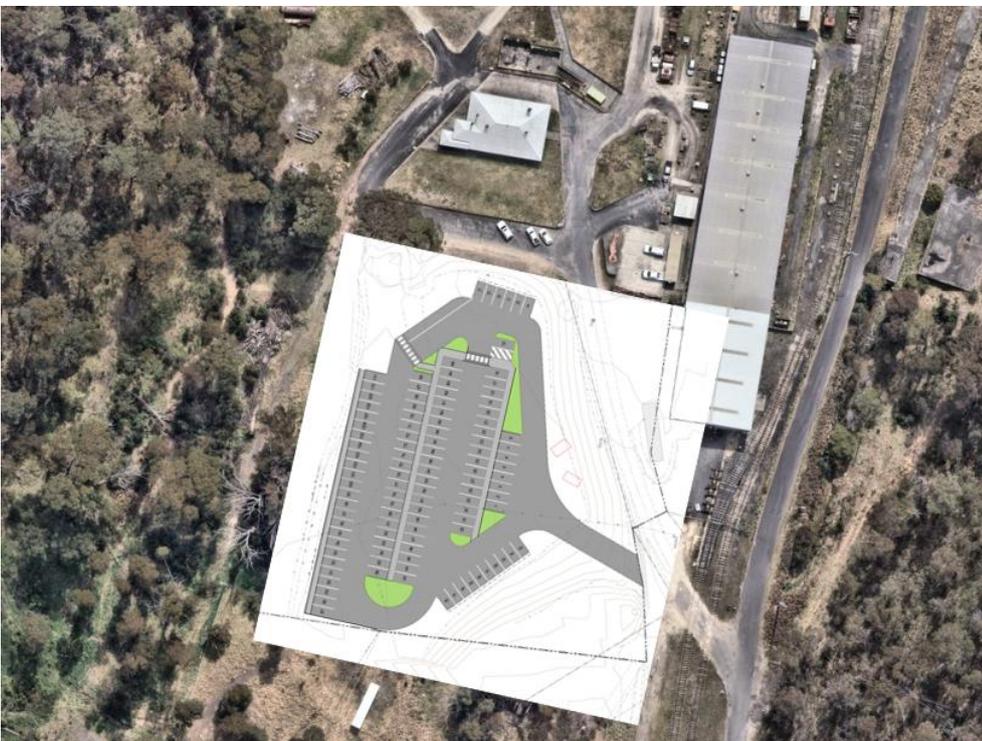
The proposed access driveway to the car park is off the access driveway to the museum, which is located off State Mine Gully Road (refer to Figure 3.10).

**Figure 3.10: Access driveway to the proposed development's car park**  
(Source: nearmap)

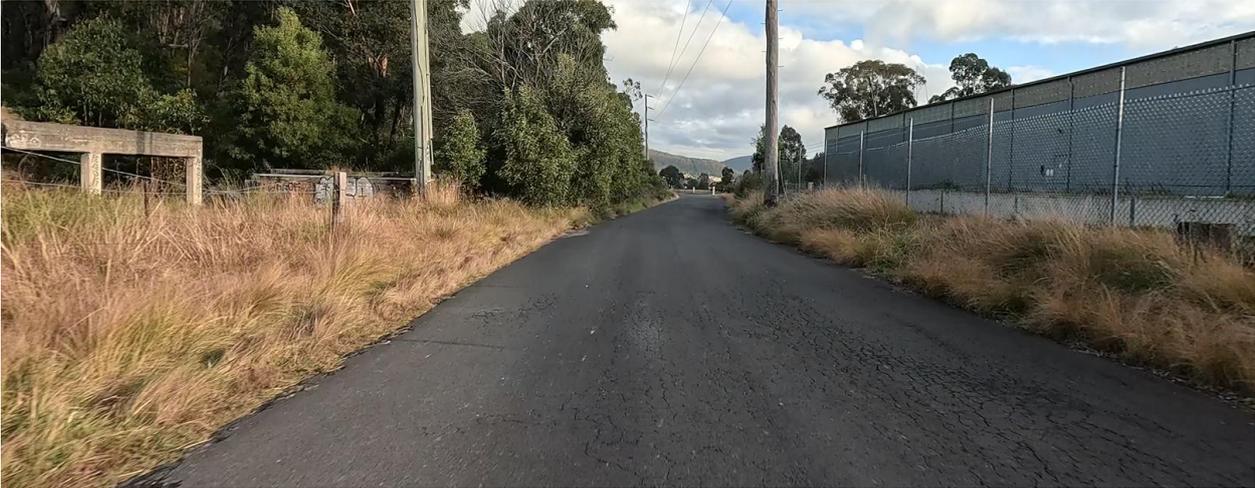
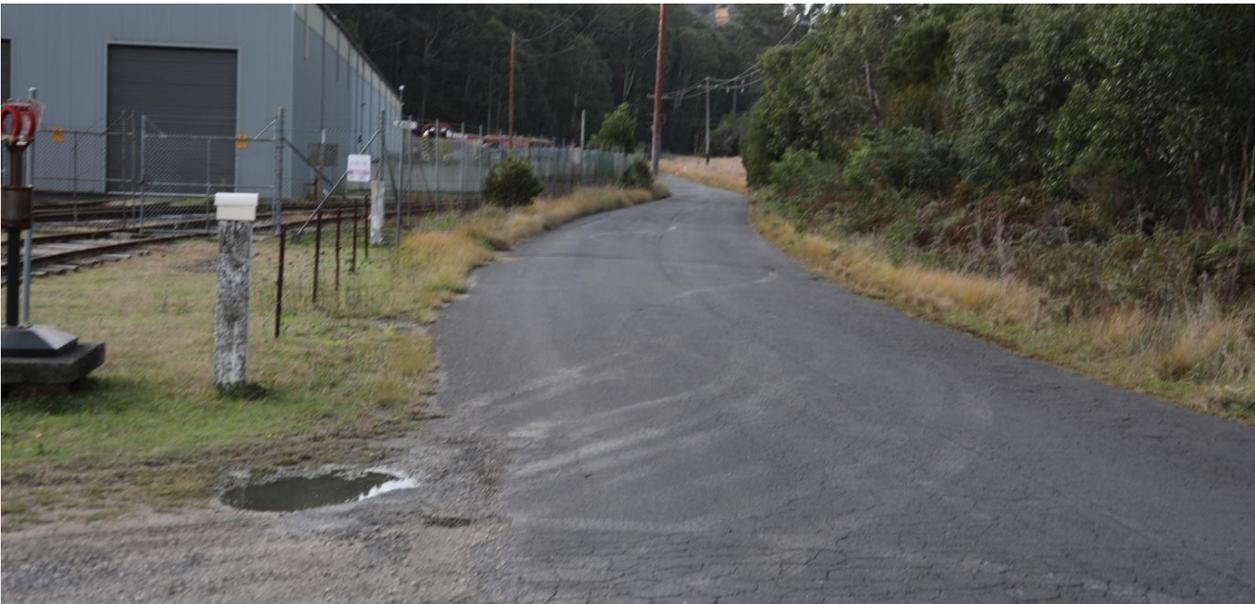
Photos 3.14 & 3.15, and Figure 3.11 show the view and sight distance of  $\approx 100\text{m}$  looking southbound along State Mine Gully Road, on the northern approach to the proposed access driveway.

**Photo 3.14: State Mine Gully Road, looking southbound, on the northern approach to the proposed access driveway - sight distance  $\approx 100\text{m}$**

**Photo 3.15: State Mine Gully Road, looking northbound, from the proposed access driveway - sight distance  $\approx 100\text{m}$**

**Figure 3.11: State Mine Gully Road, the southbound sight distance measured toward the proposed access driveway  $\approx 100m$**   
(Source: nearmap)

The **sight distance** associated with an **access driveway** is estimated based on the minimum requirements of the AS2890.1:2004. Table 3.1 determines the sight distance for vehicles entering the public roadway from an access driveway.

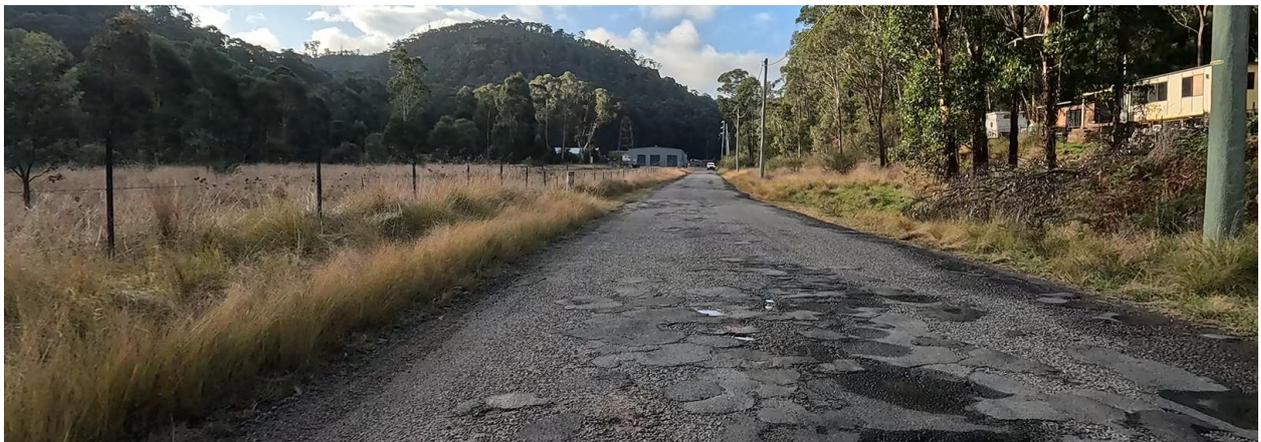
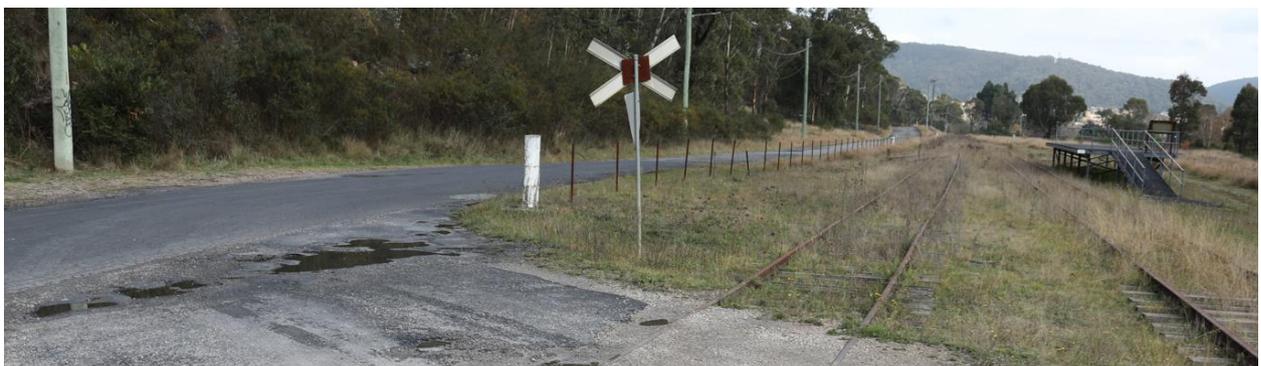
Photos 3.16 & 3.17, and Figure 3.12 show the view and sight distance of  $\approx 190m$  looking northbound along State Mine Gully Road, on the southern approach to the proposed access driveway.

**Photo 3.16: State Mine Gully Road, looking southbound, on the southern approach to the proposed access driveway - sight distance  $\approx 190m$**   
(Photo: Traffic Engineering Centre Pty Ltd)

**Photo 3.17: State Mine Gully Road, looking southbound, from the proposed access driveway - sight distance  $\approx 190m$**   
(Photo: Traffic Engineering Centre Pty Ltd)

**Figure 3.12: State Mine Gully Road, the northbound sight distance measured toward the proposed access driveway  $\approx$  190m**  
(Source: nearmap)

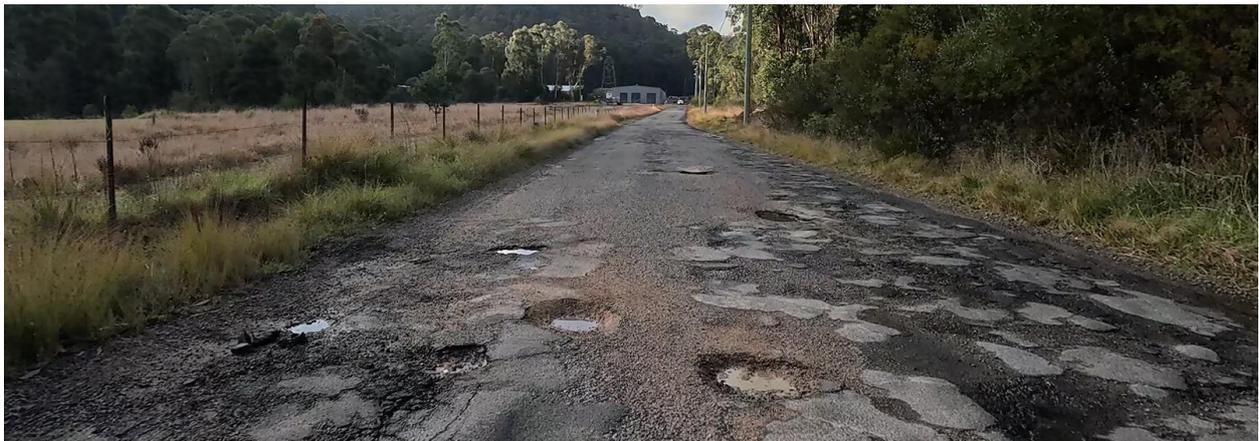
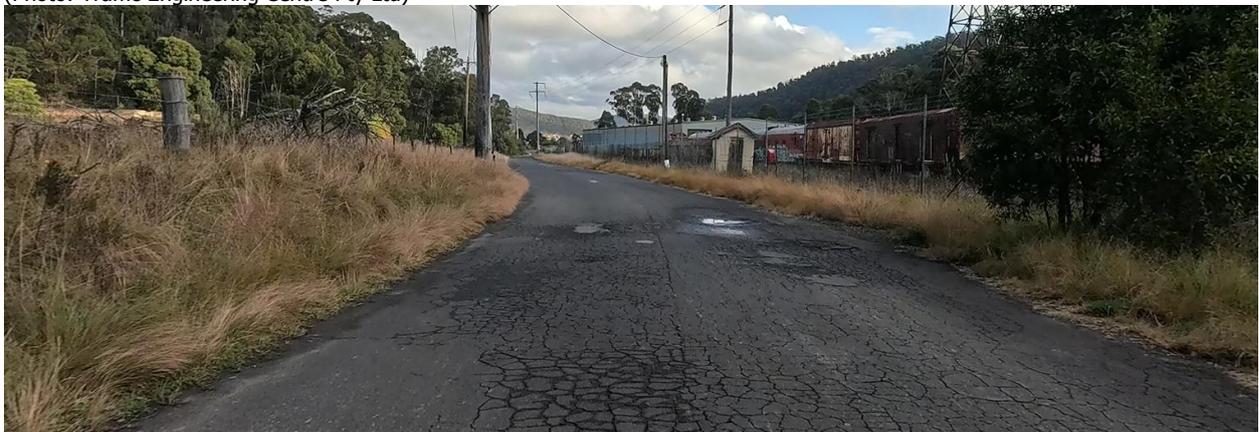
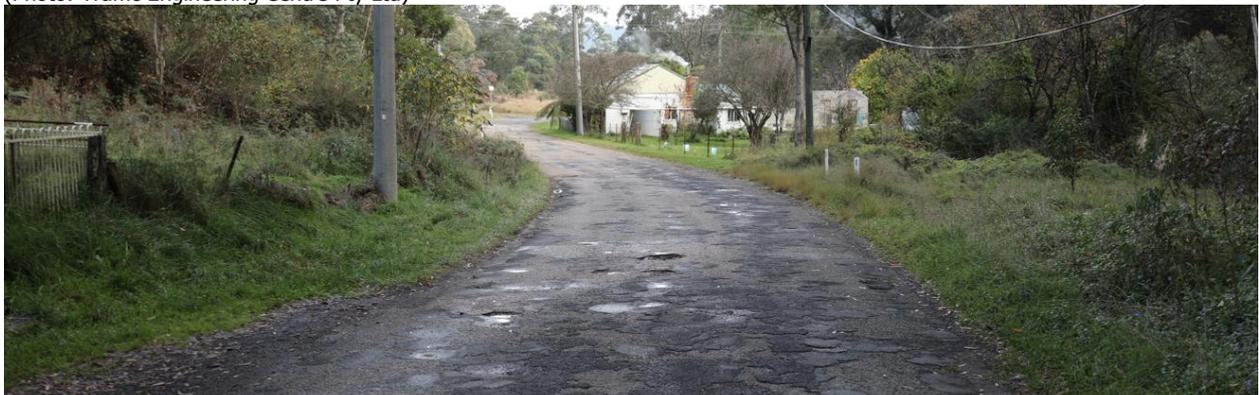
The surface of State Mine Gully Road is in poor condition with a significant number of potholes and other pavement damage (Photos 3.18 to 3.20 show only a few random locations).

Potholes and other identified pavement damage are more than just an inconvenience - they pose serious risks to traffic safety, because:

- Vehicle damage & Loss of control: hitting a deep pothole can damage tires, suspension, and steering systems, leading to sudden loss of control.
- Increased incident/collision risk: drivers may swerve unexpectedly to avoid potholes, potentially colliding with other vehicles or pedestrians.
- Reduced Braking Efficiency: Potholes can interfere with braking systems, especially in wet conditions, making sudden stops more difficult.
- Danger to Cyclists and Motorcyclists: A pothole can cause immediate instability for two-wheeled vehicles, leading to crashes.
- Traffic Congestion: drivers slowing down or taking evasive manoeuvres can disrupt traffic flow, increasing congestion and frustration.

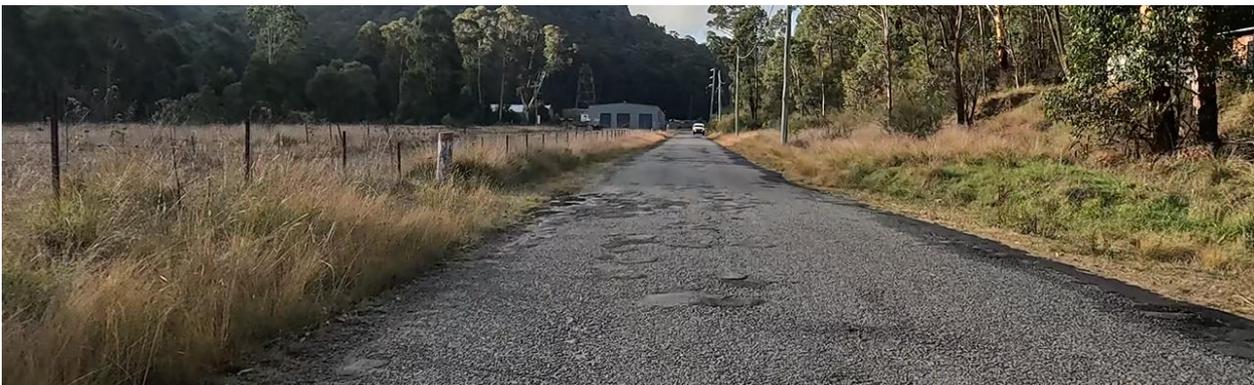
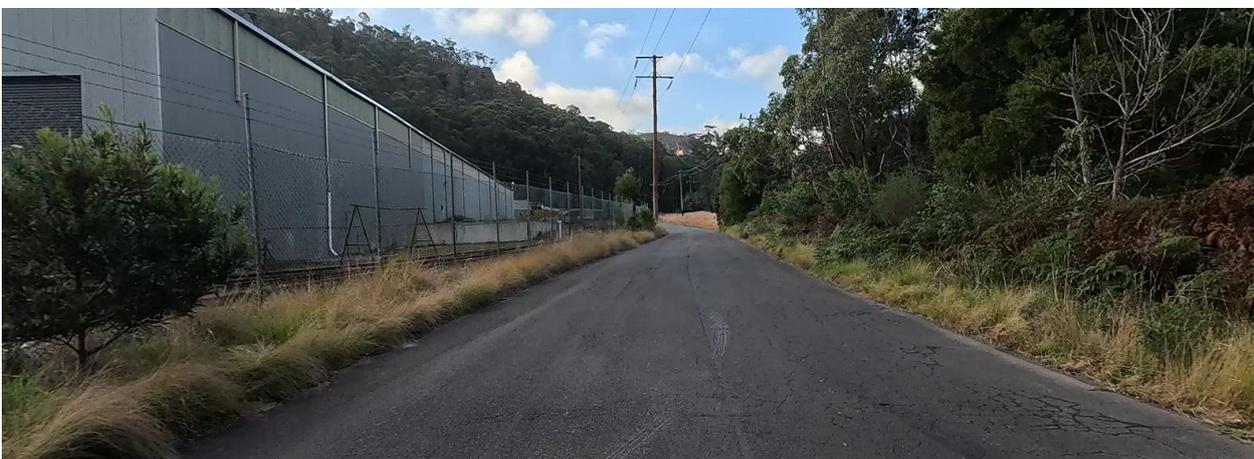
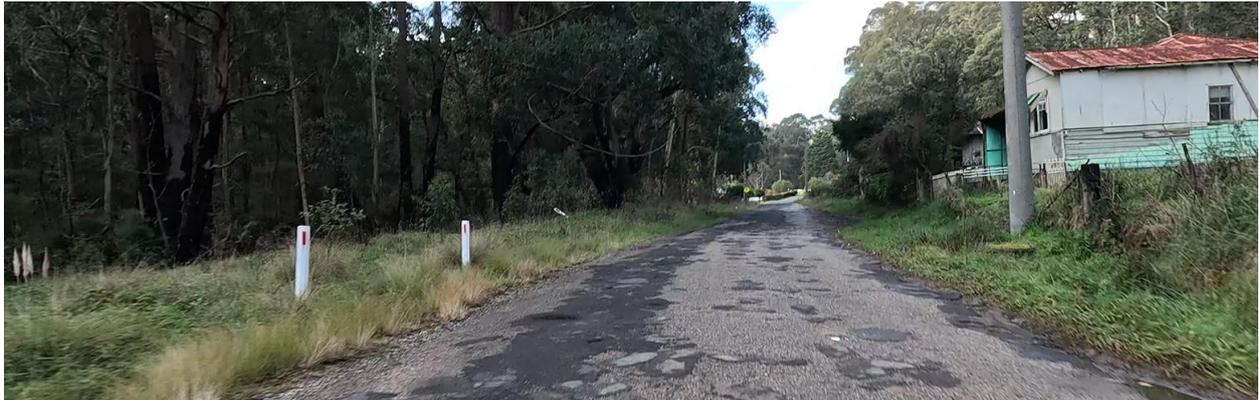
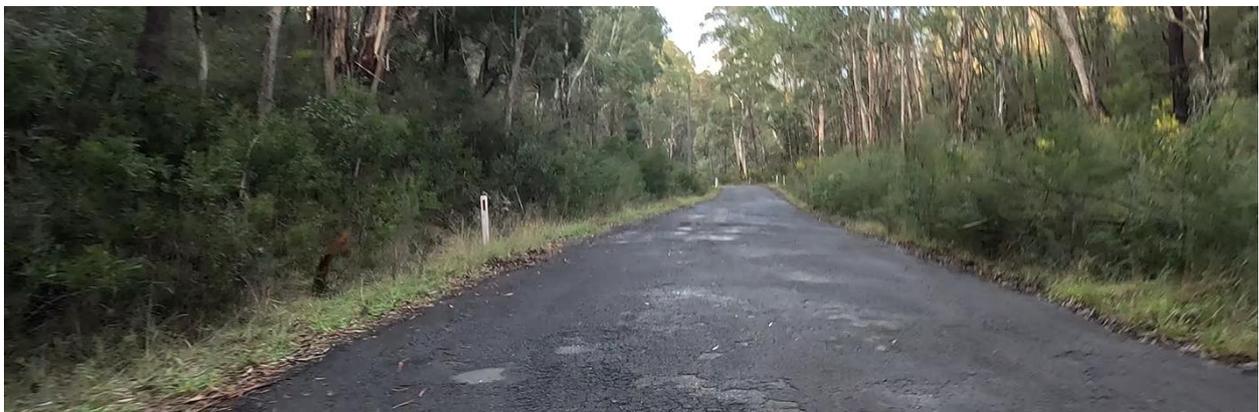
Road **delineation** is poor along State Mine Gully Road (Photos 3.20 to 3.23 show only a few poorly delineated road sections).

The lack of delineation devices results in a poor **delineation system** over the subject section of the roadway, which is likely to fail to regulate, warn, and provide tracking information and guidance to drivers so that they can carry out their driving tasks safely and efficiently.

- Driver confusion: faded or missing lane markings make it harder for drivers to stay in their lanes, especially at night or in bad weather.
- Late braking & sudden manoeuvres: unclear road boundaries can lead to last-minute braking or swerving, increasing collision risks.
- Reduced nighttime visibility: without clear reflective markings, drivers struggle to navigate safely in low-light conditions

- **High-Contrast Line Markings** – Use durable, retroreflective materials for [at least] centrelines, and lane markings to ensure visibility in all conditions.
- **Guideposts & Chevron Alignment Markers (CAMs):** position reflective guideposts and chevrons at curves and intersections to aid navigation.
- **Advanced Warning Signs & Advisory Speed Limits:** deploy signage to inform drivers of upcoming hazards, sharp bends, or reduced visibility zones.

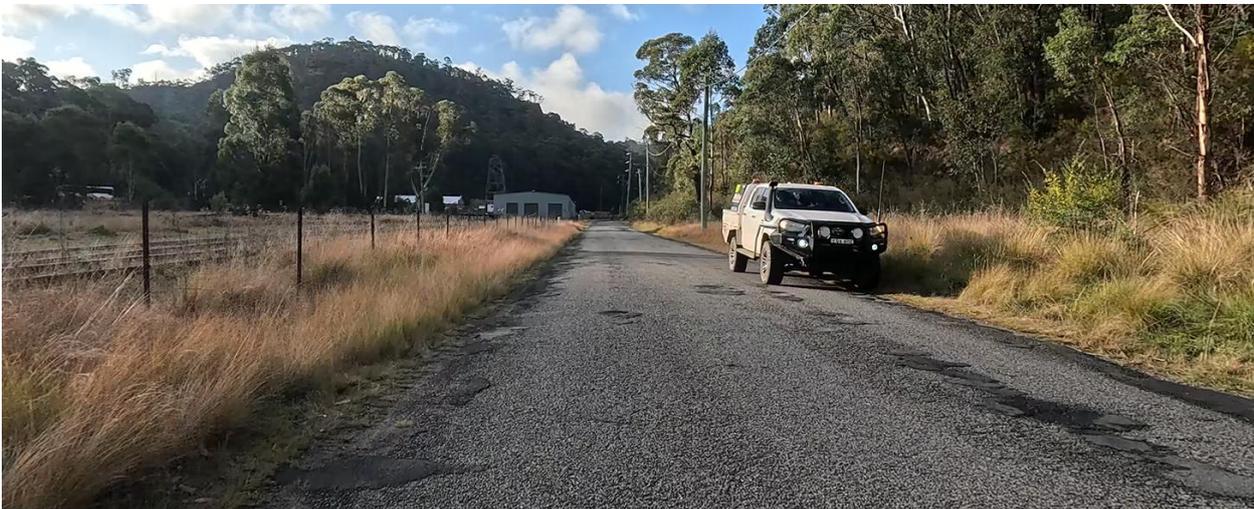
- Higher incident risk: drivers may misjudge distances, leading to crashes, especially in areas with sharp turns or blind spots.
- Limited manoeuvrability: reduced space makes it harder for vehicles to pass safely, increasing the risk of sideswipe collisions. This was observed during the site inspection when both opposing vehicles had to drive beyond the respective edge of the roadway to pass each other safely and conveniently (refer to Photo 3.22).

**Photo 3.21: State Mine Gully Road, looking northbound**  
(Photo: Traffic Engineering Centre Pty Ltd)

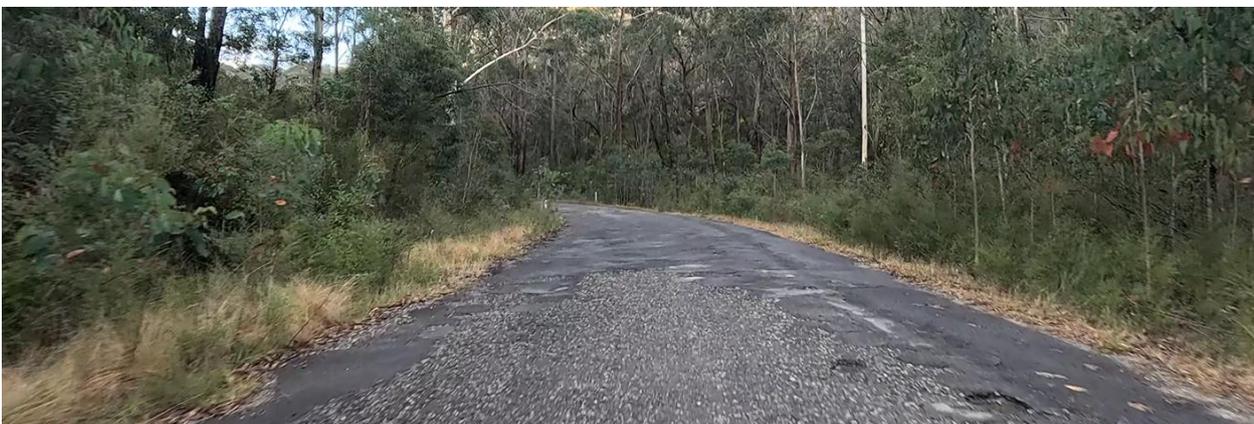
Short forward visibility/sight distance and tight corners were observed along State Mine Gully Road, between the development site and northern end of the study section (refer to Photos 3.32 & 3.33).

**Photo 3.22: State Mine Gully Road, looking northbound**  
(Photo: Traffic Engineering Centre Pty Ltd)

Short forward visibility/sight distance and tight corners pose significant safety risks for drivers, cyclists, and pedestrians for the following reasons:

- Reduced Reaction Time: limited visibility means drivers have less time to react to obstacles, pedestrians, or sudden changes in traffic
- Increased Collision Risk: tight corners and poor sight distance can lead to sideswipe accidents, rear-end crashes, and misjudged turns.
- Higher Risk in Bad Weather: fog, rain, or darkness further compound the visibility issues, making roads even more treacherous.
- Unsafe Overtaking: With substandard sight distance, overtaking becomes risky, increasing the chance of head-on collisions

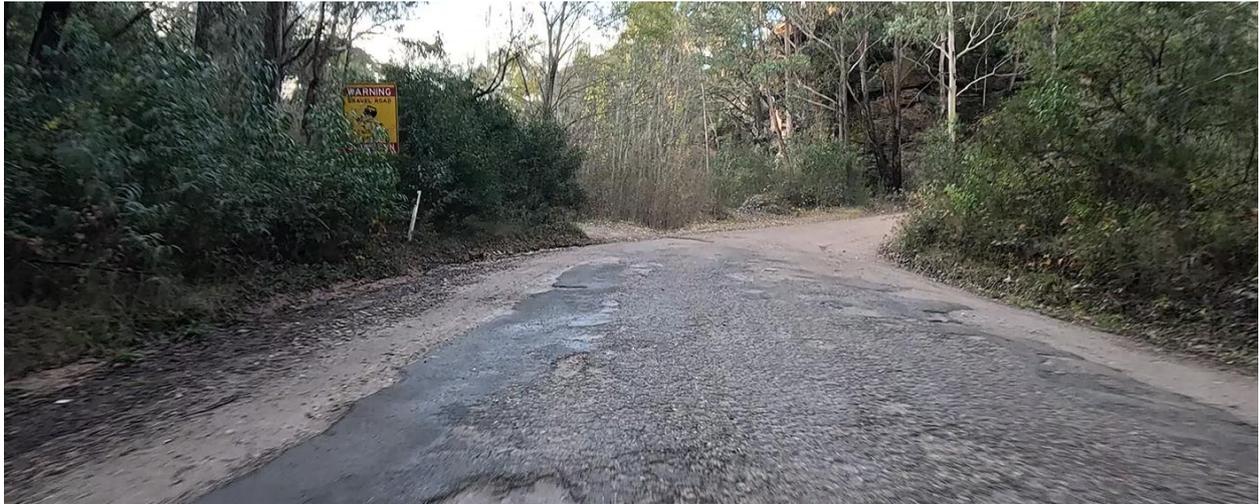
**Photo 3.23: State Mine Gully Road, looking northbound**  
(Photo: Traffic Engineering Centre Pty Ltd)

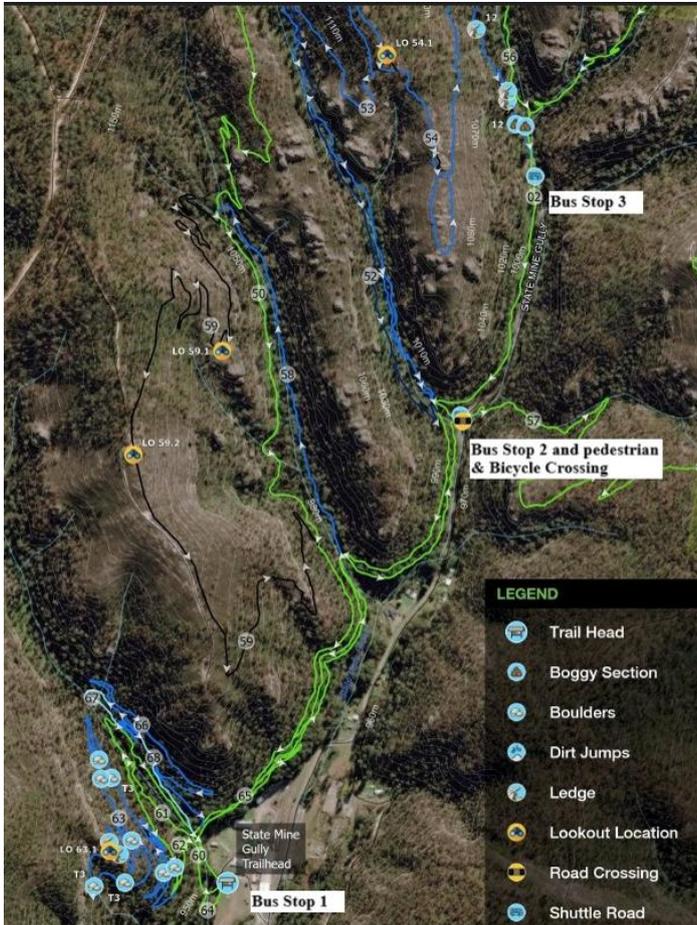
**Figure 4.3**  
 (Source: PMO 360)

Shuttle buses are proposed to operate along the study section of State Mine Gully Road, with 3 (three) bus stops (refer to Figure 4.3).

The proposed locations for all three bus stops (refer to Figures 4.3 to 4.6) have been assessed to ensure adequate lateral clearance for shuttle bus accommodation without introducing operational or safety risks (refer to Photos 4.1 to 4.3 for spatial analysis and site validation). Each site provides sufficient roadside space to facilitate safe passenger boarding and alighting, minimising potential conflicts with vehicular traffic. The 'Bus Stop 1' will be located off State Mine Gully Road, with the turnaround route utilising the museum's internal access road. The proposed development will not have any adverse impact on public transport.

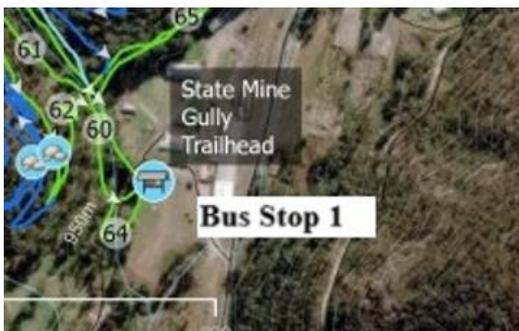
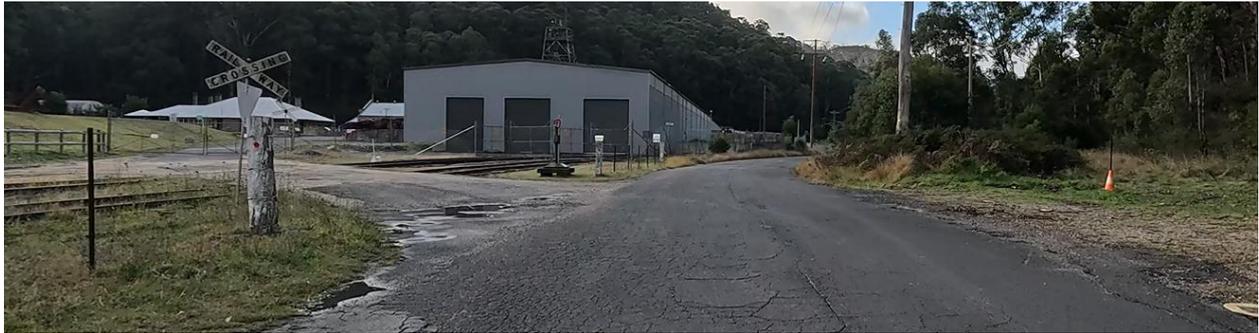
**Figure 4.4: Proposed location of 'Bus Stop 1'**  
 (Source: PMO 360)

**Photo 4.1: State Mine Gully Road, at the proposed location of the 'Bus Stop 1' – ample adequate lateral clearance for shuttle bus accommodation without introducing operational or safety risks**  
 (Photo: Traffic Engineering Centre Pty Ltd)
