# Proposed Lithgow Mountain Bike Project in Lithgow, NSW

## Traffic impact and parking assessment study

May 2025

### Central Tablelands Mountain Bike Club

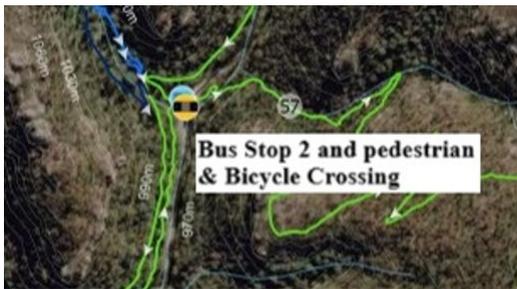
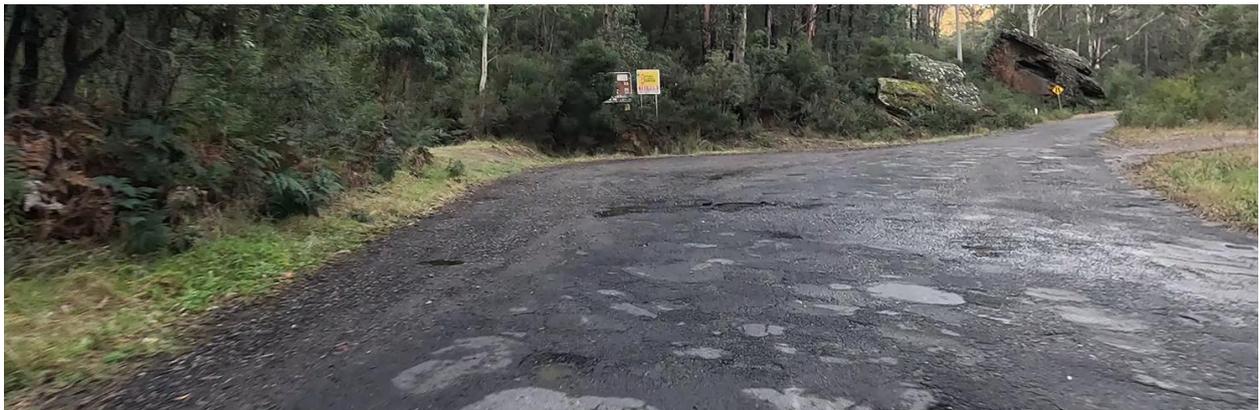
**Figure 4.5: Proposed location of 'Bus Stop 2'**  
 (Source: PMO 360)

**Photo 4.2: State Mine Gully Road, at the proposed location of the 'Bus Stop 2' – ample adequate lateral clearance for shuttle bus accommodation without introducing operational or safety risks**  
 (Photo: Traffic Engineering Centre Pty Ltd)

The proposed locations for all three bus stops (refer to Figures 4.3 to 4.6) have been assessed to ensure adequate lateral clearance for shuttle bus accommodation without introducing operational or safety risks (refer to Photos 4.1 to 4.3 for spatial analysis and site validation). Each site provides sufficient roadside space to facilitate safe passenger boarding and alighting, minimising potential conflicts with vehicular traffic. The 'Bus Stop 1' will be located off State Mine Gully Road, with the turnaround route utilising the museum's internal access road. The proposed development will not have any adverse impact on public transport.

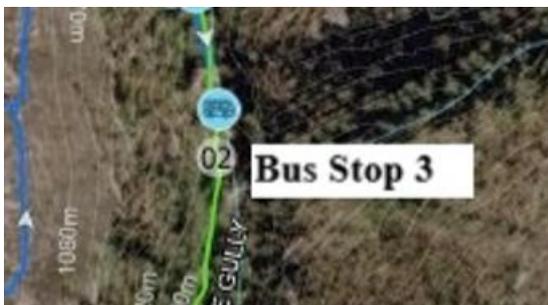
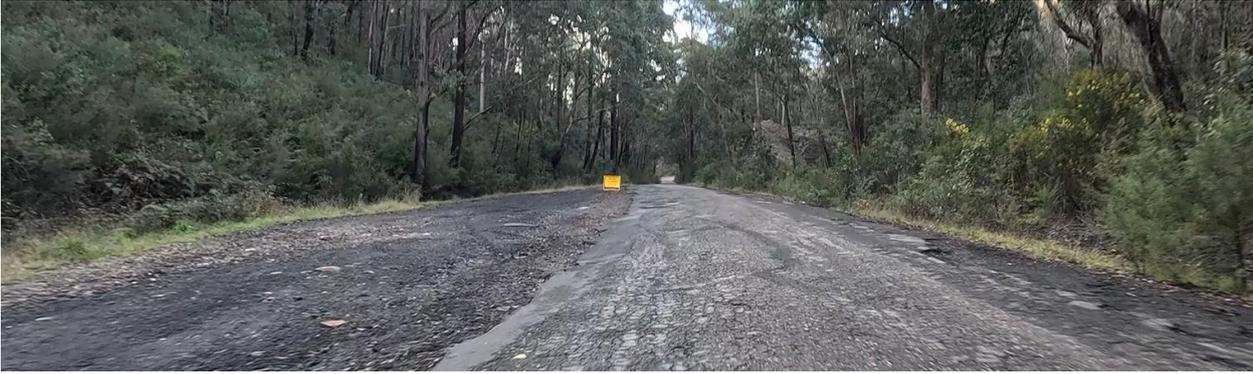
**Figure 4.6: Proposed location of Bus Stop 3**  
 (Source: PMO 360)

**Photo 4.3: State Mine Gully Road, at the proposed location of the 'Bus Stop 3' – ample adequate lateral clearance for shuttle bus accommodation without introducing operational or safety risks**  
(Photo: Traffic Engineering Centre Pty Ltd)

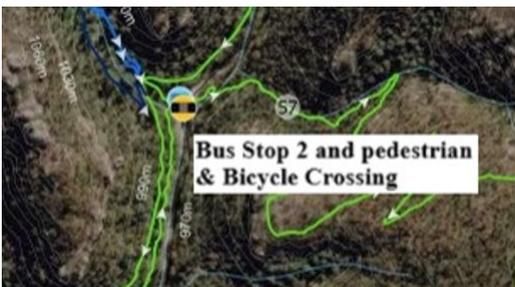
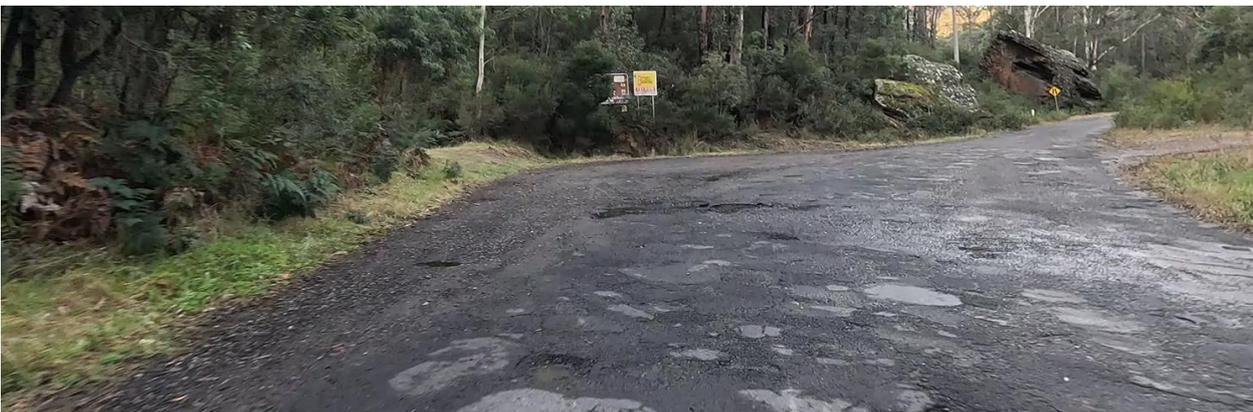
**Figure 4.7: Proposed location of pedestrian & bicycle crossing**  
(Source: PMO 360)

**Photo 4.2: State Mine Gully Road, at the proposed location of pedestrian & bicycle crossing**  
(Photo: Traffic Engineering Centre Pty Ltd)

Managing safety at mountain bike track crossings on public roads is crucial to prevent accidents and ensure smooth interaction between cyclists and motorists. The crossing will be designed in accordance with AusCycling recommendations and relative standards.

- Clear Signage & Warnings: install visible signs for both cyclists and drivers, indicating upcoming crossings and potential hazards
