Interim Reopening of Wolgan Road

Geotechnical Report

Lithgow City Council

Project name		Wolgan Road Reconstruction Project					
Document title		Interim Reopening of Wolgan Road Geotechnical Report					
Project number		12657881					
File name		12657881-GHD-00-00-REP-GE-00004_Interim Reopening Geotechnical Report.docx					
Status Code	Revision	Author	Reviewer		Approved for issue		
			Name	Signature	Name	Signature	Date
S3	01	D Jones	B Barber		D Jones		23/12/25
S3	02	B Barber	A Hunter		B Barber		02/02/26
S4	03	B Barber	A Hunter		D Jones		26/02/26
S4	04	S Ross	A Hunter		D Jones		05/03/26

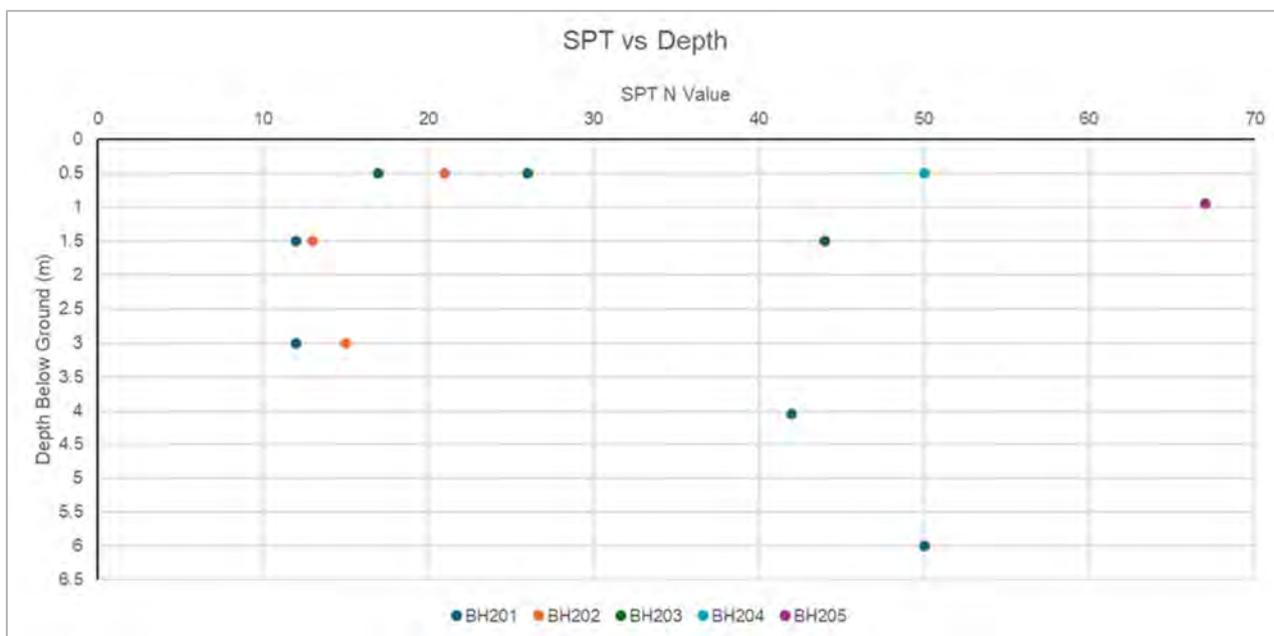
Figure 1 SPT results with depth

Standard Penetrometer Tests (SPTs) were conducted at 1.5 m depth intervals commencing at 0.5 m bgl. In the fill materials (0.5 m to approximately 1.5 m bgl), SPT N-values typically range between 12–20, indicating a loose to medium-dense consistency. Within the underlying colluvium (>1.5 m bgl), the N-values range between 20–54, reflecting a generally medium-dense to very dense profile. There is no consistent correlation between depth and N-value within either material unit (Figure 1). The results suggest the colluvium is denser and more compact than the overlying fill.

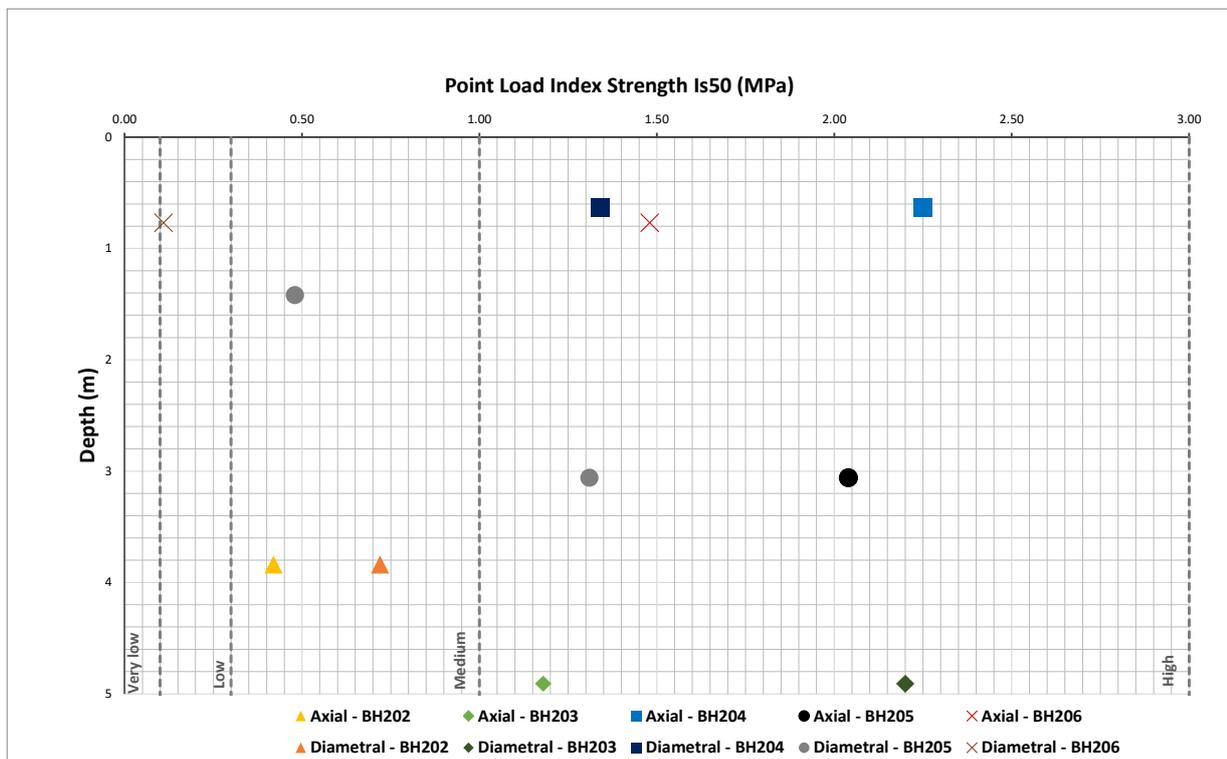
Figure 2 Point Load Test Results with depth

A range of strengths are reported, with the I_{s50} values ranging between 0.05 MPa and 2.5 MPa, corresponding to “Very Low” to “High” strength rock. All boreholes except BH206 had strengths of “Medium” to “High”. Many results show medium to high strength rock found at a shallow depth.

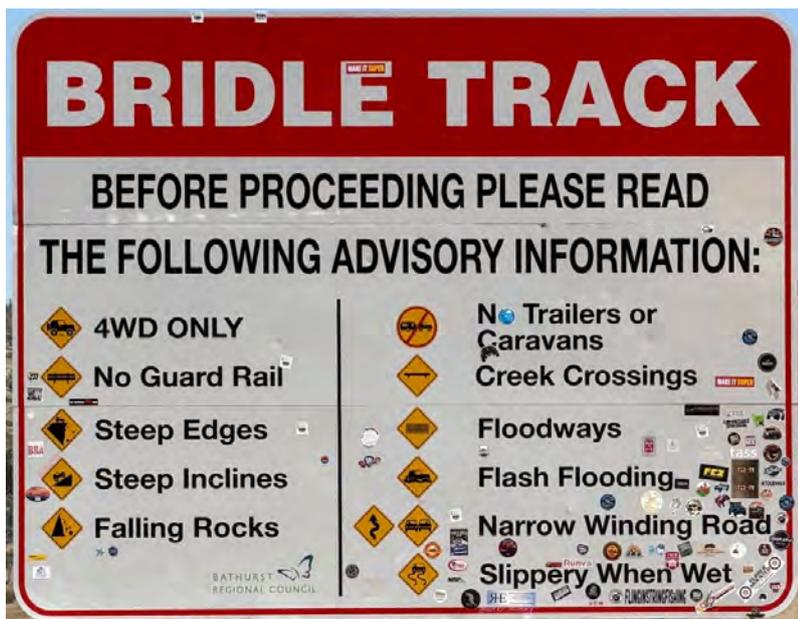
Figure 3 Example of advisory signage at the commencement of the Bridle Track, NSW.

At the start of Stage 2, advisory signage shall be installed at the road entrance (the top of the road) to alert drivers to conditions ahead. This signage will caution that although the road is open, it remains a mountain pass with hazardous conditions typically associated with these environments. Drivers are warned to proceed carefully, heed the new traffic controls (like the one-way sections or speed limits), and be aware of ongoing works if any.

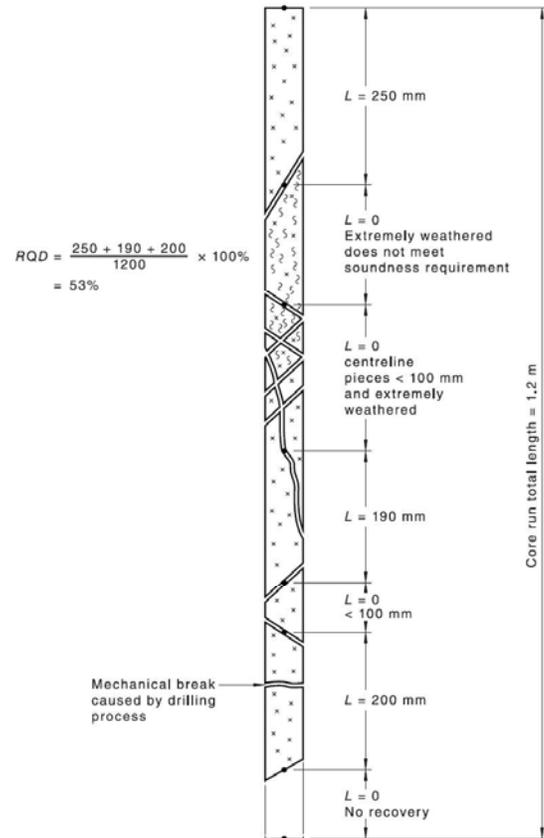
$$RQD = \frac{\sum \text{Length of sound core pieces} > 100 \text{ mm in length}}{\text{Length of core run}} \times 100\%$$

RQD measurement procedure
(reproduced from Figure 13, Clause 6.2.9.4, AS 1726- 2017, Geotechnical site investigations)

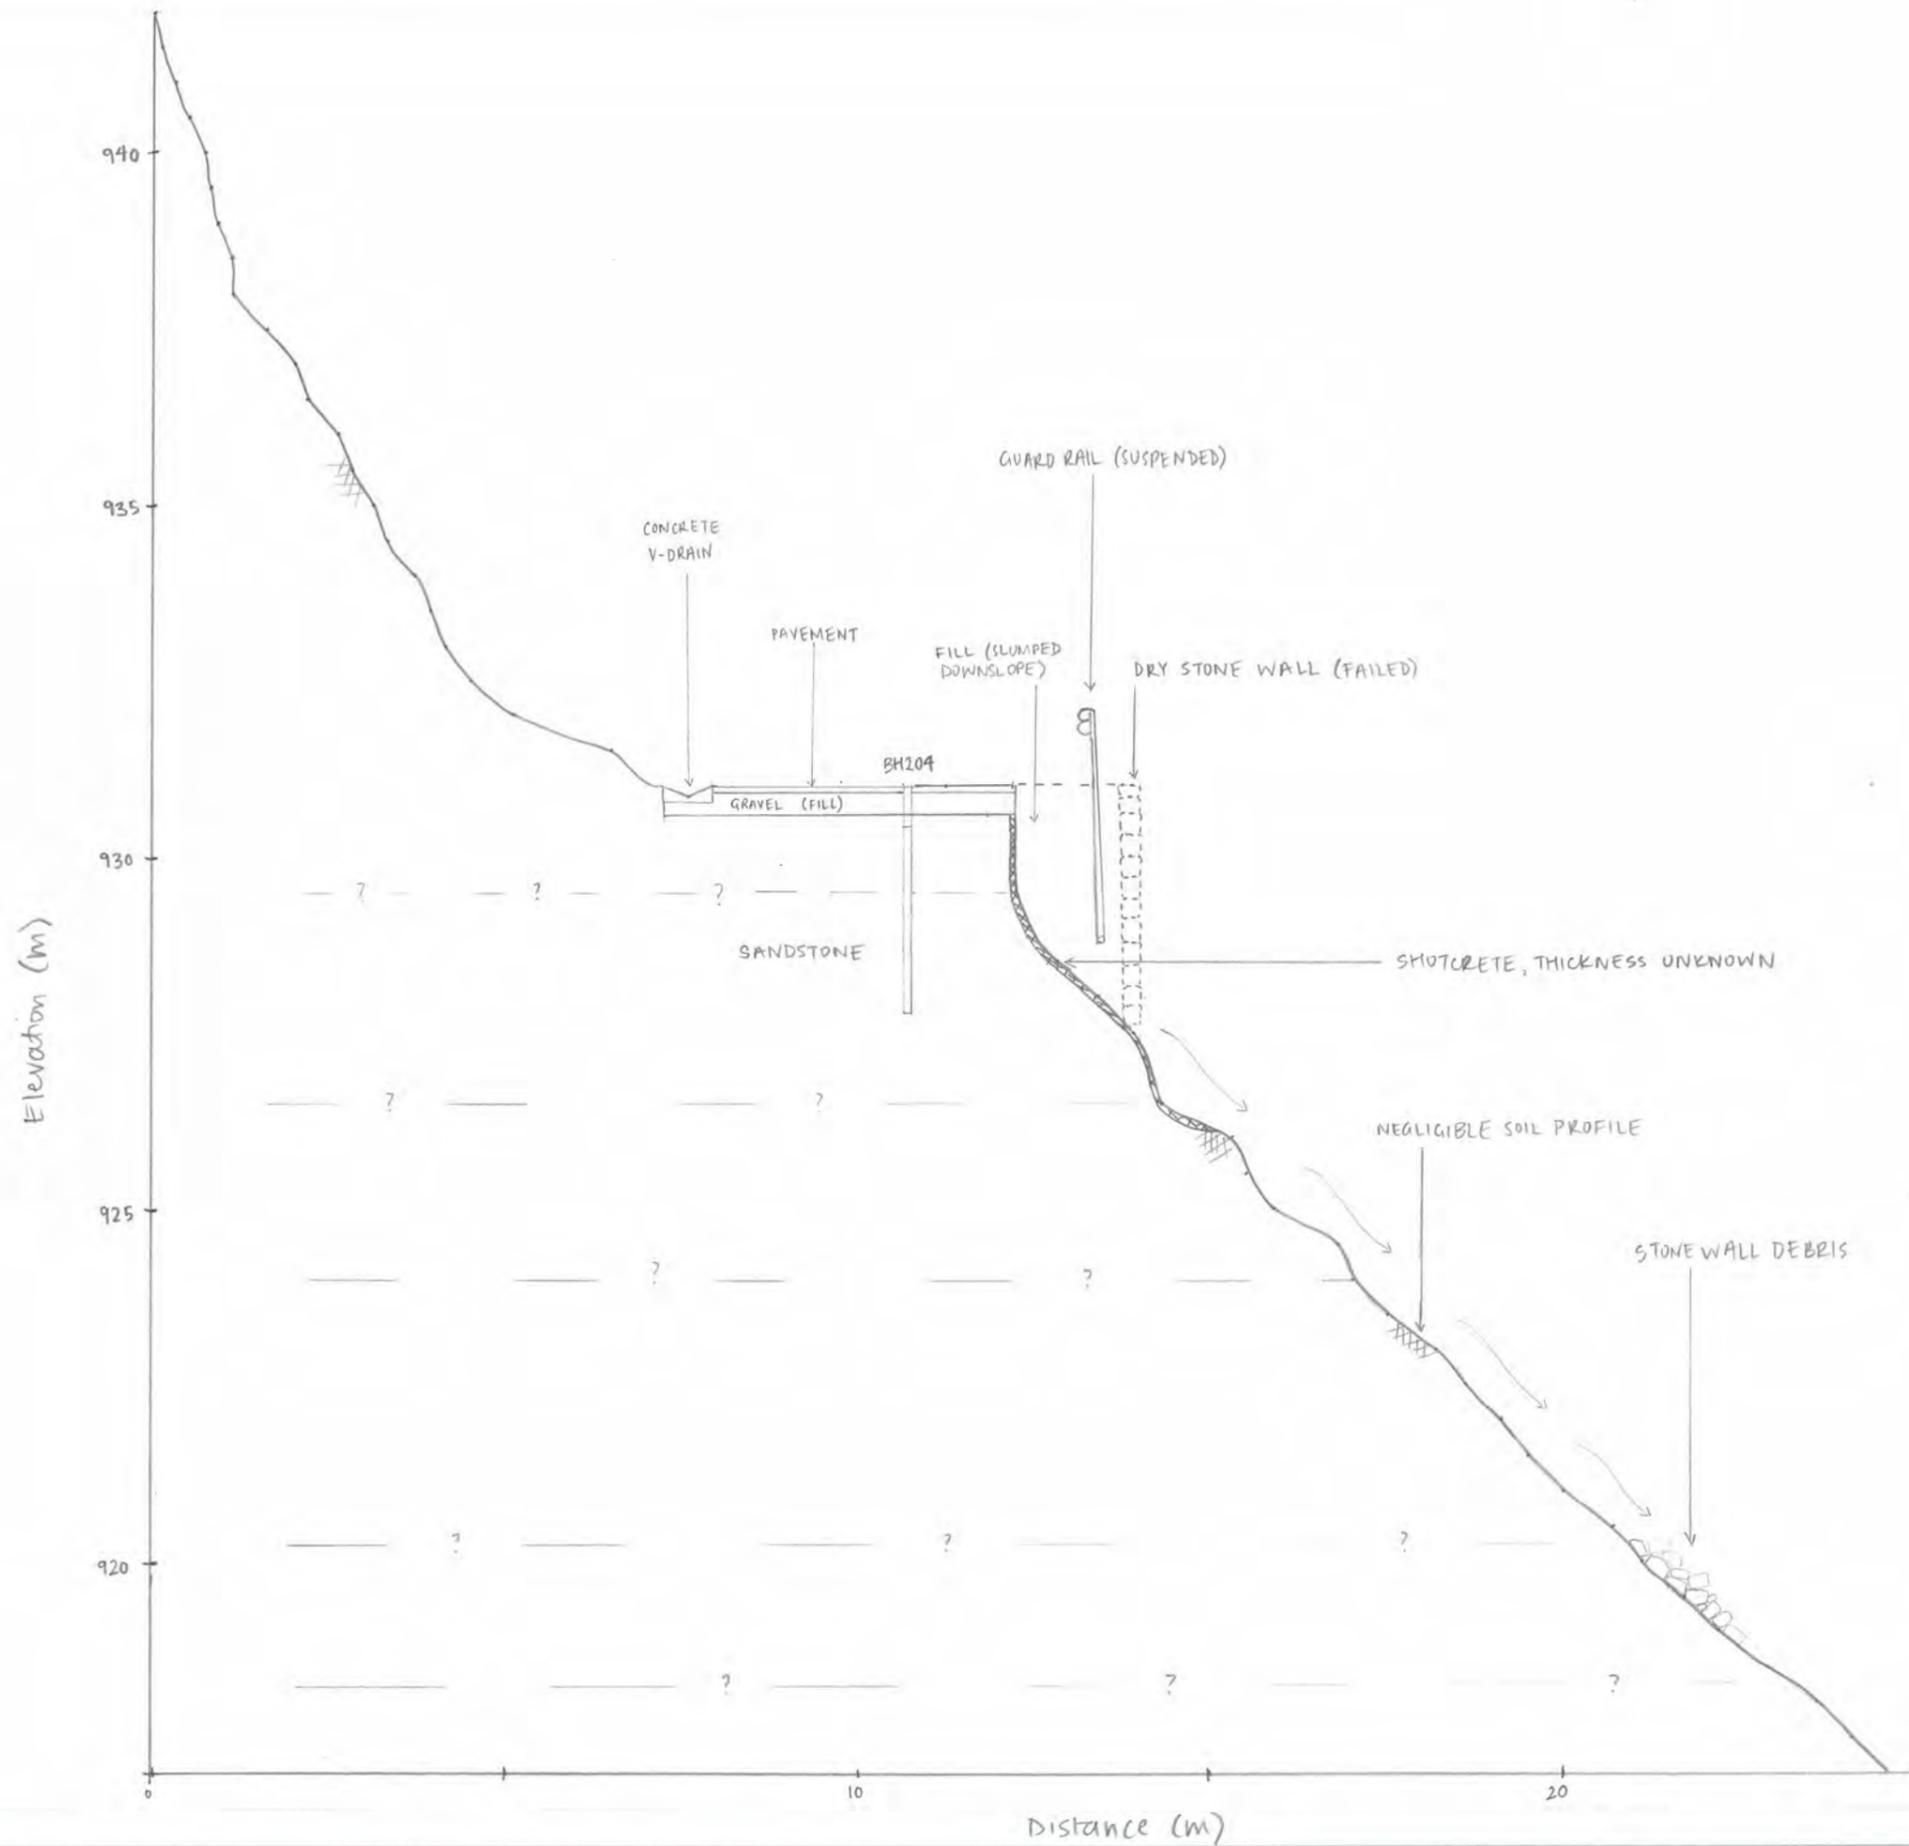
Scale 1:100

Cross section sketches at three key areas along the site were completed for CH040, CH408 and CH715. These show graphical interpretations of the site conditions and are included in Appendix B.

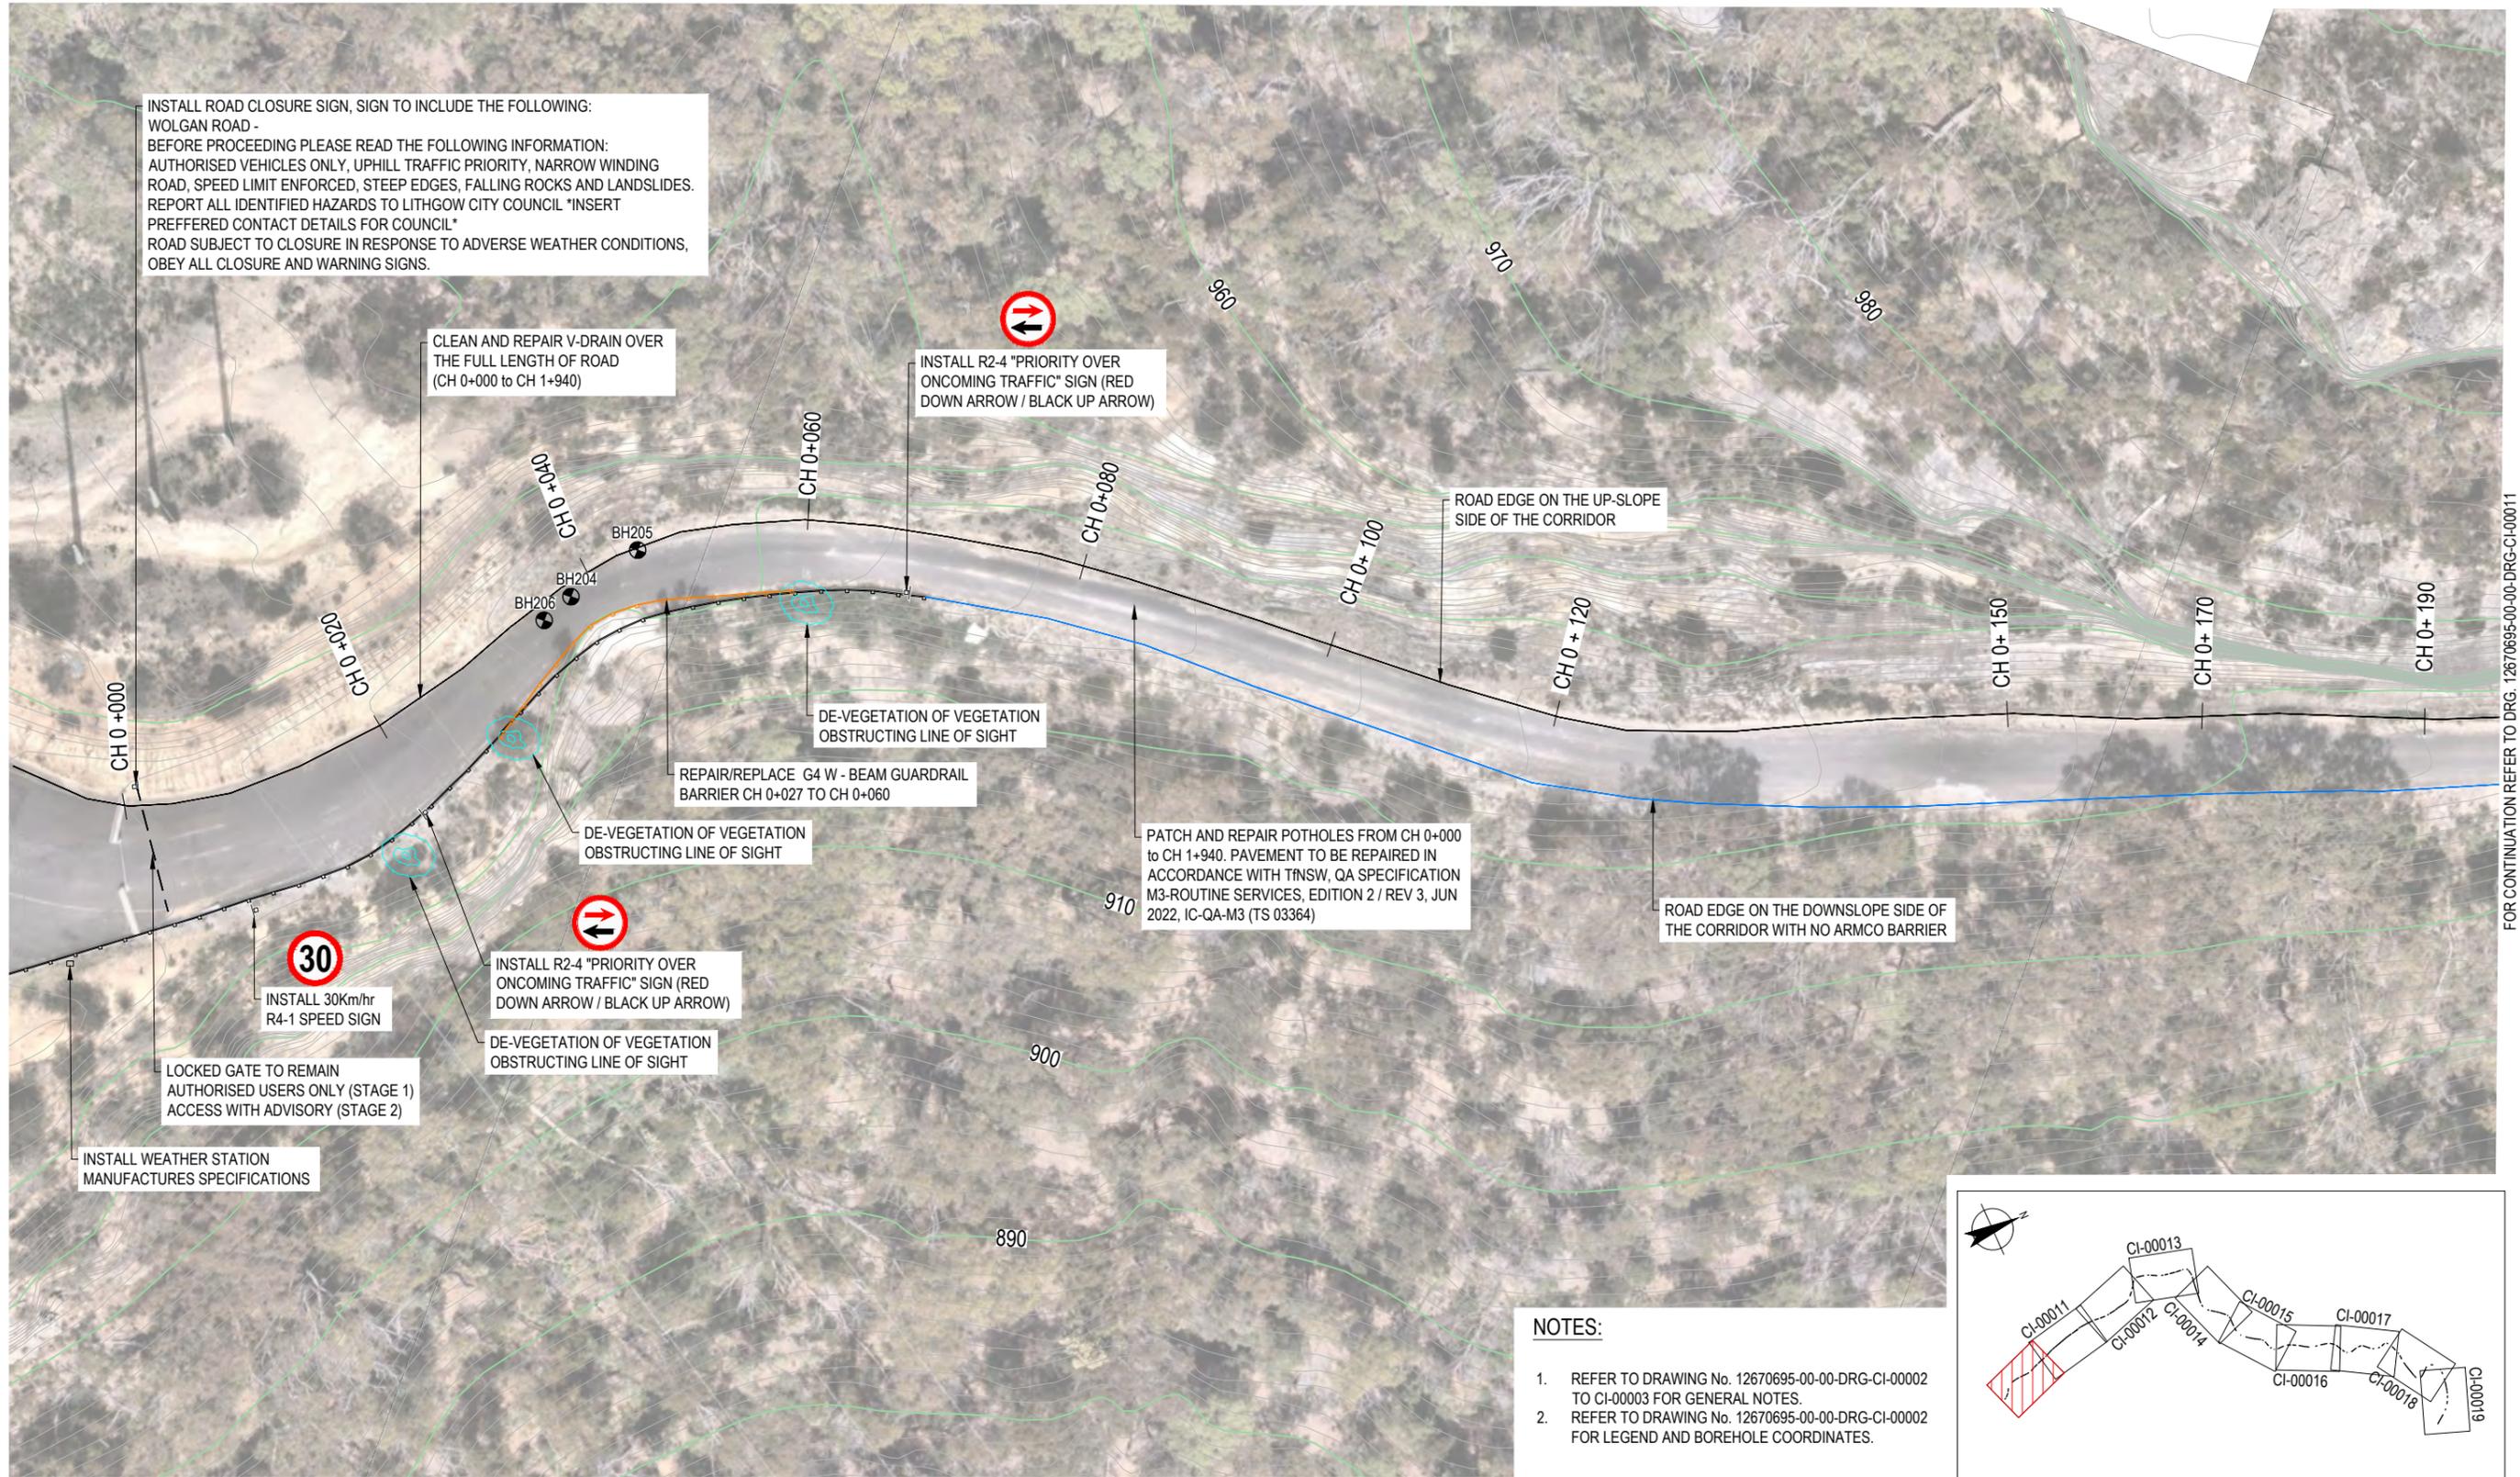
INSTALL ROAD CLOSURE SIGN, SIGN TO INCLUDE THE FOLLOWING:
 WOLGAN ROAD -
 BEFORE PROCEEDING PLEASE READ THE FOLLOWING INFORMATION:
 AUTHORISED VEHICLES ONLY, UPHILL TRAFFIC PRIORITY, NARROW WINDING
 ROAD, SPEED LIMIT ENFORCED, STEEP EDGES, FALLING ROCKS AND LANDSLIDES.
 REPORT ALL IDENTIFIED HAZARDS TO LITHGOW CITY COUNCIL *INSERT
 PREFERRED CONTACT DETAILS FOR COUNCIL*
 ROAD SUBJECT TO CLOSURE IN RESPONSE TO ADVERSE WEATHER CONDITIONS,
 OBEY ALL CLOSURE AND WARNING SIGNS.

CLEAN AND REPAIR V-DRAIN OVER
 THE FULL LENGTH OF ROAD
 (CH 0+000 TO CH 1+940)

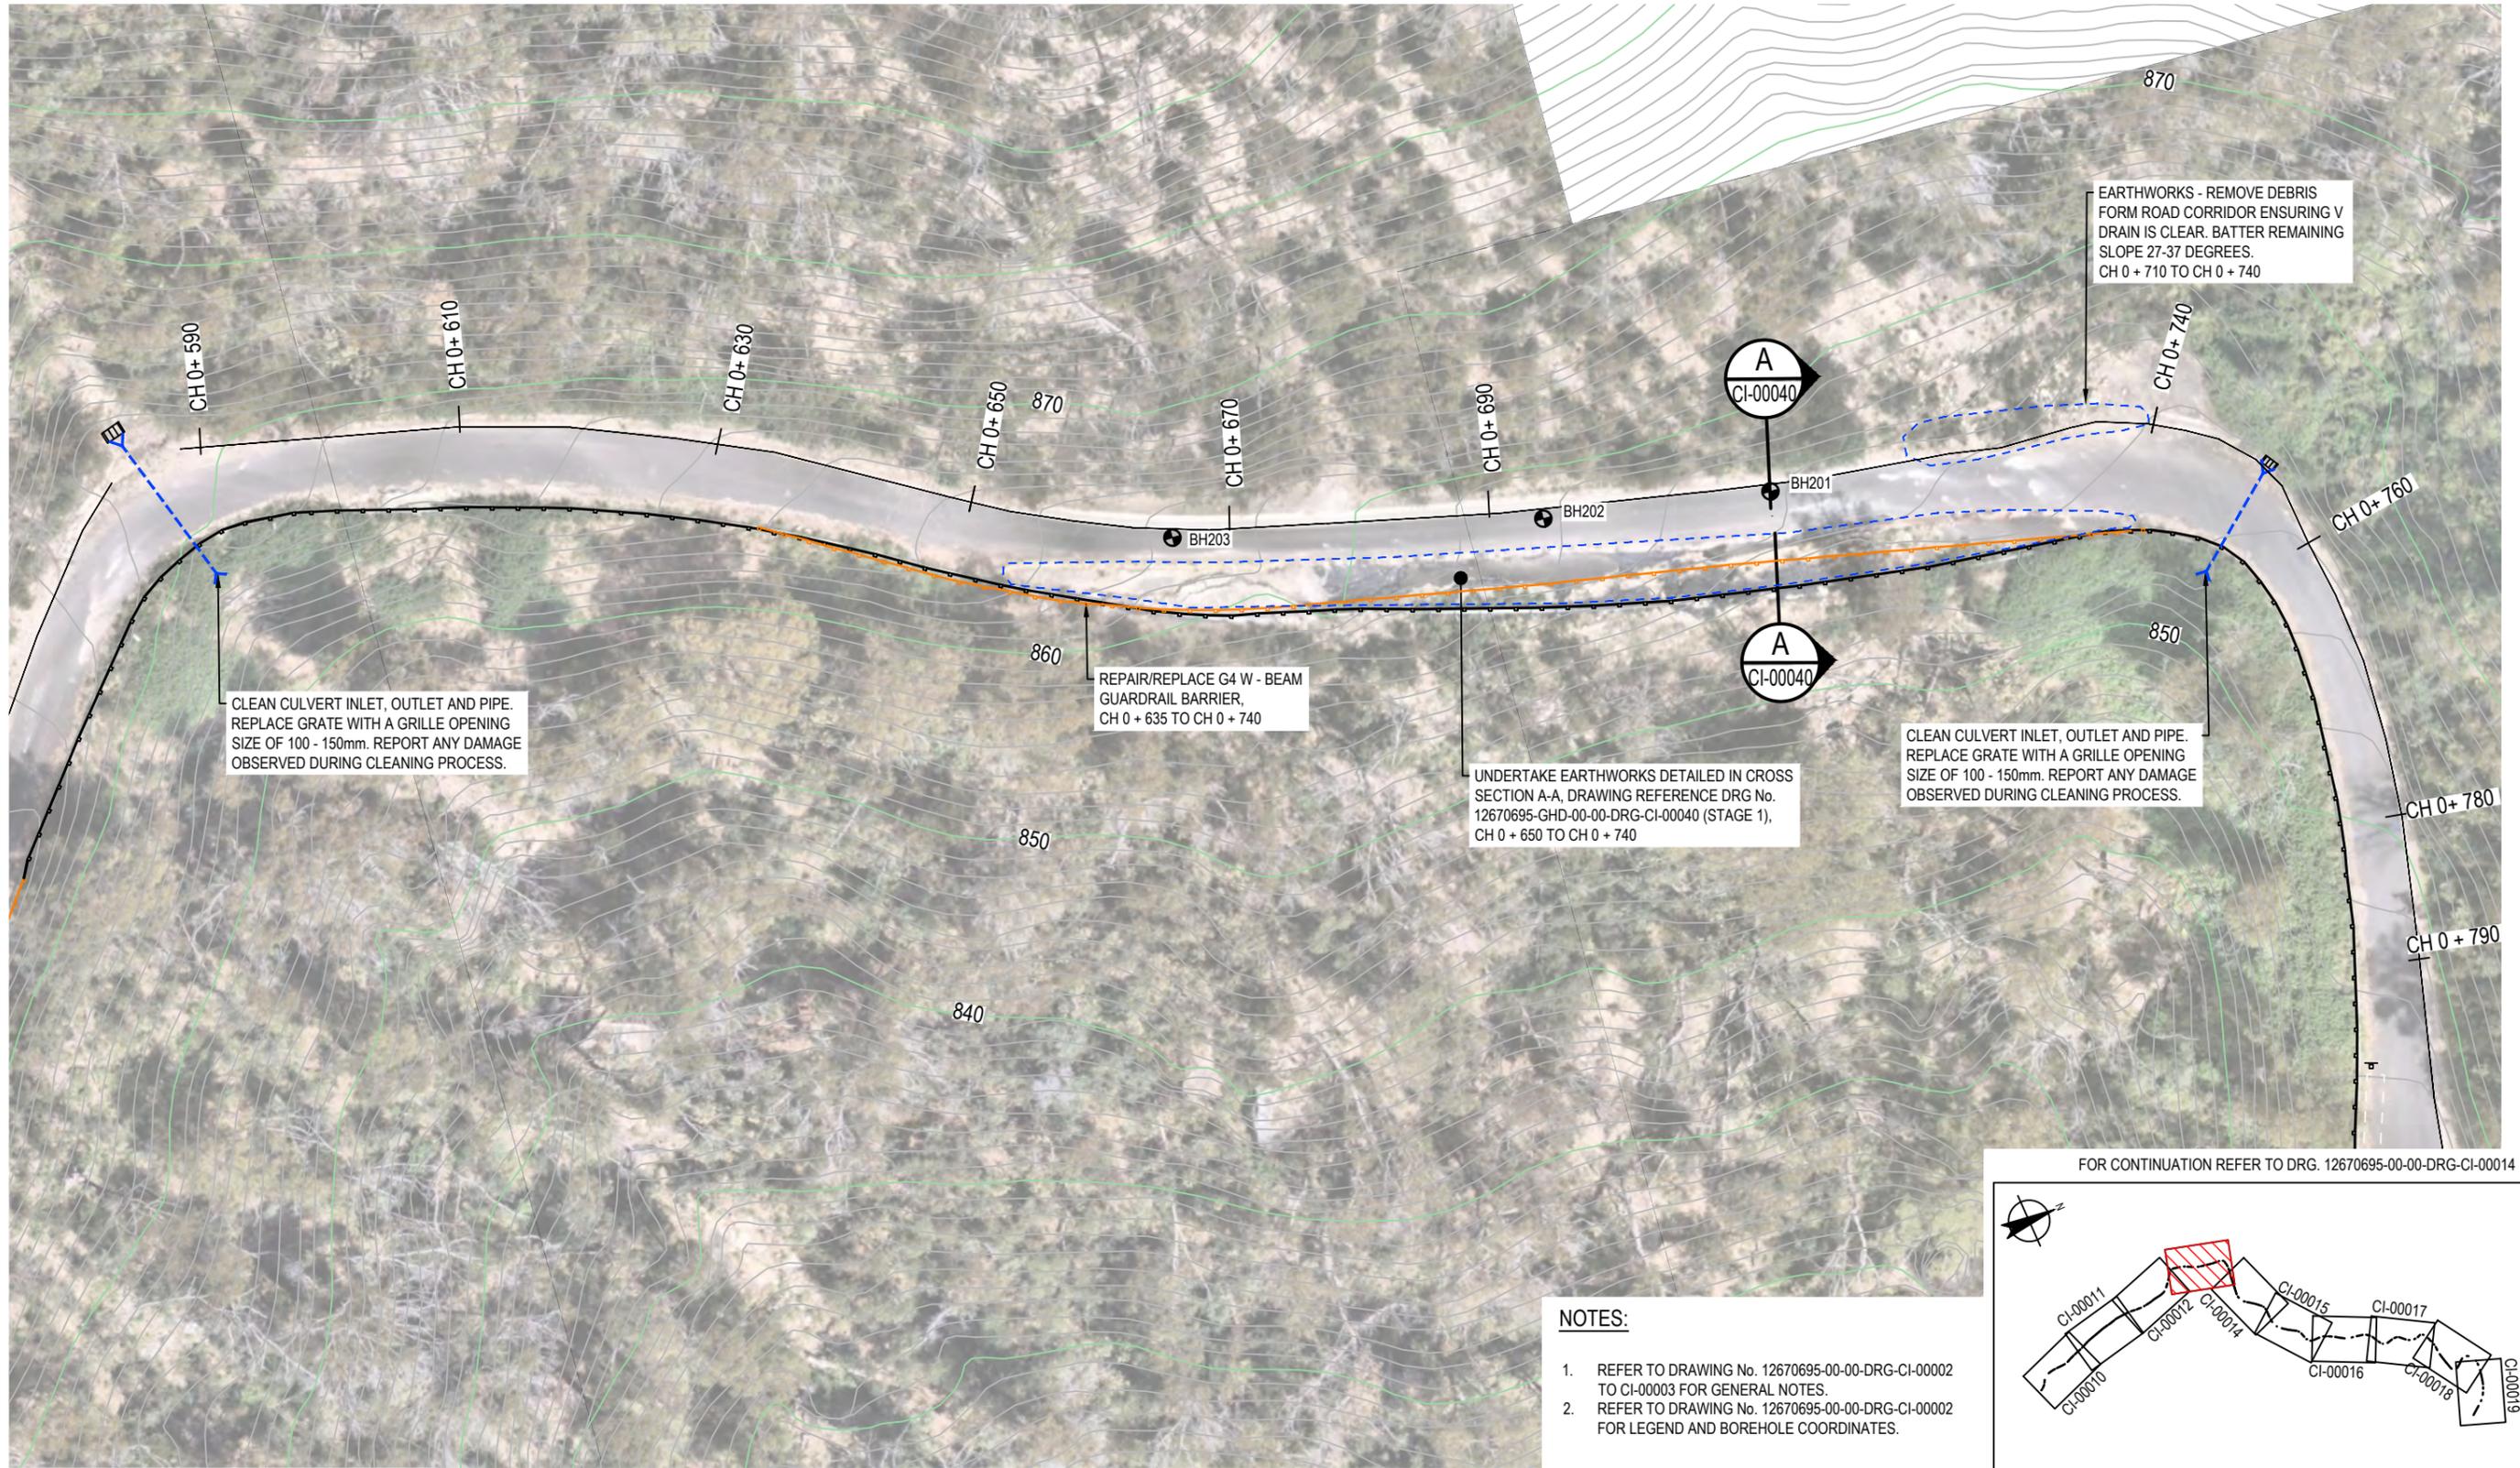
EARTHWORKS - REMOVE DEBRIS FROM ROAD CORRIDOR ENSURING V DRAIN IS CLEAR. BATTER REMAINING SLOPE 27-37 DEGREES. CH 0 + 710 TO CH 0 + 740

CLEAN CULVERT INLET, OUTLET AND PIPE. REPLACE GRATE WITH A GRILLE OPENING SIZE OF 100 - 150mm. REPORT ANY DAMAGE OBSERVED DURING CLEANING PROCESS.

1.10	Minor Earthworks and Slope Regrading	530 – 550 downslope 650 - 740 downslope 720 - 740 upslope	Earthworks/ Slope Stabilization	Conduct localised earthworks to remove failed section of road embankment encroaching into the road corridor (upslope). Remove and disposal of material within the road corridor. Areas specified for repair within the road corridor will require a temporary asphalt spray to seal the surface, link the existing and new surfaces and prevent water ingress into the road.

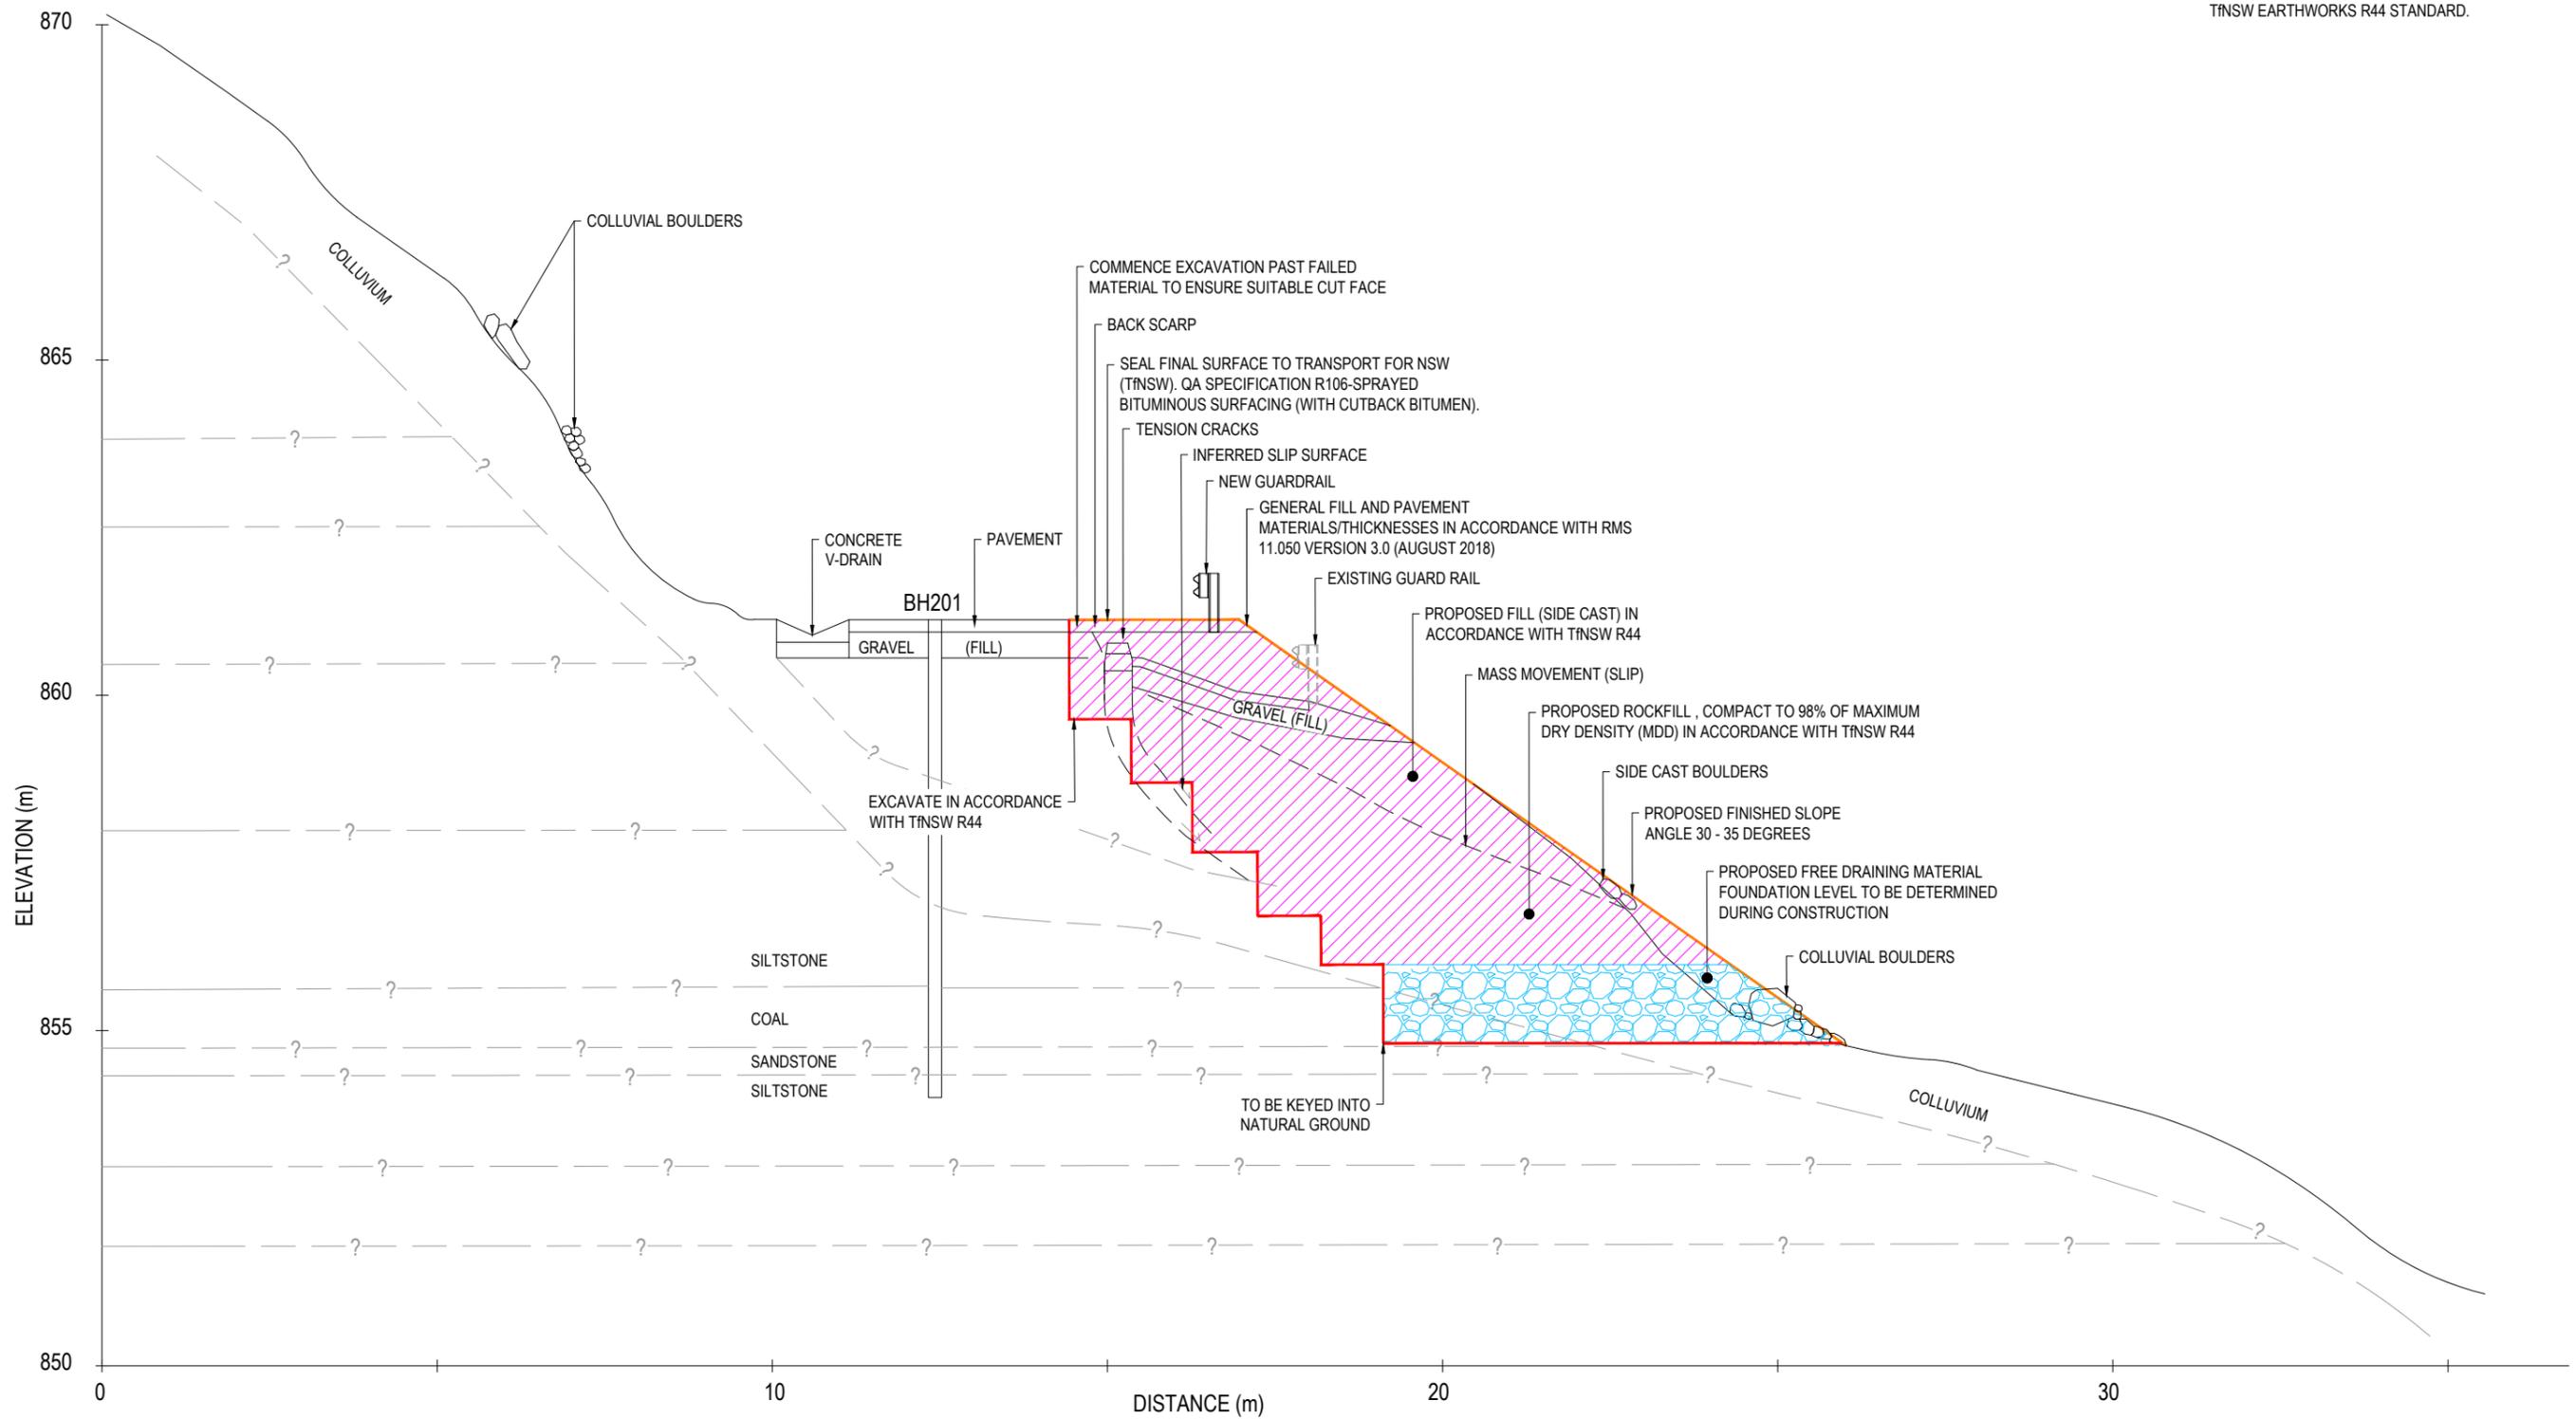
A SECTION A - A
CI-00013 SCALE 1 : 100

- EARTH WORKS TO BE IN ACCORDANCE WITH TNSW EARTHWORKS R44 STANDARD.

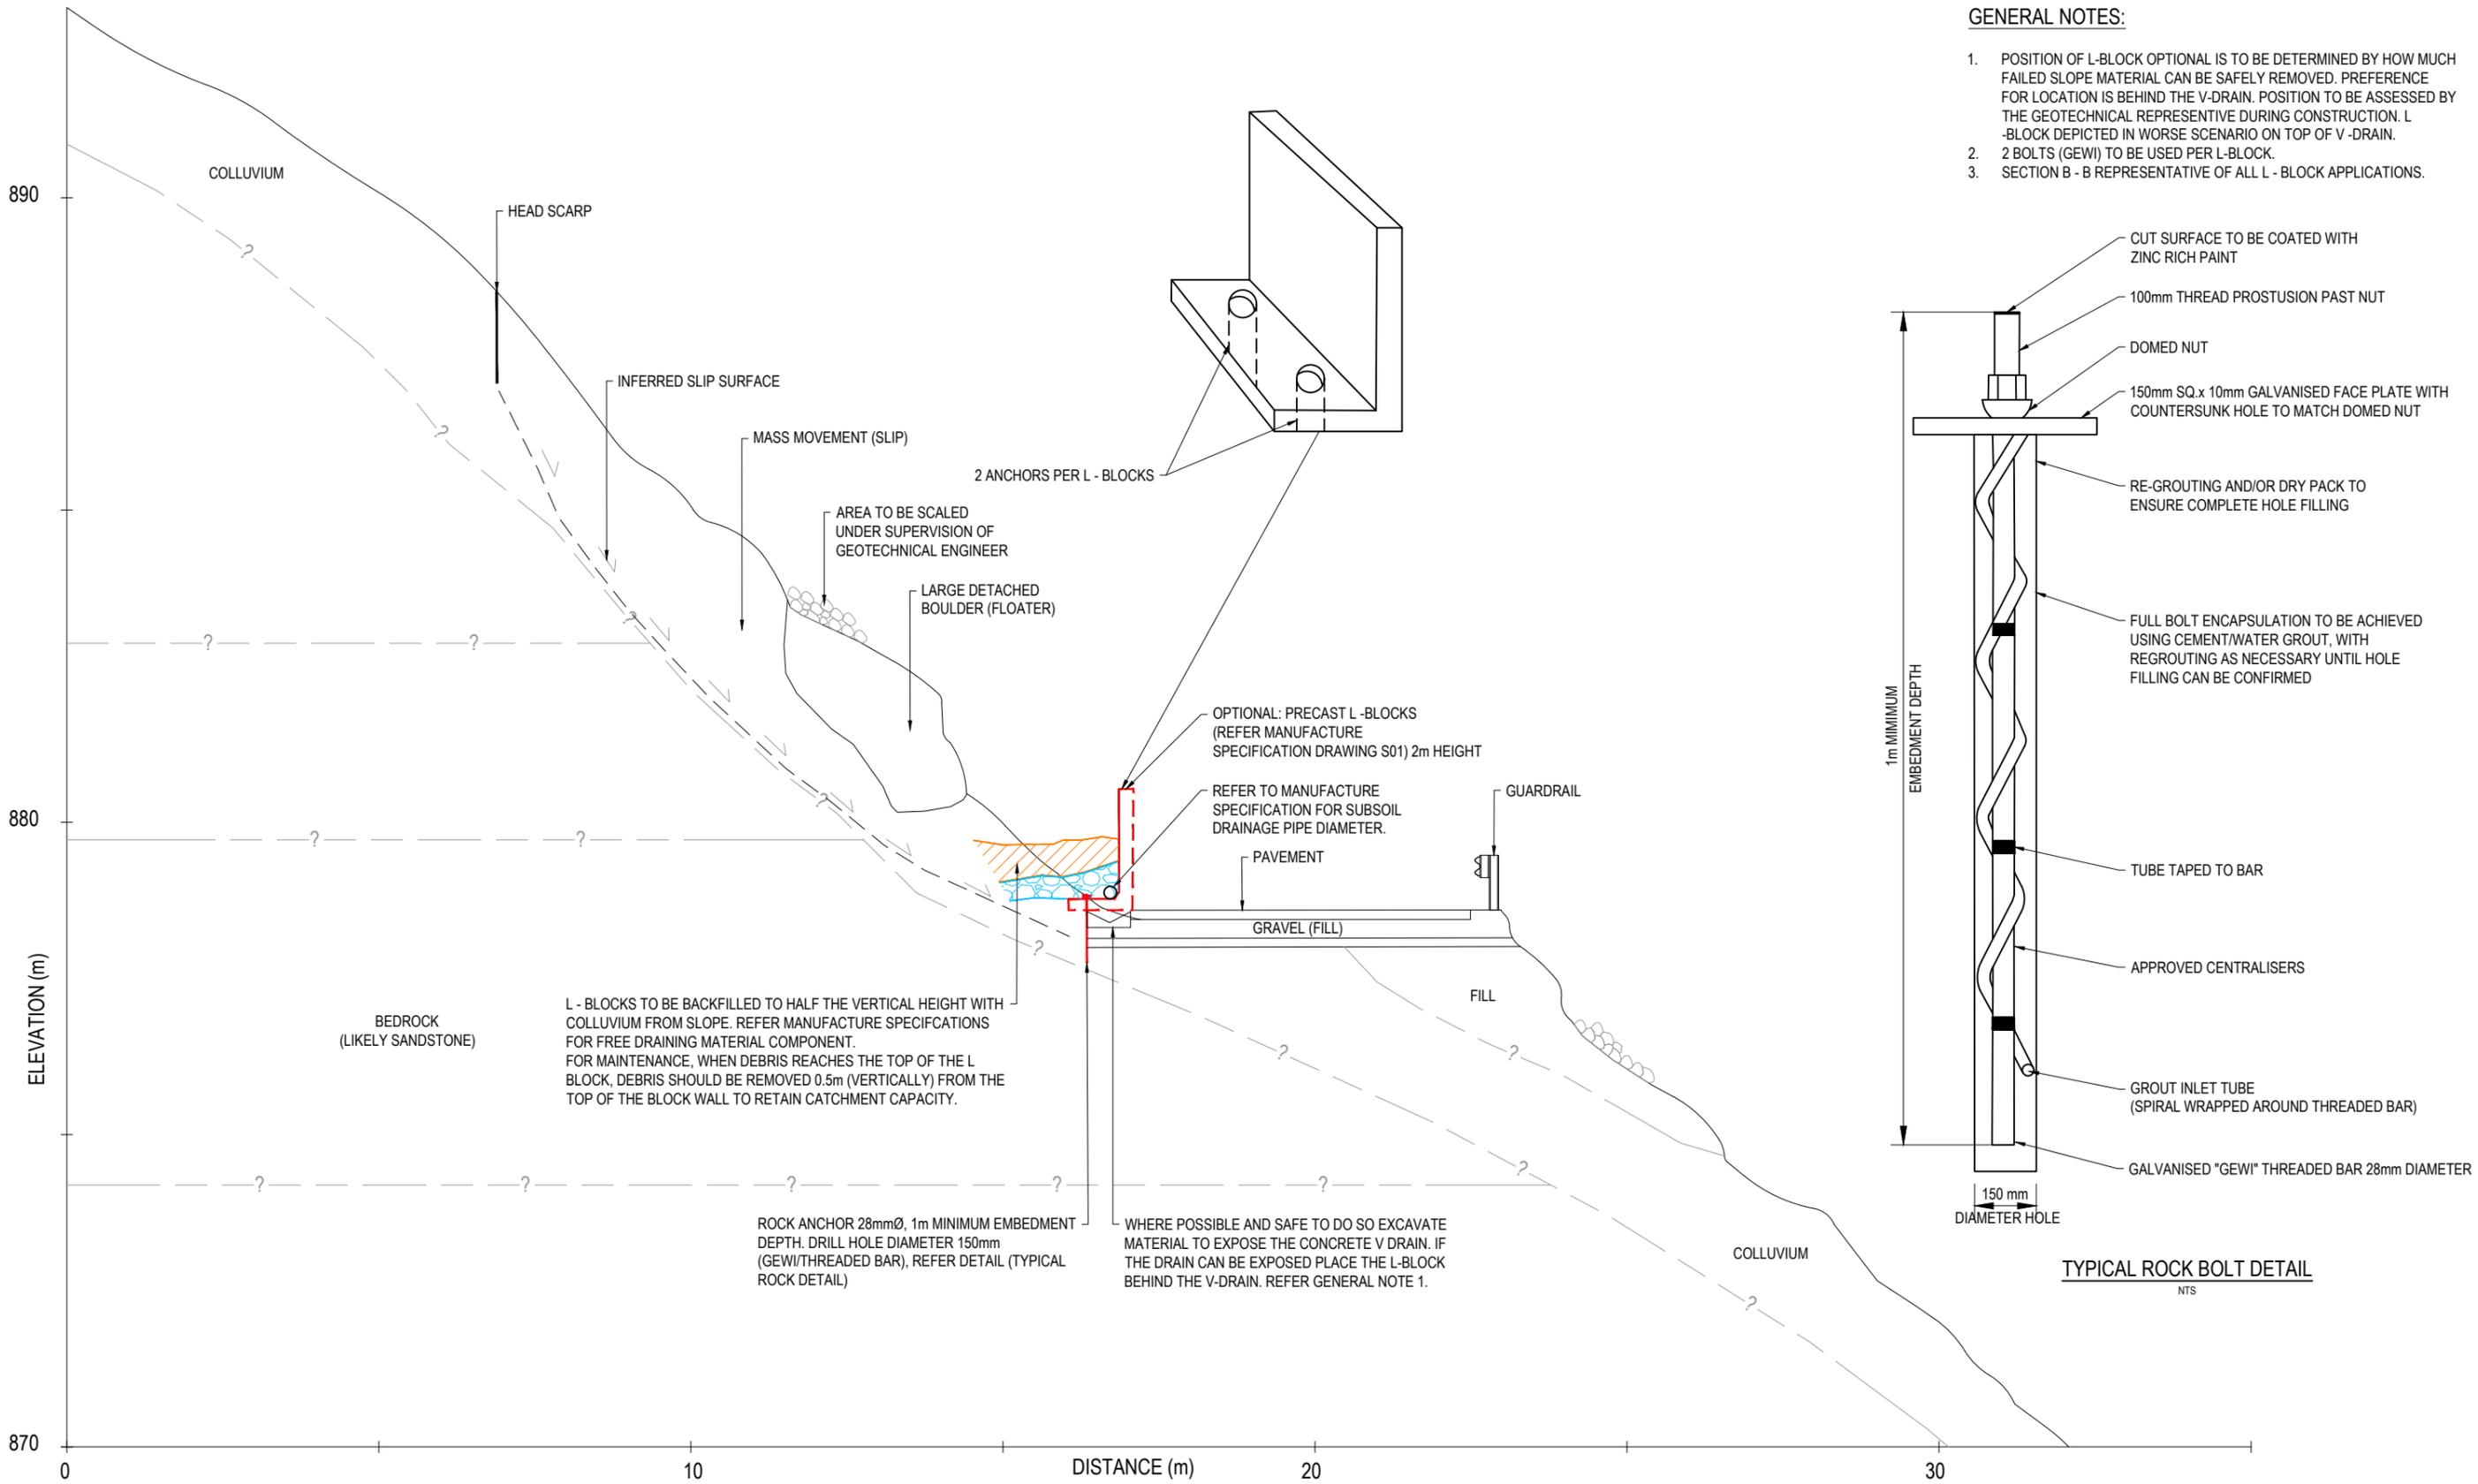
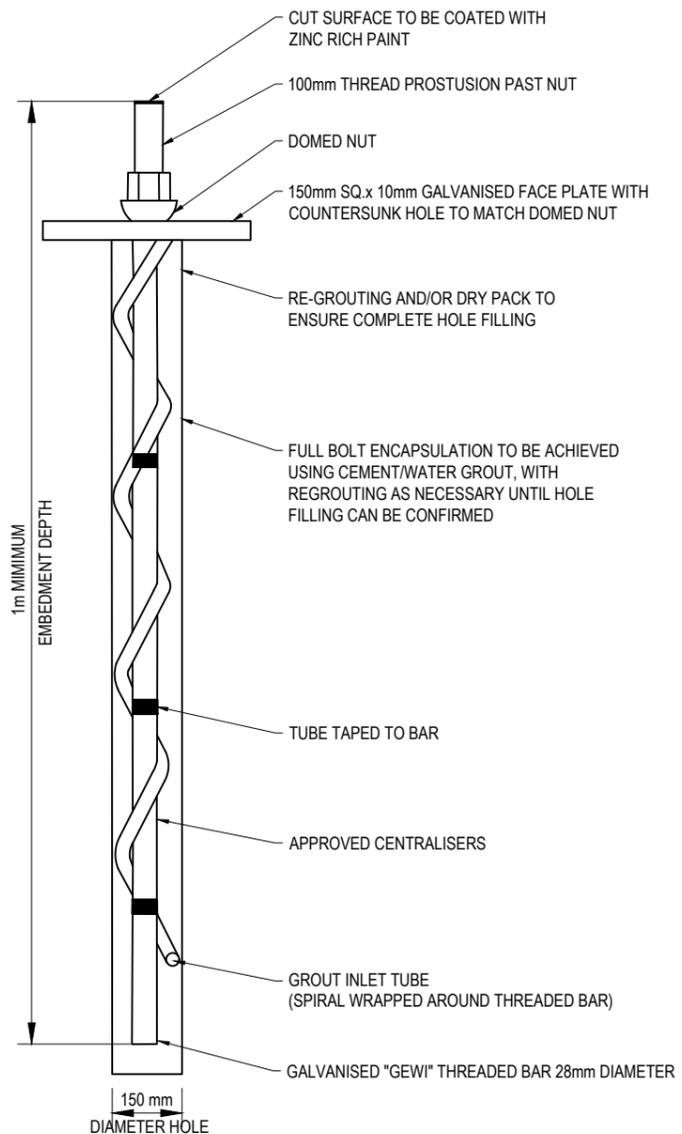
B SECTION B - B
SCALE 1 : 100

1. POSITION OF L-BLOCK OPTIONAL IS TO BE DETERMINED BY HOW MUCH FAILED SLOPE MATERIAL CAN BE SAFELY REMOVED. PREFERENCE FOR LOCATION IS BEHIND THE V-DRAIN. POSITION TO BE ASSESSED BY THE GEOTECHNICAL REPRESENTATIVE DURING CONSTRUCTION. L -BLOCK DEPICTED IN WORSE SCENARIO ON TOP OF V-DRAIN.
2. 2 BOLTS (GEWI) TO BE USED PER L-BLOCK.
3. SECTION B - B REPRESENTATIVE OF ALL L - BLOCK APPLICATIONS.
