Interim Reopening of Wolgan Road

Geotechnical Report

Lithgow City Council

Project name		Wolgan Road Reconstruction Project					
Document title		Interim Reopening of Wolgan Road Geotechnical Report					
Project number		12657881					
File name		12657881-GHD-00-00-REP-GE-00004_Interim Reopening Geotechnical Report.docx					
Status Code	Revision	Author	Reviewer		Approved for issue		
			Name	Signature	Name	Signature	Date
S3	01	D Jones	B Barber		D Jones		23/12/25
S3	02	B Barber	A Hunter		B Barber		02/02/26
S4	03	B Barber	A Hunter		D Jones		26/02/26
S4	04	S Ross	A Hunter		D Jones		05/03/26

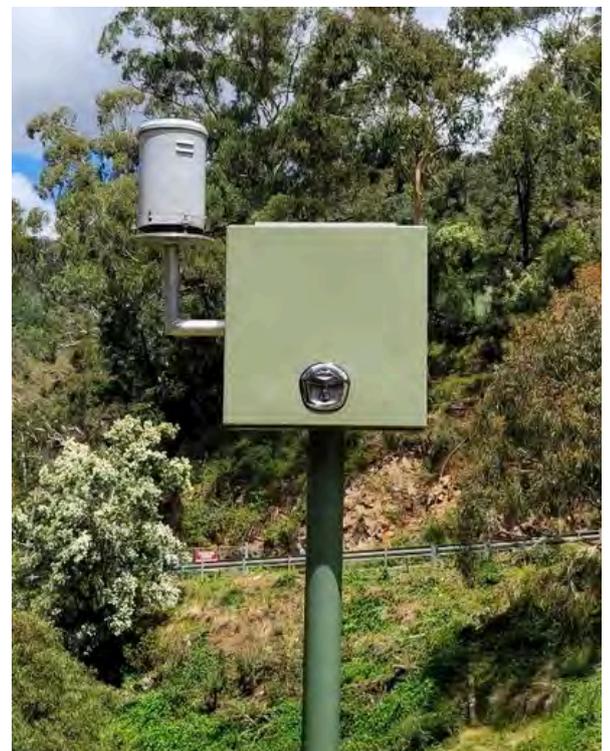
Figure 3 gives an example of the type of weather station that would be required at Wolgan Road. A similar setup was used by GHD in conjunction with Transport for NSW at Jenolan Caves.

Figure 3 Weather station installed by MHL at Jenolan Caves

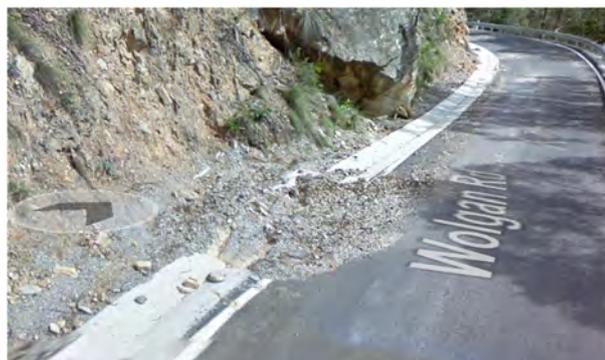
To facilitate the installation of the alternate pit grates and debris management, a small crew of experience tradesmen would be required to carry out the works including any concrete adjustment work. It is noted that from some investigations into the road alignment during its operation before the current defects, debris blockage of the stormwater pits was an ongoing issue as is representative in the following image.

Figure 1. pre damage photo, showing debris caught at pit grate

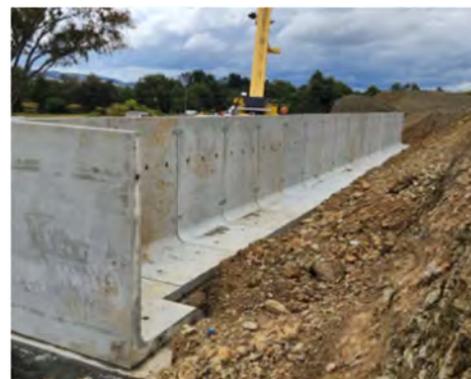
- Verification of extent of treatment.
- Procurement of precast wall units, including any custom features to accommodate curved installation.
- Once units are available from precasting operations, carry out:
 - Excavation and foundation preparation, which would include a base gravel foundation construction.
 - Carry out vertical rock anchor installation into the foundation to provide vertical and lateral restraint
 - Installation of the proposed L block units.
 - Installation of subsoil drainage and drainage medium behind the wall, progressively with backfill material where specified.

Figure 2 Proposed L precast catch barrier wall units
