Preliminary contamination investigation

Lot 1 DP914028, Lidsdale NSW

Summary report

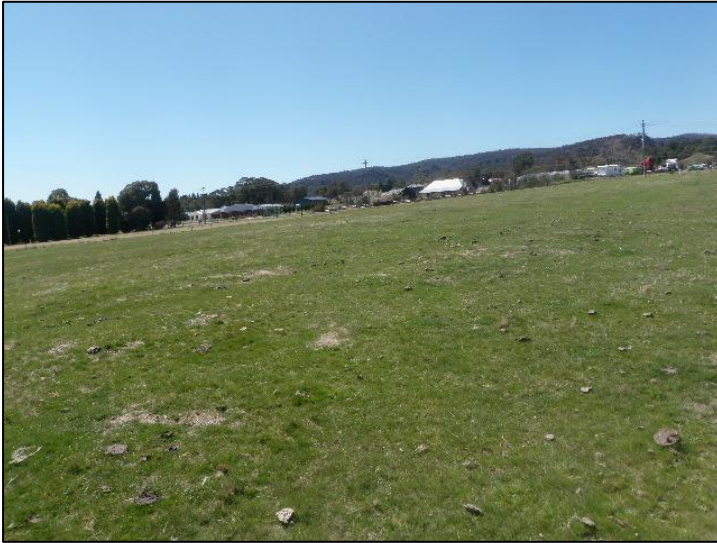
Looking north east across eastern section of site

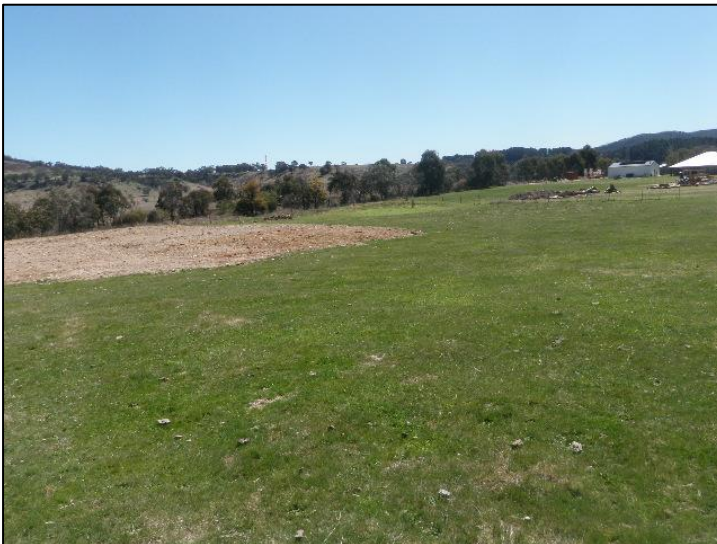
Surface cover on the site comprised pastures grasses including ryegrass and red grass. No trees were present. A level building pad in the west of the site comprises imported fill material. Fill material imported to the site for a level building pad was pre classified as ENM.

Looking north east across western section of site showing imported fill pad

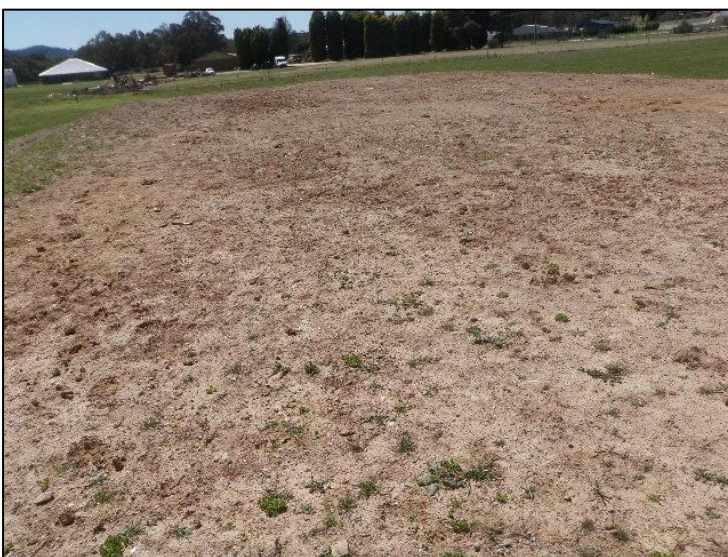
Fill material imported to the site for a level building pad was pre classified as ENM and is not considered a potential contaminate.

Looking north across imported fill pad

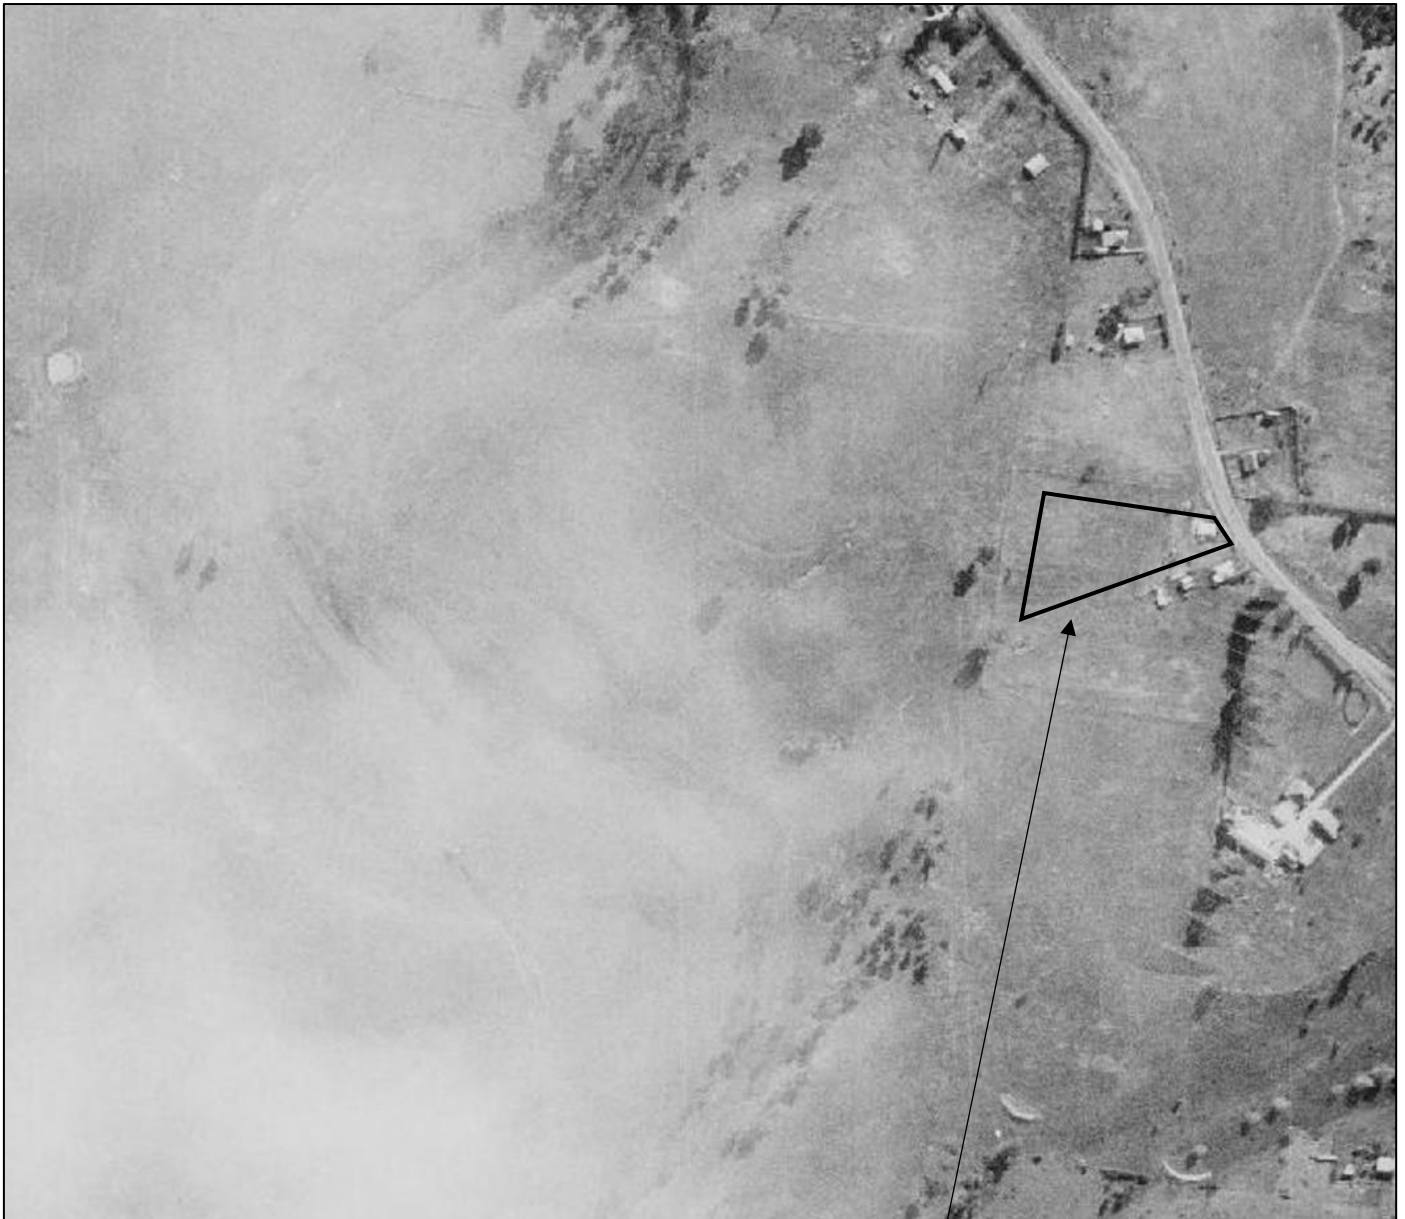
Appendix 1.1 1969 Aerial photograph		
Lot 1 DP 914028, 32 Ian Holt Drive, Lidsdale NSW

Year	Visual observations on site and surround land
1969	A structure presumed to be a dwelling is present in the east of the site with other infrastructure located to the south east of the site. The remainder of the site appears to be agricultural pasture. A presumed industrial complex/site is located to the south east. Ian Holt Drive is located to the east. Residential dwellings are located to the north. Agricultural land is located to the south and west.
1975	No significant changes identified.
1984	The dwelling has been removed a potential concrete slab remains. Disturbance is present to the east of the site.
1991	A series of soil stockpiles/disturbed areas are located in the central section of the site. The stockpiles form a cross country track for motorbikes. Industrial complex/site to the south east has expanded and an additional driveway to Ian Holt Drive is present.
1998	No significant on-site changes identified, former dwelling site remains visible. Original driveway at Industrial complex/site to the south east has been removed. Additional Industrial infrastructure is located to the east.

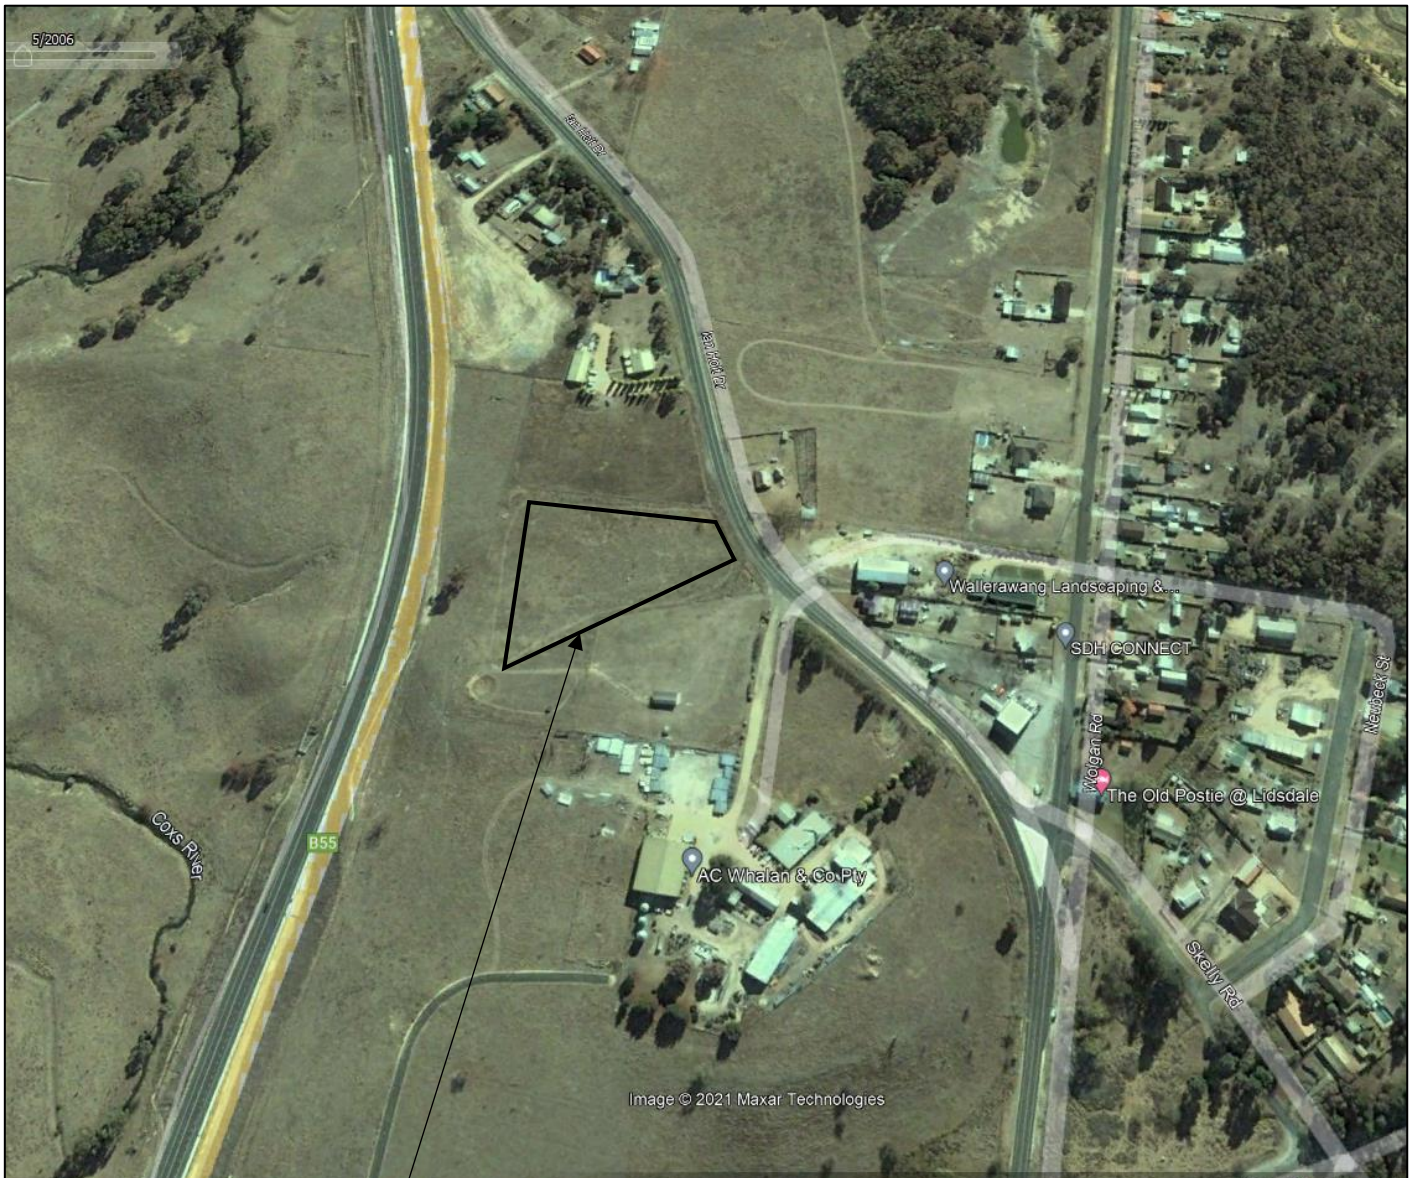
Appendix 1.6 2006 Aerial photograph		
Lot 1 DP 914028, 32 Ian Holt Drive, Lidsdale NSW

2006	The former dwelling slab and other infrastructure to the south east have been removed. The site appears vacant. A track is evident around the boundary of the site. A shed has been constructed to the south east on 32 Ian Holt Drive. The Castlereagh Highway has been constructed to the west. Industrial complex/site to the south east has expanded
2014	A disturbance possibly stockpiling is noted in the south west of the site. The disturbance was identified as motorcycle jumps during the site inspection. The remainder of the site is well vegetated. Cattle are present on the site. A dwelling and associated infrastructure has been constructed to the south east.
