# **Bell Quarry Rehabilitation Project**

## **Supplementary Environmental Impact Statement**

19 November 2021

# Submission of Supplementary EIS

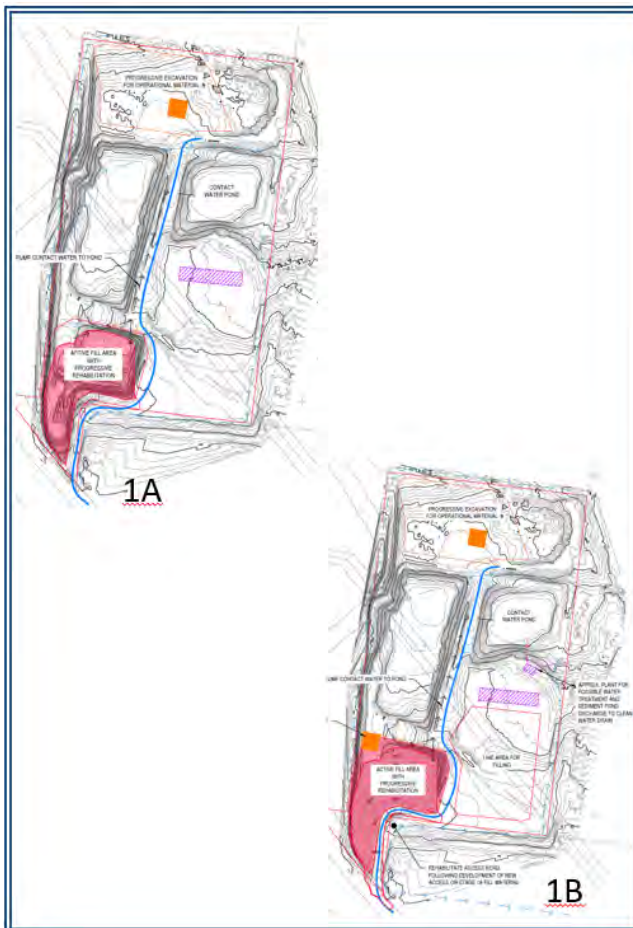
Figure 2.2 Indicative Staging plans

### STAGE ONE

**VOLUME:** 220,100 m<sup>3</sup>

- During the filling works in south eastern area, contact water collected and drain/pumped to contact water pond.
- Intermediate capping progressively installed on western intermediate batter.
- Direct sediment laden water from intermediate cap areas to temporary pond for treatment before discharge.
- Construct temporary clean water diversion system for water from west of the site.
- Dewater the western void, for Stage 3 filling

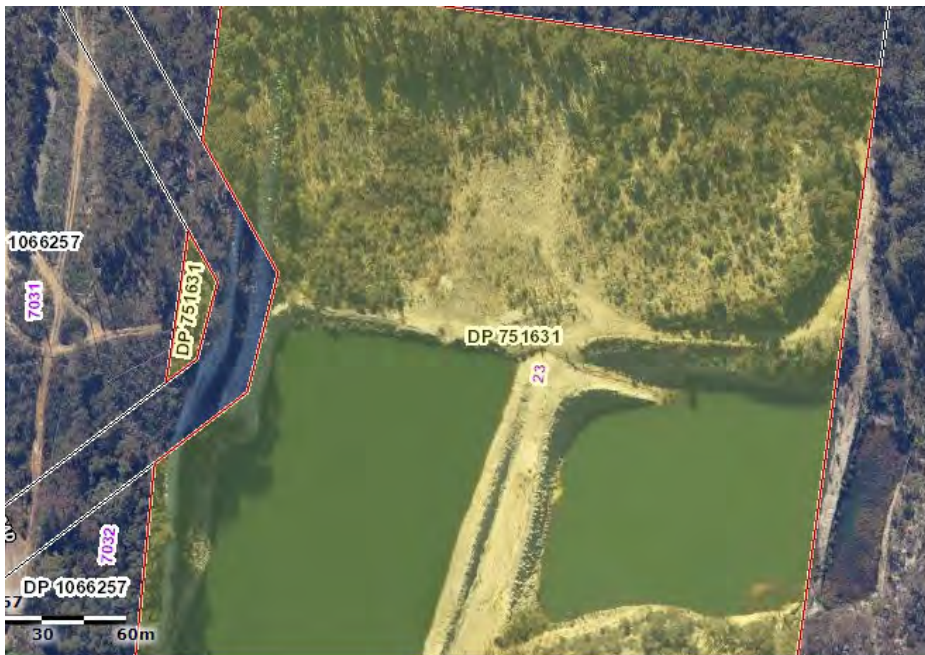
Figure 2.3 Aerial taken from six-maps showing the part of the Western Boundary of the main void which extends beyond the site boundary

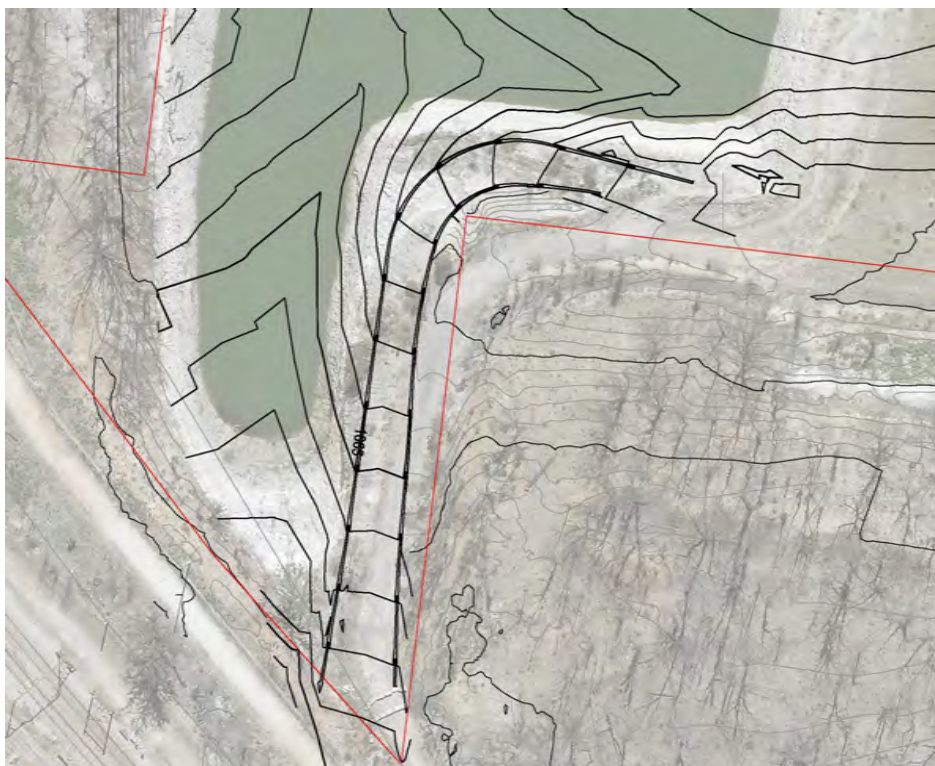
**Figure 2.6** *Revised Final Landform*

An indication of the revised final landform overlaid above an existing aerial is included in and indicates how the road cannot be installed until the completion of filling the southern void in Stage 1A of the proposed emplacement sequence due to the steepness of the existing land's surface and close proximity to the quarry walls. The filling of Stage 1A is predicted to be complete within around 12 months from commencement.

The road will be established near the end of the proposed filling of Stage 1A and will result in a slight change in final landform and reduction in filling volume to accommodate the road design.

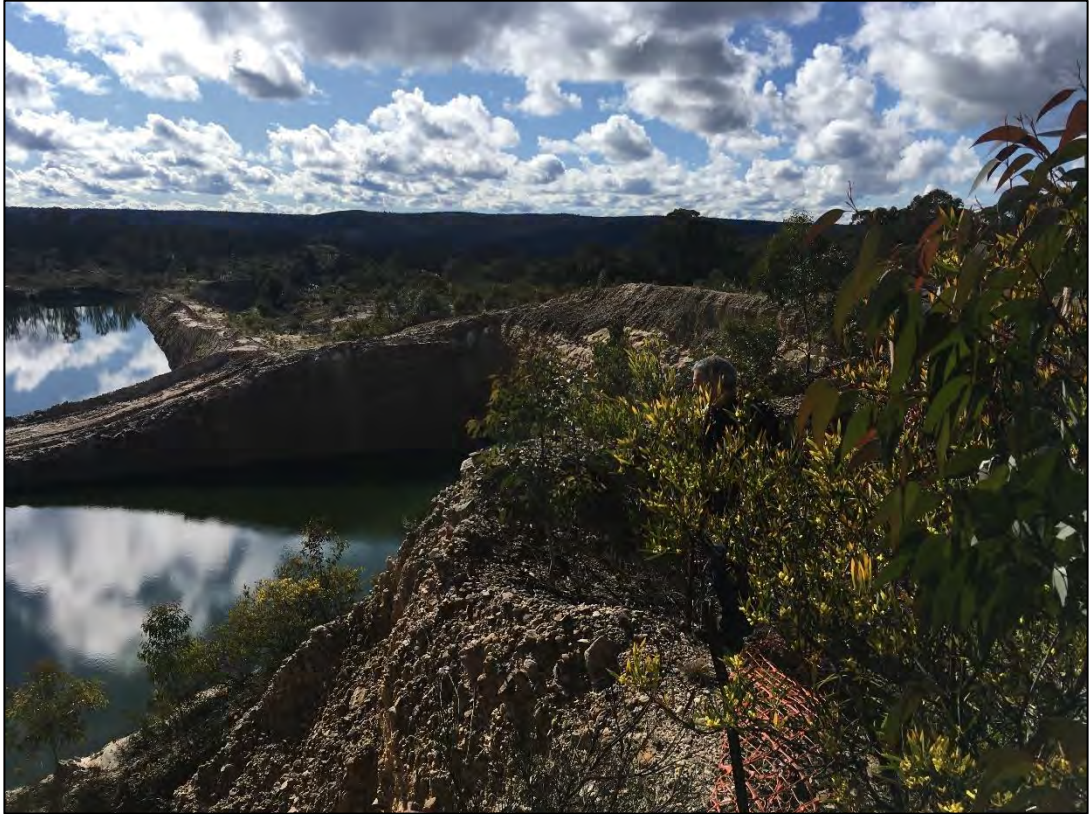
**Figure 2:** Former quarry site with Pond 2 on left and Pond 1 at centre of photo.

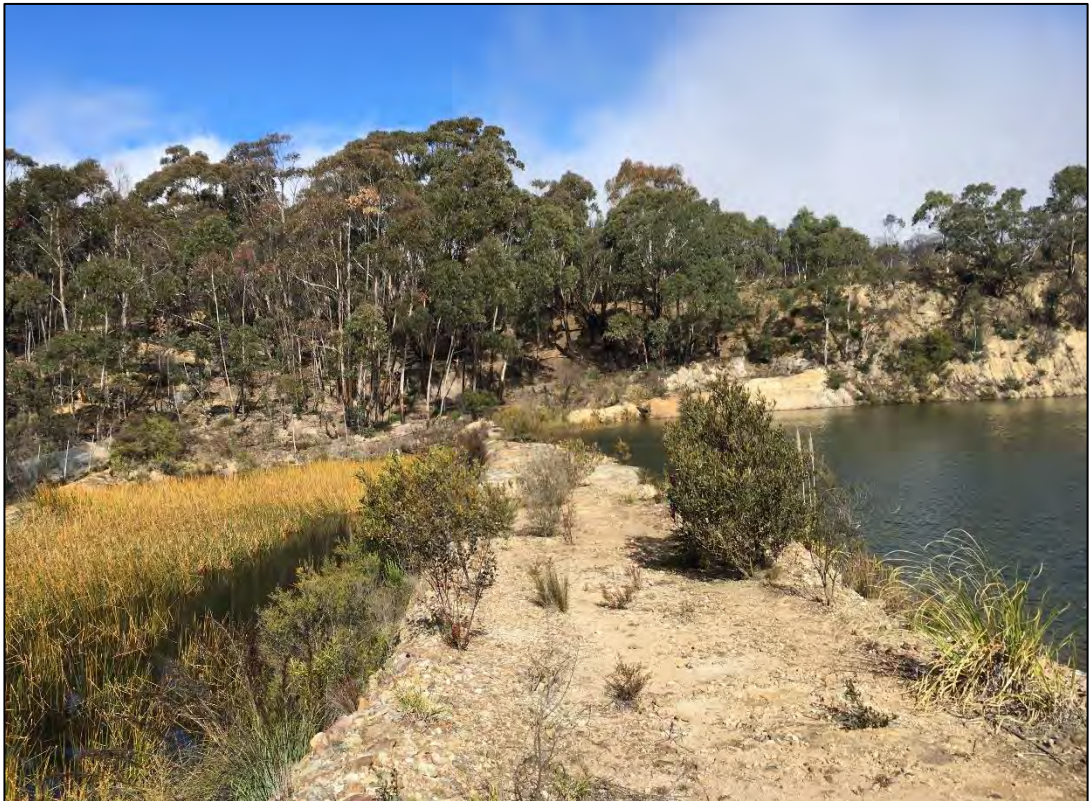
**Figure 3:** Existing Pond 2 (at right) and wetland (at left).

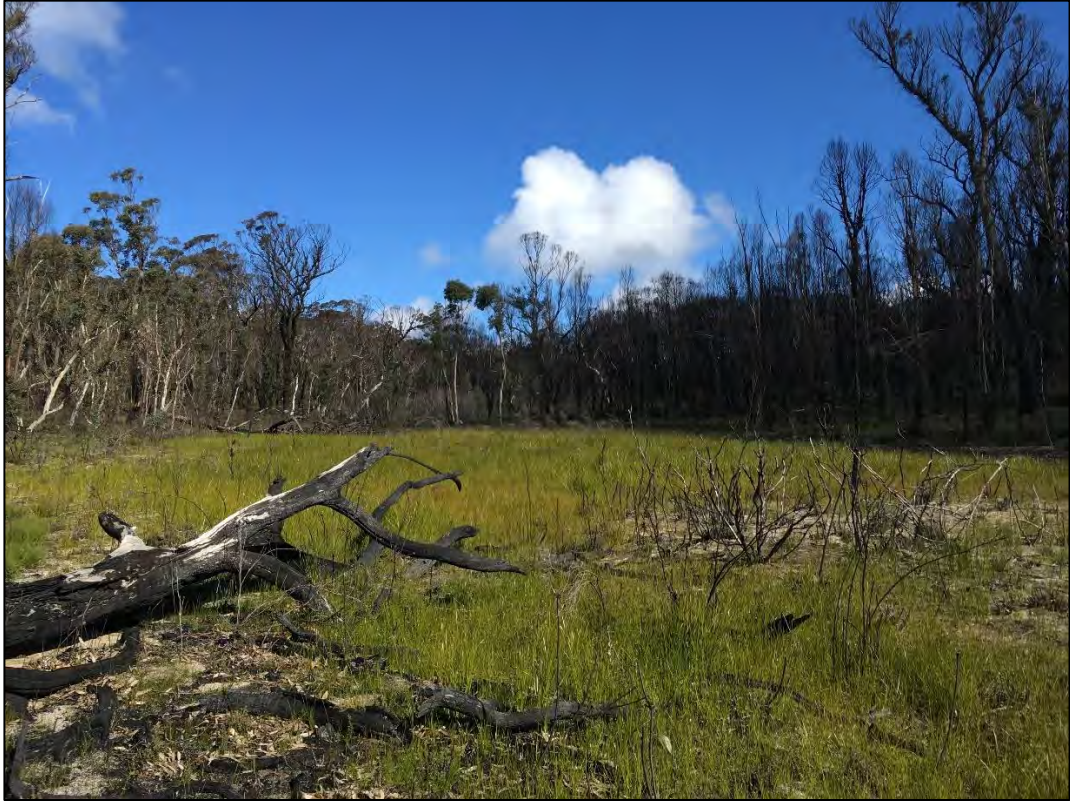
**Figure 4:** Hanging swamp downstream of quarry indicating recent bushfire activity.

3. Water inflow at the upstream end of the swamp arrives via a narrow channel approximately 0.5-1.0 m wide and up to 0.5 -1.0 m deep (see for example Figure 9). However, the channel form diminishes to nothing at the entry point to the swamp where surface flows are infiltrated into the sandy sediment (Figure 4 and Figure 8).

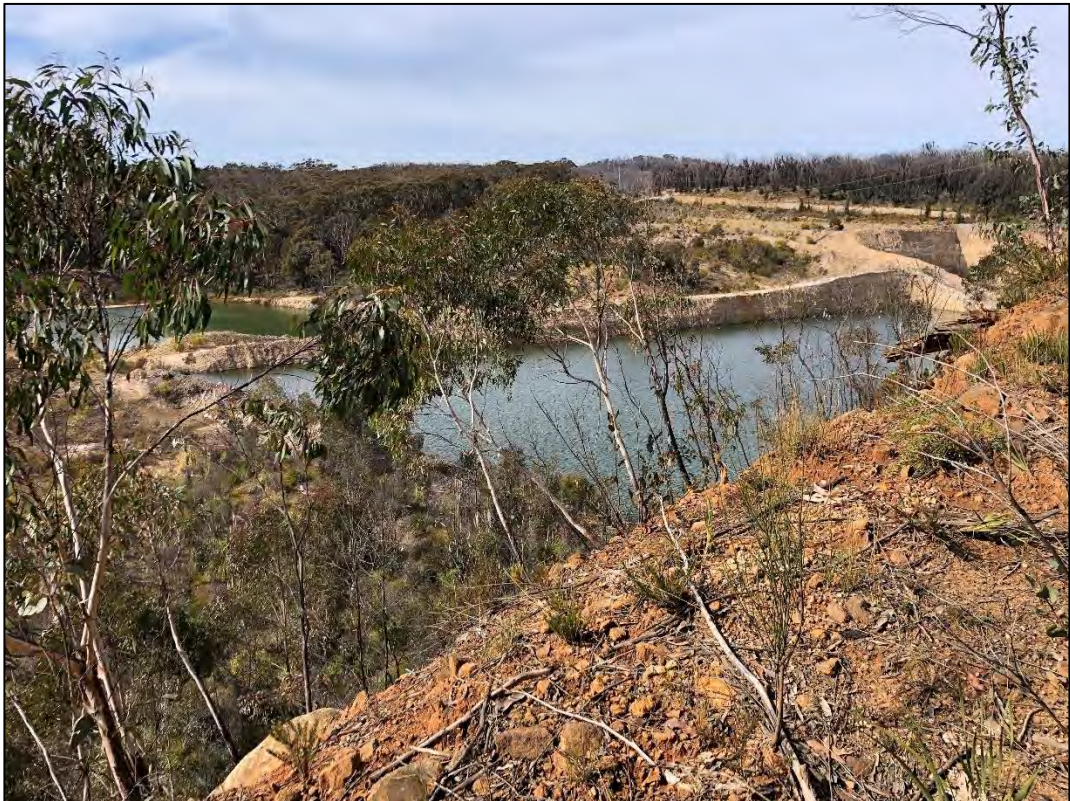
**Figure 5:** Overlooking Site from western edge of quarry void showing existing site topography.

Site slopes are variable, generally of the order of 0 – 10% at the top of ridgelines and in previously active quarry stockpiling and access areas, to near vertical along the edges of the quarry voids. Valley side slopes are generally between 10 – 20% downslope of the Site (Figure 5). Map 6 shows Site and local slopes.

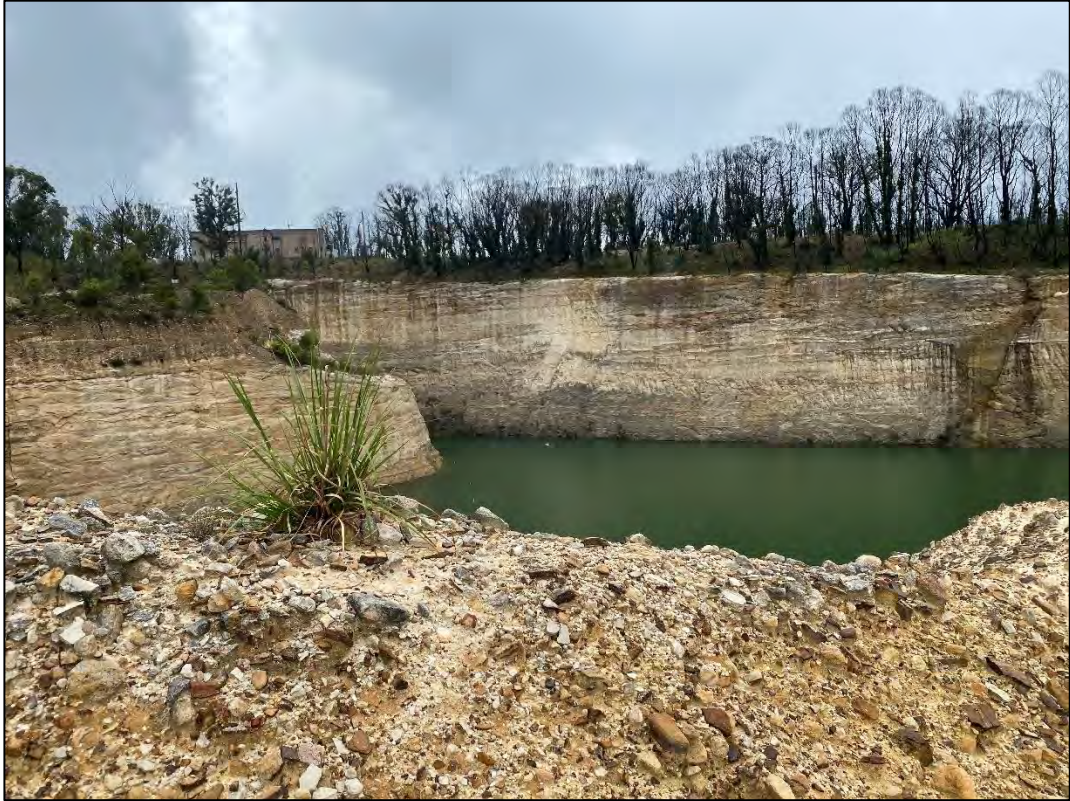
**Figure 6:** Local sandstone bedrock profile in Pond 1 (side wall of existing void).

Review of the Sydney 1:250,000 Geological Series Sheet S1 56-5 (NSW Department of Mines, 1966) shows that local geology consists of sandstones, shales and tuffs of the Narrabeen Sandstone Group (Figure 6).

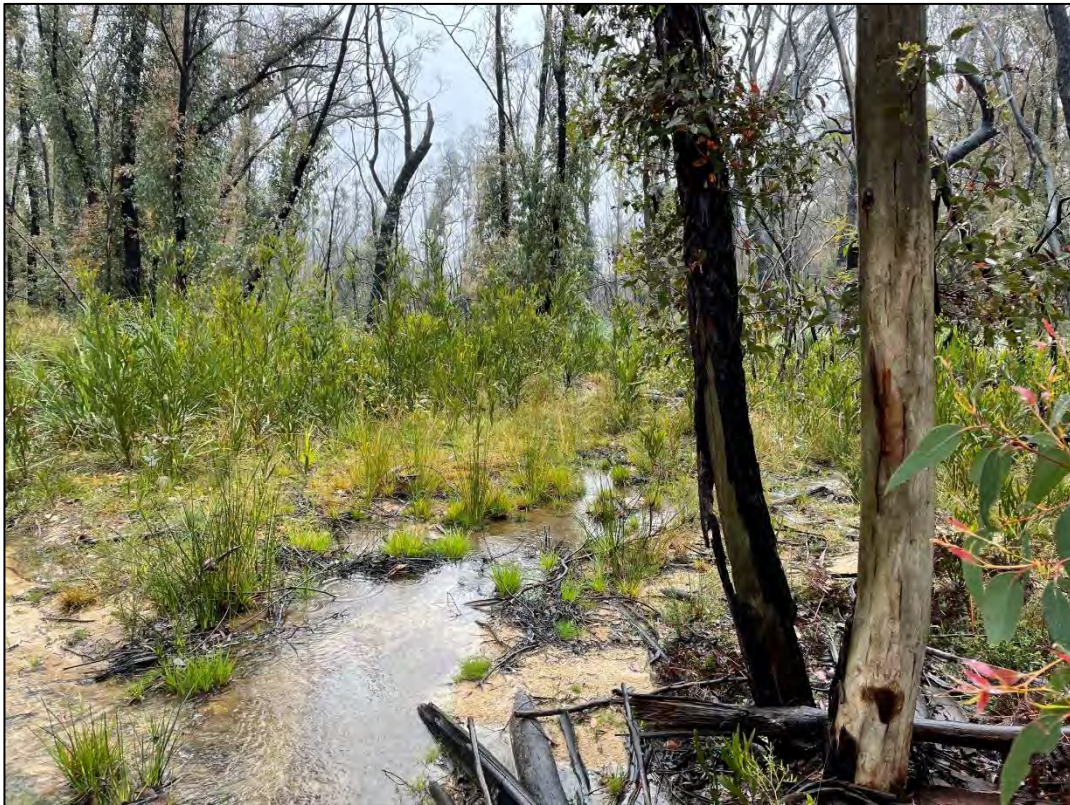
**Figure 7:** Inflow to hanging swamp showing infiltration of surface flows and absence of defined channel.

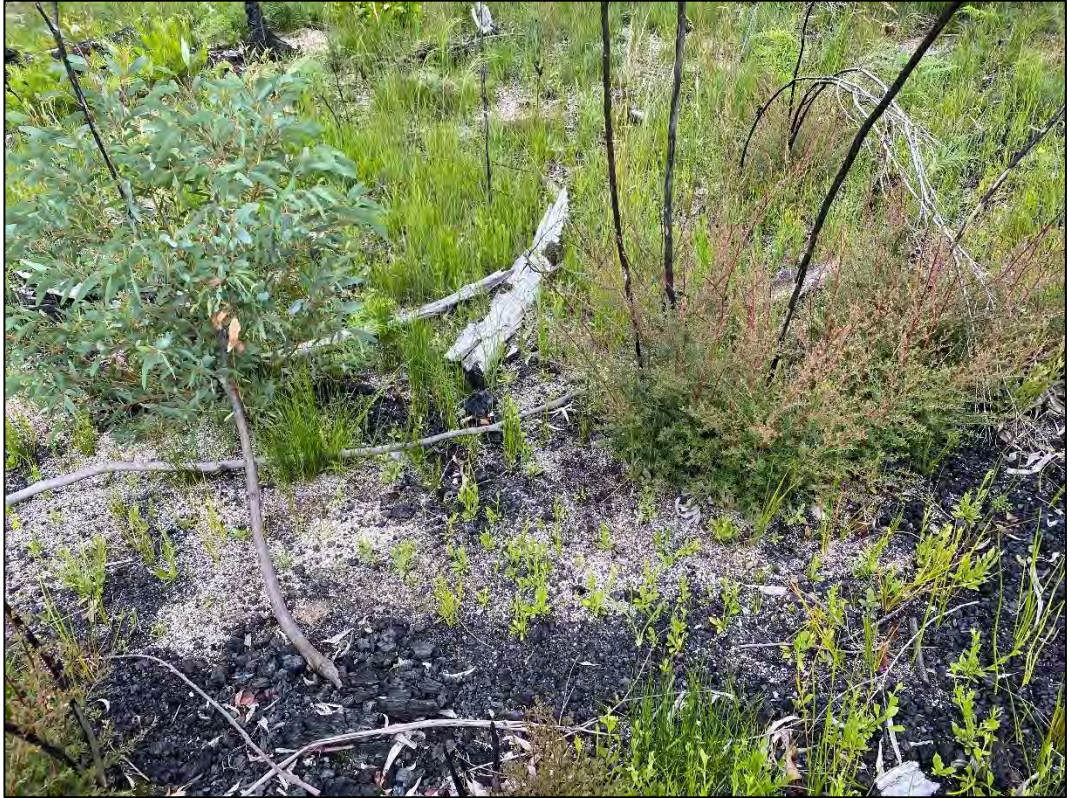
**Figure 8:** Typical sandy local topsoils (charcoal from recent local bushfire).

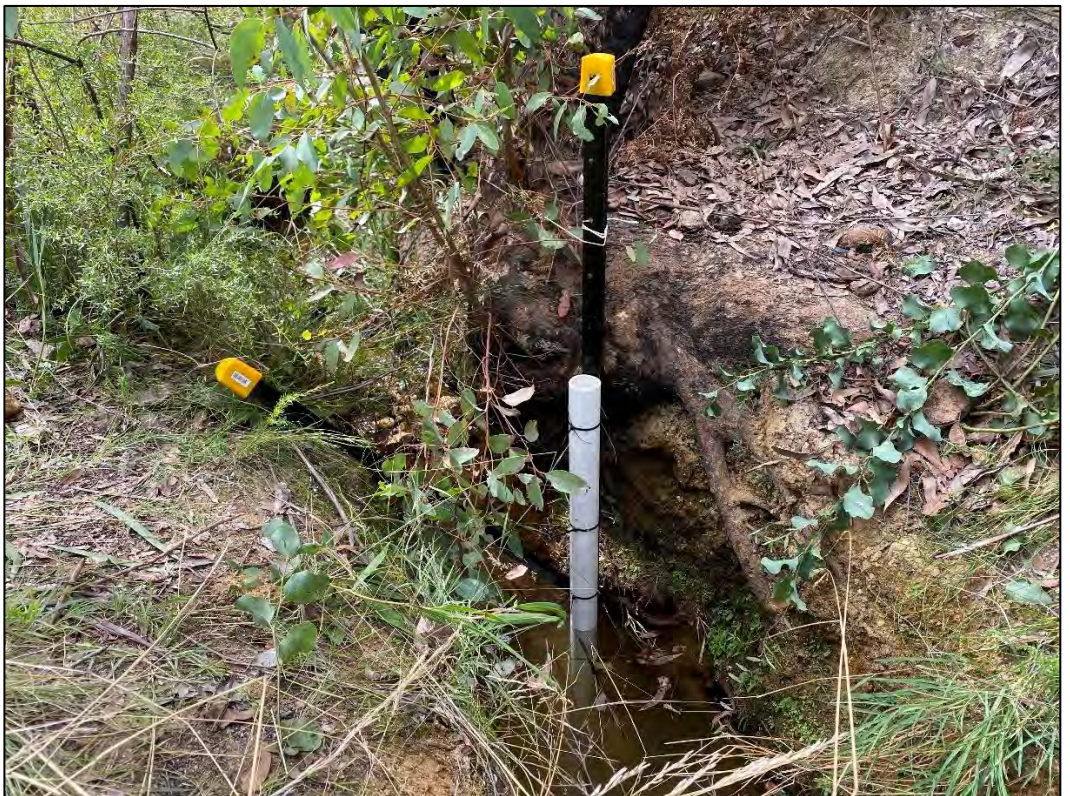
**Figure 9:** Flow monitoring station at upstream end of hanging swamp.

Directly downslope of the Site is an unnamed watercourse which forms part of the upper Wollangambe River catchment (Figure 1). Two flow monitoring stations have been installed on this watercourse at the upstream and downstream ends of the hanging swamp (Figure 9 and Figure 10). This watercourse runs north-eastwards prior to joining another unnamed watercourse to the north of the Site (Figure 11).

Two stream gauges (Figure 9 and Figure 10) were set up at the upslope and downslope ends of the hanging swamp to determine flows and assess likely changes to hydrological conditions, should the Site be rehabilitated to remove the quarry voids. Map 11 shows the position of flow gauging sites and catchments draining to each gauge.

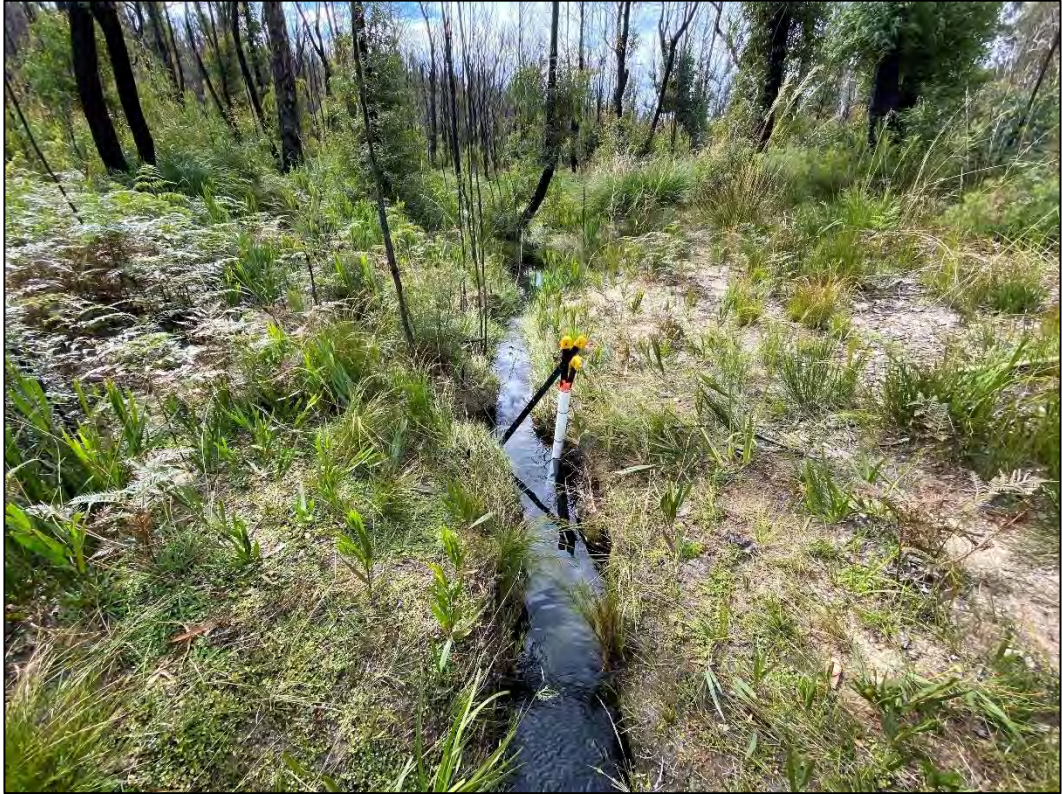
**Figure 10:** Flow monitoring station at downstream end of hanging swamp.

4. Water outflows, including shallow groundwater seepage and overland flows, are reconcentrated at the downstream end of the swamp, where a small approximately 1.0 m wide and 0.5 m deep channel re-emerges (see for example Figure 10).

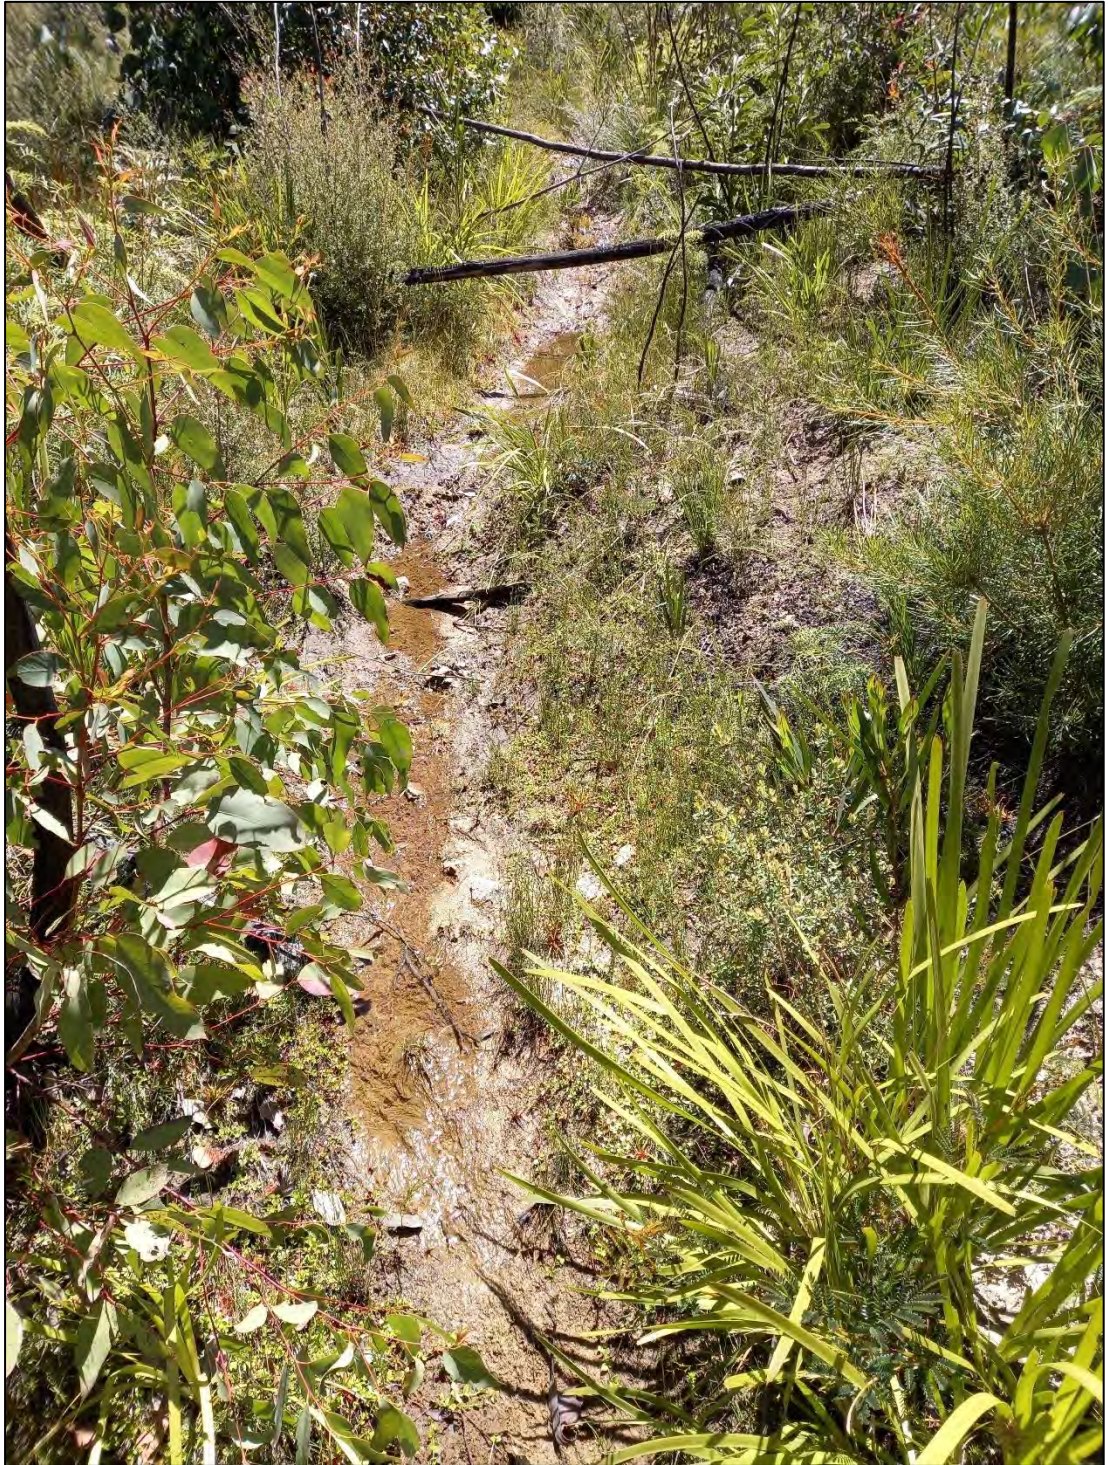
**Figure 11:** Left bank tributary entering at downstream end of hanging swamp.

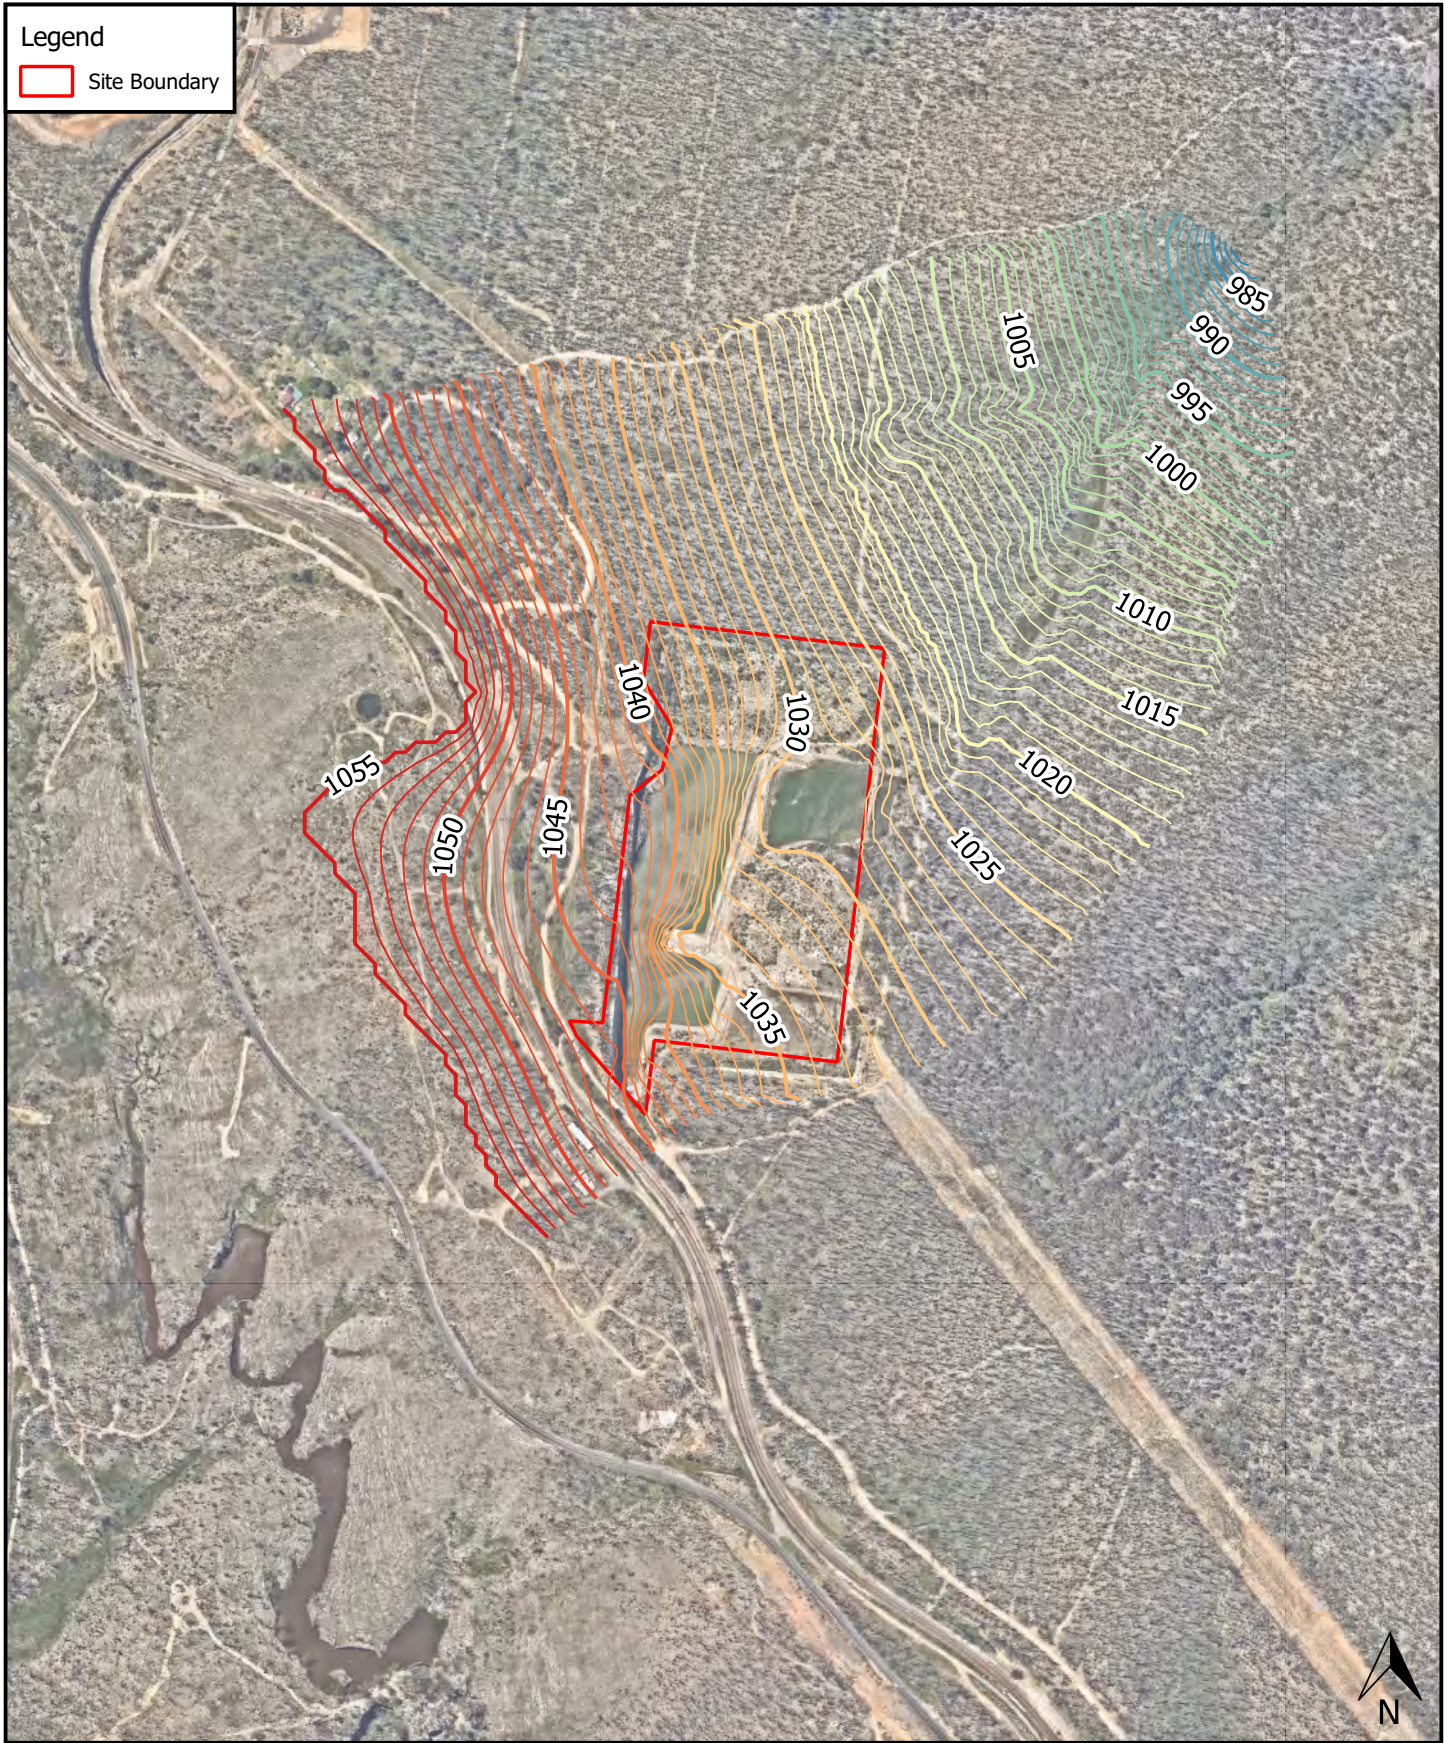
## Filling Stage Groundwater Drawdown from Pre-Quarry Conditions

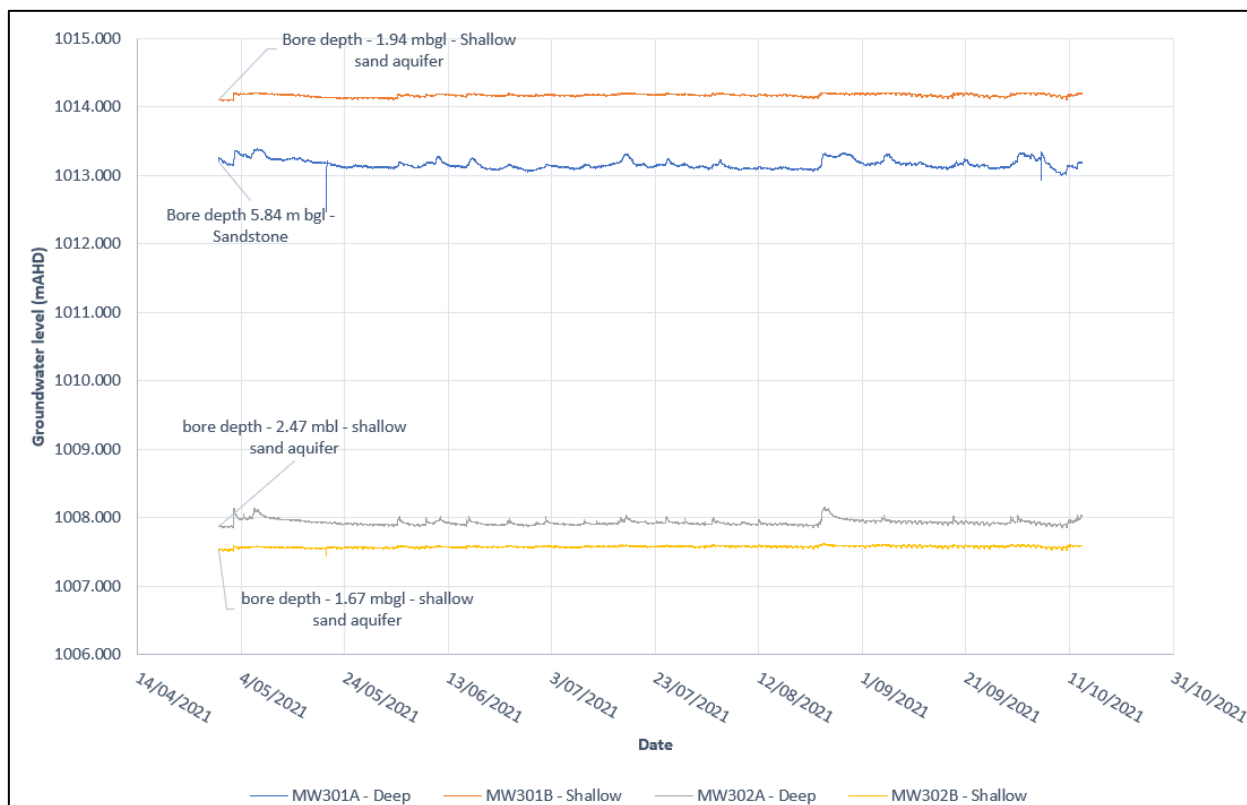
Figure 3.4 Groundwater levels at swamp between 4 May 2021 and 11 October 2021

Figure 3.4 presents the groundwater levels from monitoring wells at the swamp (in locations at the upstream end of the swamp [MW301A (deep) and MW301B (shallow)] and middle areas of the swamp [MW302A (deep) and MW302B (shallow)]). The purpose of shallow and deep wells adjacent to each other is to characterise the vertical hydraulic gradient. MW301A and MW301B are effective at measuring vertical hydraulic gradient because of the difference in the well depth from 1.94 metres (shallow, in sand) to 5.84 metres (deep, in sandstone). MW302A and MW302B are less effective in measuring vertical hydraulic gradient due to both being screened in the same shallow sandy aquifer where vertical head differences cannot be established.

MW301A and MW301B demonstrate a downward vertical hydraulic gradient as seen by the shallower MW301B hydraulic head being higher than the deeper MW301A hydraulic head by approximately 1 metre. The shallower well is screened in the sand aquifer above the sandstone, while the deeper well is screened in the sandstone unit. This downward vertical gradient indicates that the groundwater is being recharged from the swamp with an approximate vertical hydraulic gradient calculated as 0.26.

The horizontal hydraulic gradient can be measured from the difference in hydraulic head (SWLs) between the same sandy aquifer of MW301 and MW302 compared to the distance between them. The calculated horizontal hydraulic gradient between MW301 and MW302 is 0.009 and reflects groundwater flow direction within the shallow aquifer between the two wells.

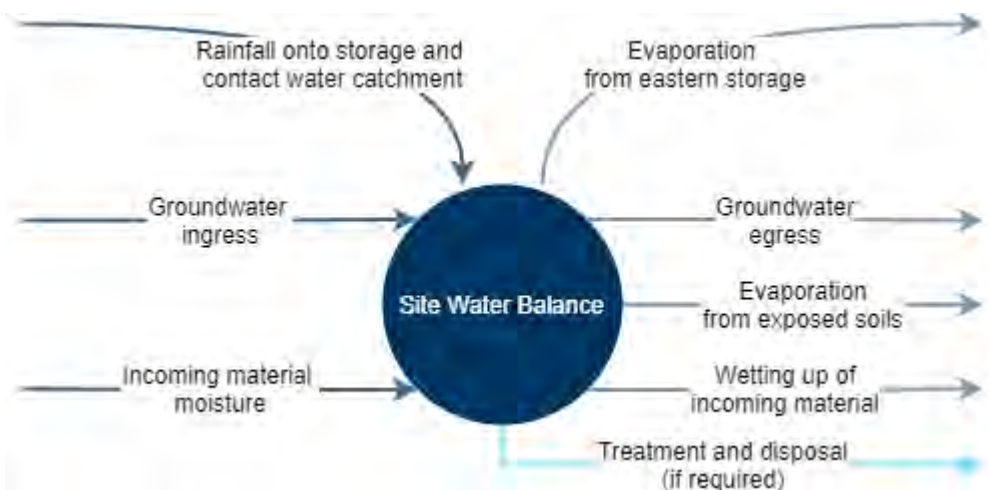
Figure 5.1 Water balance model configuration

Therefore, the adopted system configuration for the water balance modelling is shown in Figure 5.1. This system was modelled, not with the aim of quantifying all water elements, rather to confirm the feasibility of containment and to inform the required treatment rate (if any).

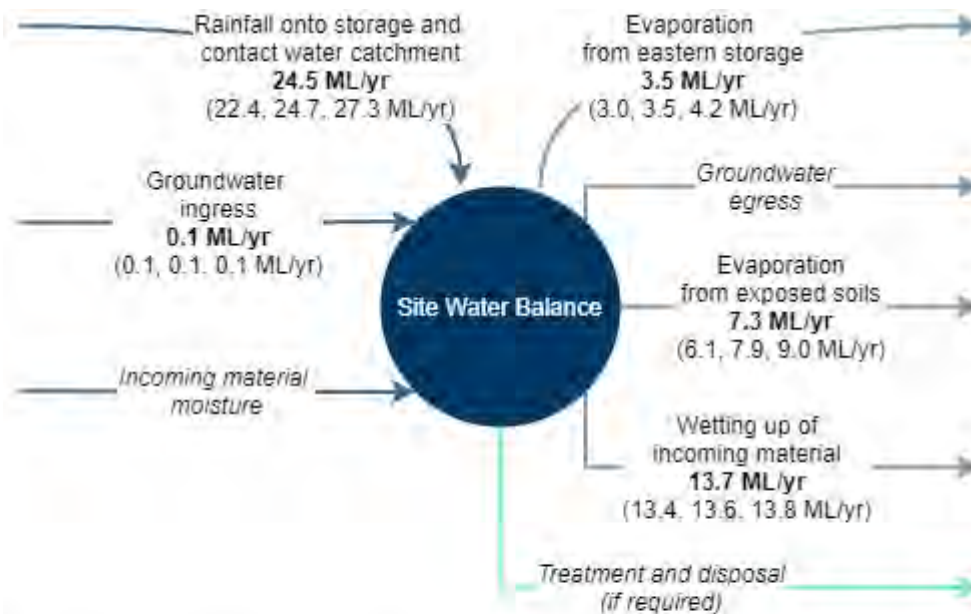
**Values in bold are based on the historical climate period.**  
 (Values in brackets are shown as the 1st, 5th and 9th Decile of climate change models.)  
 Components in *italics* are not directly modelled.

Figure 5.3 Average annual results for historical and future climate considerations

not predicted based on the historical climate and are only predicted in four of the twelve climate change models. Average flows of the modelled system elements are shown on Figure 5.3.

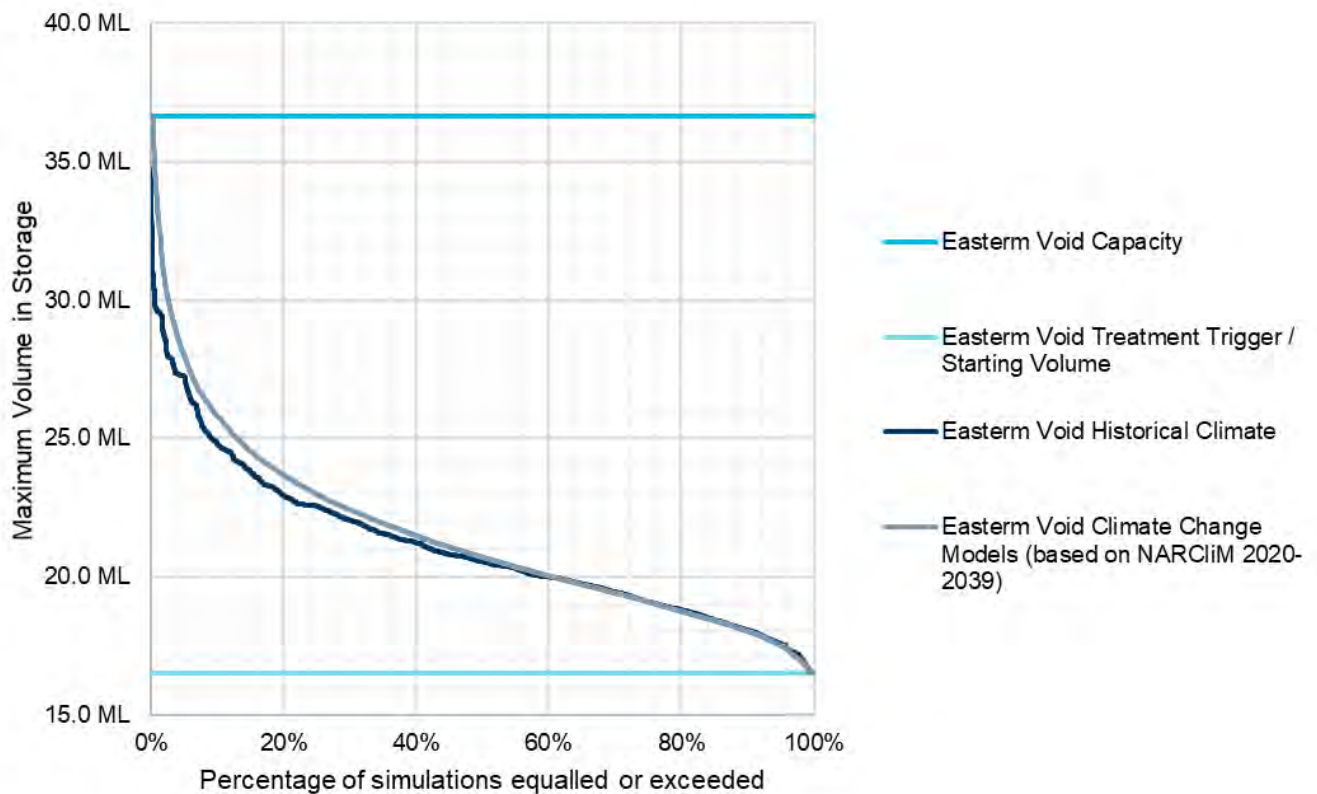
Figure 5.4 Statistics on maximum volume in the eastern void for historical and future climate considerations

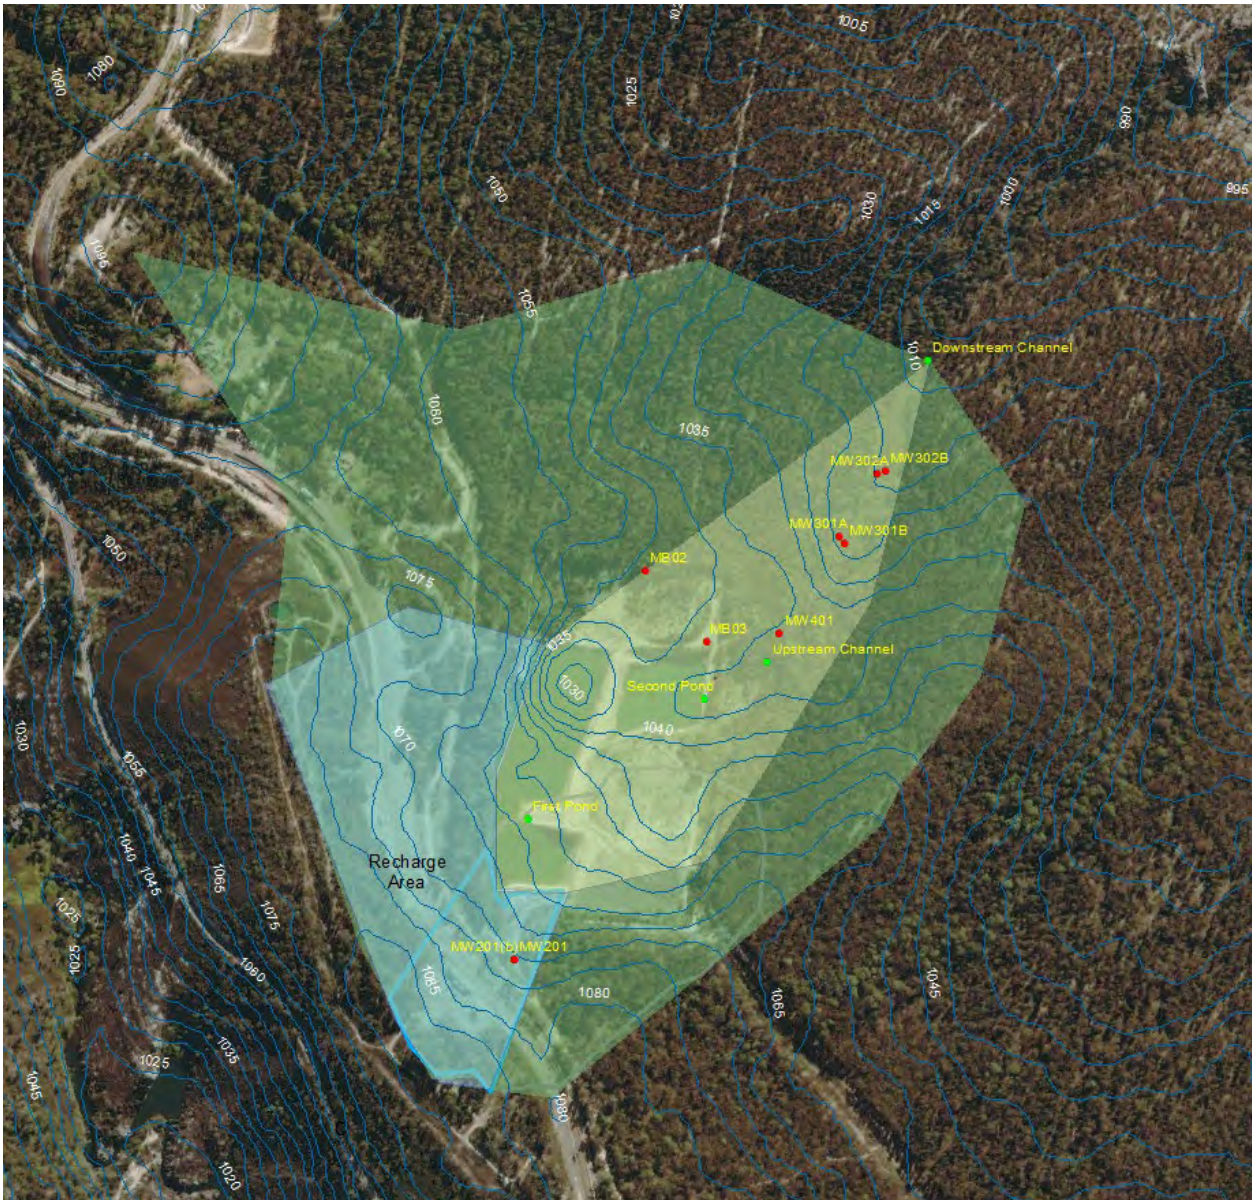
**Figure 6.2** The total catchment area for Bell Quarry indicating the recharge area upgradient from pit 1 (blue area) and the geochemical modelling area downgradient from the voids to the downstream channel (yellow area). Total catchment area is indicated by the sum of the green area, yellow area and blue area

Upgradient groundwater interpreted to be seeping into or beneath the site is expected to originate from rainfall recharge in the blue shaded area in Figure 6.2, which has an area of 11.1 Ha as presented in Table 6.2. This represents groundwater that can mix with leachate emanating from the site at the start (Cell 0) in the PHREEQC model (see Figure 6.1).

The downstream receptor receives rainfall recharge from the geochemical modelled area (yellow) and the wider catchment area (green), which is approximately 82.3 per cent of the total catchment area (Figure 6.2). This water is mixed with the upgradient rainfall recharge (blue) and void leachate to provide a potential mixing ratio at the point of discharge to the downgradient receptor.

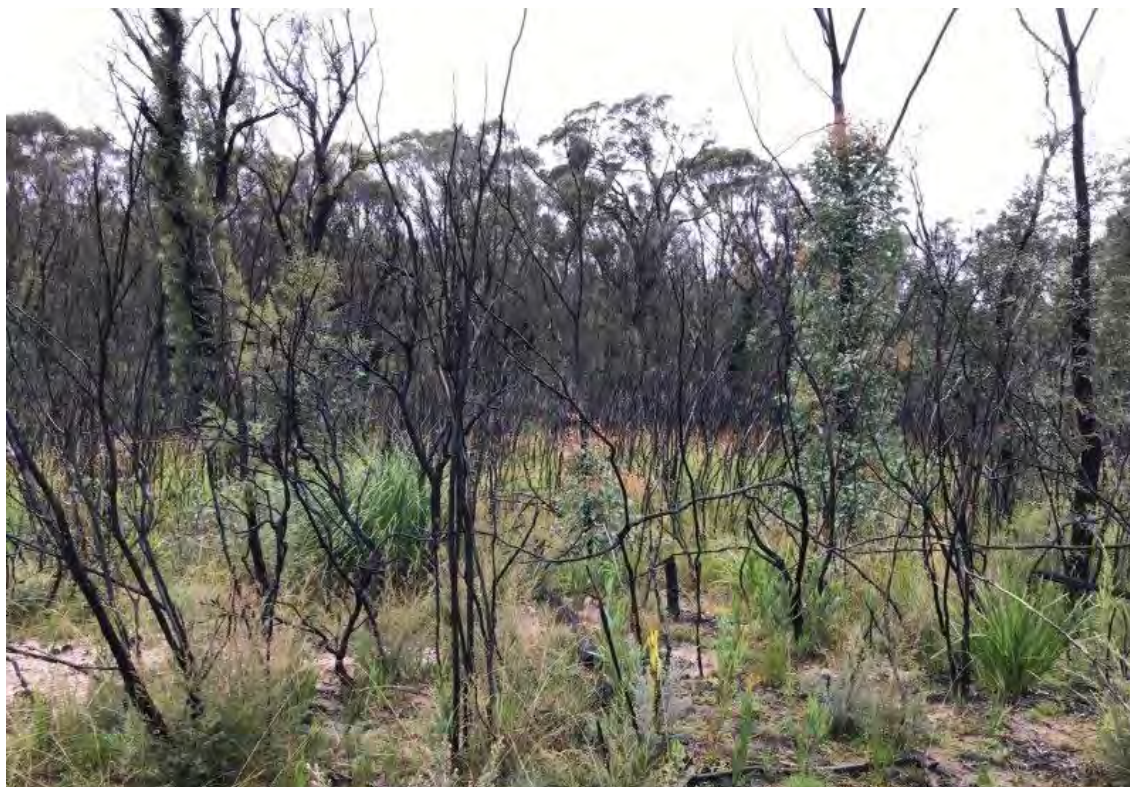
**Photograph 1** *Leptospermum*-dominated swamp vegetation

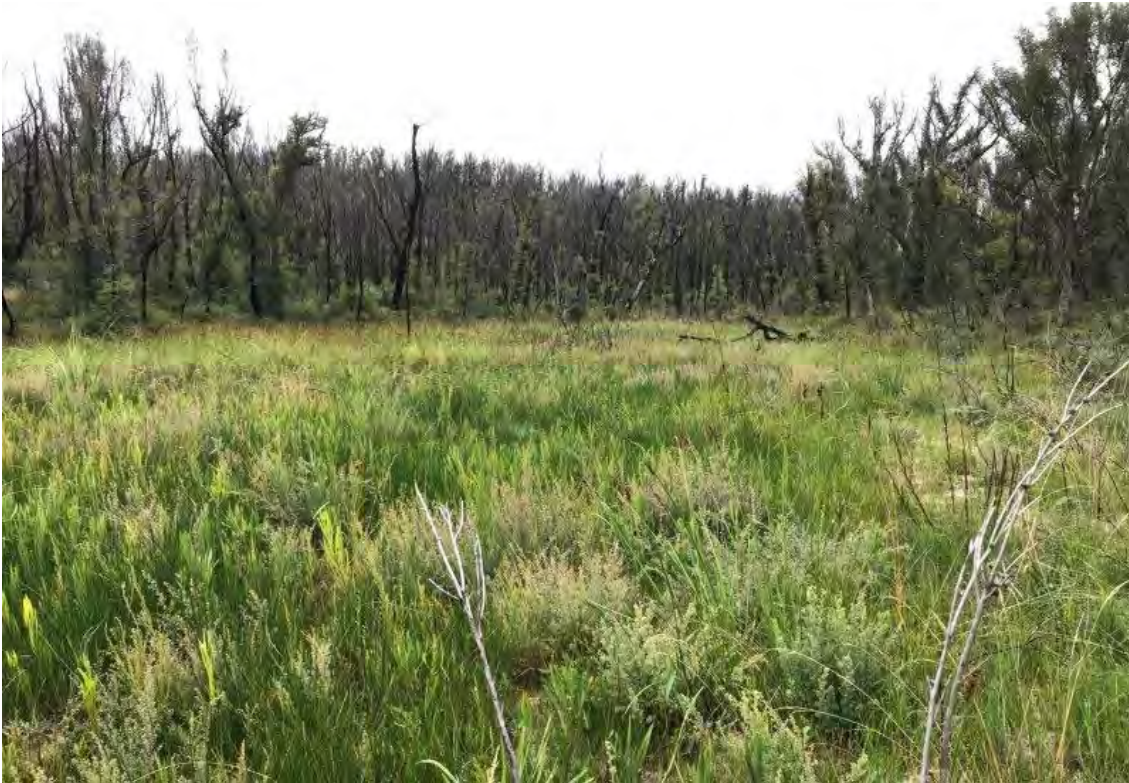
**Photograph 2 Sedge-dominated swamp vegetation**
