# **Bell Quarry Rehabilitation Project**

## **Supplementary Environmental Impact Statement**

19 November 2021

# Submission of Supplementary EIS

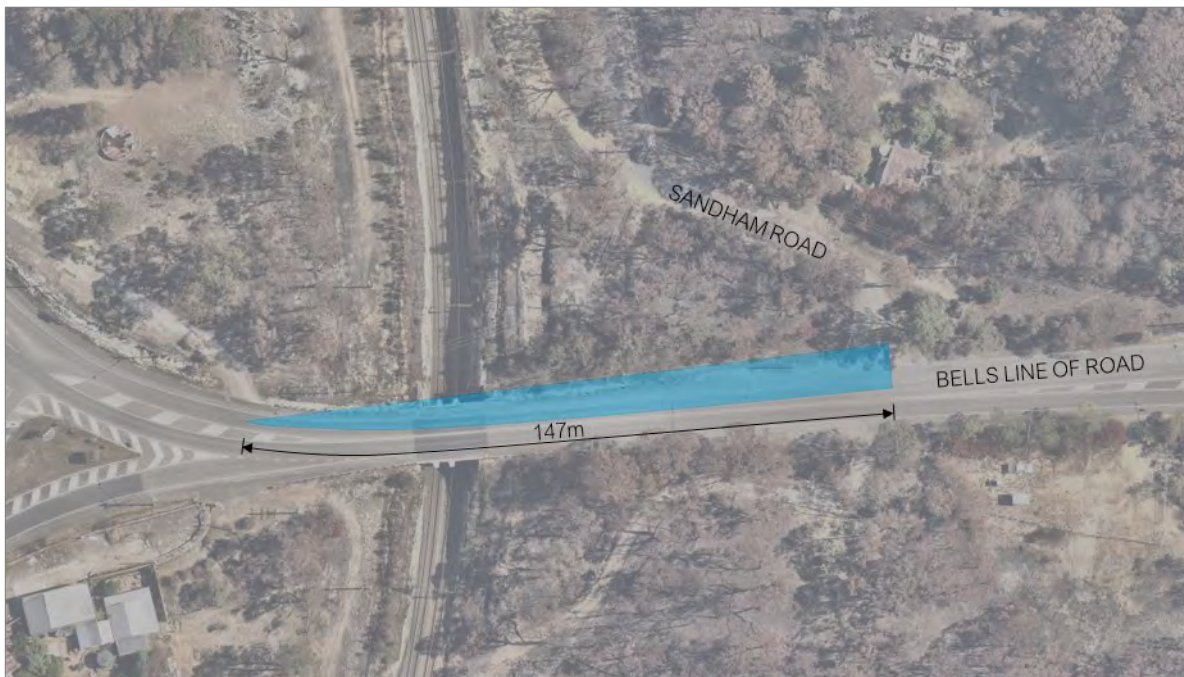
Figure 1: SISD requirements

The TfNSW Supplement states that industry practice in NSW is to use a driver reaction time of 1.5 seconds for calculating sight distance requirements for roads with design speeds less than or equal to 90km/h. Based on an 85<sup>th</sup> percentile speed of 72km/h, this results in a SISD requirement of 147 metres. Application of this SISD requirement to eastbound vehicles is shown in Figure 1.

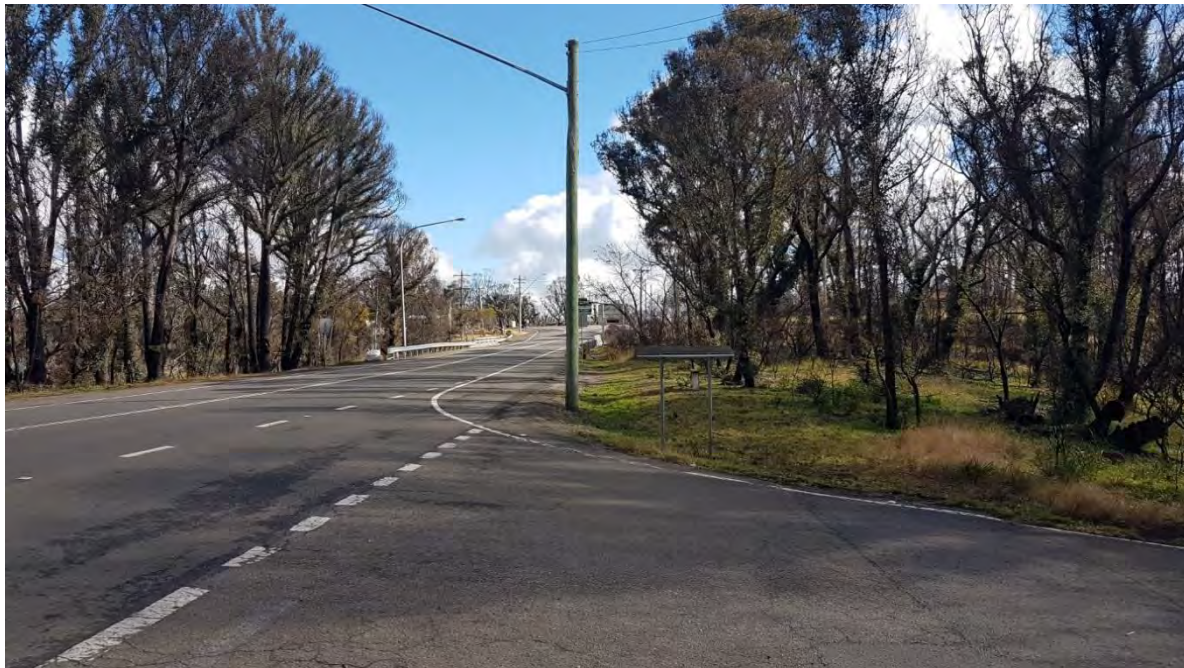
Figure 2: Available sight lines from Sandham Road to the west

Site observations indicate that required SISD can generally be achieved subject to minor pruning of trees along the northern side of Bells Line of Road as shown in Figure 2 and Figure 3. It is noted that there is a TfNSW road sign related to the heavy vehicle safety station located immediately after Sandham Road within the SISD. However, site observations indicate drivers are generally able to see around this sign, while also noting that vehicles are able to move forward from the hold line to the edge of the travel lane to further improve the available sight distance. This is typical driver behaviour at intersections where left turn deceleration lanes are provided (noting in this instance, the area forms the start of the exit lane for the heavy vehicle safety station. Alternatively, this TfNSW road sign could potentially be relocated outside of the SISD (possibly to the western side of the bridge) to further improve the available sight lines at Sandham Road.

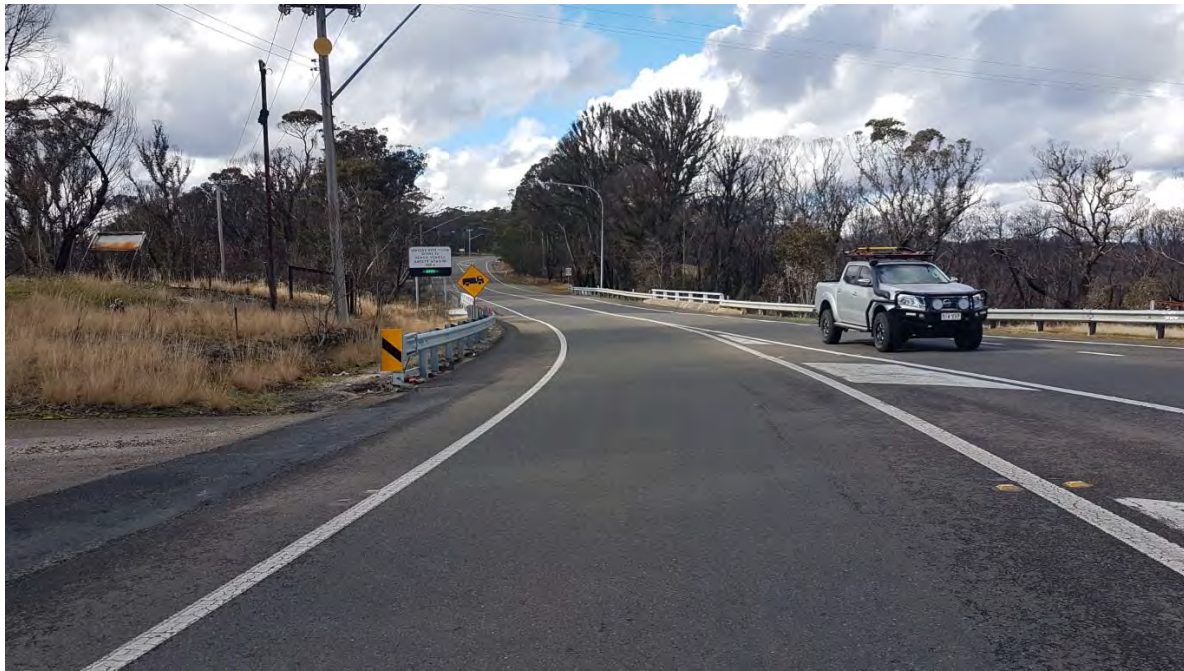
Figure 3: Driver's point of view from the SISD (147m) to the west of Sandham Road

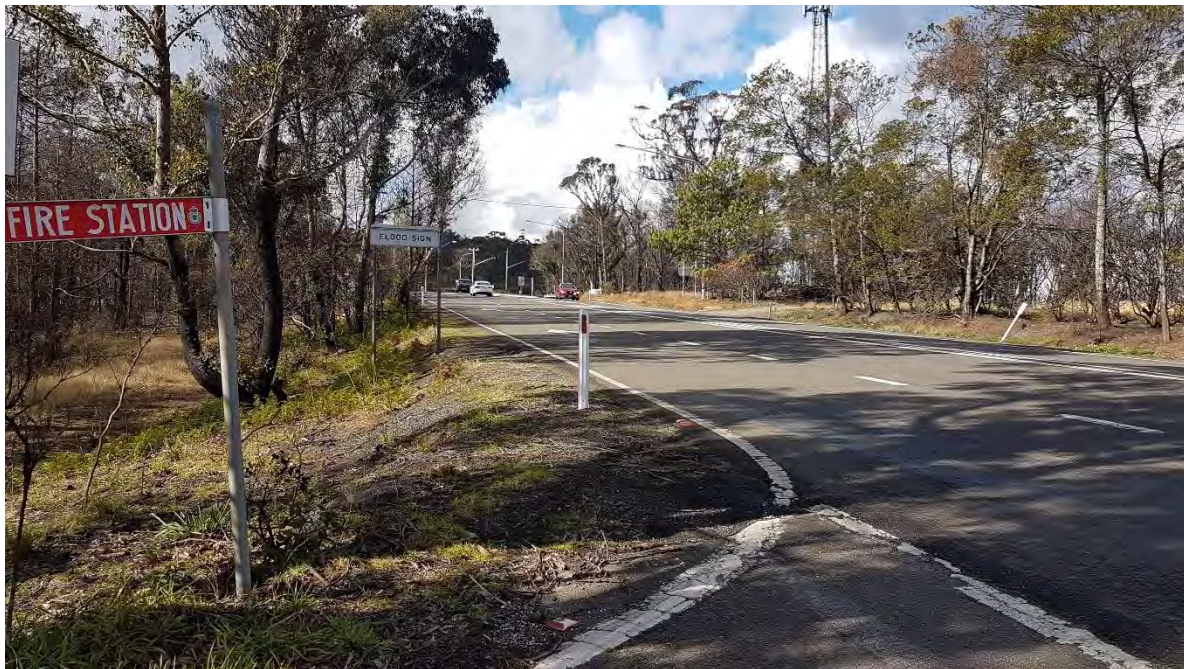
Figure 4: Available sight lines from Sandham Road to the east

Site observations indicate that there is adequate sight distance available to the east of Sandham Road, as shown in Figure 4.
