Geotechnical site investigation report

Proposed Bunnings Warehouse, Part Lot 26 DP1244557, 21 Willowbank Avenue,
Lithgow NSW

Ref: R13677g
Date: 10/12/2021

Envirowest Consulting Pty Ltd ABN 18 103 955 246

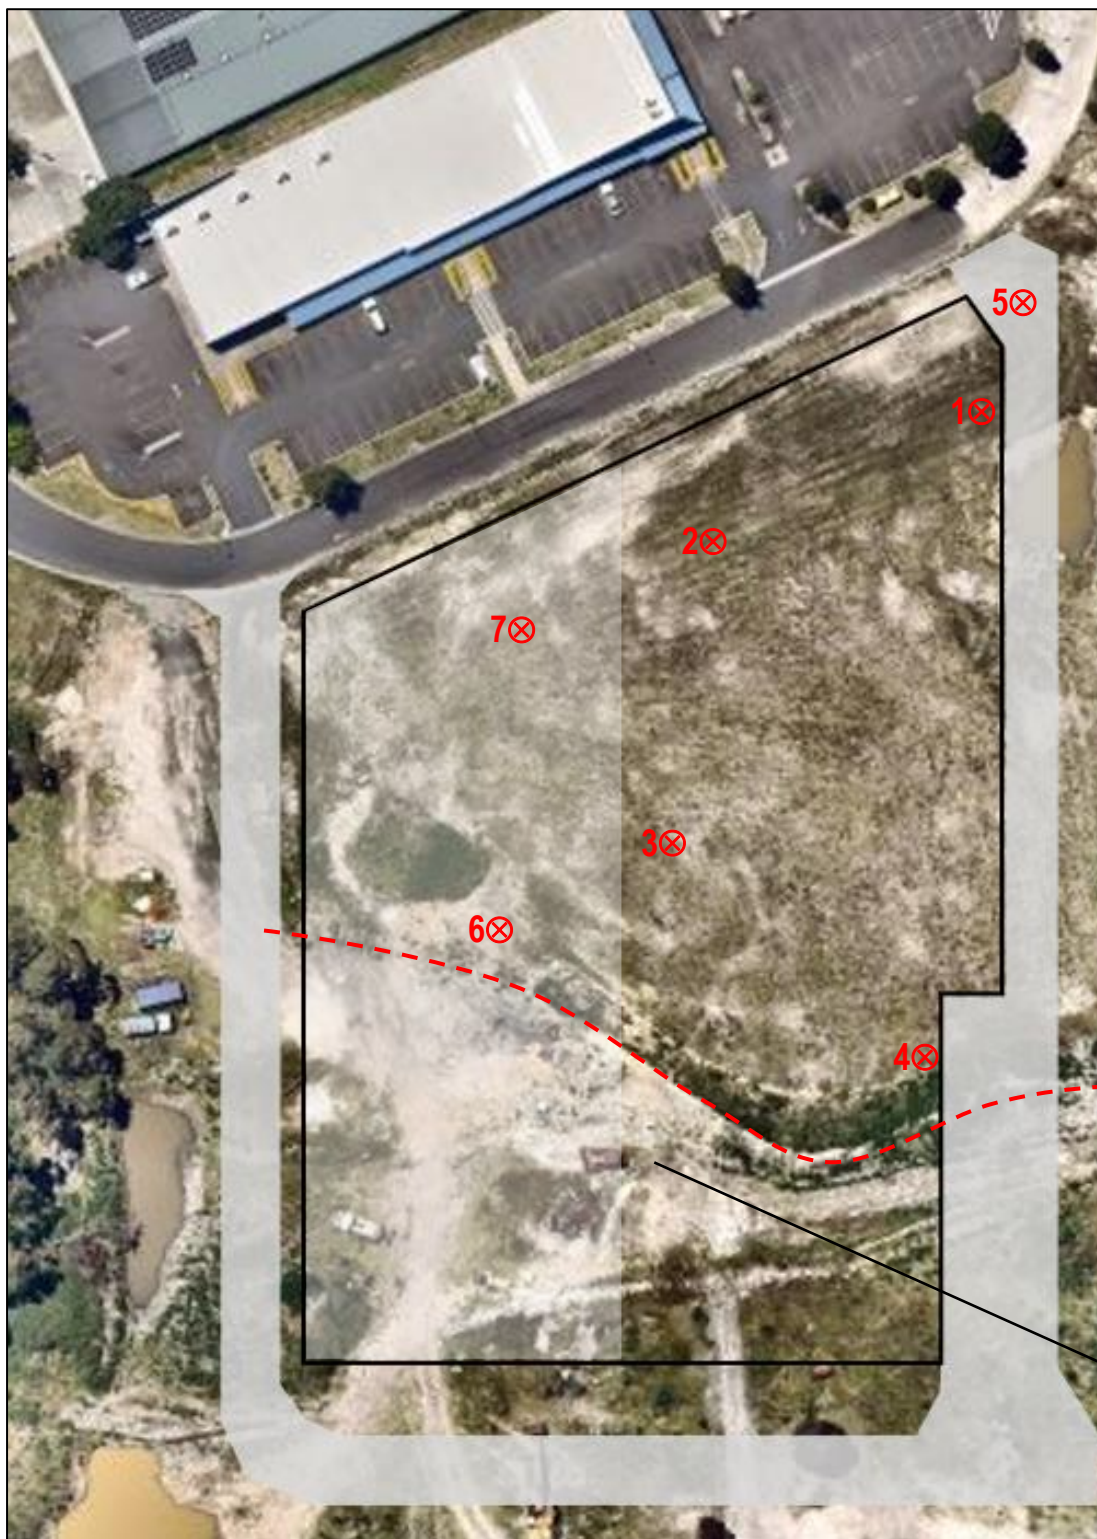
Site inspections and subsurface investigations were undertaken on 21 September 2021. Coal has been removed from part of the development site (northern section) and the pit backfilled. The coal in the southern section has yet to be removed and was not assessed in the geotechnical investigation (Figure 1).

Sampling locations are outlined in Figure 1 and Figure 2. The schedule of sampling is presented in Table 1.

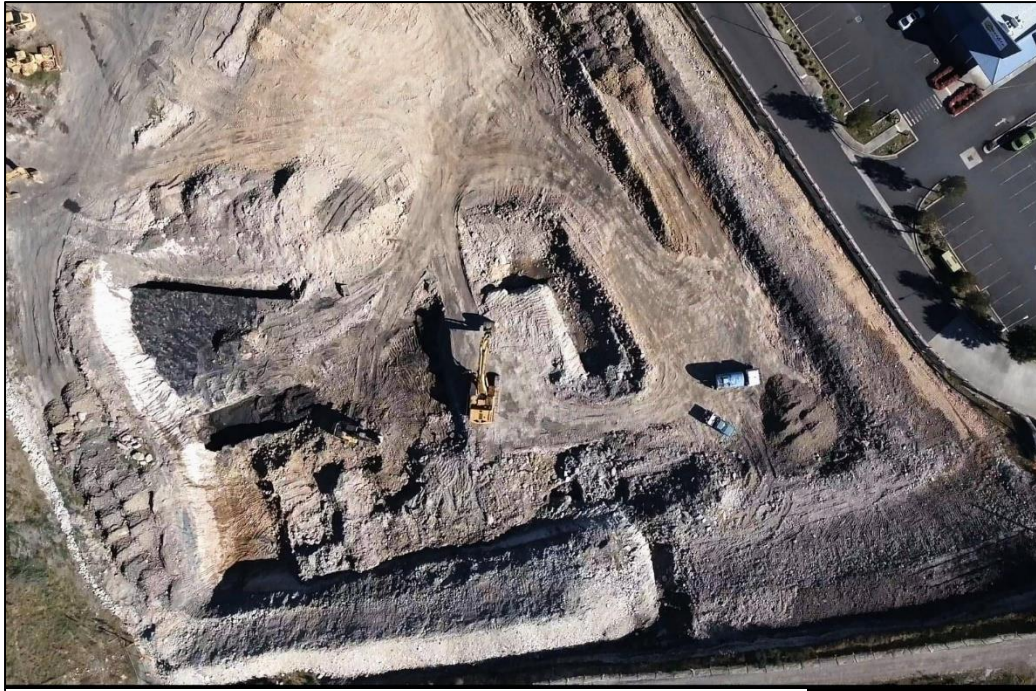
Aerial image during excavations 2018-2019 (supplied by client)

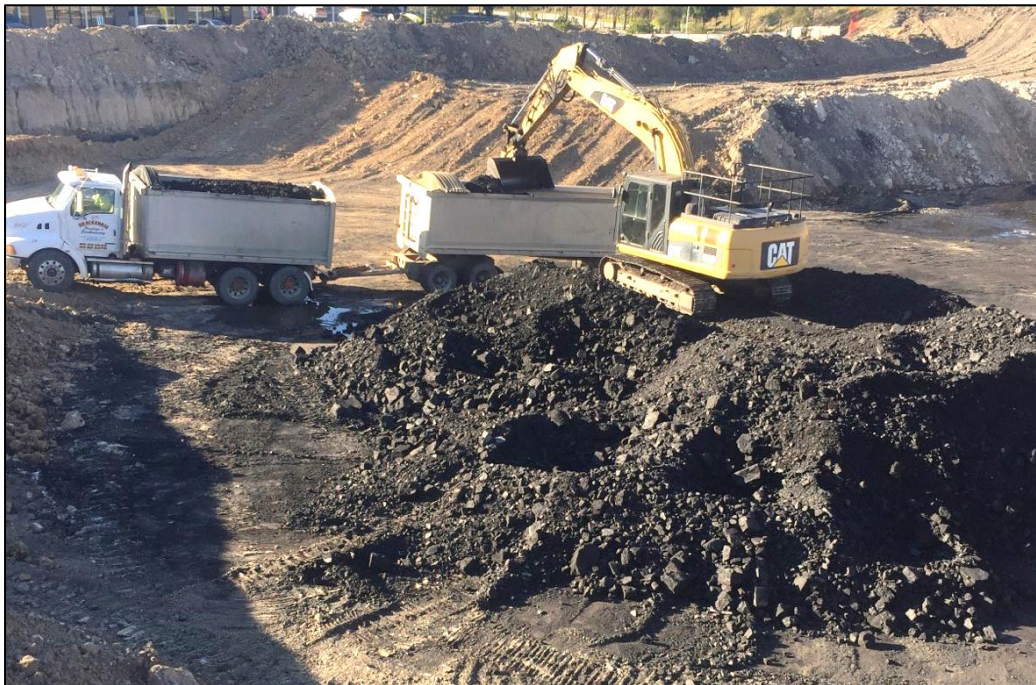
Looking north across the site during excavation 2018-2019 (supplied by client)

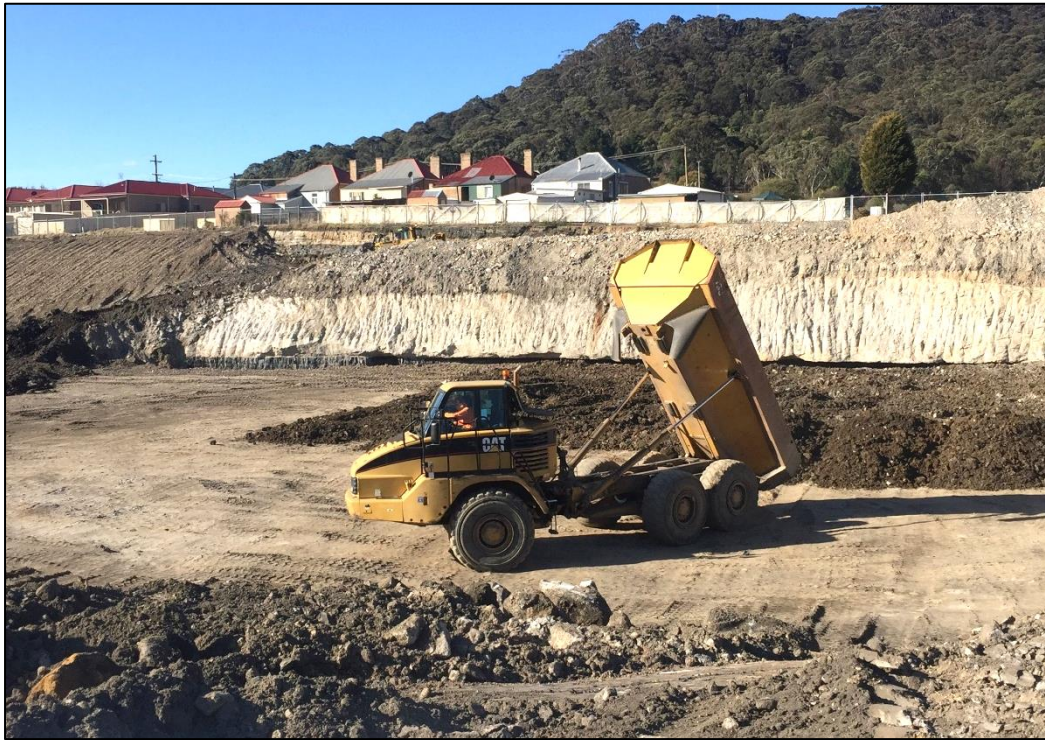
Looking east across the site during backfilling 2019 (supplied by client)

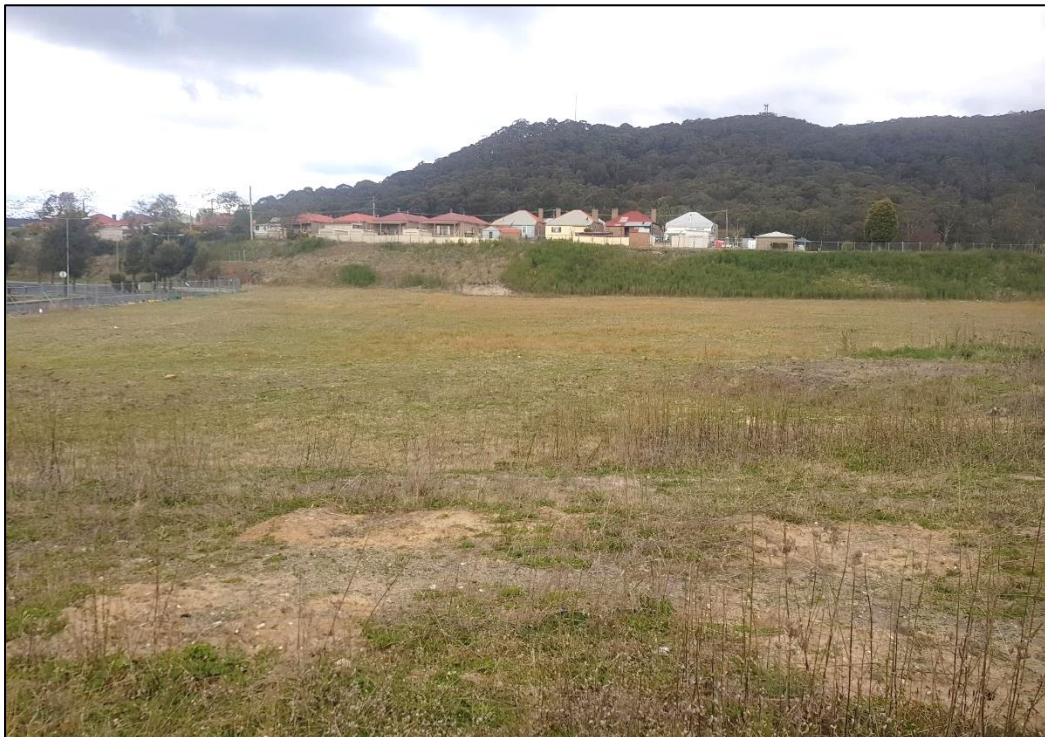
Looking east across the site on 21/9/2021
