Lake Lyell Geotechnical Drilling Program

Aboriginal heritage due diligence assessment

Prepared for EnergyAustralia
March 2022

E211001 RP1

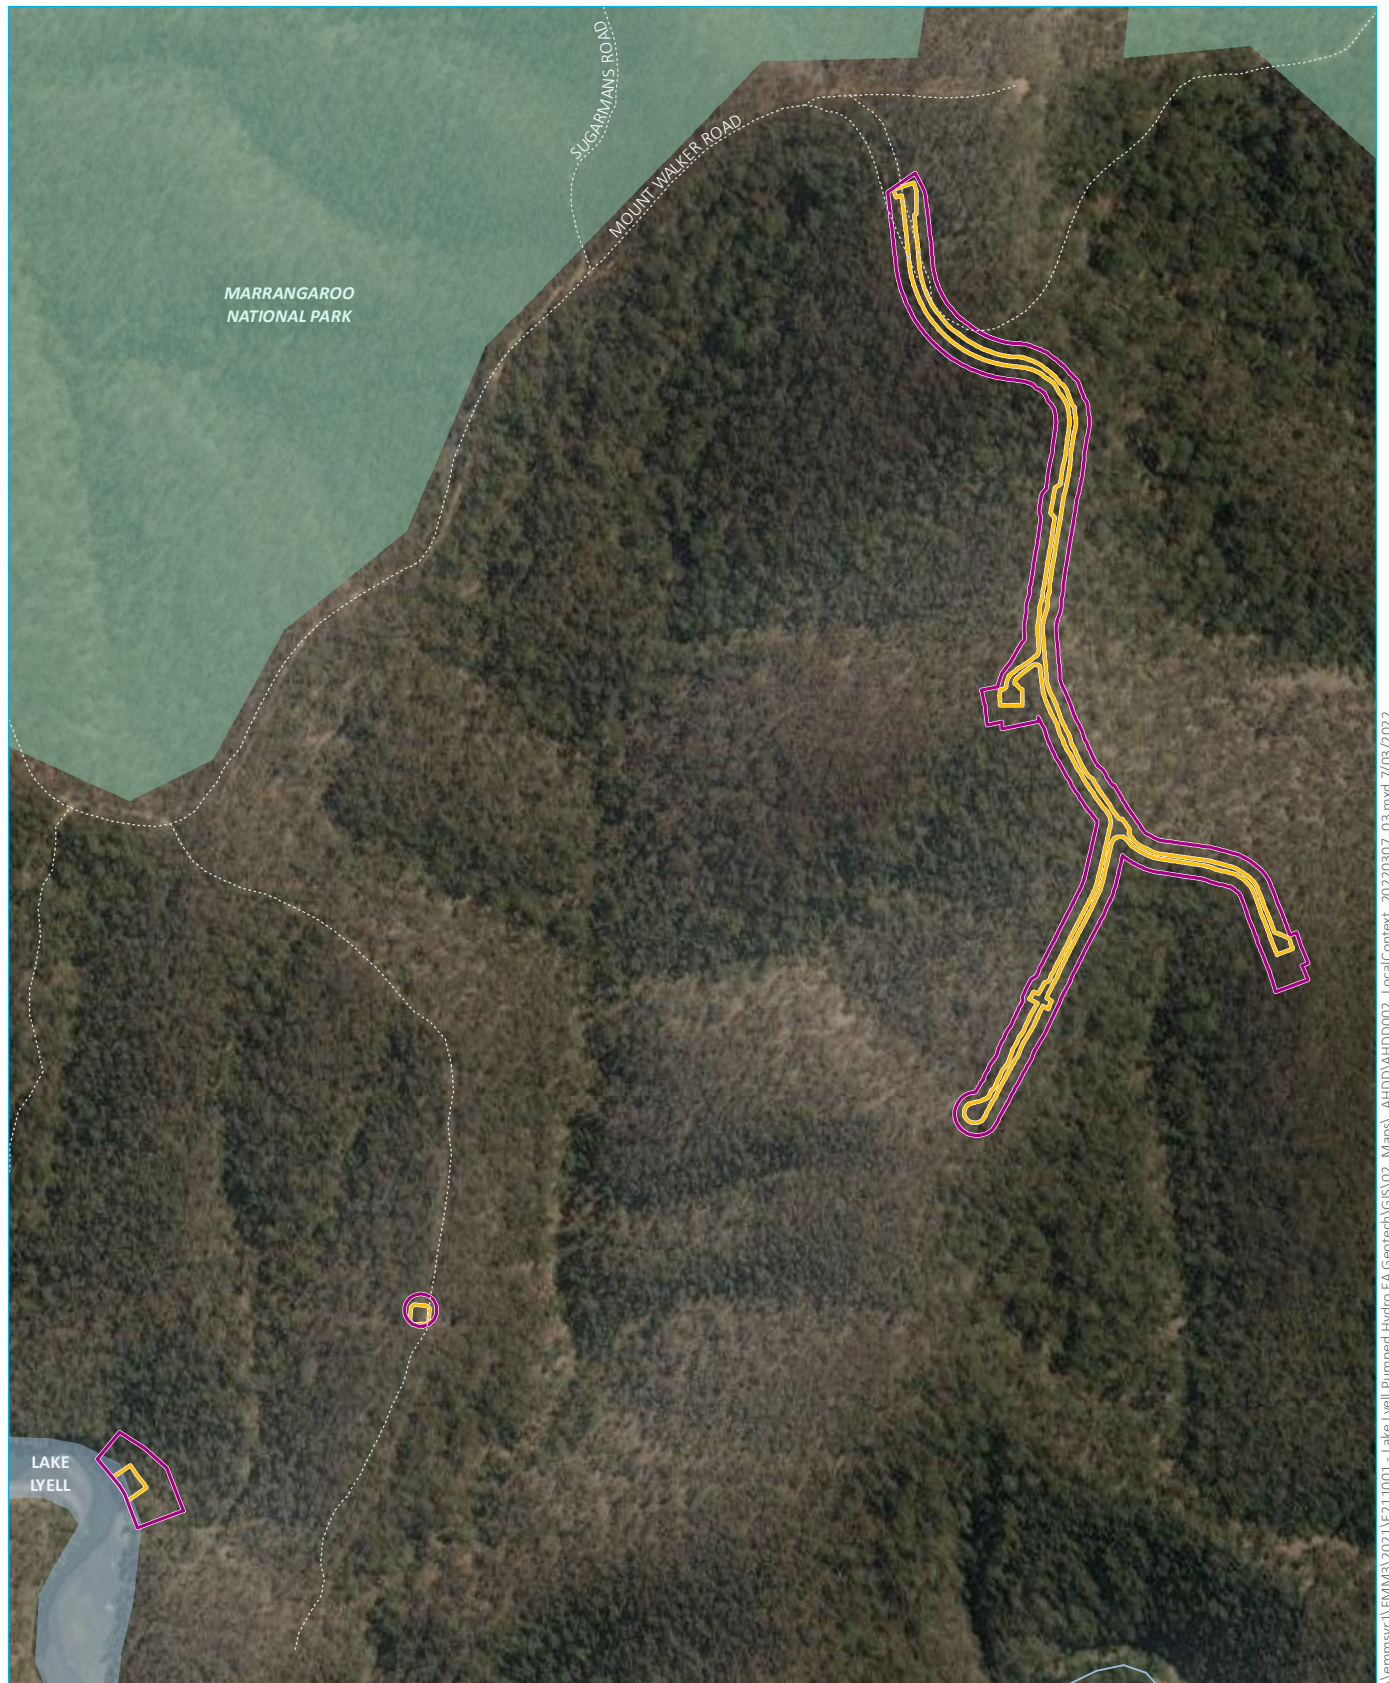
Lake Lyell Pumped Hydro
Aboriginal heritage due diligence
Figure 1.2

An overview of the activity is shown in Figure 1.2.

Local setting

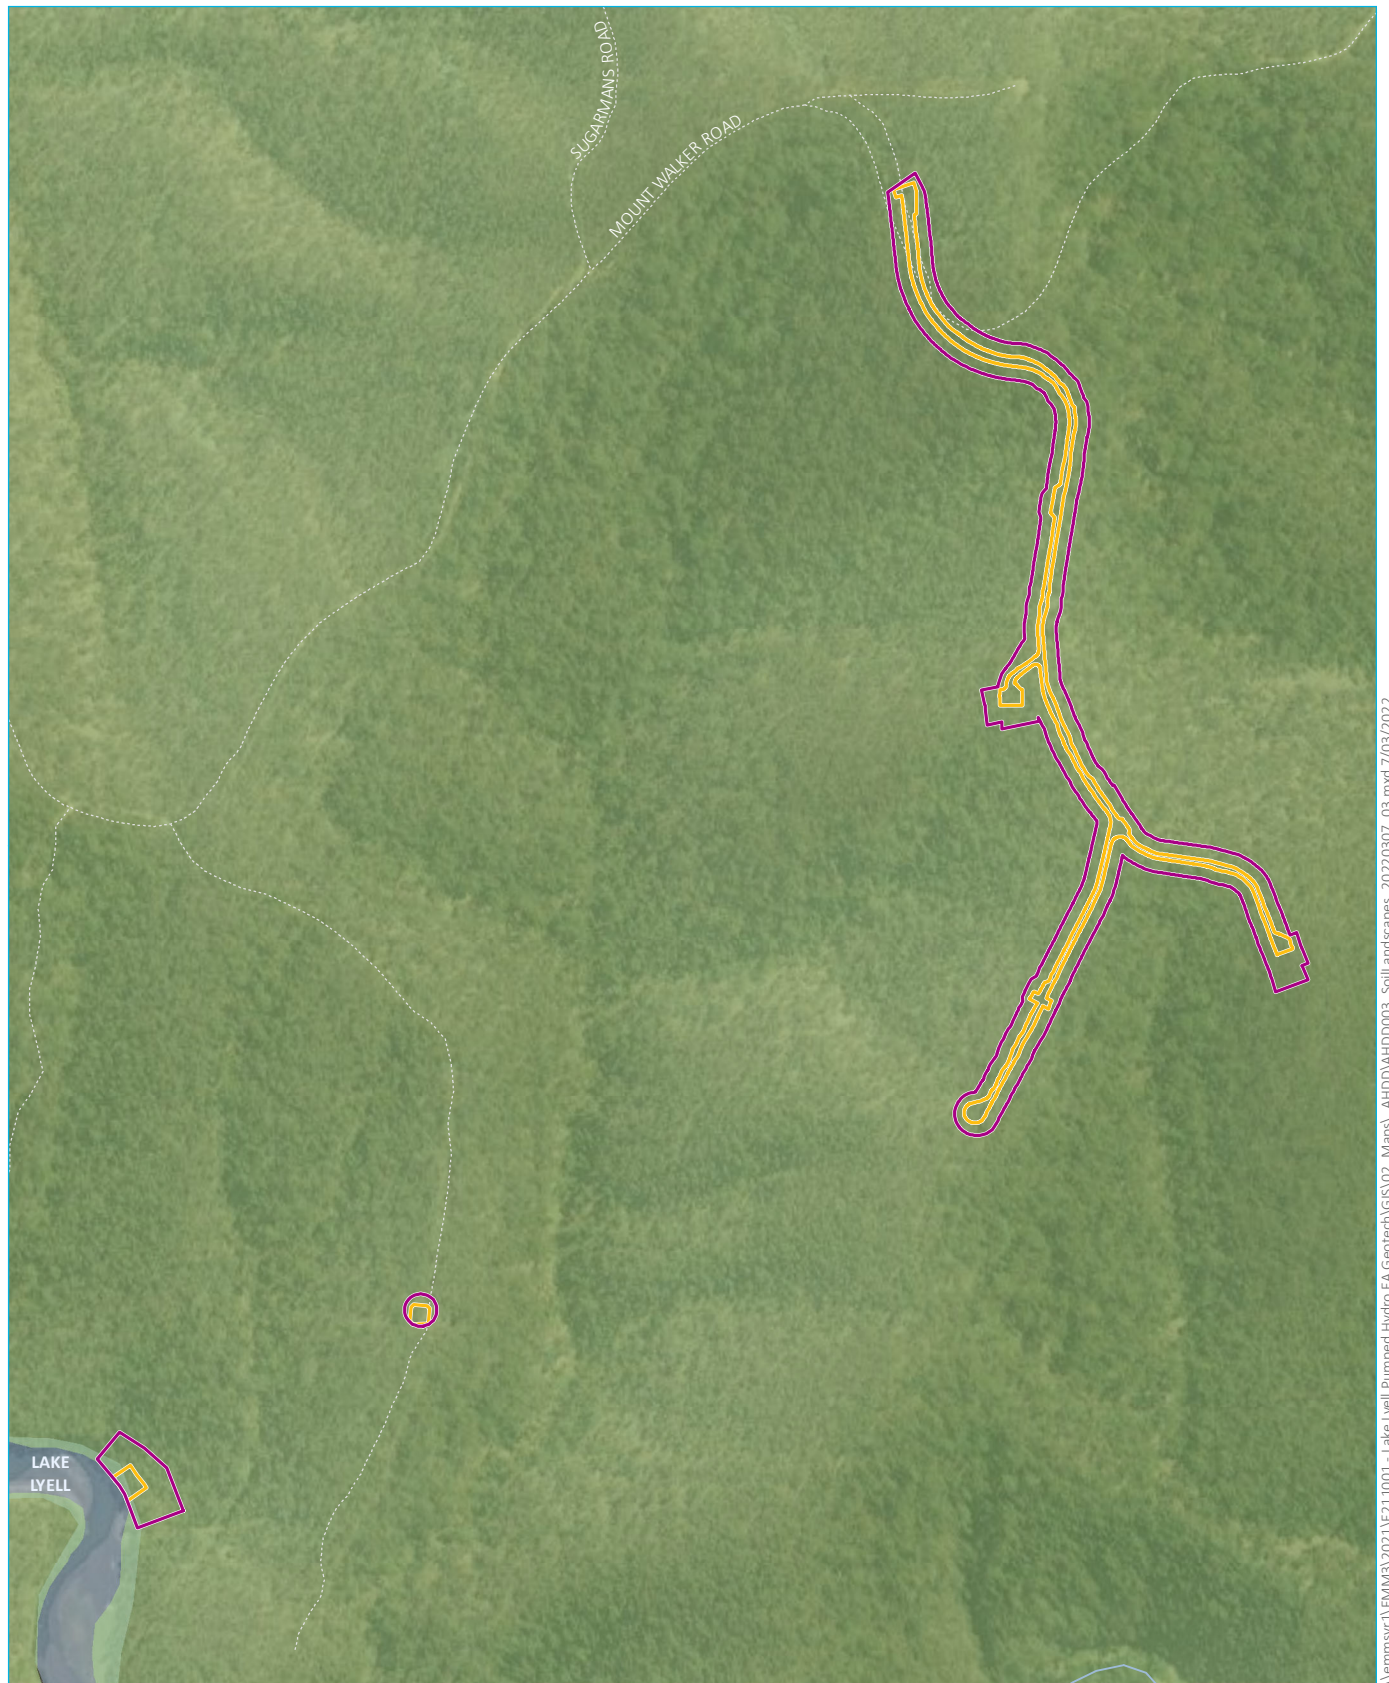
Lake Lyell Pumped Hydro
Aboriginal heritage due diligence
Figure 2.1

The Soil Landscapes of Central and Eastern NSW database, mapped by the Department of Planning, Industry and Environment (DPIE), places the study area within in the Mount Walker Soil Landscape (DPIE 2020) (Figure 2.1). The topography of this landscape (see Figure 2.2) is characterised by narrow rounded crests on steep to very steep slopes, with slopes greater than 25% and local relief between 40–200 m. Elevation ranges from 780–1,190 m. Rock outcrops and overhangs, as well as narrow, deeply incised valleys, are common. Mount Walker soils generally feature shallow (up to 30 cm) of gravelly brown loam topsoil (A horizon) overlying sandstone bedrock or reddish brown silty clay loam subsoil (B2 horizon) on crests and upper slopes. Lower slopes usually exhibit less than 30 cm of gravelly brown loam (A1 horizon) overlying up to 30 cm of yellow orange fine sandy loam topsoils (A2 horizon), with subsoil consisting of yellow brown clay (B2 horizon).

Soil landscapes

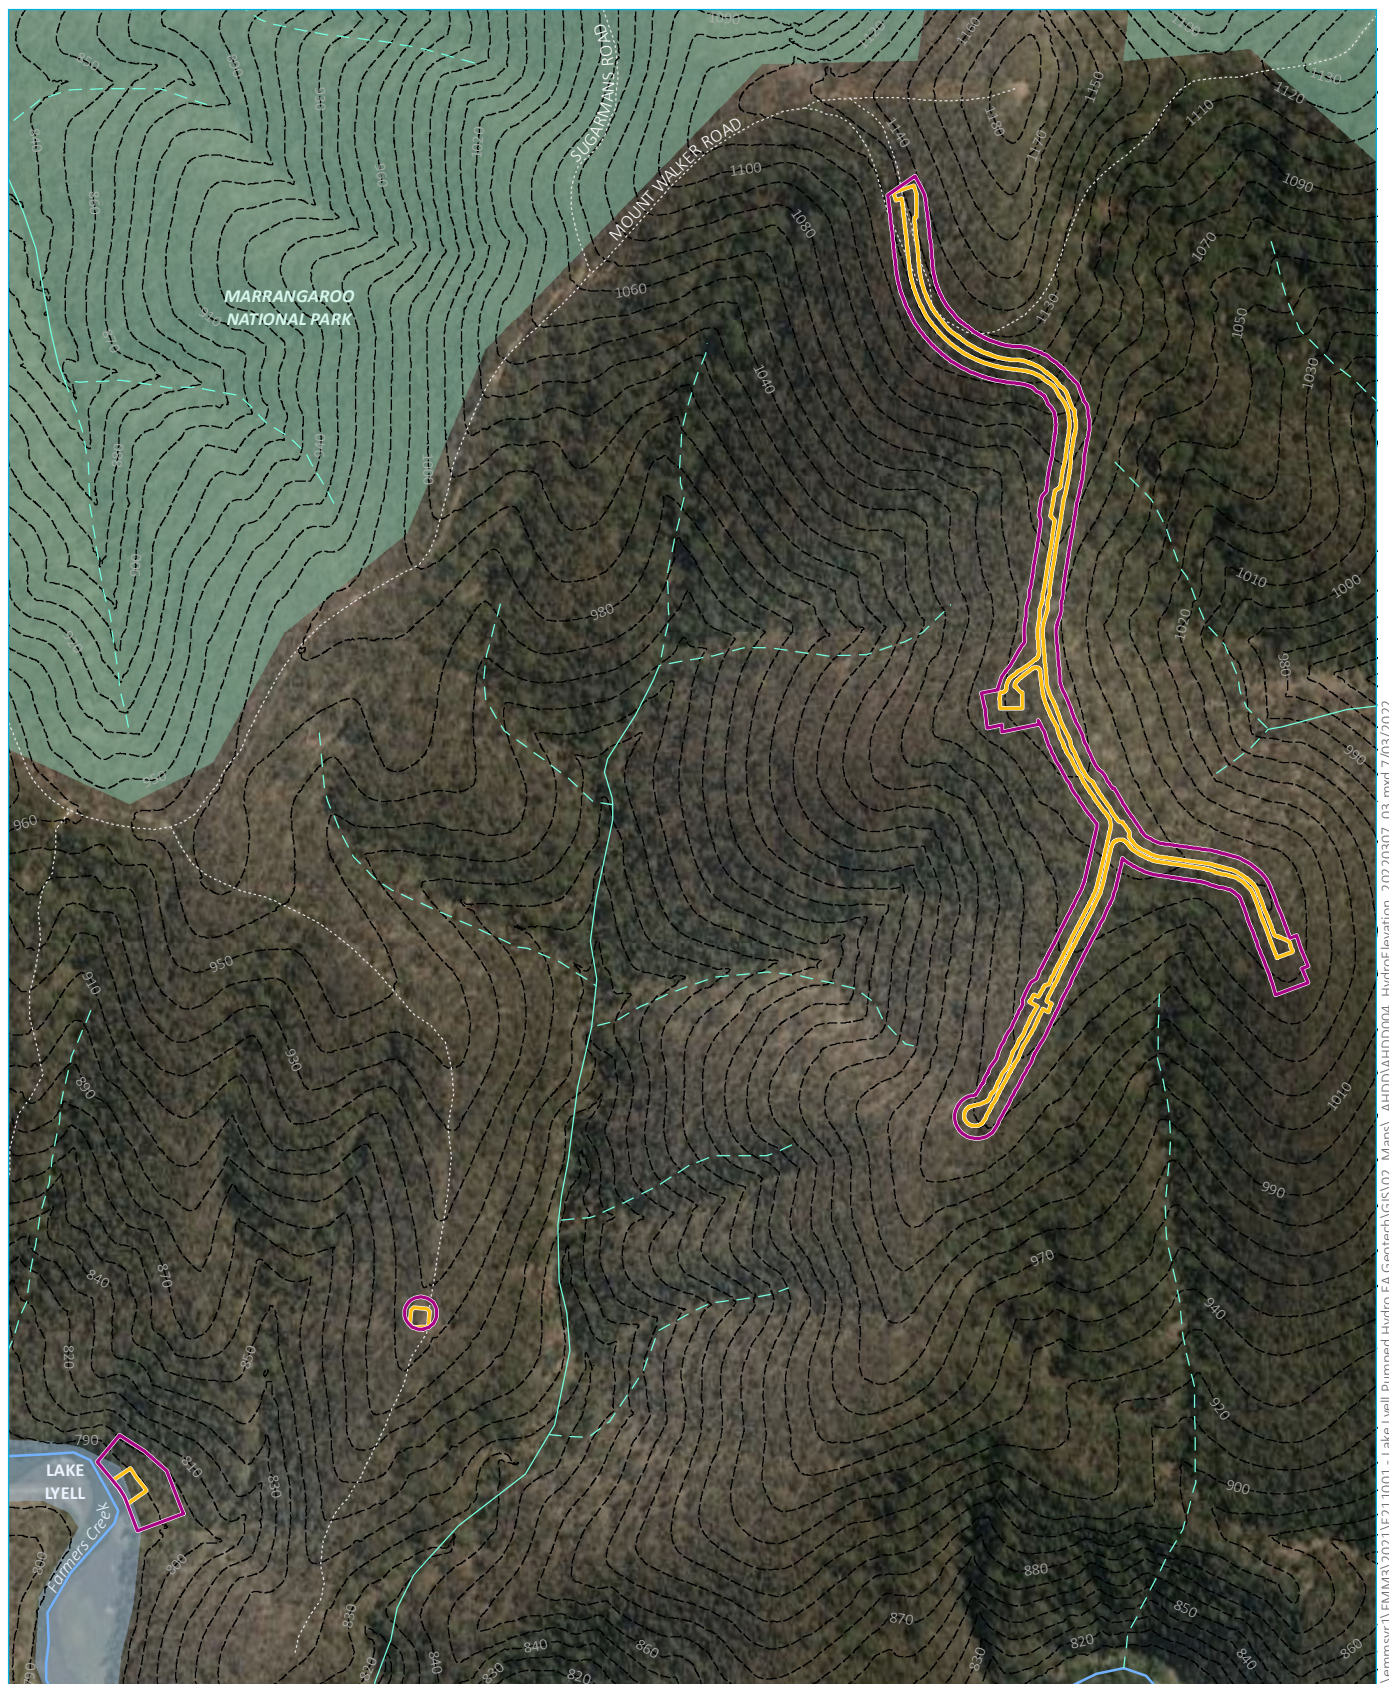
Lake Lyell Pumped Hydro
Aboriginal heritage due diligence
Figure 2.2

Farmers Creek (a 4th order Strahler stream) lies adjacent to the south of the study area and is fed by several unnamed 1st, 2nd and 3rd order watercourses to the north and south (Figure 2.2).

Criterion (iii) is also relevant to the study area, as it runs along a ridgeline comprised of a narrow crest surrounded by adjoining slopes (Figure 2.2). Aboriginal people are known to have focused their activities around waterways and on elevated landform elements like ridgelines, as these locales provided natural resources essential for daily life (eg fresh water, aquatic and terrestrial sources of food) as well as dry areas for camping and travel. Therefore, based on the presence of the landform elements discussed above, the study area potentially has archaeological sensitivity.

Elevation and hydrology

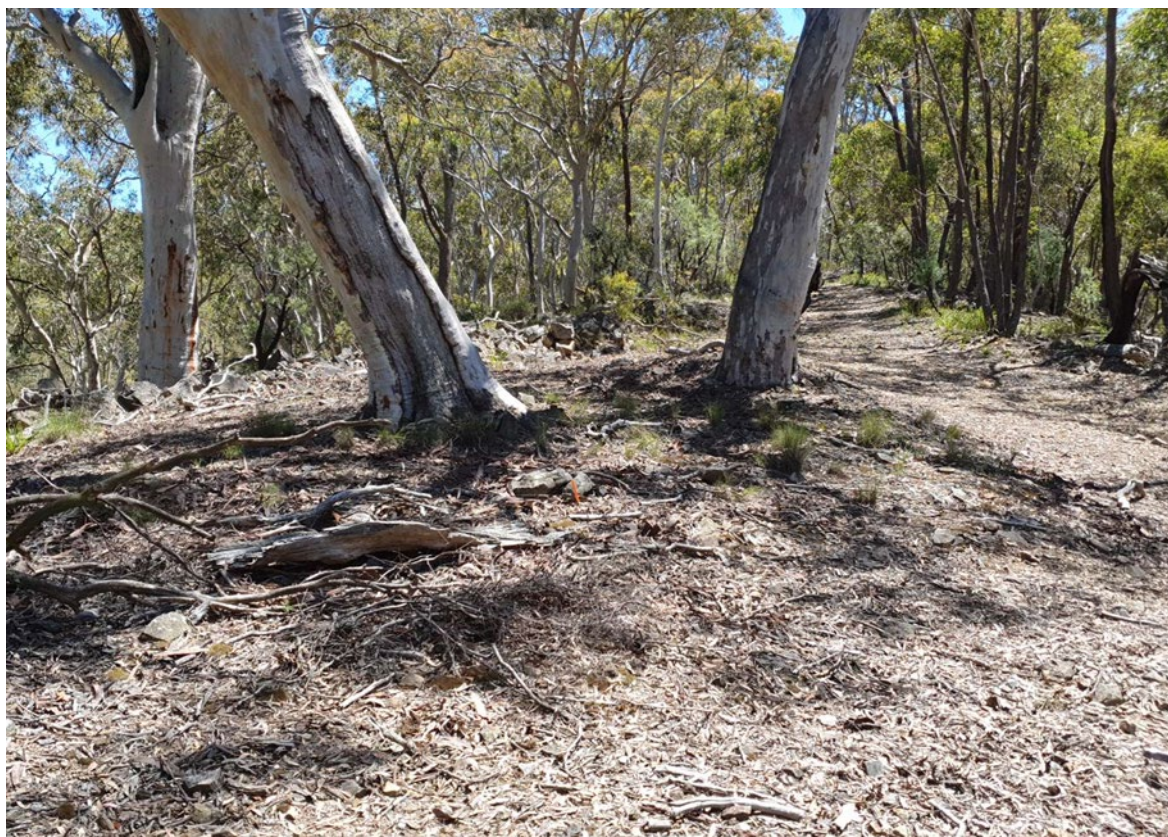
Plate 4.3 View north showing location of BH106 on eroded access track. Tree to left contains a non-cultural scar (ie scarred by insect and/or vehicle damage).

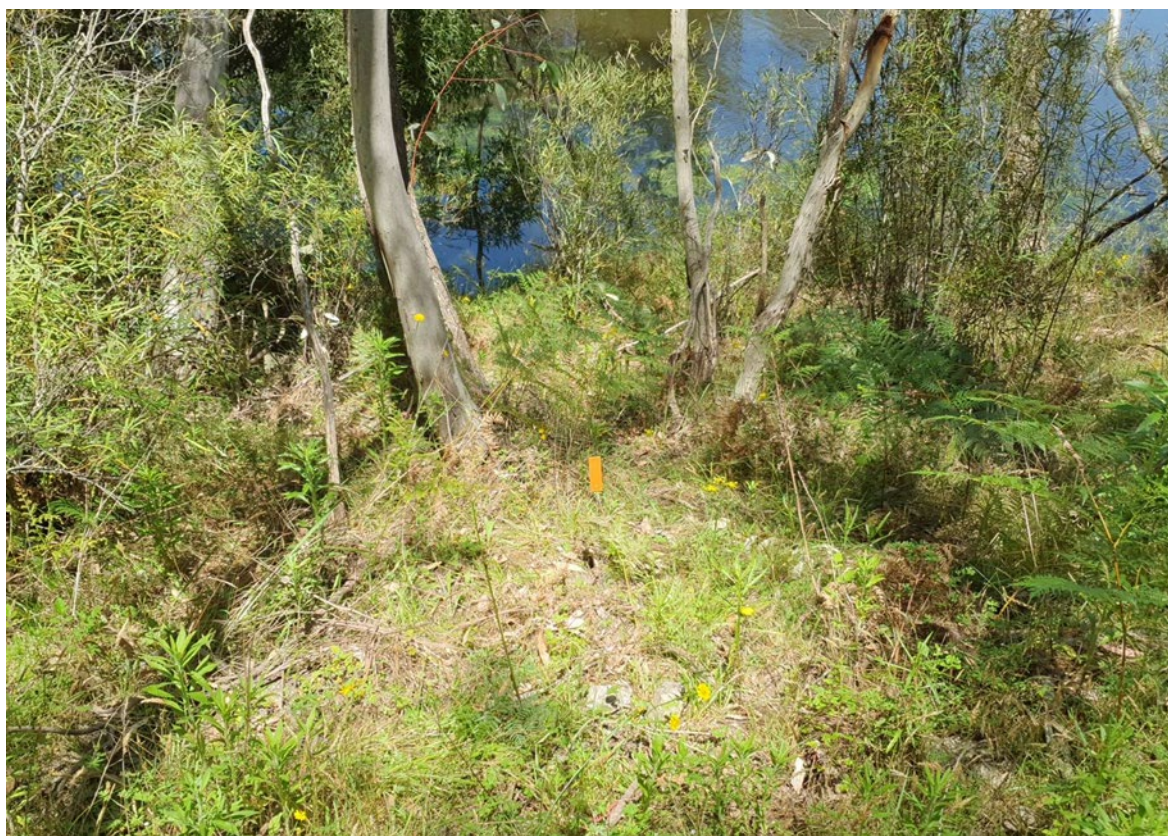
Plate 4.4 View west showing location of BH108 on northern bank of Farmers Creek/Lake Lyell.

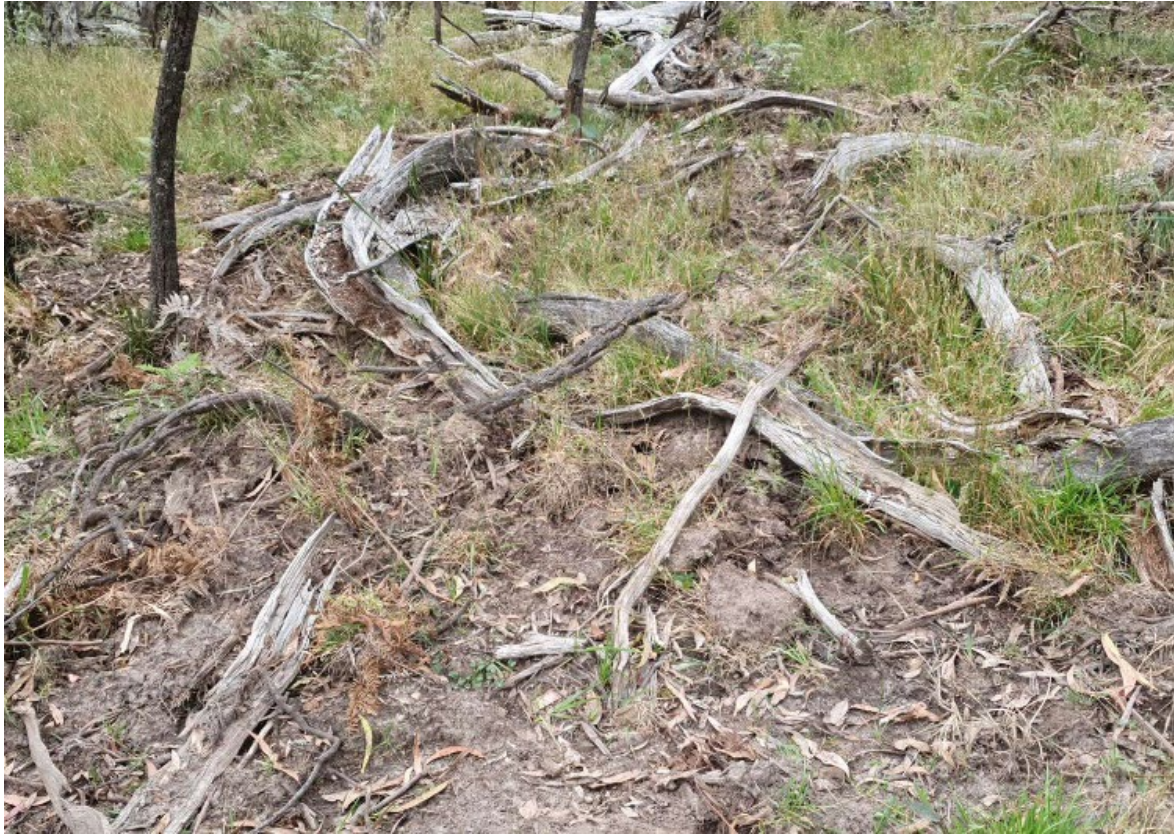
Topographically, the study area was characterised by an unsealed fire trail curving around to a ridgeline descending several metres from the trail level. The ridgeline continued south and branched off into two arms, and featured gentle to moderate slopes descending southwards (Plate 4.1 and Plate 4.2). Remnant bushland was present throughout. BH101, BH103 and BH104 located at intervals throughout the main portion of the study area adjacent to the proposed new access track, and BH105 and BH102 were located at the southern extent of each branch of the study area where the access track is proposed to end. BH106 was located on an unsurfaced fire trail on a ridgeline in an isolated spot, and BH107/108 was situated in a sloping, heavily vegetated spot on the northern bank of Farmers Creek (Plate 4.3 and Plate 4.4). A small part of this area was flat and may contain remnant topsoil. However, poor visibility at the time of survey prevented confirmation of this. Indeed, visibility across the study area was poor, with the exception of the exiting fire trail in the north and several areas of ground surface exposed by feral pig activity (Plate 4.5).

Plate 4.5 **Pig disturbance encountered in the study area. This exposure showed some remnant topsoil.**
