Wolgan Road, NSW

Review of Wolgan Gap Slope Hazards 2022

Lithgow City Council

PS129742-SYD-GEO-REP-001-REV 0

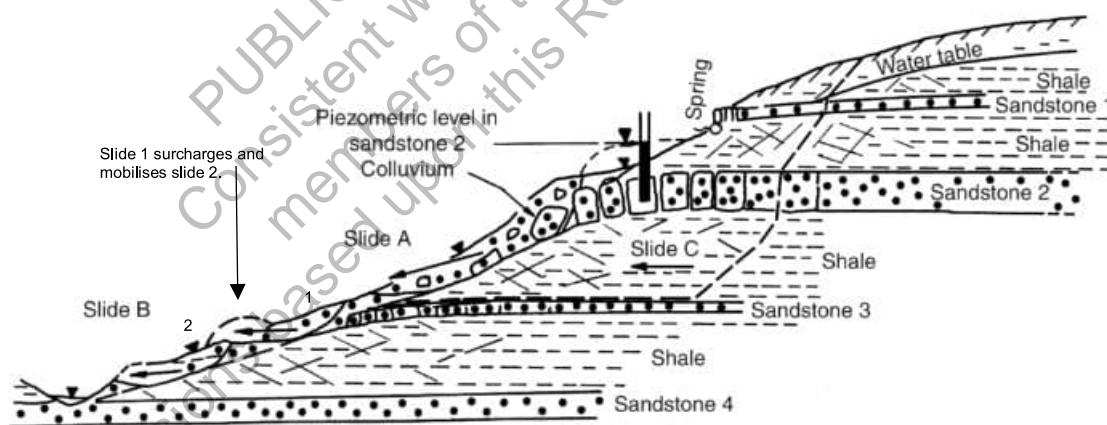
Figure 1 : Example landslide mechanisms in interbedded sedimentary sequences (Adapted from Deere & Patton 1971)

- Type A – landslide within colluvium triggered by high pore water pressure at weathered rock interface.
- Type B – ‘double slide’ in which the toe of a slide above (i.e. slide 1 in Figure 1) overloads a slide surface of marginal stability below (i.e. slide 2 in Figure 1) resulting in mobilisation of slide 2.
- Type C – deep-seated landslide with rupture surface through weathered rock.

One component of the landslide mechanisms of Figure 1 is the restriction of drainage from the upper sandstone beds by the overlying colluvium generating high pore water pressures at the colluvium weathered rock interface and causing sliding. Evidence for those groundwater conditions were observed at Site 1I in the form of a relatively dry colluvial mass overlying weathered rock with localised seeps and saturated zones close to the weathered rock contact, as well as from behind and adjacent to large (more than 5 m minimum dimension) boulders within the colluvium. Similar observations of a relatively dry colluvial mass overlying

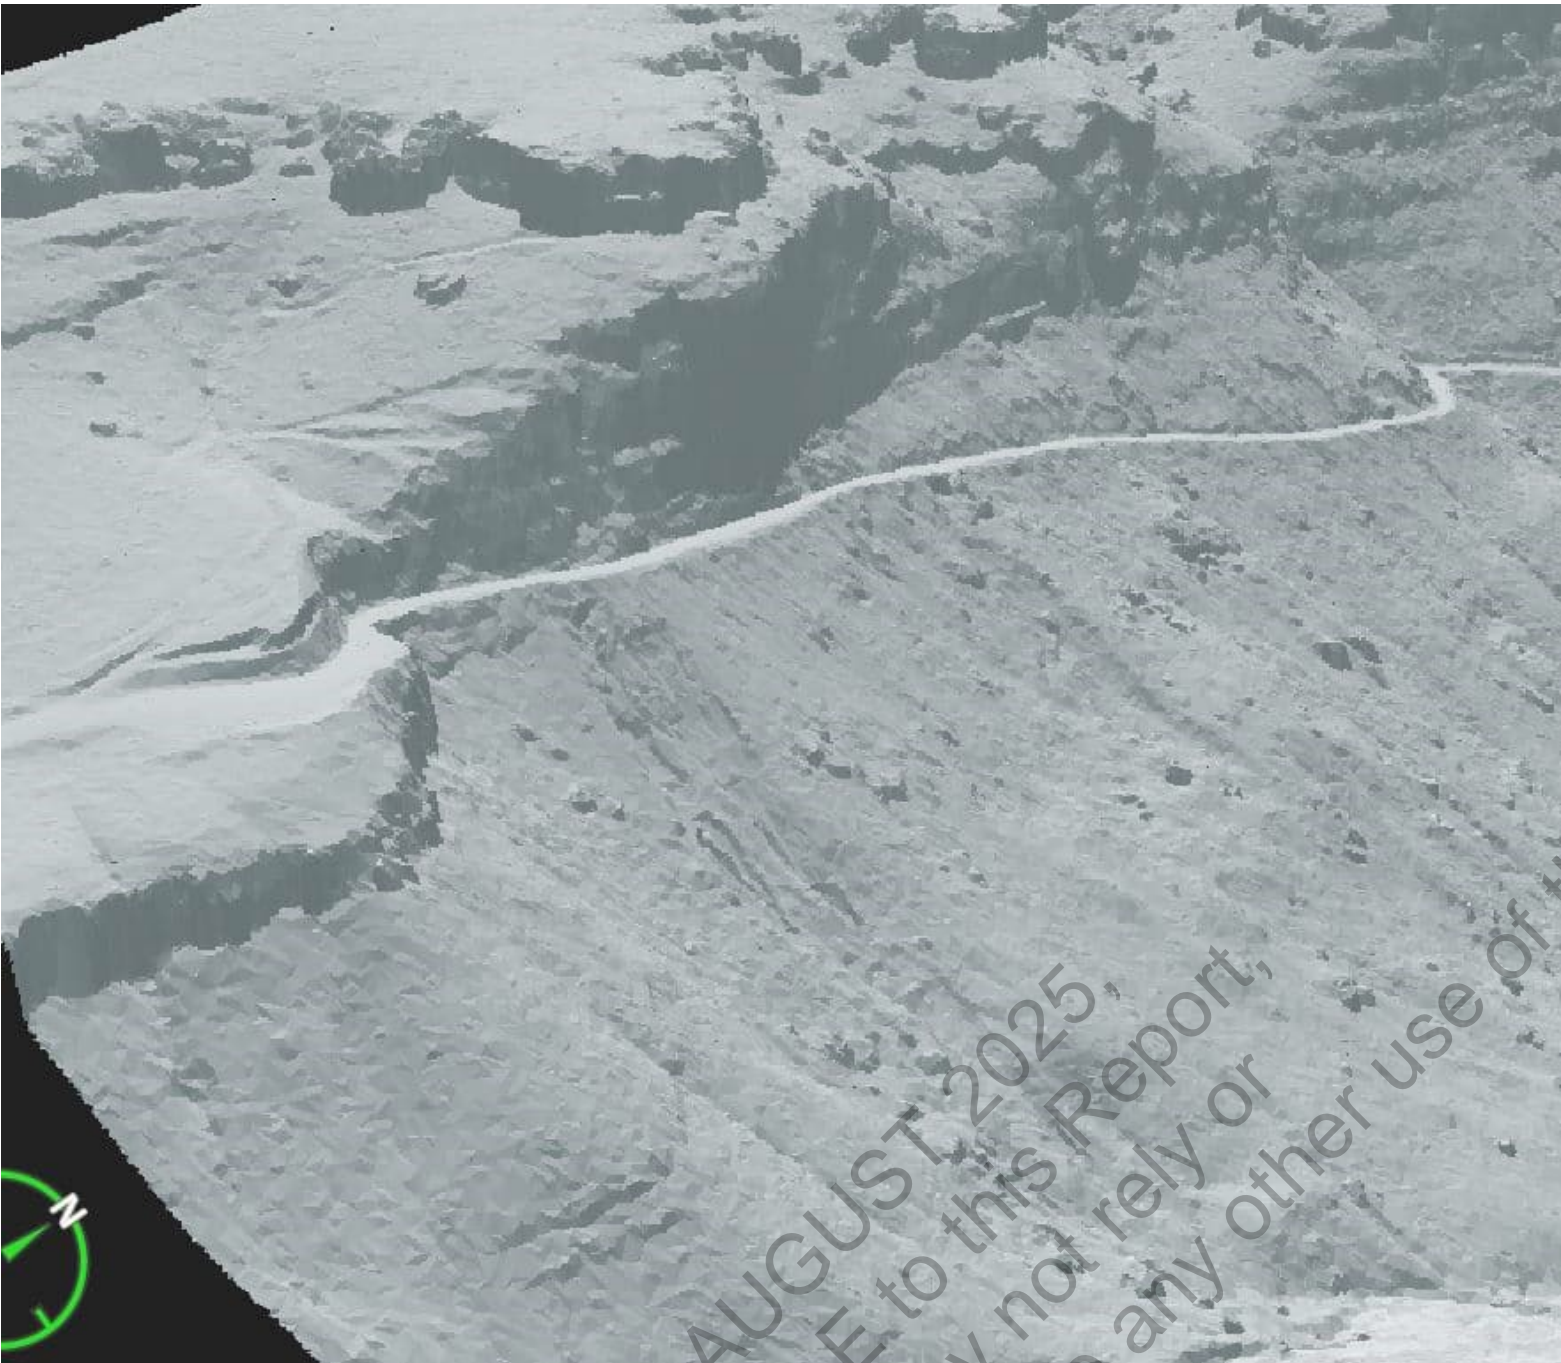
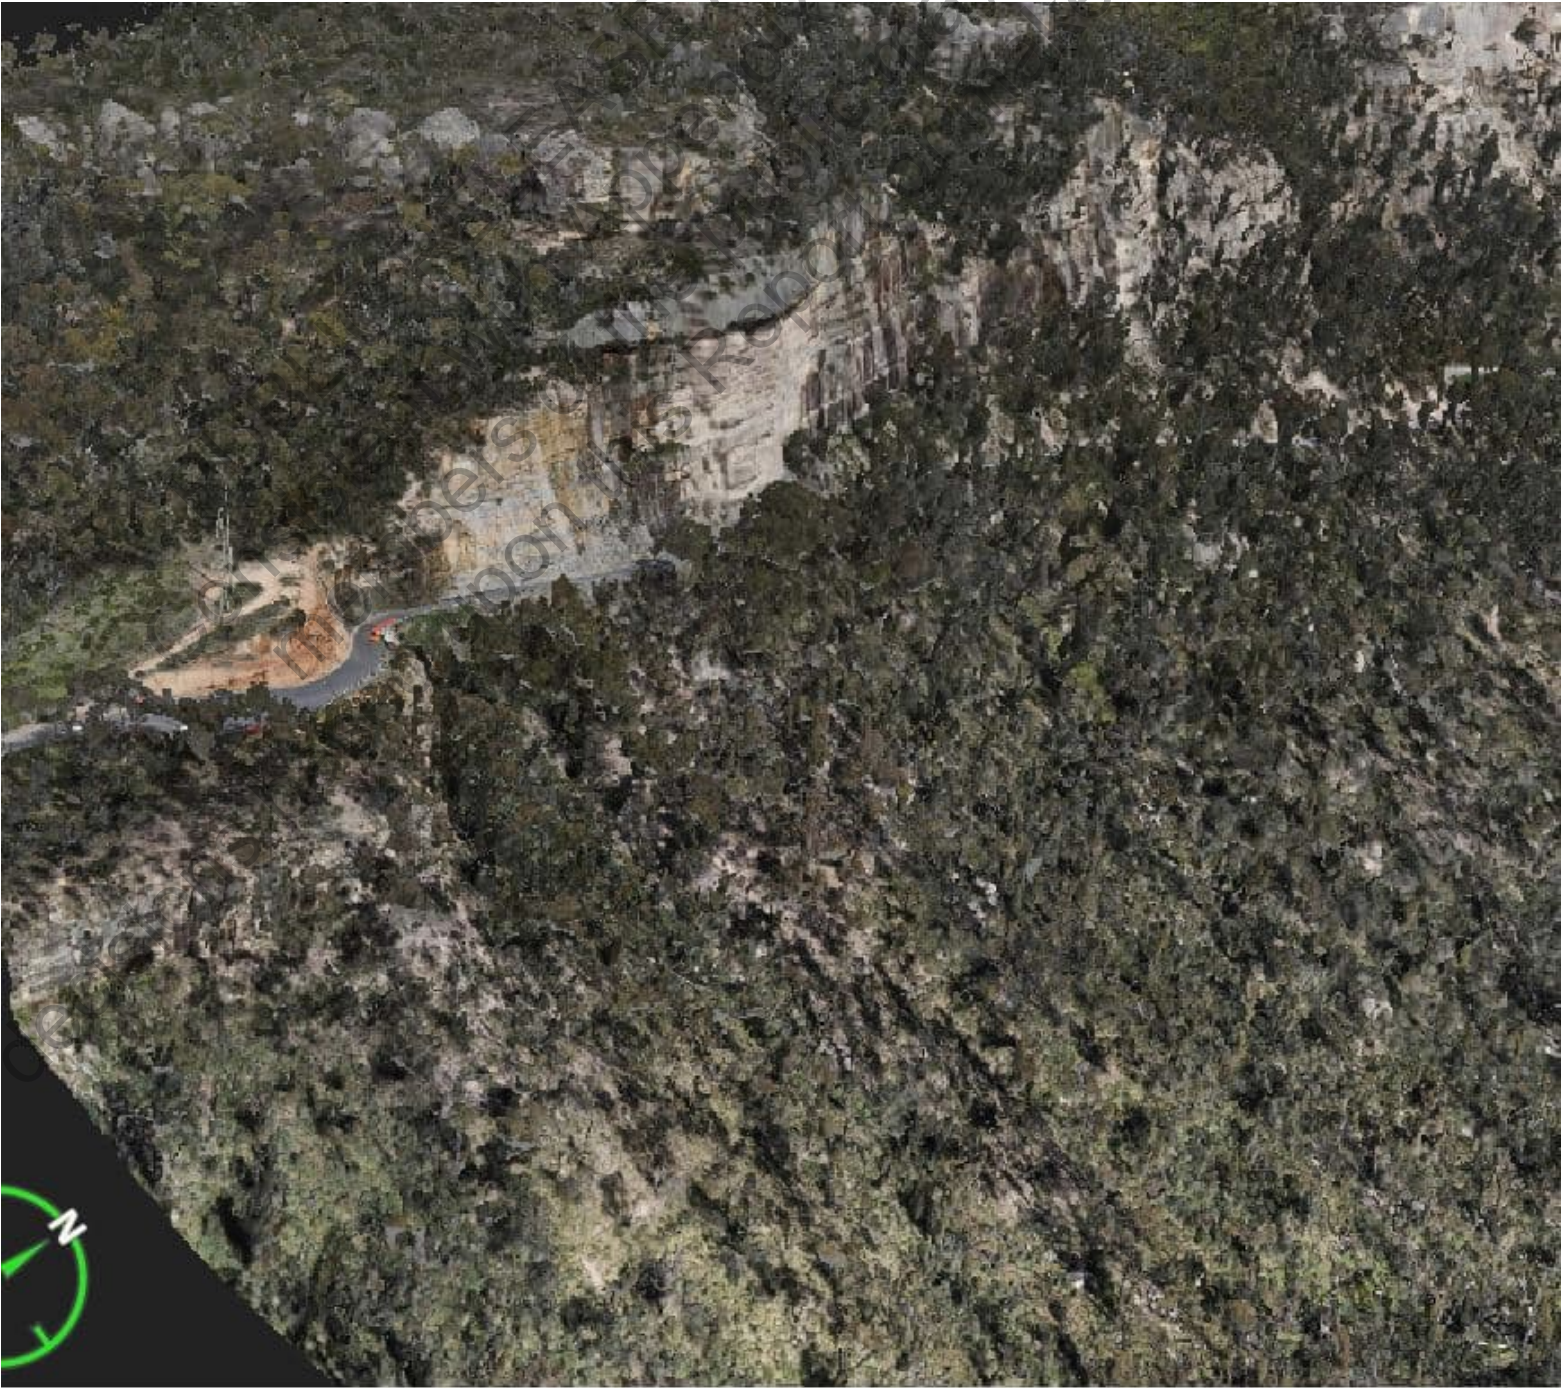
PROJECT NO	DOC	REV.	FIGURE
PS129742	001	0	C1

The colluvial slopes along the 2.7 km section of Wolgan Road show evidence of numerous existing landslides including medium scale (i.e. 50,000 m³ to 250,000 m³ in accordance with Fell's 1994 classification). These landslides are inferred to be typically immobile under the average Bureau of Meteorology (BOM) documented rainfall conditions in the area. There are also numerous, typically small scale (i.e. 5,000 m³ to 50,000 m³) or less, landslides evident within larger landslide masses and the colluvial slopes. Perspective views of the slopes which show landslide scars within the 15th November 2022 Lidar and photo aerial imagery are provided as Figures C1 to C5 of Appendix C.
