DESKTOP GEOTECHNICAL AND MINE SUBSIDENCE ASSESSMENT

Lithgow Mountain Bike Park

Prepared for Central Tablelands Mountain Bike Club

RCA ref 17539-201/2

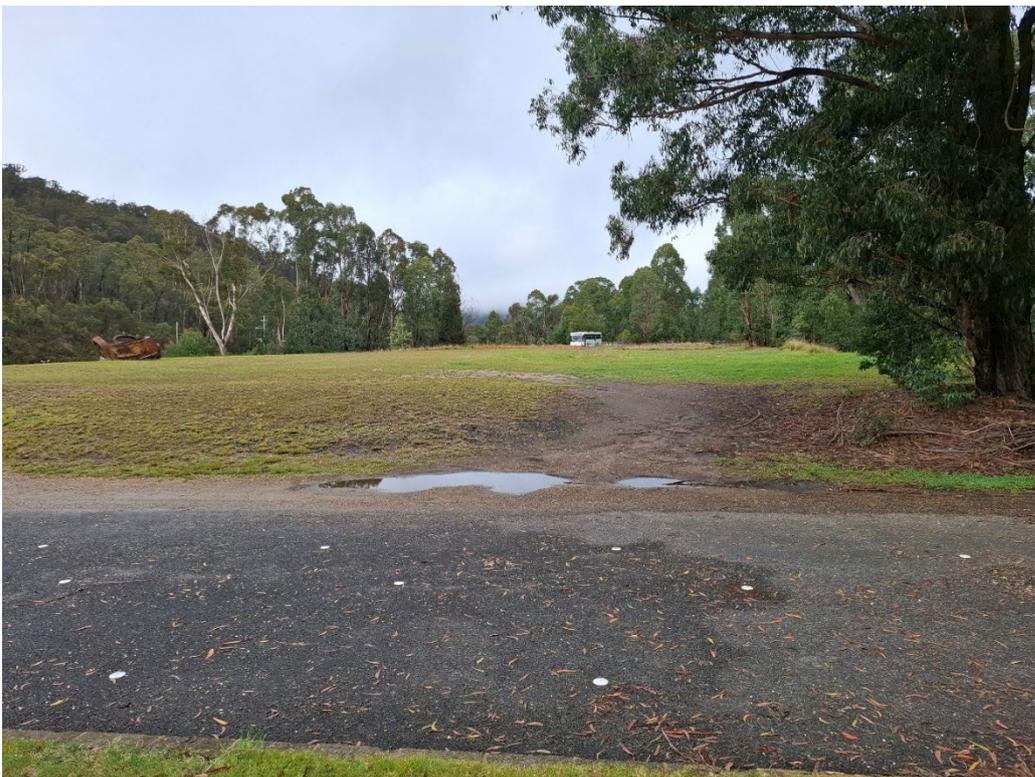
Photograph 1 *View to the north across the area proposed for the starting point of the trail network. Visible in the background are the Park Museum Building with the poppet head over the colliery downcast shaft behind (shaft is 80m deep, fully lined and capped with concrete)*

At the site starting area (see **Photograph 1**, **Photograph 2** and **Photograph 3**) there is understood to be an unknown depth of fill comprising mine spoil present.

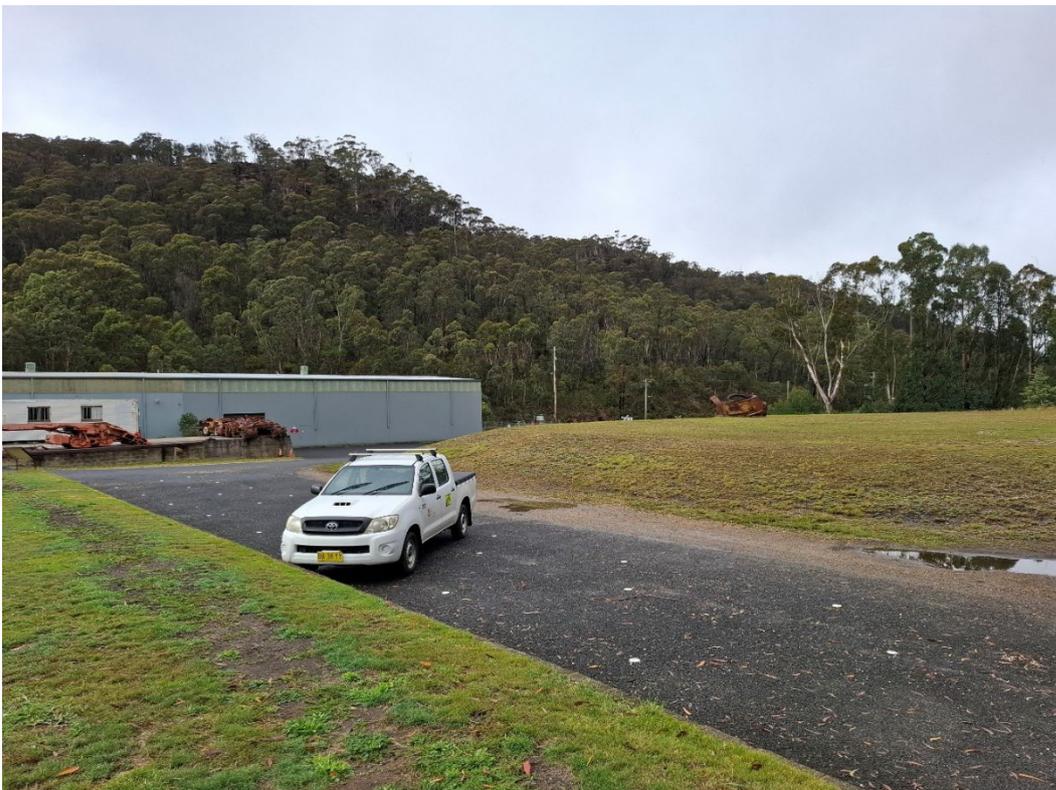
Photograph 2 *View to the south across the area proposed for the starting point of the network. The Heritage Park carpark is in the foreground.*
