**APPENDIX 8 GEOTECHNICAL REPORT**

# KEIGHRAN GEOTECHNICS

**Re: Geotechnical Land Use Stability Assessment  
Lot 1 DP 1130700 , Lot 1 Section 60 DP 758855, Lot 1 DP 922029, Lot 1 DP 9223398 and Lot 1 DP 115461  
No. 2 and No.23 Williwa Street – Portland**

**GEOTECHNICAL INVESTIGATION**

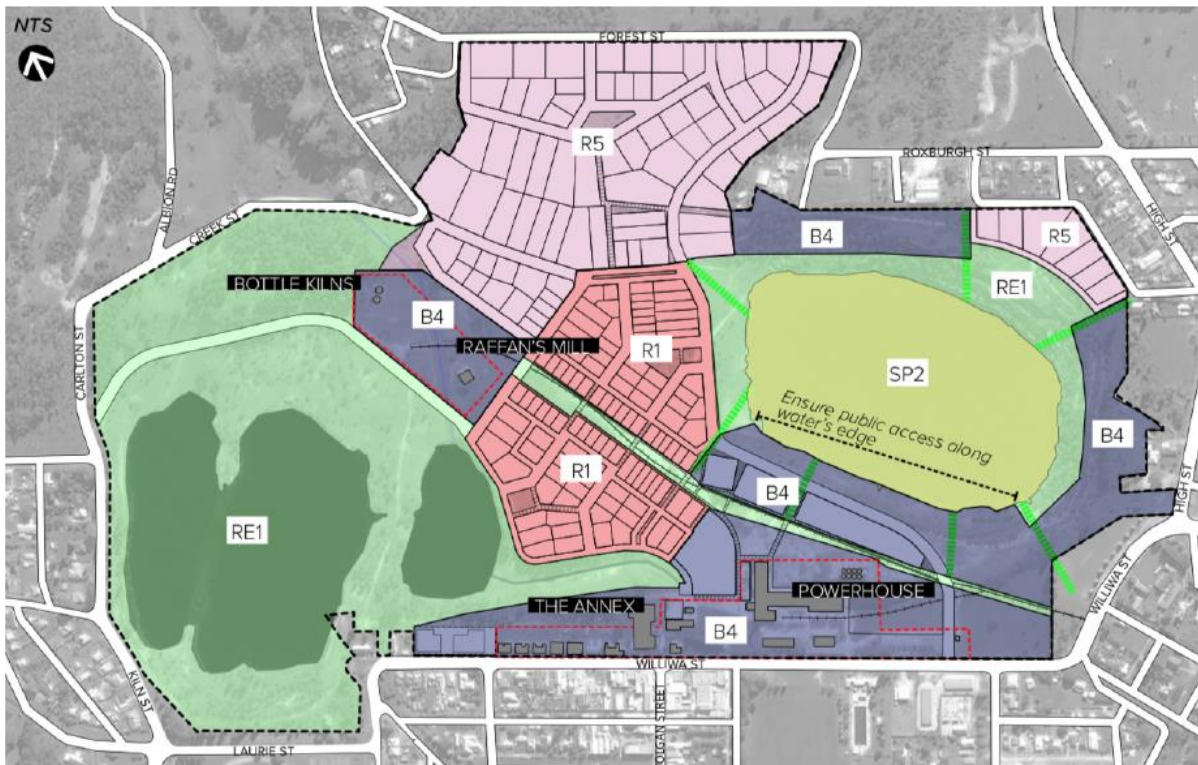
A development concept plan was developed for the new Owners AWJ Civil Pty Ltd by Compliance Health & Environmental Consulting Pty Ltd in February 2019 and is indicated in Drawing CH1060 Figure No.2.
