REPORT**Wolgan Gap, Wolgan Road***Slope Risk Assessment Update 2022 - Domain 1 and 2*

PS129742-SYD-GEO-REP-002-REV 0

17th February 2023

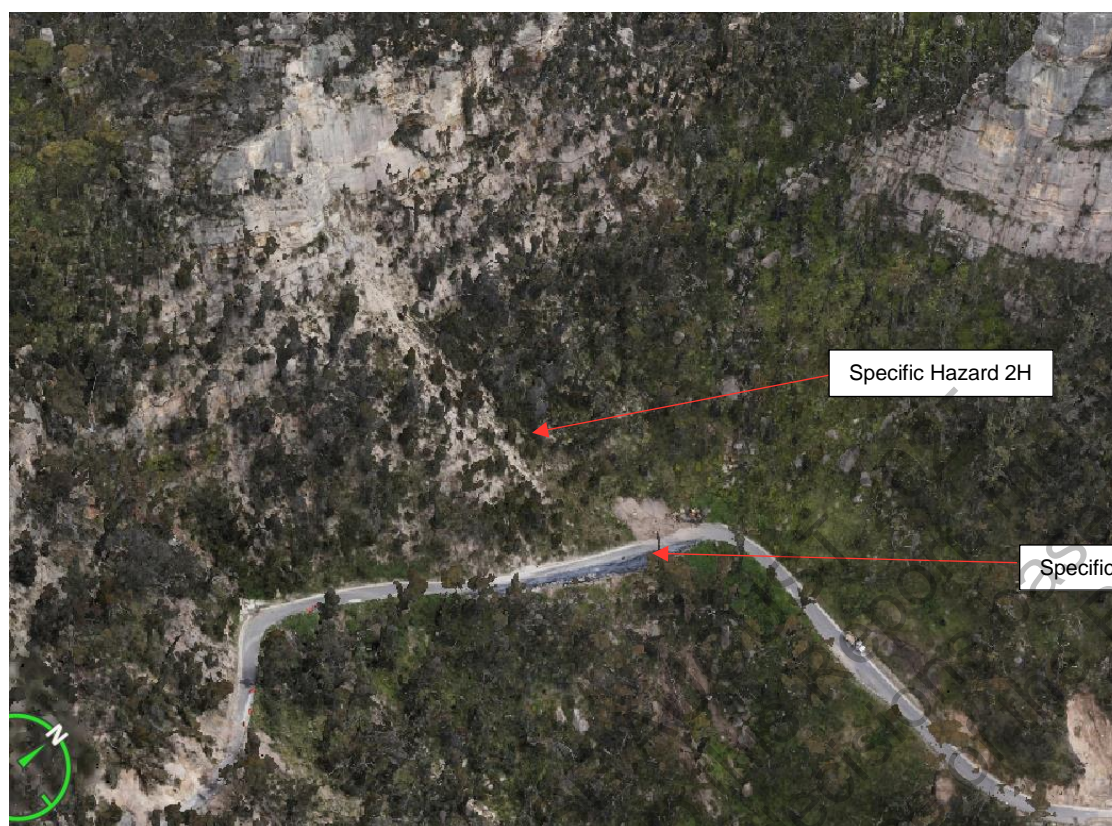
Figure 1: Aerial photogrammetric view of Hazard 2B below Hazard 2H from 15.11.2022 Aerial Survey

As an example, by the methods outlined in Section 2.4 above, Site 2B alone can be calculated to have experienced a loss of value of \$193,500 over the period June 2022 to December 2022 (i.e. a 6 month period). Site 2B is active (i.e. the landslide continues to move) and enlarging and the calculated annualized loss of value property risk for that hazard is \$1.5 million (of which a loss of value of \$193,500 has already been realized in accordance with the method of calculation adopted herein). Further details regarding Site 2B are provided in WSP-Golder 2023. The actual cost to safely investigate, design and implement an effective long-term remediation may be significantly greater than the calculated loss of value for that hazard. Aerial photogrammetric and LiDAR derived hillshade views of Hazard 2B are shown in Figures 1 and 2 below respectively. Figure 3 shows a close-up of vertical displacement at Hazard 2B taken on 10th October 2022.

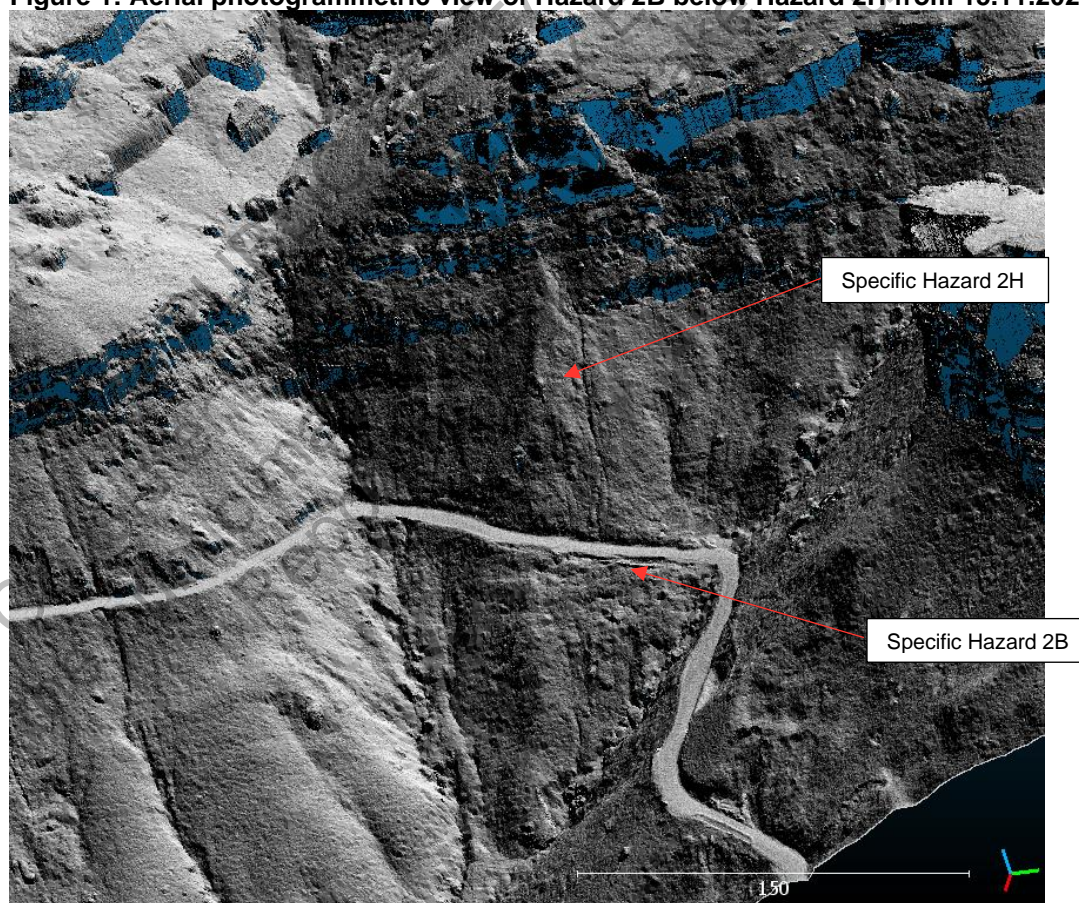
Figure 2: Aerial perspective view of Hazard 2B below Hazard 2H from 15.11.22 LiDAR derived hillshade

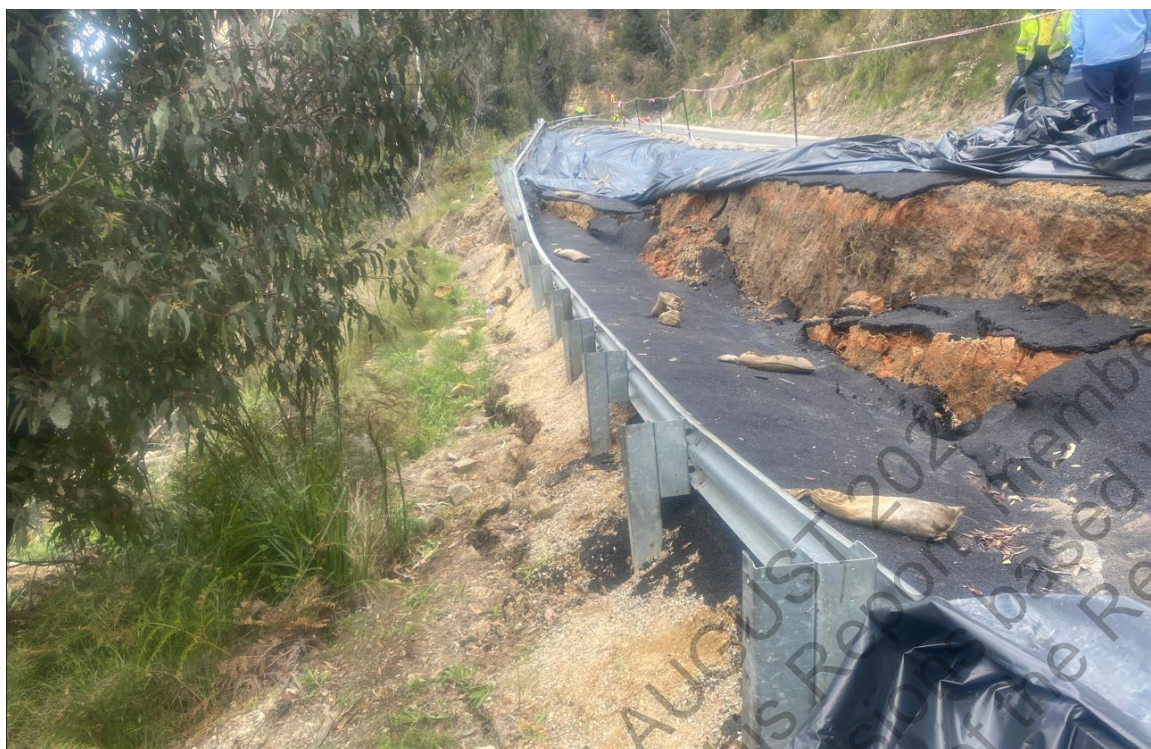
Figure 3: Looking south at Hazard 2B, photograph taken 10th October 2022

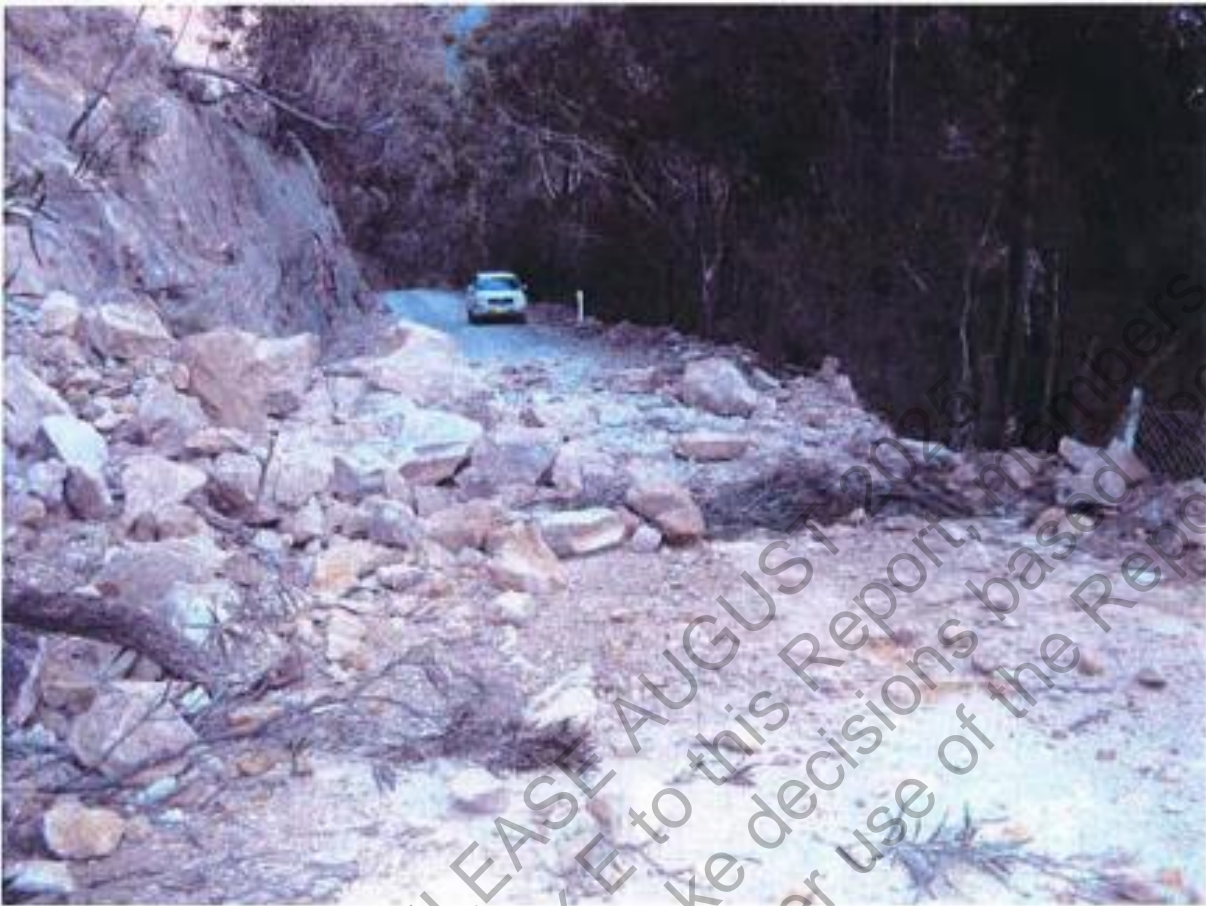
Figure 4: Looking north on 9th September 2008 after Domain 1 rockfall event.

Remediation works to mitigate the risk to road users from hazards H1.1.1 and H1.1.2 were undertaken in 2009 over an approximately 240 m upslope section of Wolgan Road immediately north of the Wolgan Gap lookout, following a rockfall event which occurred in Domain 1 (Domain boundaries are shown in Figure A2 of Appendix A) on 8th September 2008. Figure 4 below shows some of the debris left on the road following the 8th September 2008 rockfall within Domain 1.

The works proposed to mitigate H1.1.1 and H1.1.2 hazards over the immediate upslope area along the approximately 240 m length of Wolgan Road included a combination of items 1 to 5 below.

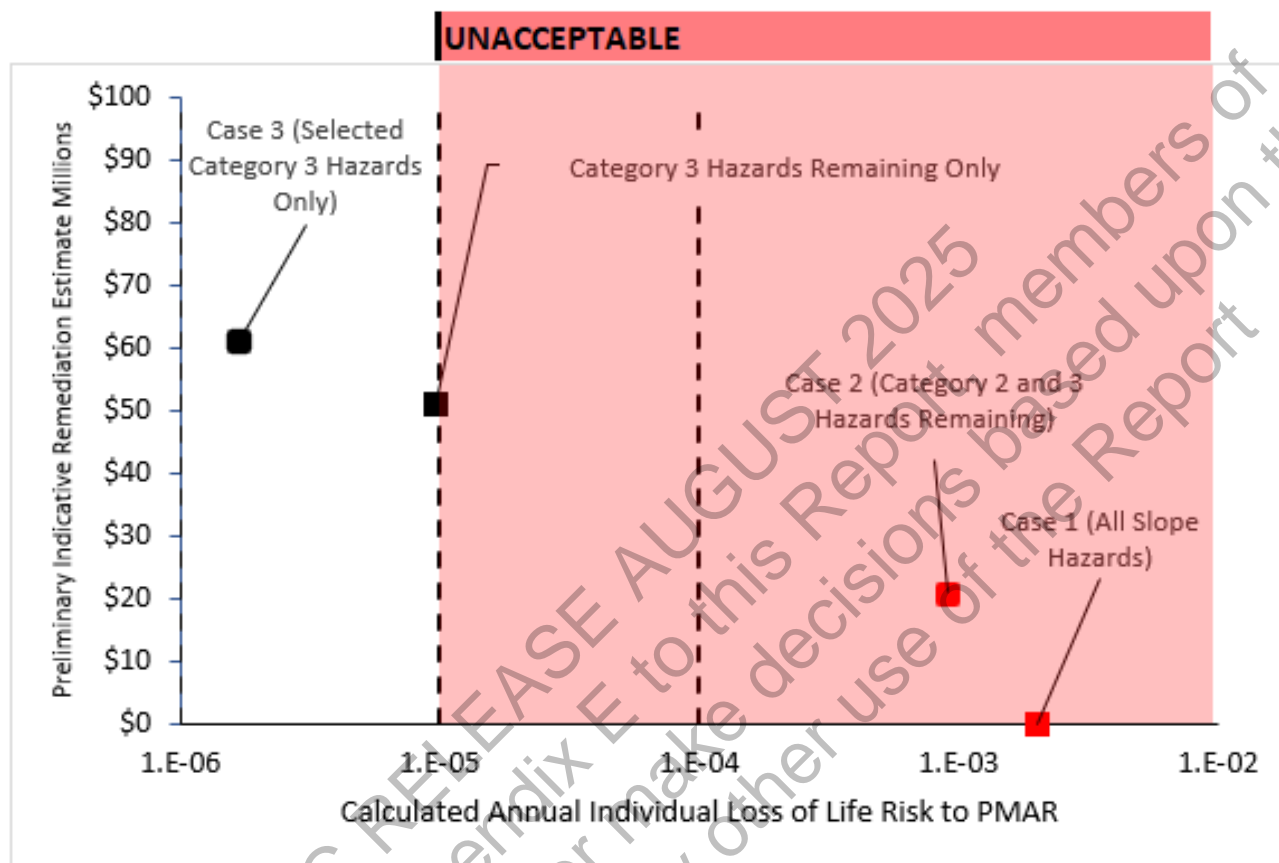
Calculated annual individual loss of life risk values versus the indicative remediation costs presented in Table B6 of Appendix B are summarized in Figure 5 below.

Figure 5: Change in Calculated Annual Individual Loss of Life Risk for PMAR Between Cases

As shown in Figure 5 above, the indicative preliminary cost to remediate Category 1 hazards (i.e. Case 2) exceeds the assumed asset value for the road of \$20 million. Even with that level of expenditure, as shown in Figure 5 and Figure 6 respectively, calculated annual individual loss of life risk and calculated annual societal loss of life risk remain in the unacceptable range, as does annual property (i.e. loss of value) risk which is calculated to remain over \$2 million p.a. as shown in Figure 7.

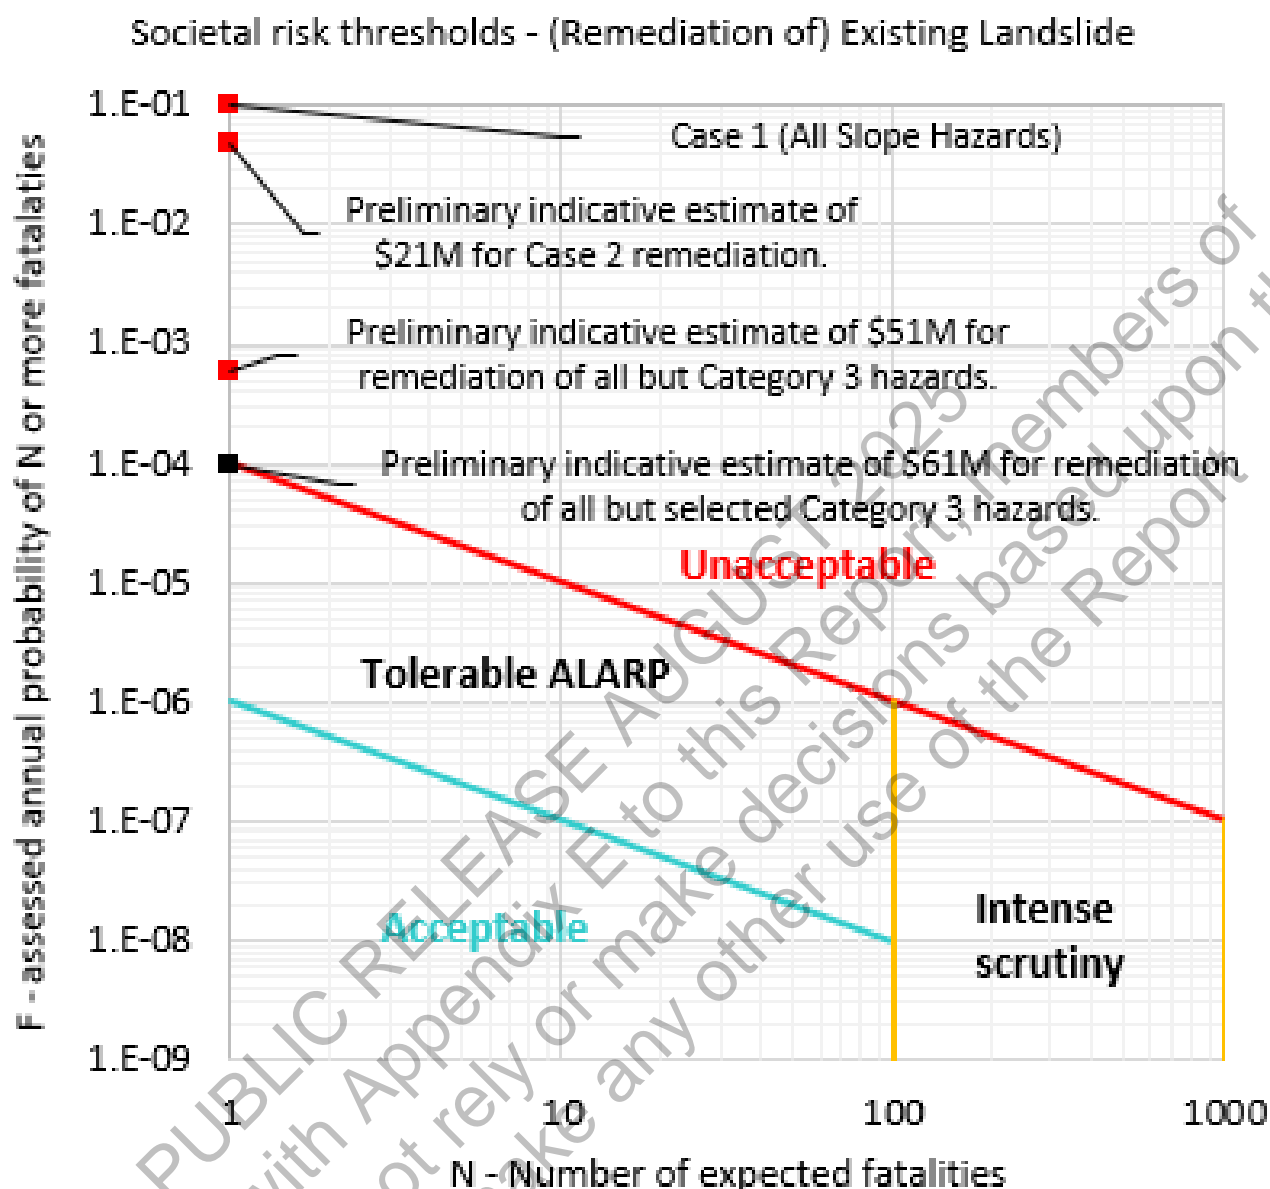
Calculated residual annual societal loss of life risk of one or more fatalities (for each of the cases considered) and the indicative remediation costs are shown on Figure 6 below.

Figure 6: Change in calculated annual Societal risk of one or more fatality (i.e. $N \geq 1$) between Cases (adapted from NSW NPWS 2019)

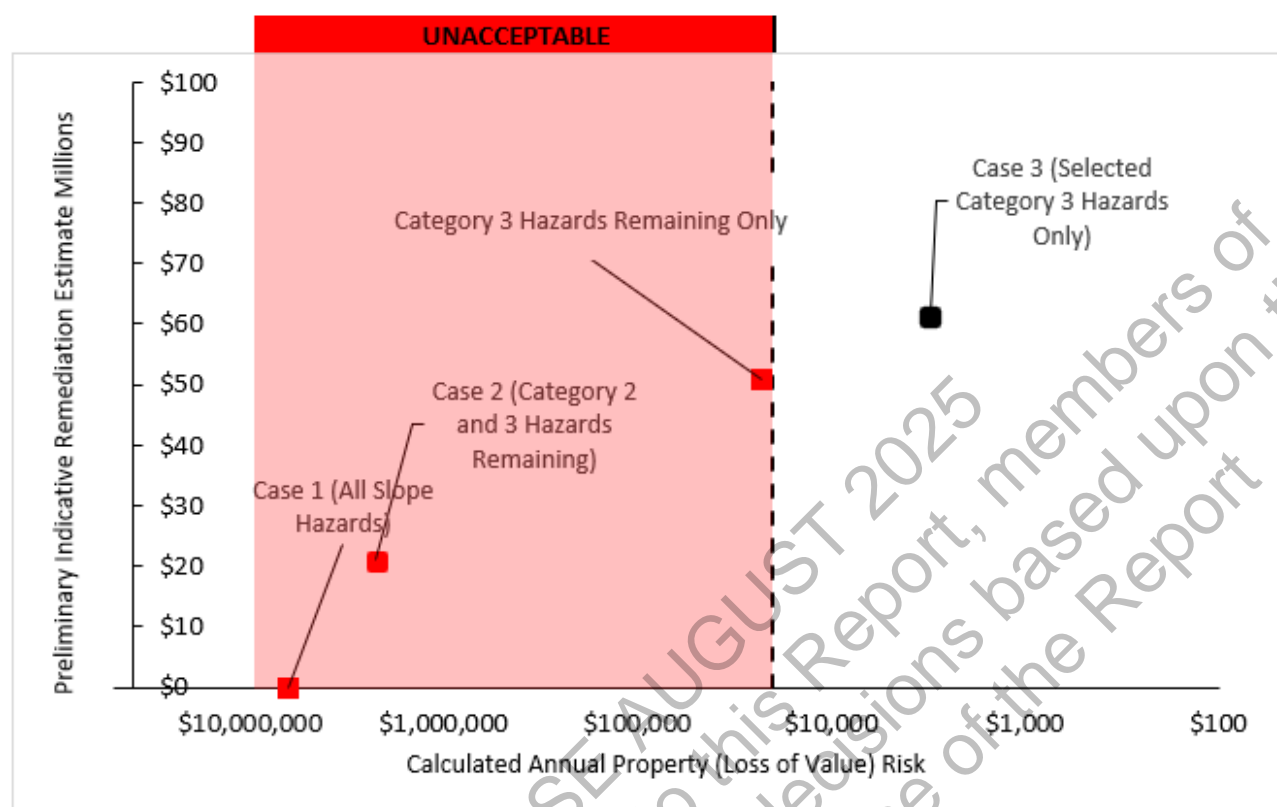
Calculated residual annual property (i.e. loss of value) risk versus the indicative remediation costs are shown on Figure 7 below.

Figure 7: Change in calculated annual property (i.e. loss of value) risk between Cases

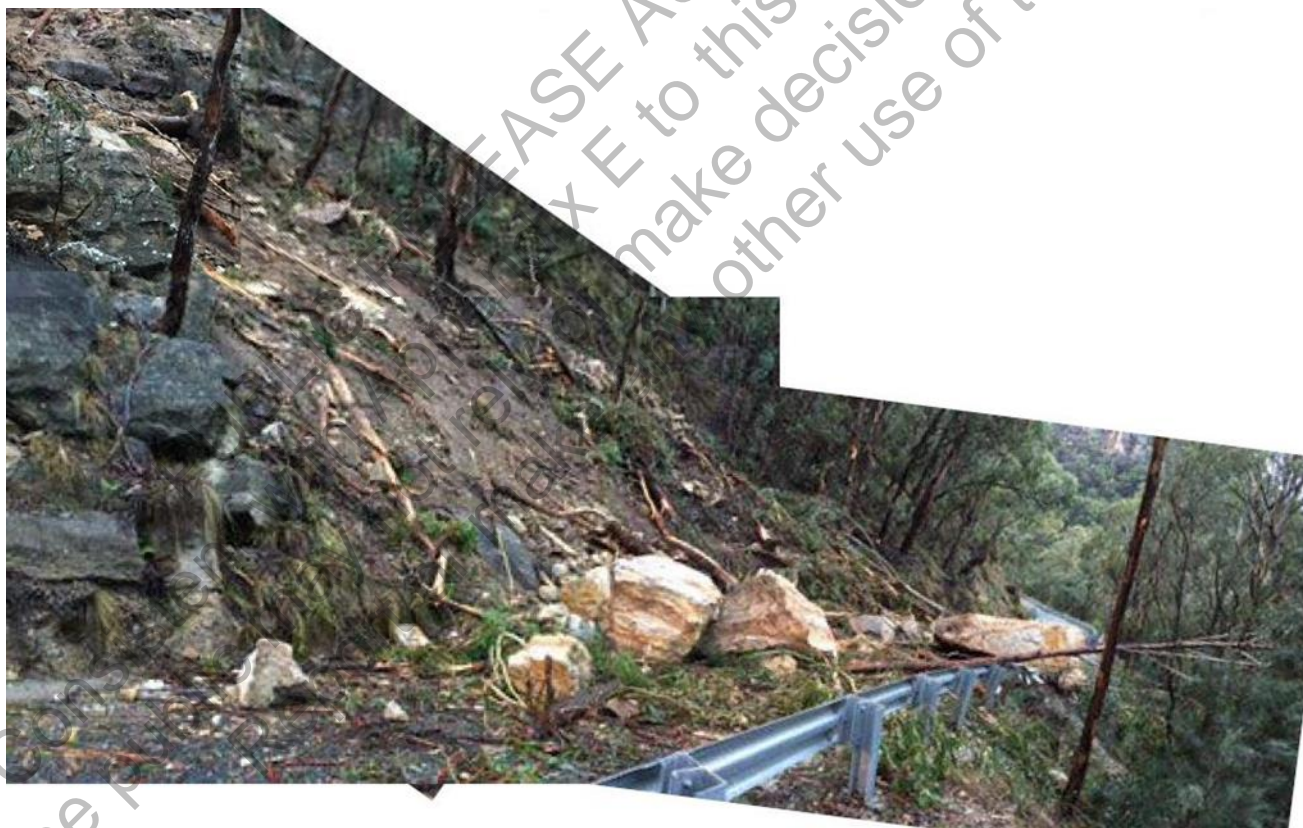
In addition to the potential for repairs of the road and road furniture (e.g. barriers), there would be a potential need for repair of remediation measures, depending what those remediation measures are and how effectively they are maintained and how they perform. For example, the occurrence of a rock topple which impacts a catch fence designed for a lower energy level (e.g. for rockfall rather than rock topple) may require repair or replacement of part or all of the catch fence over the impacted extent. An example of some debris which was left on Wolgan Road following a 2016 rock topple within Domain 1 is shown in Figure 8 below.

Figure 8: Debris left on road following rock topple within Domain 1 in June 2016.

Potential for such events would need to be considered in the development of remediation designs and establishment of on-going annual repair budgets. Additionally, if remediation measures such as catch fences are not adequately maintained (e.g. via removal of accumulated debris) then there would be a risk of damage, occurring due to the cumulative effect of multiple events, even where those individual events are below the design energy level for the fence. Thus, annual repair budgets would need to be developed in consideration of

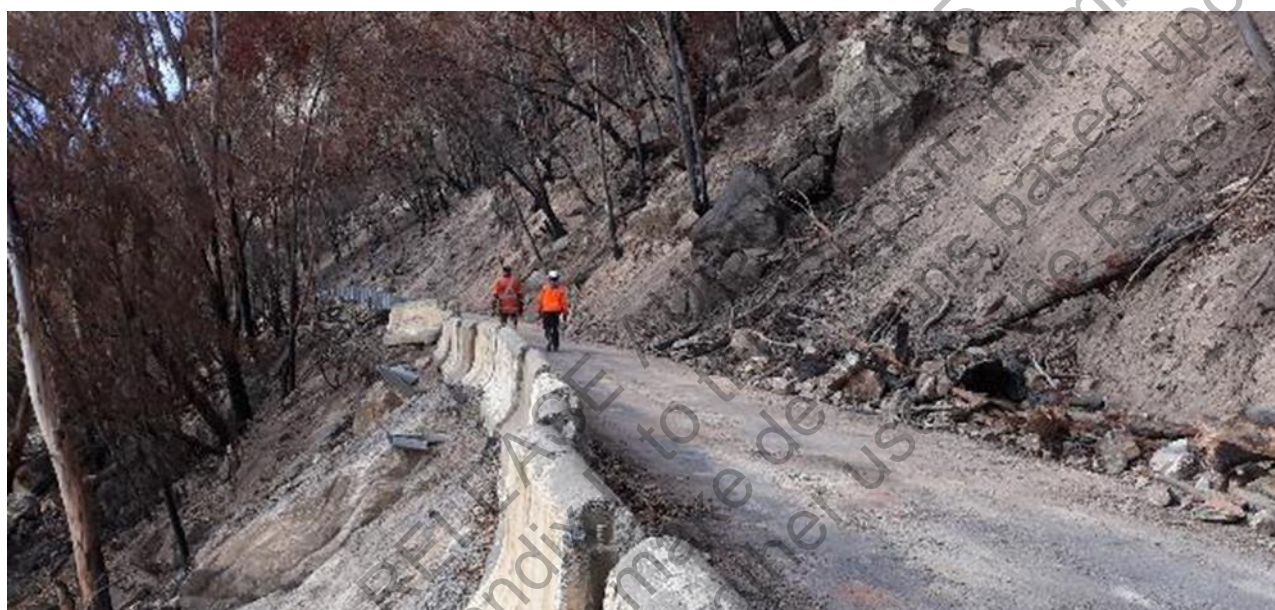
If the currently closed section of Wolgan Road was remediated and re-opened, an annual budget allowance for replacement would be needed to account for the eventual need to replace remedial measures. In addition to natural on-going slope process associated with the hazards of Section 2.1 above, there is the potential for damage or destruction of the road and remedial measures from other hazards including tree fall (e.g. which could impact catch fences or attenuator systems were they adopted) and the effects of bushfire. Figure 9 below shows the condition of Wolgan Road within Domain 1 in the aftermath of the December 2019 bushfire.

Figure 9: Looking south in Domain 1 during clean-up following December 2019 bushfire.

Development of an annual budget for complete replacement of portions of the road, its furniture and/or remedial measures would need to consider the extent and nature of remedial measures adopted.

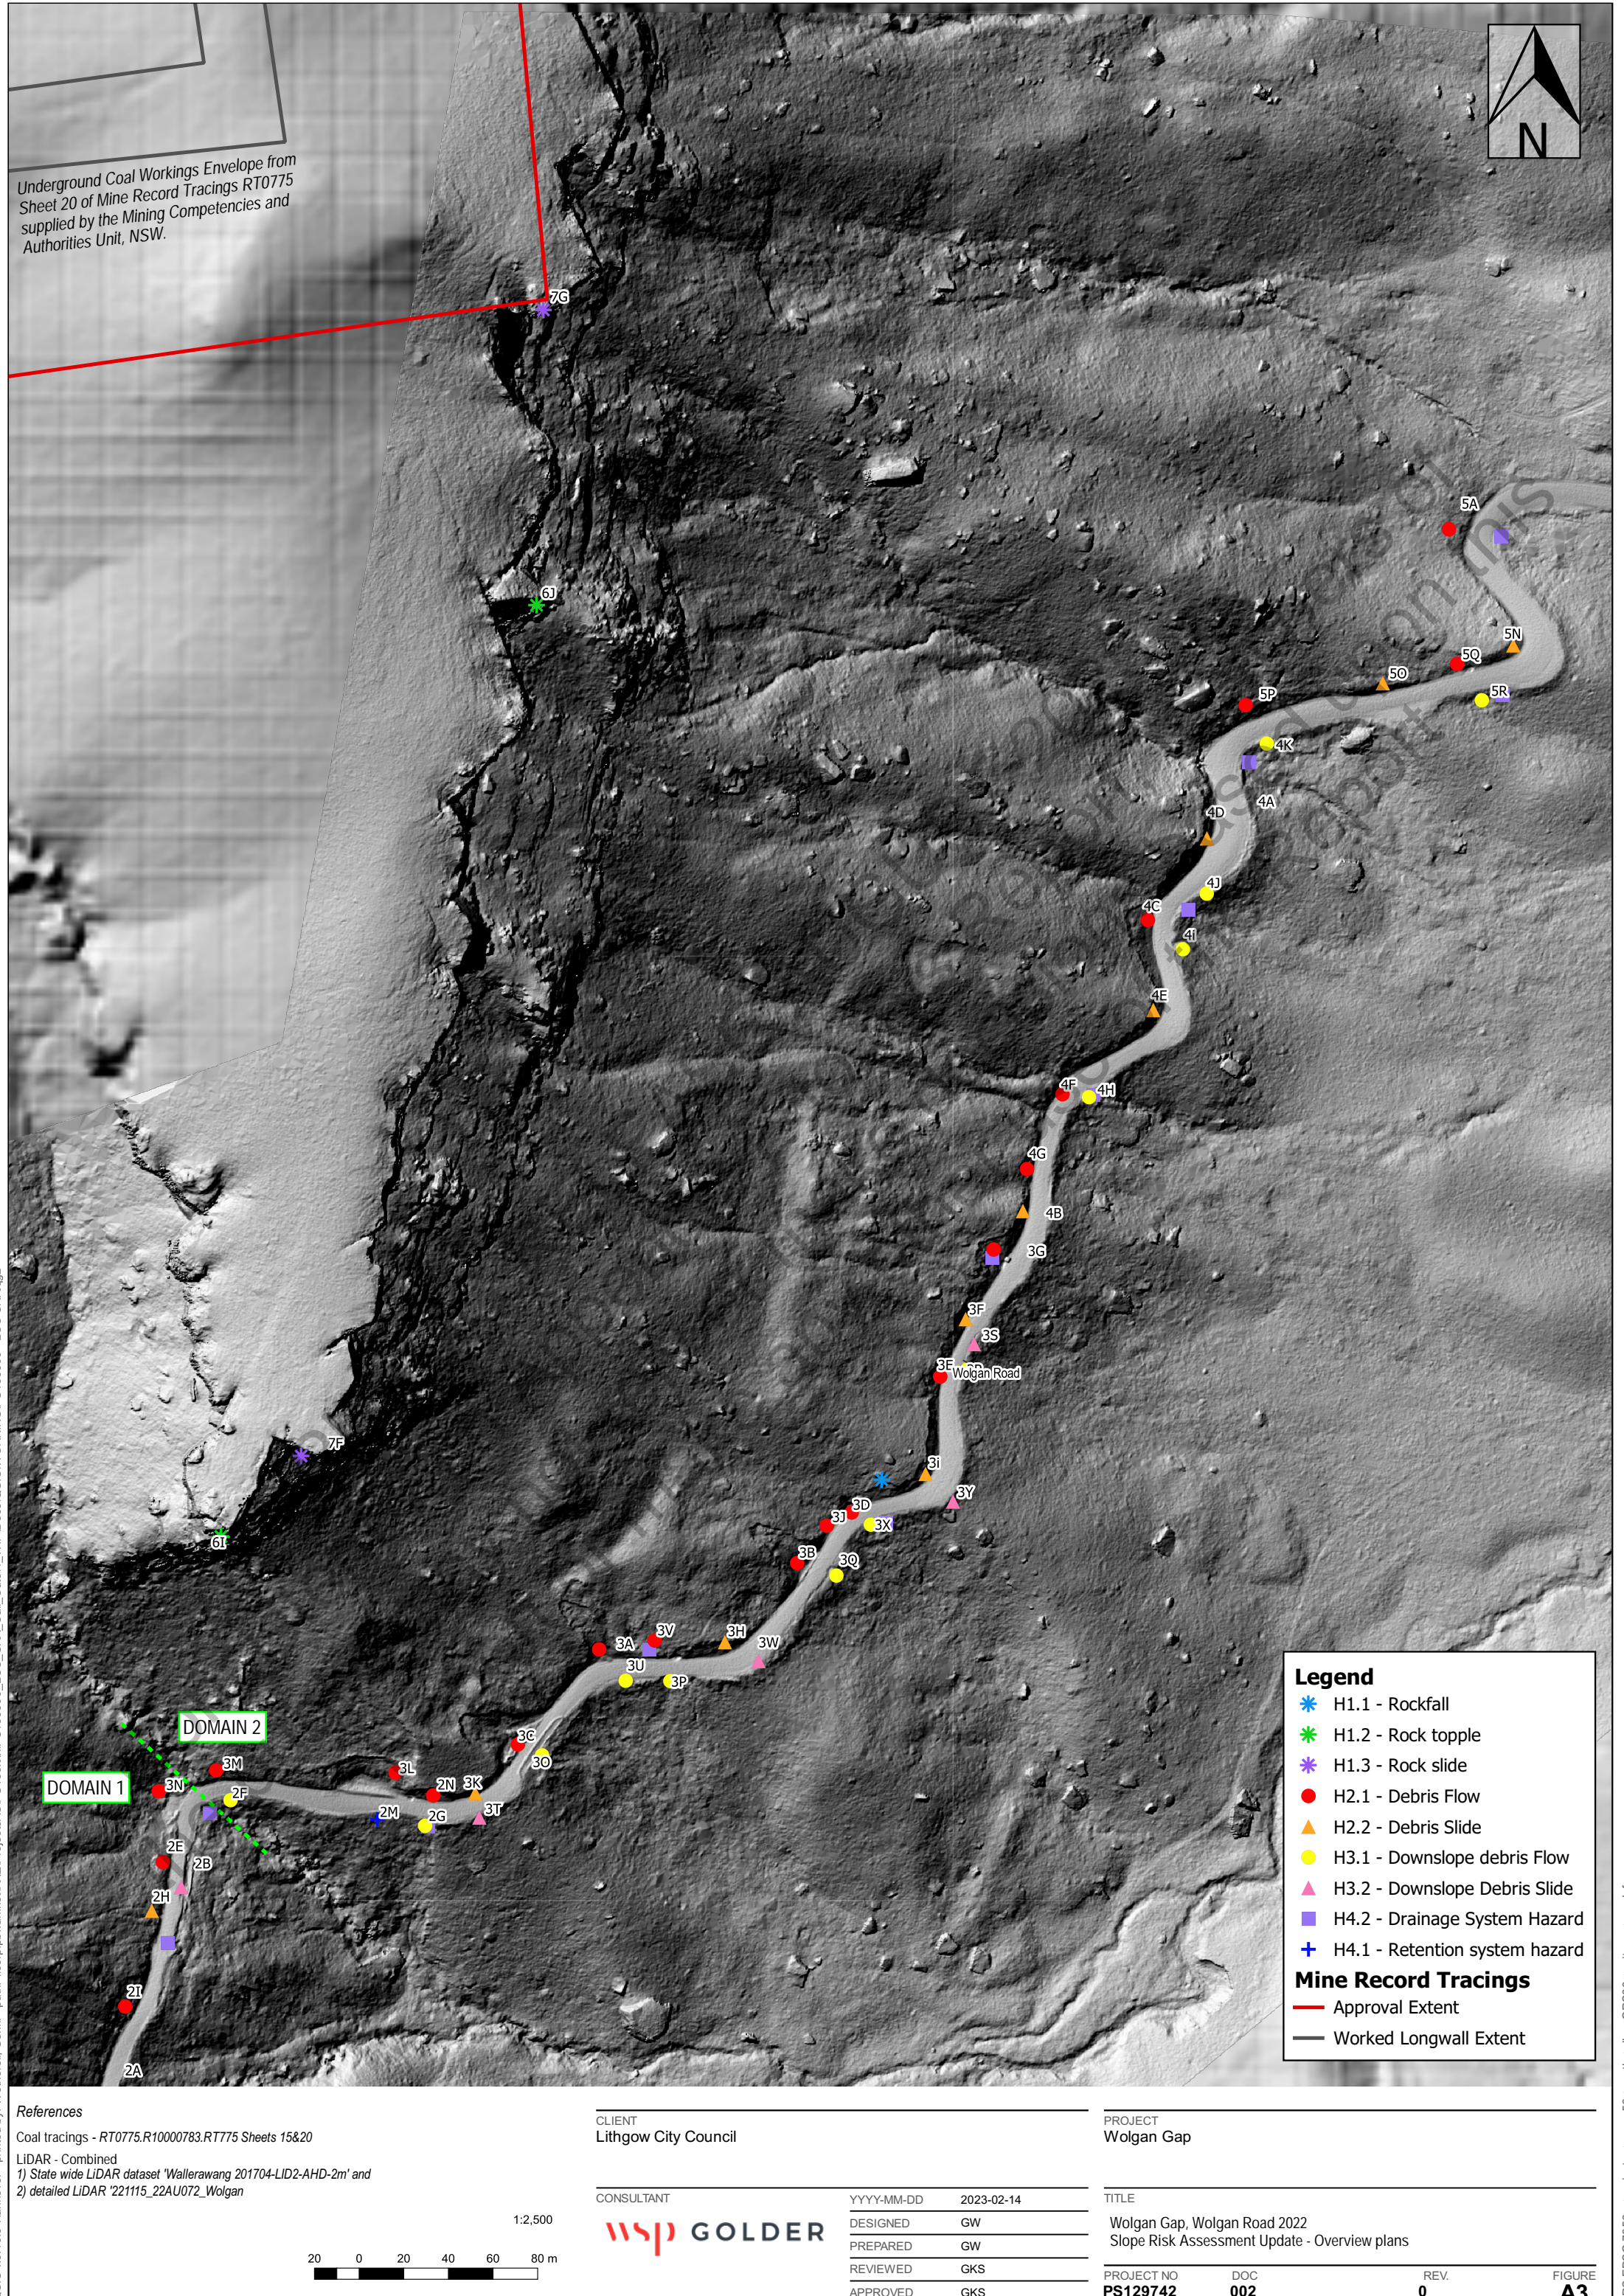
PROJECT NO	DOC	REV.	FIGURE
PS129742	002	0	A2

Prior to 2022, the dominant slope hazard affecting the Wolgan Road at Wolgan Gap was rockfall with an upslope source zone in the area described as Domain 1 herein (i.e. up to approximately 700 m north of the Wolgan Gap lookout) and shown on Figure A2 of Appendix A.
