FINAL REPORT

Stage 1 Environmental Site Assessment

Lithgow Mountain Bike Park, State Mine Gully Road, State Mine Gully, Lithgow NSW

11 August 2025

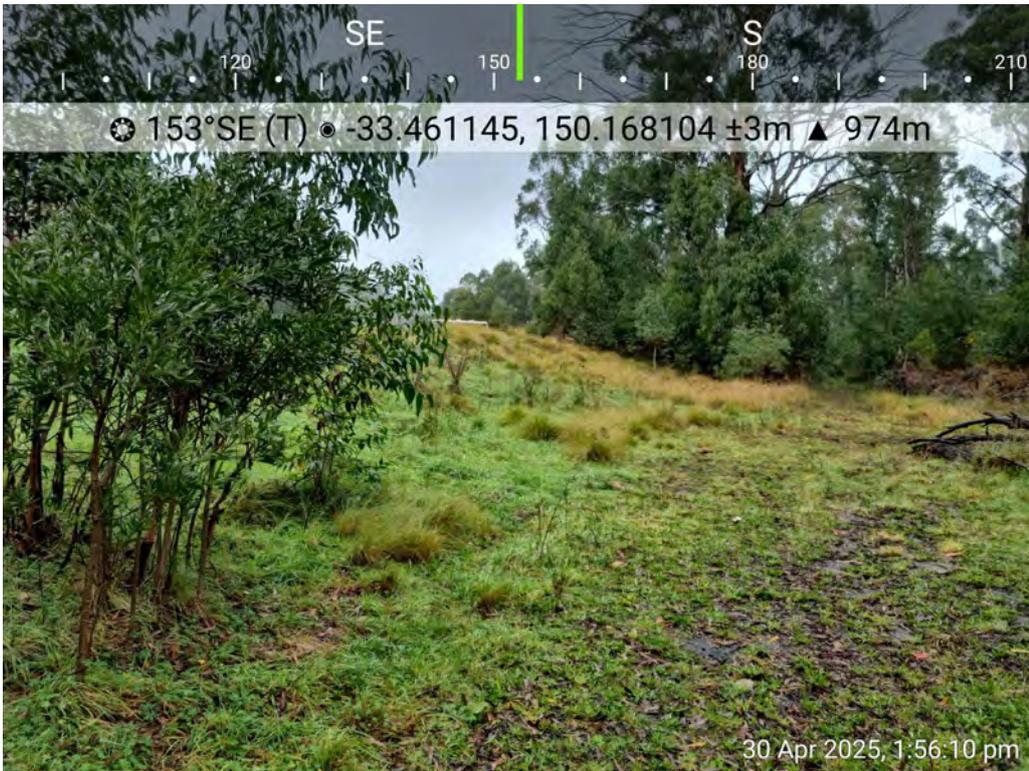
Plate 5: View of western edge of mounded area which forms part of the Site – looking SE

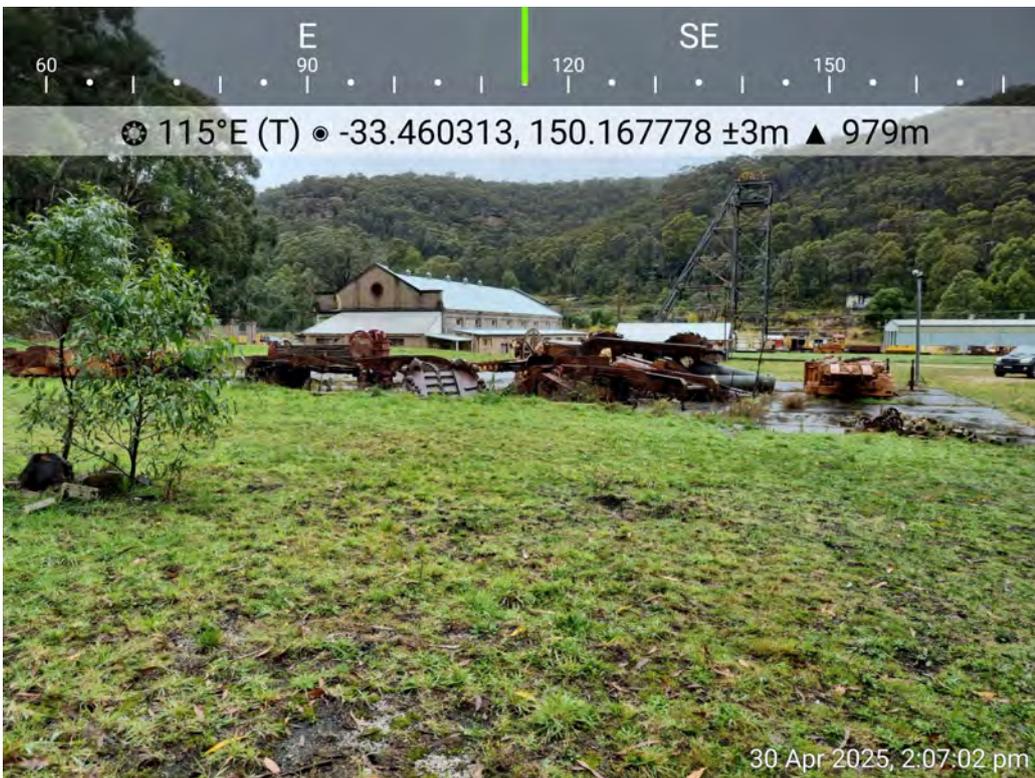
Plate 18: View of former bath house and power house building on State Mine Heritage Park from western area of Park – looking ESE

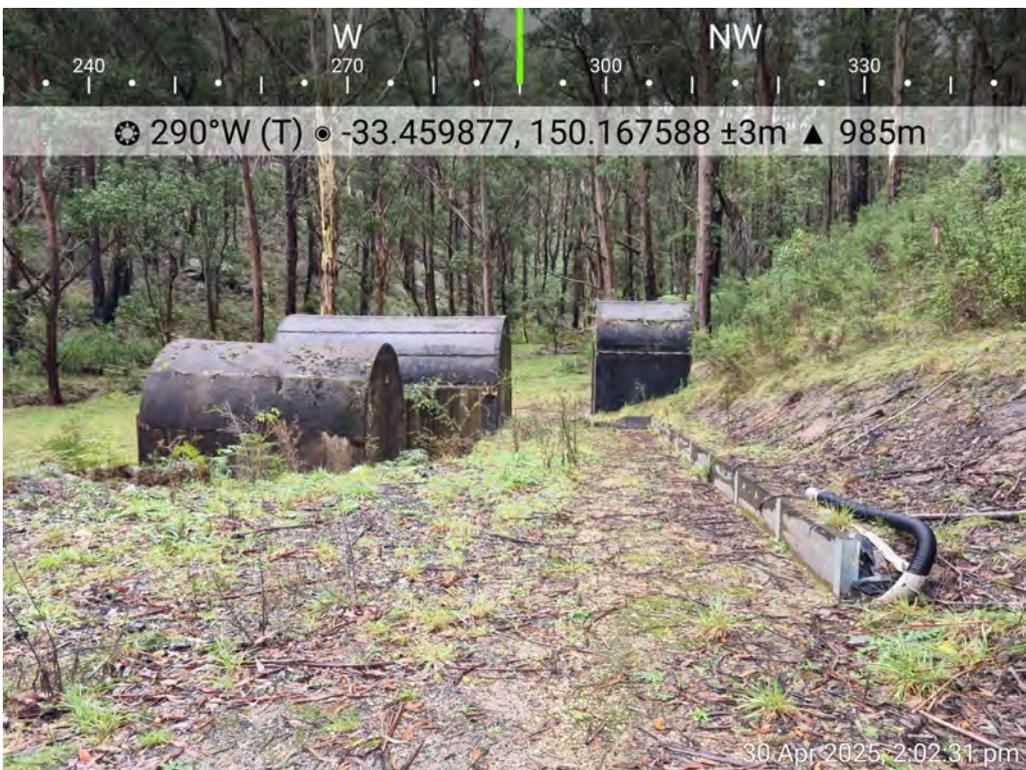
Plate 20: View of former magazine huts located on western area of State Mine Heritage Park – looking W

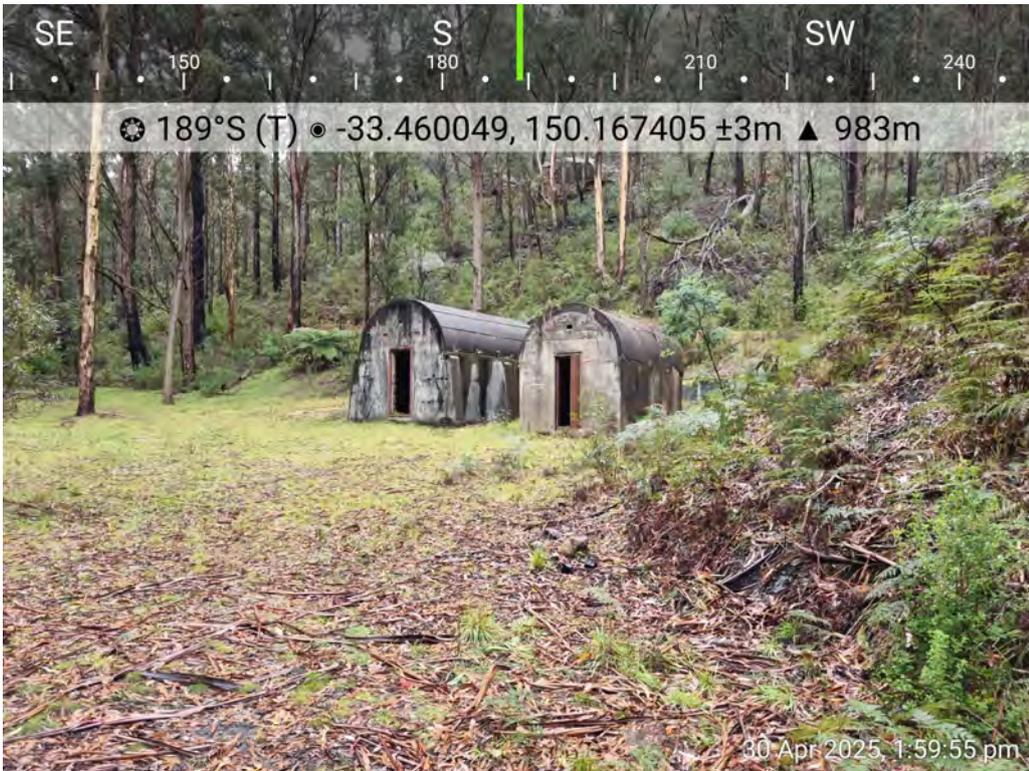
Plate 21: View of frontage of magazine huts in Plate 20 looking S

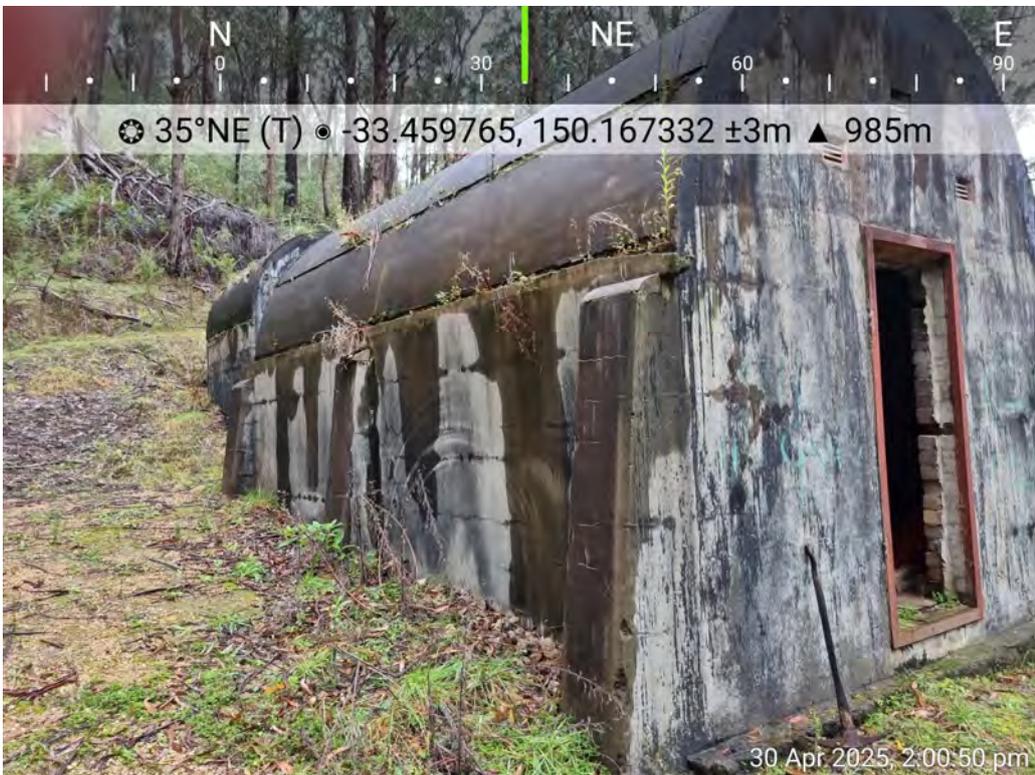
Plate 22: View of side of magazine huts – looking NE

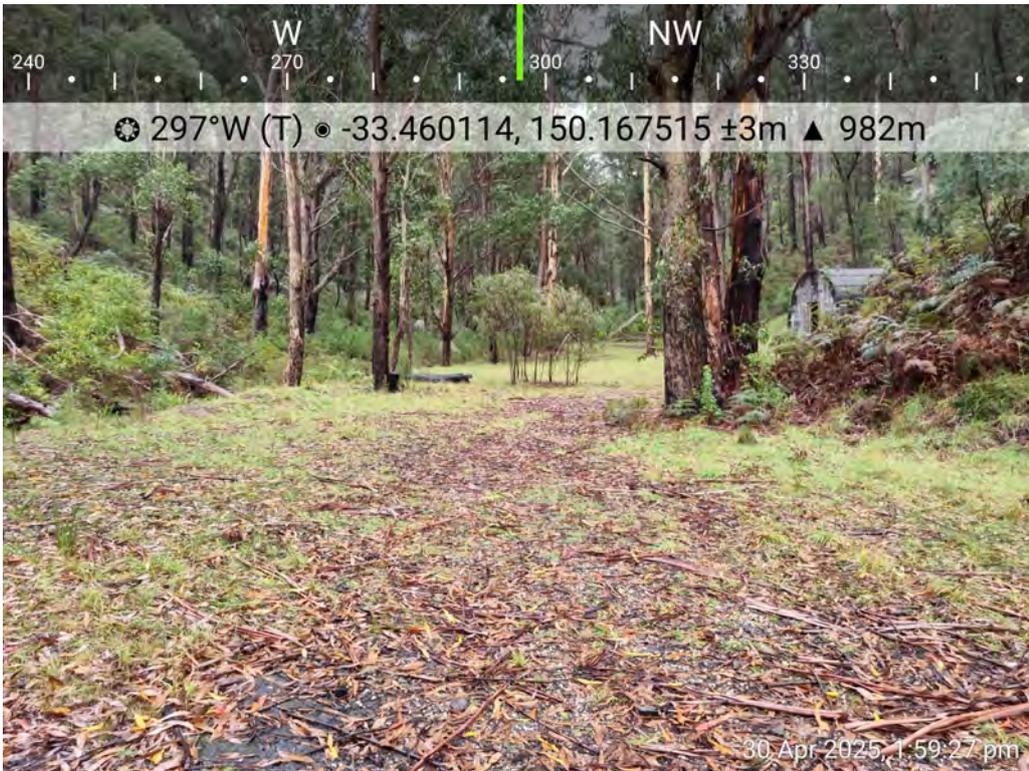
Plate 23: View of cleared area that provides access to the magazine huts – looking WNW

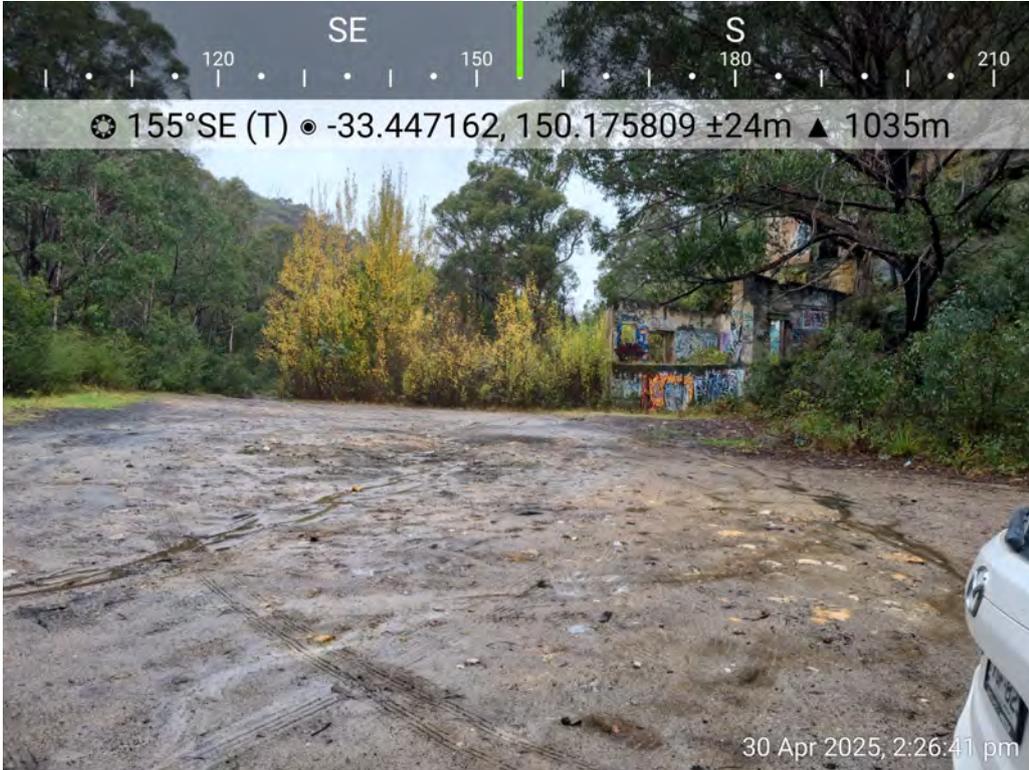
Plate 31: View of cleared area where former mine shaft operated a few km to north along State Mine Gully Road from the mine site remnant structures can be seen. Location for proposed 2nd shuttle bus stop – looking SSE

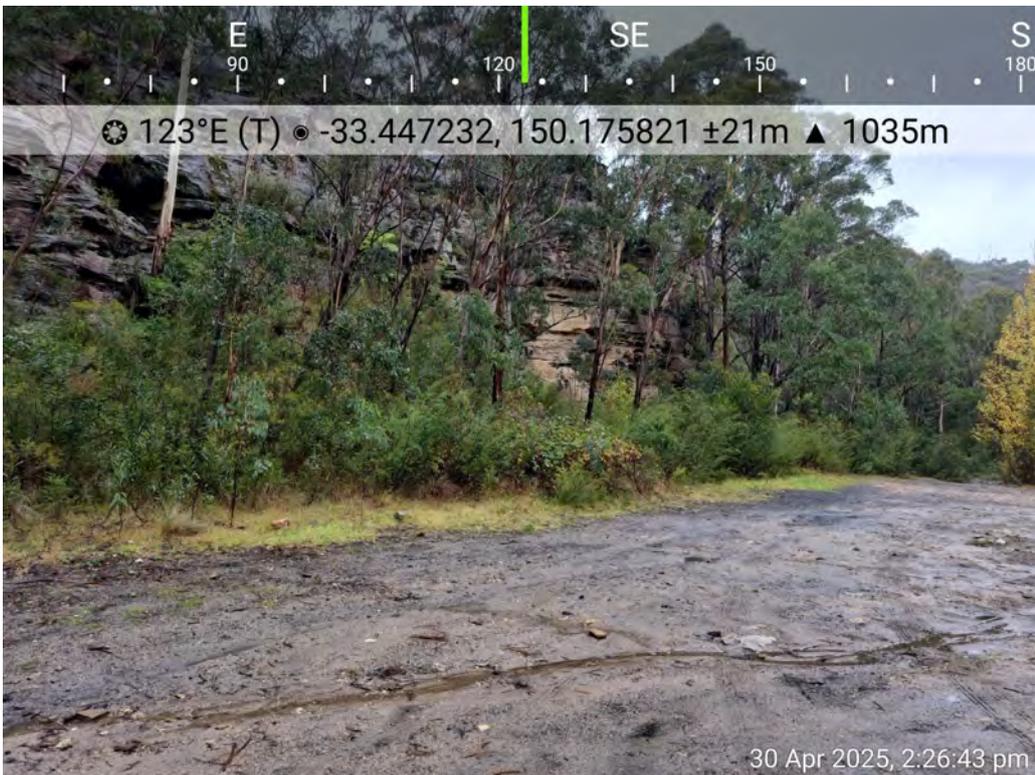
Plate 32: View of sandstone cliff where former mine shaft operated – same location as Plate 31

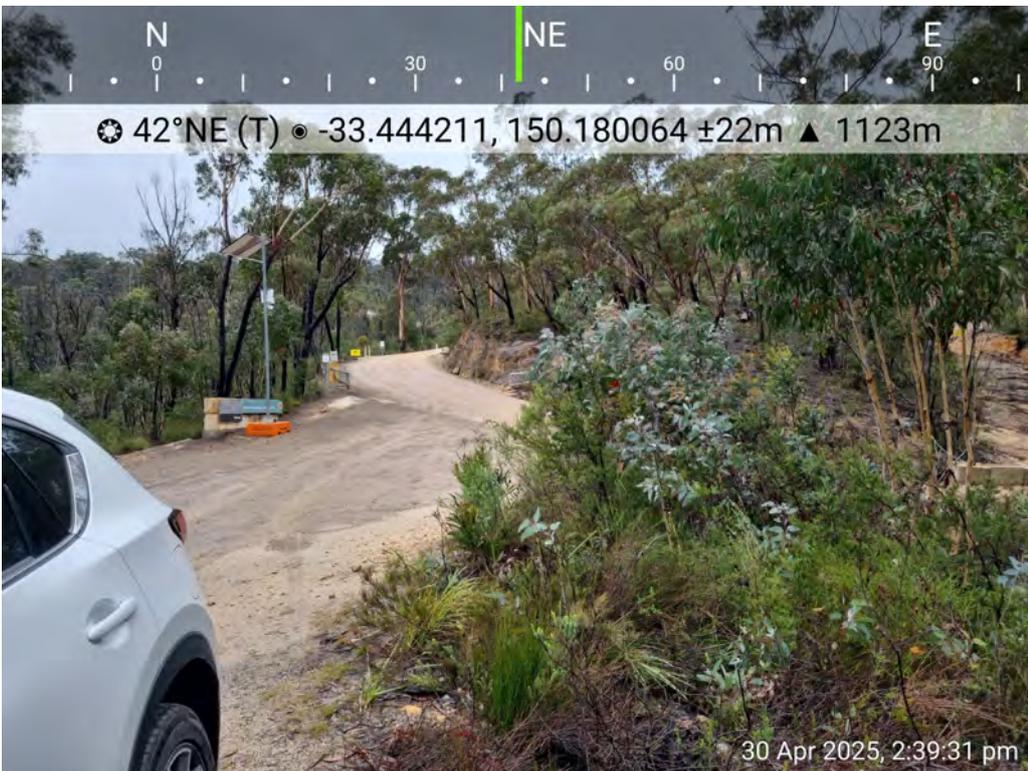
Plate 40: View of cleared area used for parking at area proposed for Secondary Trailhead location at the northern extent of the Site off State Mine Gully Road, which continues to the national park further to the north – looking NE

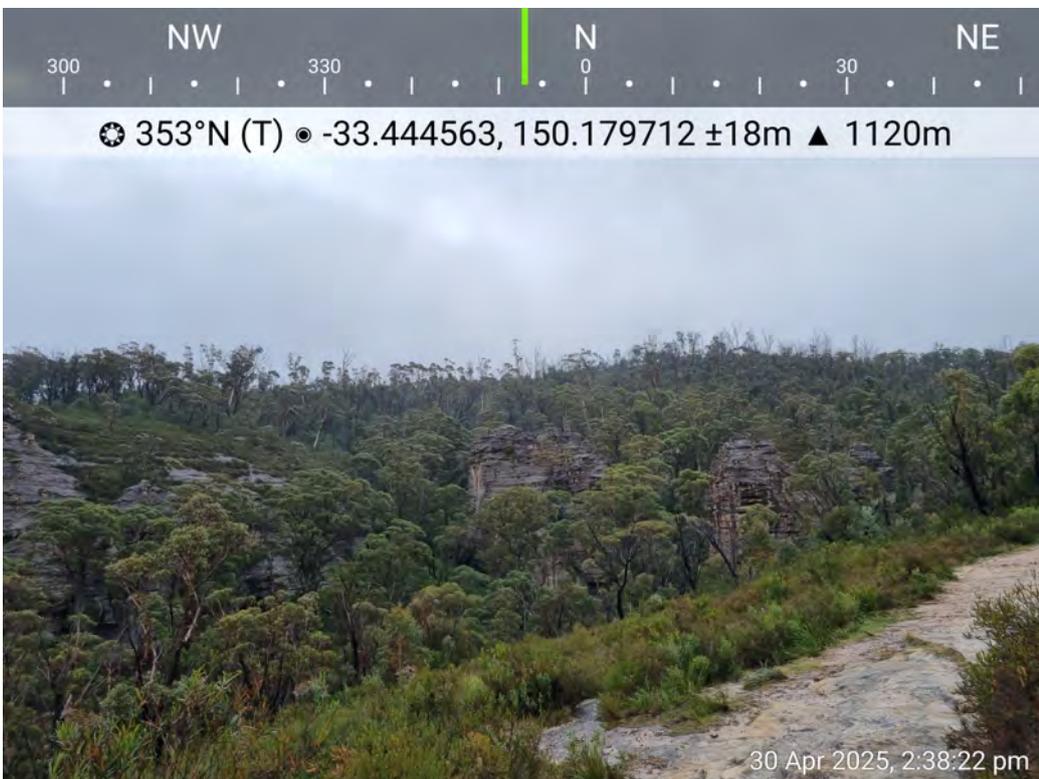
Plate 42: View across upper higher areas of Site from area off Secondary Trailhead location – looking N

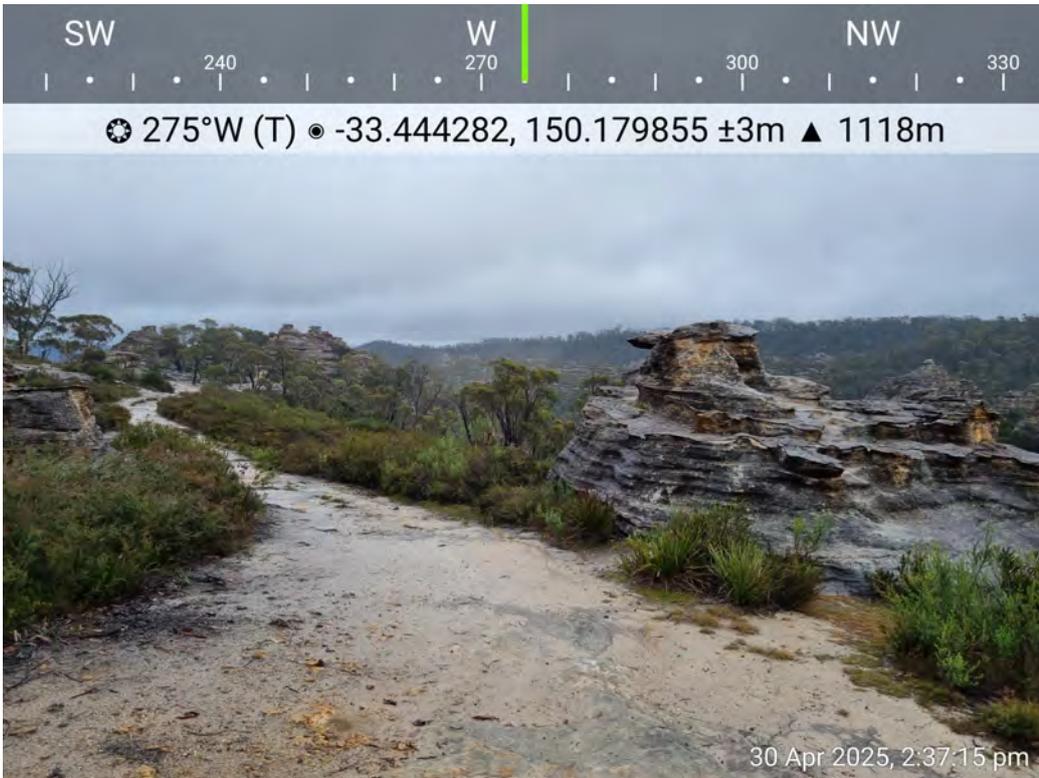
Plate 43: View across upper higher areas of Site from area off Secondary Trailhead location – looking W

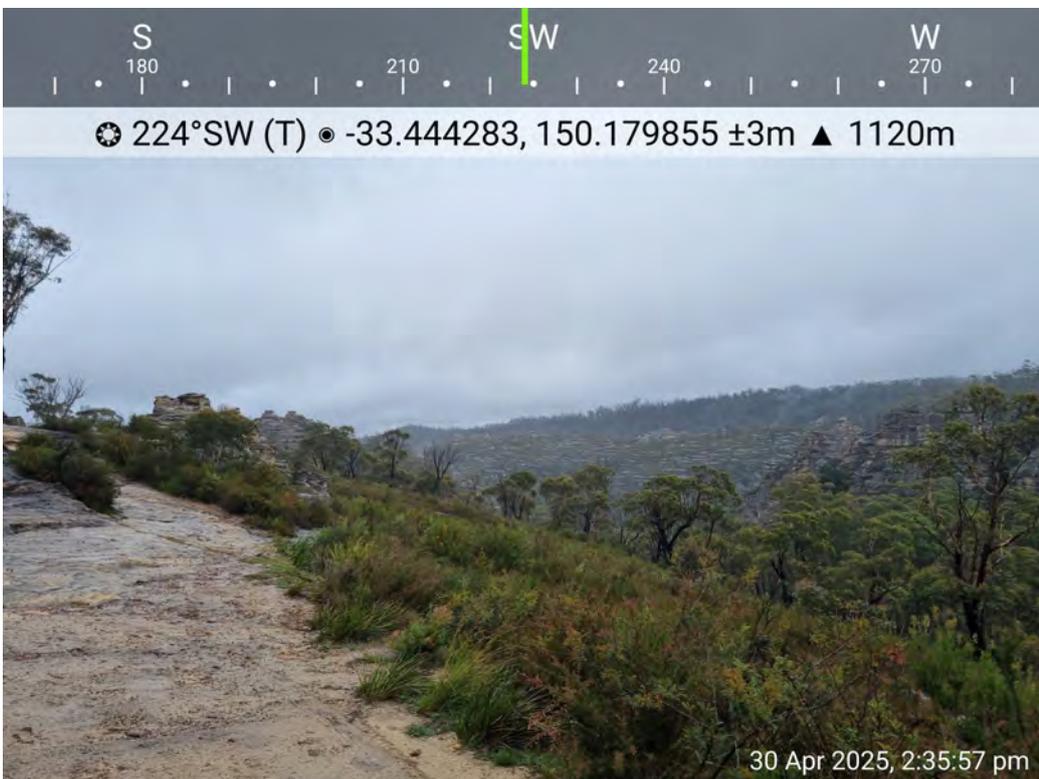
Plate 44: View across upper higher areas of Site from area off Secondary Trailhead location – looking SW

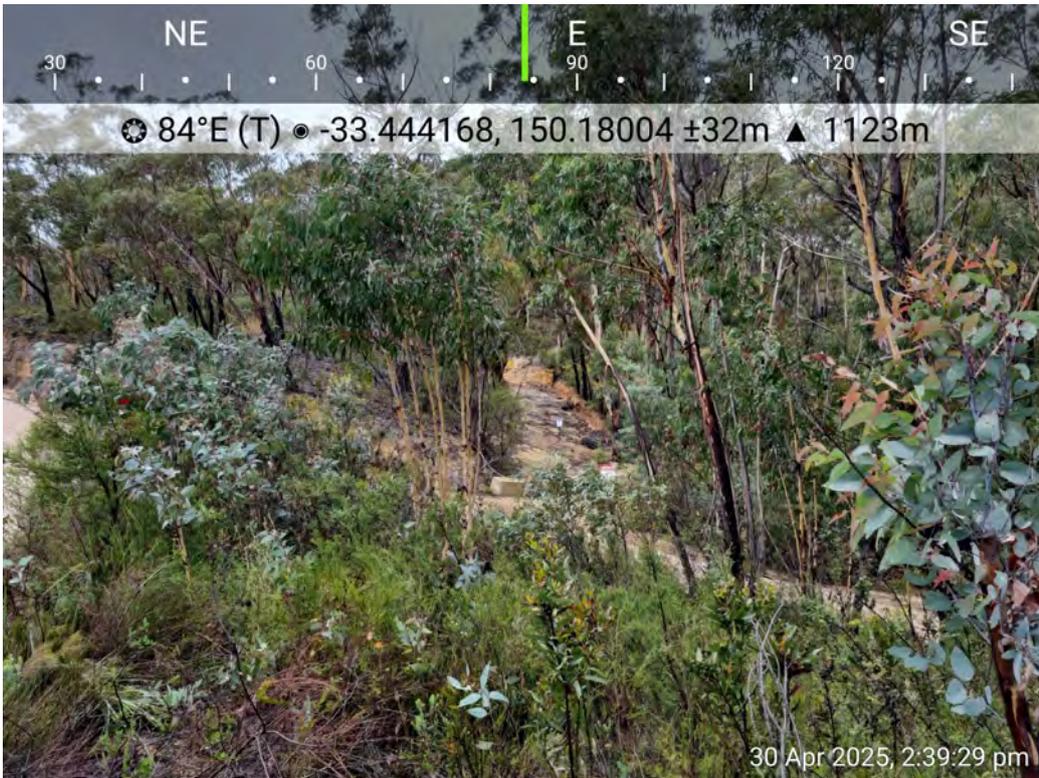
Plate 45: View of bush and fire trail on Site from area off Secondary Trailhead location – looking E
